Concrete Overlay Performance on Iowa's Roadways

**Field Data Report
July 2017**

National Concrete Pavement
Technology Center

Sponsored by
Iowa Highway Research Board
(IHRB Project TR-698)
Iowa Department of Transportation
(InTrans Project 15-559)

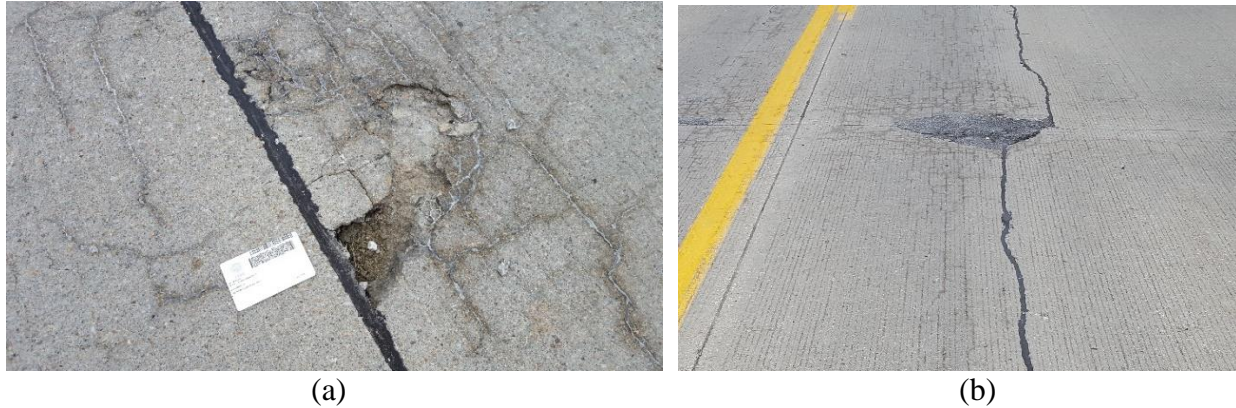
Distresses related to material deficiencies were the most common cause of performance drop based on the field reviews. The most extensive material-related distresses were observed on Pottawattamie County Highways L-34 and L-66. Areas of both overlays exhibited map- or web-shaped cracking, suggesting issues with aggregate durability (D-cracking) or reactivity (ASR). These distresses are shown in Figure 75(a). Joint deterioration was also observed on the Pottawattamie County projects, including the example shown in Figure 75(b) at the intersection of a transverse joint and longitudinal crack.

Figure 75. Material durability-related distresses on (a) Pottawattamie County L-34 and (b) Pottawattamie County L-66 (November 2016)

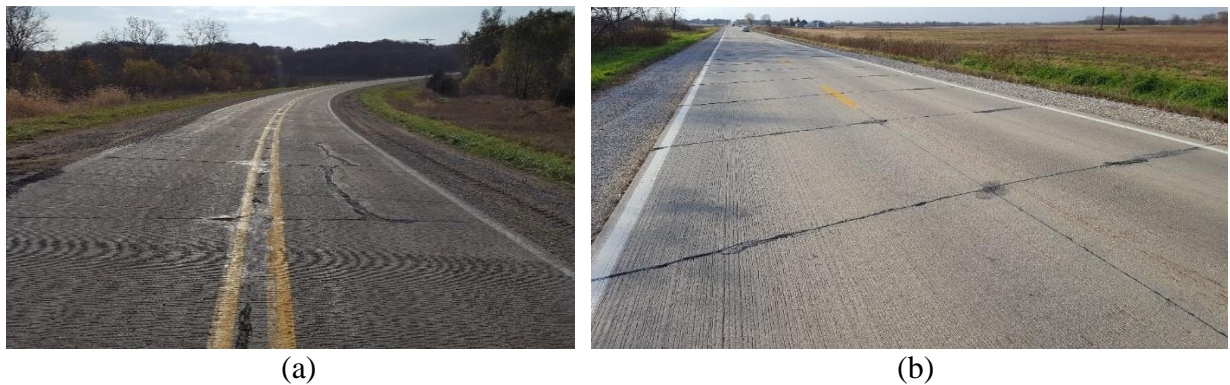
A pair of overlays in Dallas County on separate sections of County Highway F-31 west of Minburn and west of Granger also exhibited MRD in the form of joint deterioration (see Figure 76).

Figure 76. Joint deterioration on Dallas County F-31 at sections (a) west of Minburn and (b) west of Granger (November 2016)

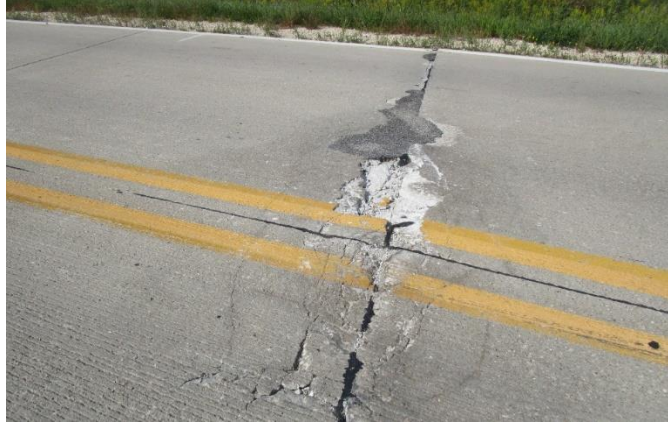
Another issue observed during field reviews was rough ride. In one area of study on North 10th Street in Linn County, the rough ride appeared to be the result of faulted dominant joints at an interval of about every three slabs. The faulting at these joints caused significant ride roughness and occasionally appeared to result in joint deterioration, as shown in Figure 77.

Figure 77. Joint deterioration on North 10th Street in Linn County (September 2016)

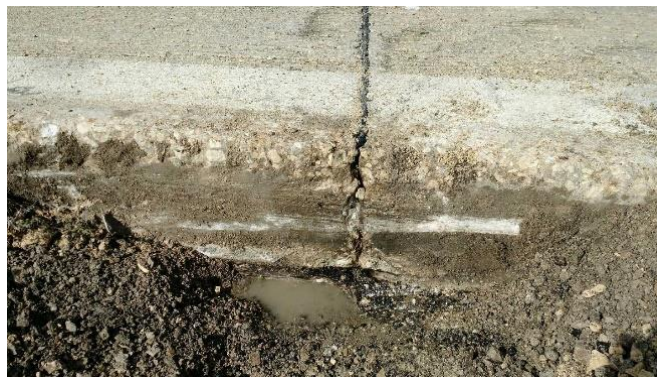
The exact cause of the faulted joints and accompanying distress on North 10th Street was unknown. There was suspicion that cracks may not have developed under every transverse joint on the overlay, perhaps leading to the dominant joint behavior at intervals of every three to four slabs. However, when county crews dug along the shoulder to observe the behavior of the transverse joints at the adjacent slabs, they found that cracks did deploy beneath those joints, as shown in Figure 78.

Figure 78. Crack deployment in joint adjacent to blowup

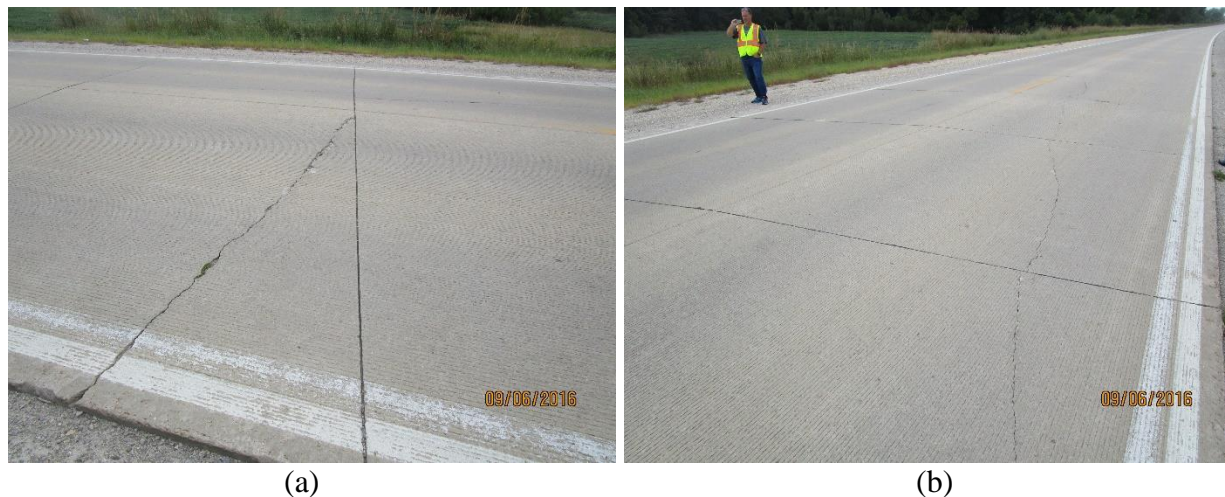
Finally, there were some projects that experienced significant amounts of cracking. Cracking issues were most significant on Blairs Ferry Road in Linn County and Dallas County Highway F-90. On Blairs Ferry Road, shown in Figure 79, the transverse and longitudinal cracking patterns appeared to result from loss of support.

Figure 79. (a) Longitudinal and (b) corner cracking on Blairs Ferry Road (September 2016)

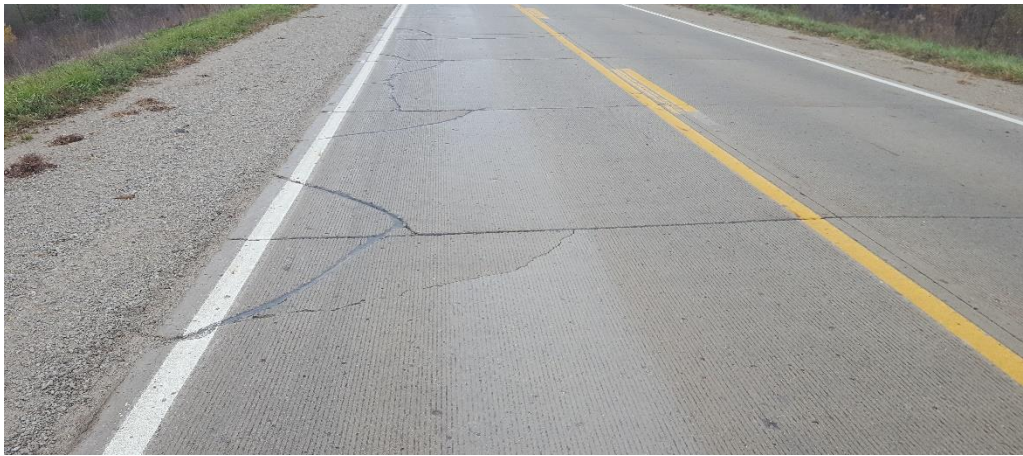
Meanwhile, cracking observed on Dallas County Highway F-90, shown in Figure 80, appeared to be caused by traffic loads.

Figure 80. Cracking on Dallas County F-90 (November 2016)

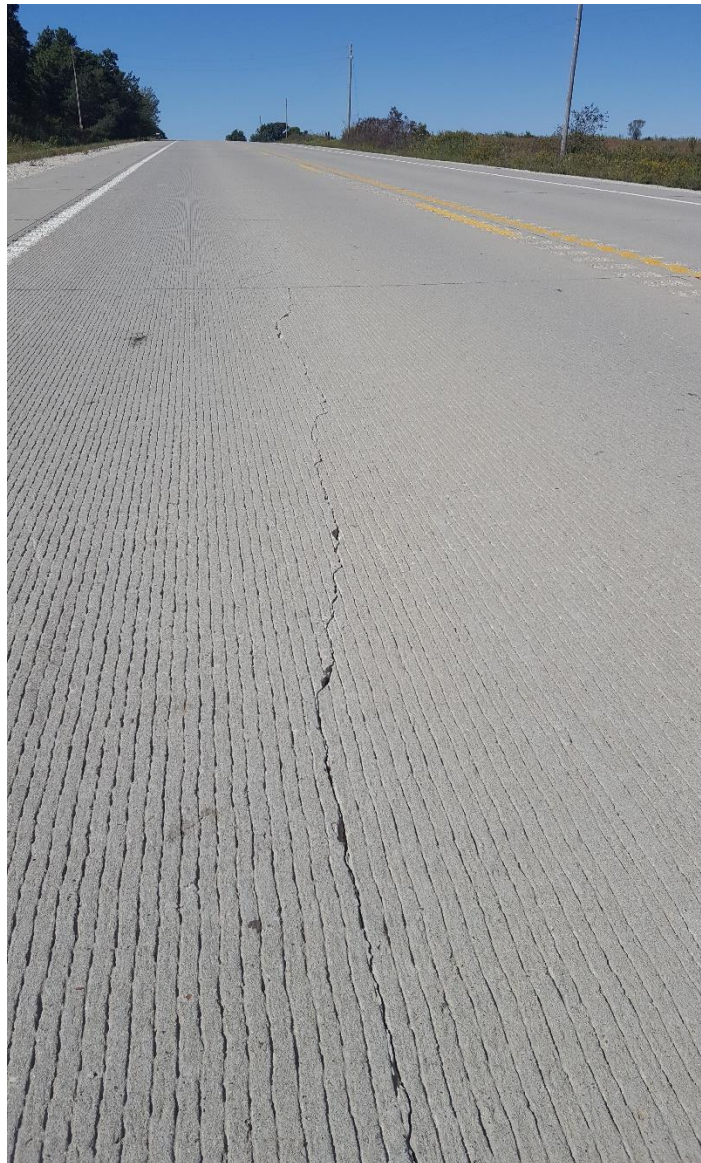
However, even at an age of three years, occasional instances of longitudinal cracking began to develop in this overlay, which can be seen in Figure A.2.

Figure A.2. Longitudinal cracking in Buchanan County D-22, September 2016

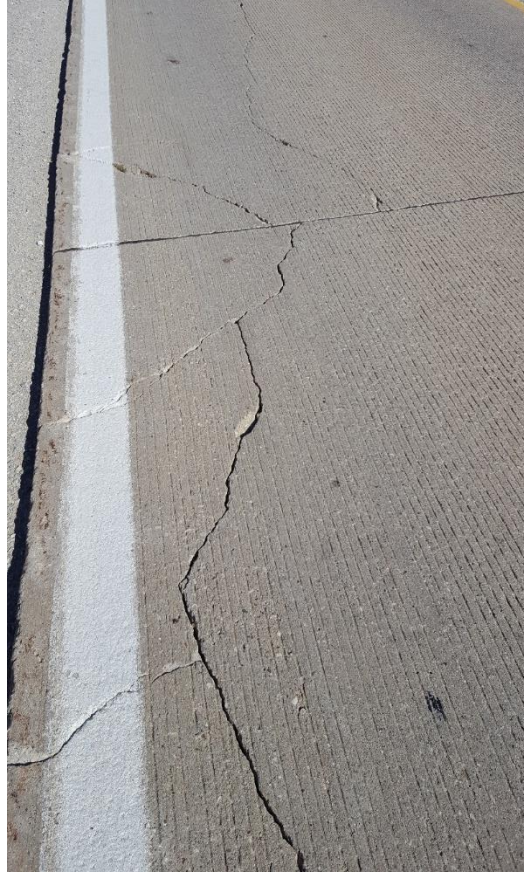
Overall, Buchanan County W-40 was found to be in good condition and the performance metrics were in line with the overall trend of similarly designed overlays (PCI of 85 and IRI of 93.2 in/mi at an age of 8 years). However, some distresses had developed in areas along the southbound pavement edge as shown in Figure A.11.

Figure A.11. Longitudinal and corner cracking at slab edge in southbound lane of Buchanan County W-40, September 2016

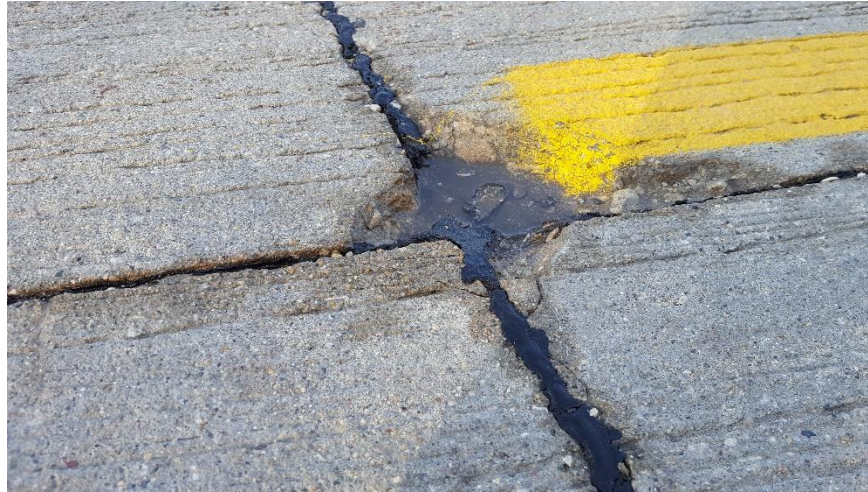
Figure A.18. Water at spalled joint and adjacent joint shadowing on Dallas County F-31 west of Granger, November 2016

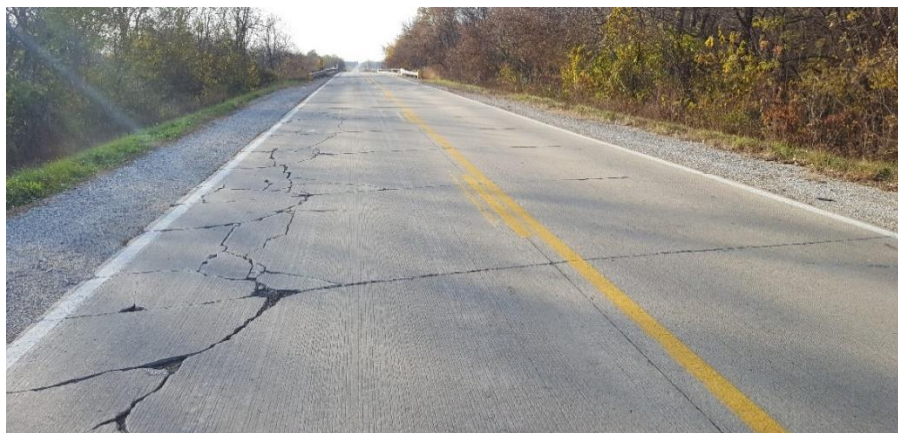
Figure A.19. Cracking at slab edge approaching creek crossing on Dallas County F-31 west of Granger, November 2016

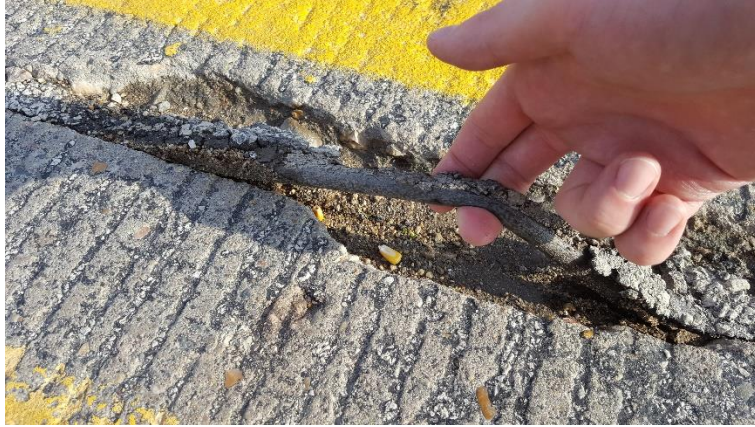
Figure A.23. Deterioration around and underneath the backer rod on Dallas County F-31 west of Minburn, November 2016

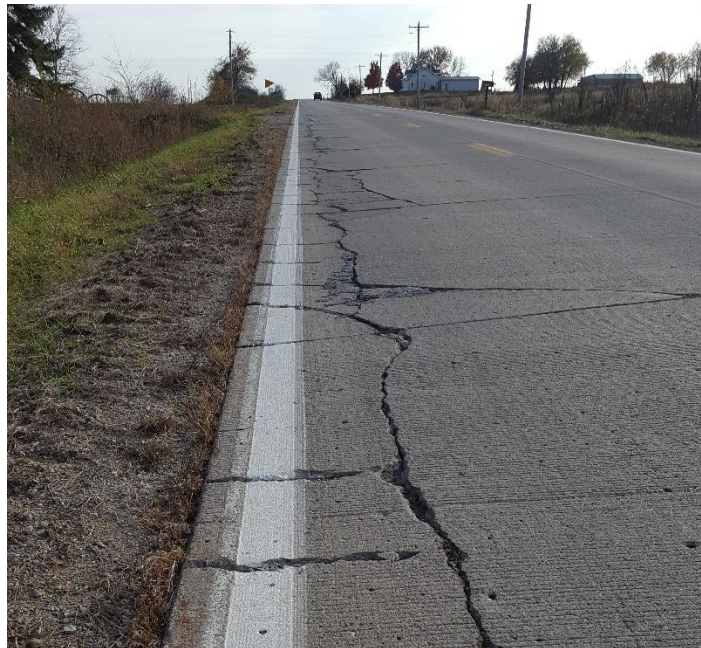
Figure A.30. Loss of support along pavement edge on Dallas County R-22, November 2016

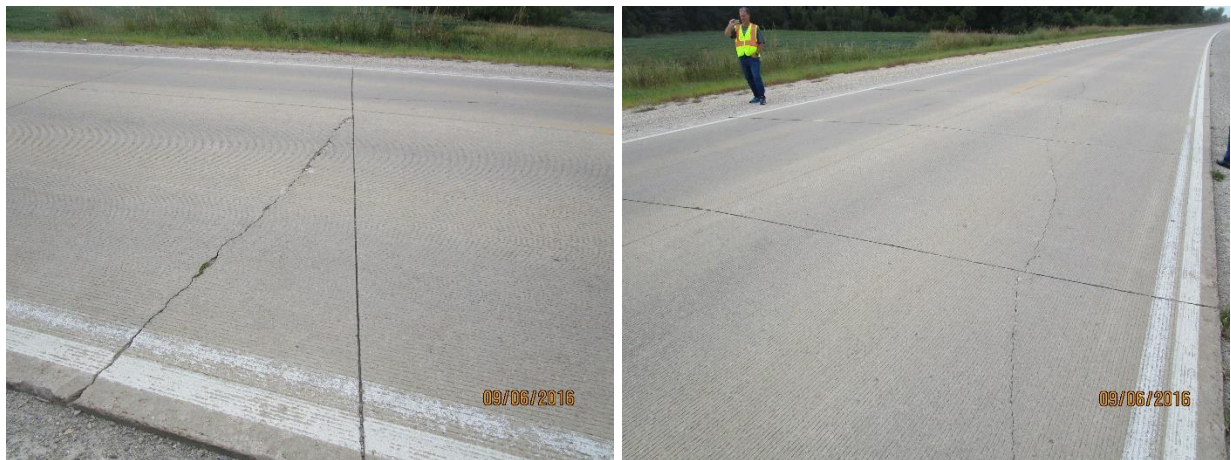
Figure A.32. Longitudinal and corner cracking on Linn County Blairs Ferry Road, September 2016

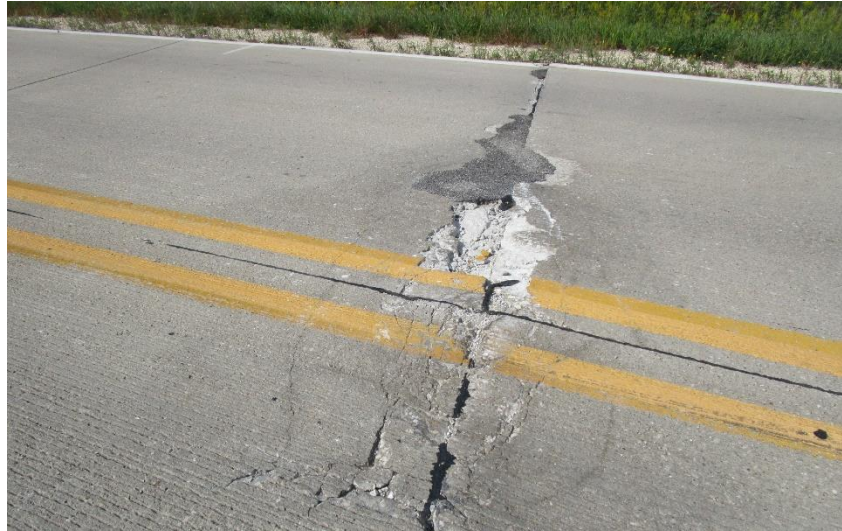
Figure A.36. Joint deterioration on Linn County North 10th Street, September 2016

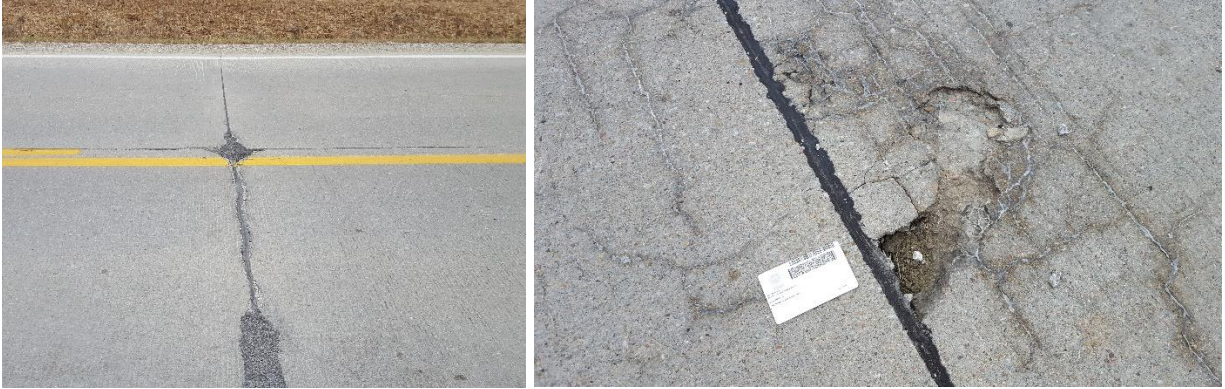
Figure A.44. Apparent material-related distresses at joints on Pottawattamie County L-34, November 2016

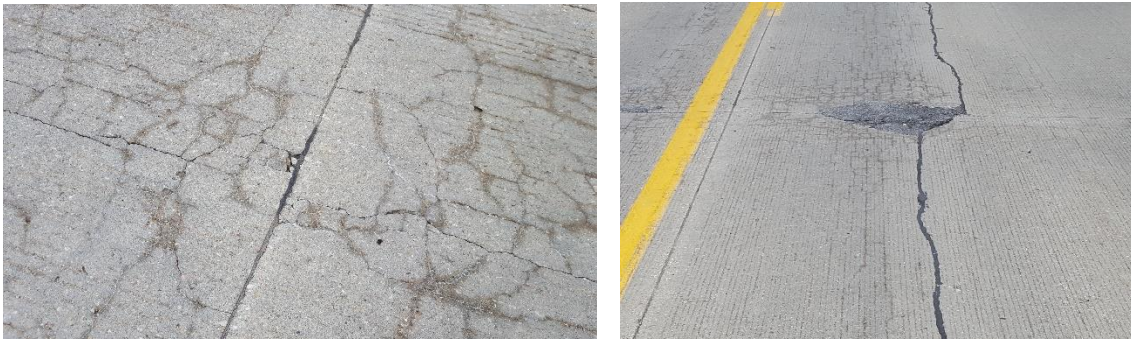
Figure A.48. Materials-related distresses on Pottawattamie County L-66, November 2016

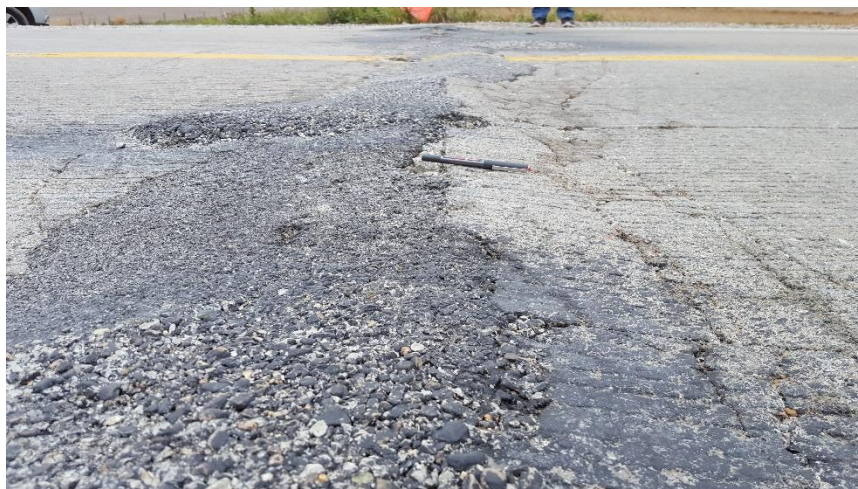
Figure A.49. Apparent blow-up on Pottawattamie County L-66, November 2016
