Tools to Improve PCC Pavement Smoothness During Construction (R06E)

# **FIELD REPORT: IOWA EQUIPMENT LOAN**

The equipment loan was performed in April 2016 on a project in Lyon County, Iowa. Table 1 summarizes the pertinent project details.

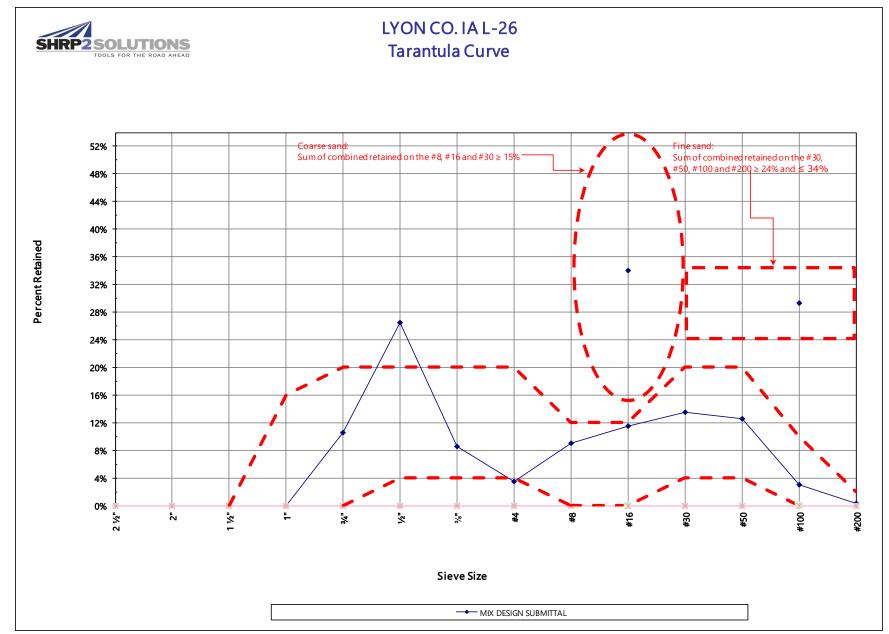
Figure 7. Lyon Co. L-26 Combined Percent Retained (Tarantula Curve)

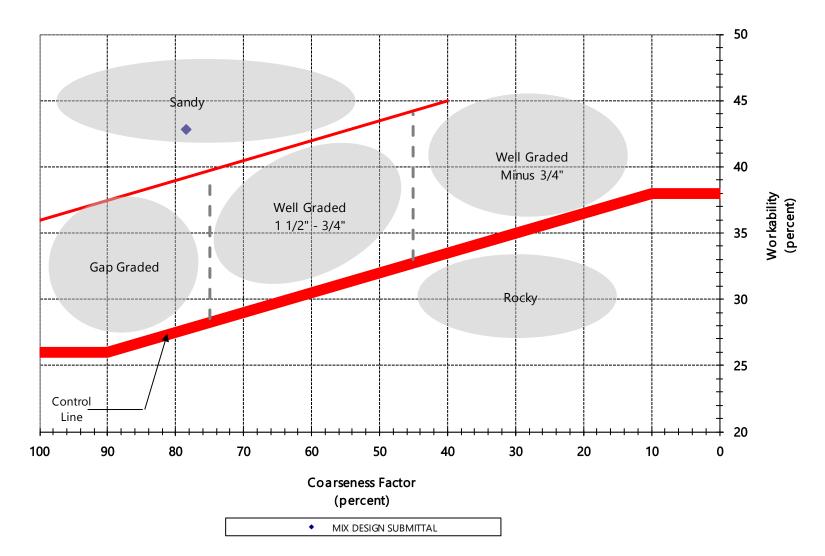
Figure 8. Lyon Co. L-26 Combined Gradation Coarseness and Workability Factors

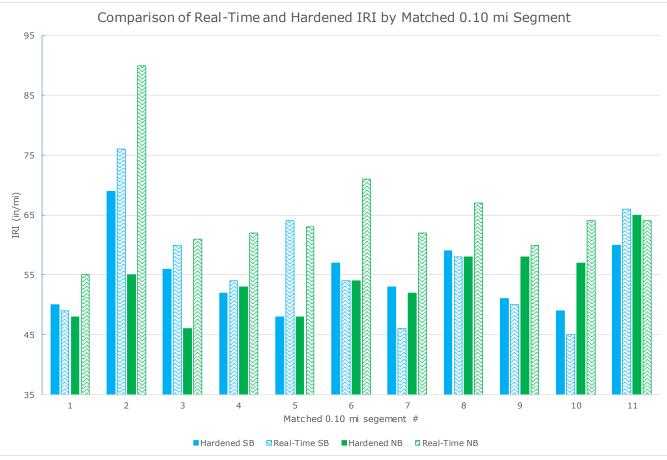
Real-time smoothness measurements tracked closer than normal with hardened profile results. This is likely due to the fact that there is no embedded steel in any of the joints. A comparison of the first three days of profile results is shown in Table 5 and Figure 9.

Figure 9. Real-Time and Hardened IRI for Matched Profile Sections

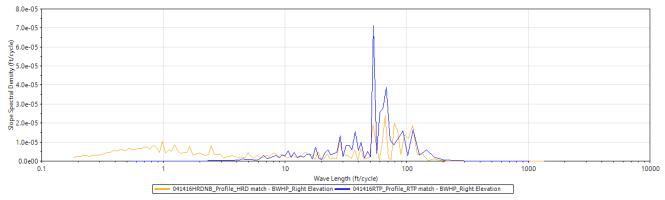
The power spectral density analysis (PSD) from ProVAL shows no shorter wavelength repeating features in either the real-time or hardened profiles (Figure 10). This again is likely due to the fact that there is no embedded steel in any of the joints and minimal curling and warping as a result of the small slab dimensions (6' x 6'). There is a repeating feature with a wavelength of approximately 55' which is more pronounced in the real-time profile than the hardened profile. The root cause(s) of this roughness was not identified during the equipment loan, one possible source that deserves further investigation is the 3D model,

*Figure 10. PSD Analysis Showing No Shorter Wavelength Repeating Features Contributing to Pavement Roughness*

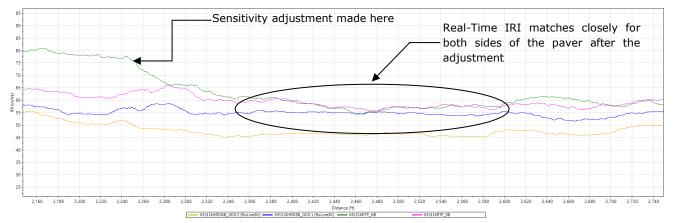
Flynn's years of experience with this paver and reviews of their hardened profile data had taught them that the right side of the paver was consistently rougher than the left side. A slight adjustment was made to the hydraulic sensitivity of the paver on 13APR2016. This adjustment improved the real-time smoothness of the right side and the effect was observable in real-time watching the localized roughness screen of the RTP display. The impact on hardened IRI is not discernable (Figure 11), perhaps due to hand finishing or other interfering factors that affect smoothness. Regardless, we know from experience that improving real-time IRI translates to overall lower hardened IRI.

Figure 11. Continuous IRI (528' segment length), Showing Improved Real-Time IRI After an Adjustment to Hydraulic Sensitivity
