Effects of Damage on the Behavior of Pretensioned/Prestressed Concrete Beam (PPCB) Bridges

FRANCESCO M. RUSSO, F. WAYNE KLAIBER, TERRY J. WIPF, AND WILLIAM A. LUNDQUIST

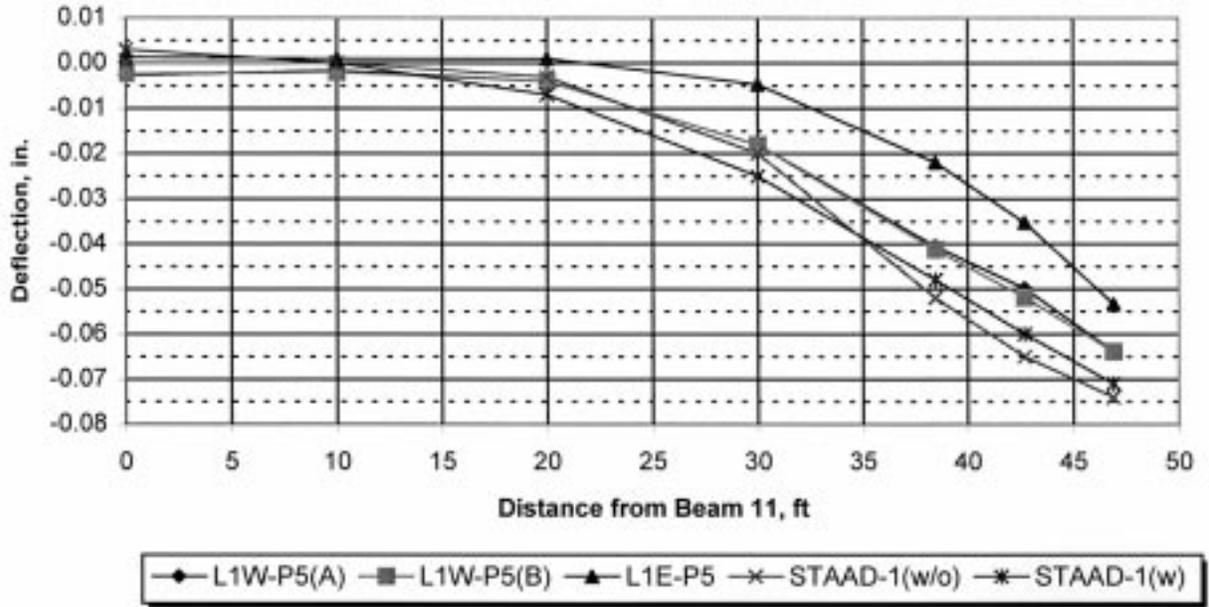
FIGURE 3 Transverse deflection, midspan, center span, lane 1 loaded.

Figure 3 is a plot of several transverse deflected shapes taken at midspan of the damaged center span of the westbound bridge and the complementary location in the eastbound bridge. L1W-P5(A) and (B) are tests performed at the same location of the westbound bridge and illustrate repeatability of the experiment. L1E-P5 is a similar test of the eastbound bridge. The accompanying series entitled STAAD-1 (w/o) and (w) are computer models where the effects of the midspan diaphragm were included (w) or excluded (w/o) from the model. The model presumes that the members are undamaged, there is no edge-stiffening participation from the barrier rail, and that all beam ends are simply supported (i.e. continuity with the tail spans is ignored). It is reasonable to initially assume that there is no continuity because of the lack of pintles in the curved sole plate pier bearings along beam lines 1, 2, 10, and 11, along with the fact that the pier diaphragm does not encase the beam ends.

Figure 3 illustrates several key points. First, there is close agreement between the undamaged analytical models and the behavior of the damaged westbound bridge. This may either indicate that the damage is such that it has no measurable effect on the response of the bridge or that a number of other factors such as barrier rail stiffening or interior beam line continuity result in a deflected shape that appears undamaged. If in fact the analytical model is too "soft," the behavior of a more representative model may tend to more closely match that of the eastbound bridge and one could conclude that the damage was sufficient to alter the behavior of the westbound bridge. Figure 1 also illustrates the negligible change in deflected shape due to the presence of a midspan intermediate diaphragm. This would tend to indicate that the exterior beam line intermediate diaphragms have little effect on overall deflection patterns.

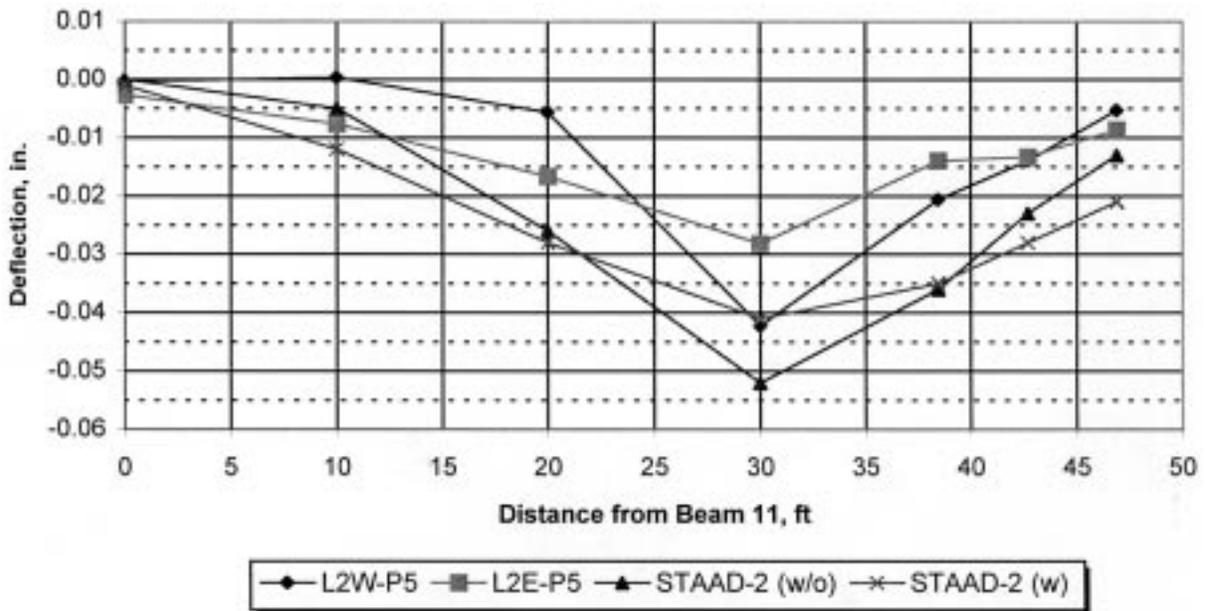
FIGURE 4 Transverse deflection, midspan, center span, lane 2 loaded.

Figure 4 depicts the experimental and analytical transverse response when loads are moved to the second longitudinal lane line. In this figure it is again apparent that the analytical models are more flexible than either of the bridges tested. The westbound bridge appears to be resisting the majority of load in a localized area surrounding the point of application more so than the other scenarios. The presence of intermediate diaphragms has a more pronounced effect on the response than when loads are placed in lane 1.

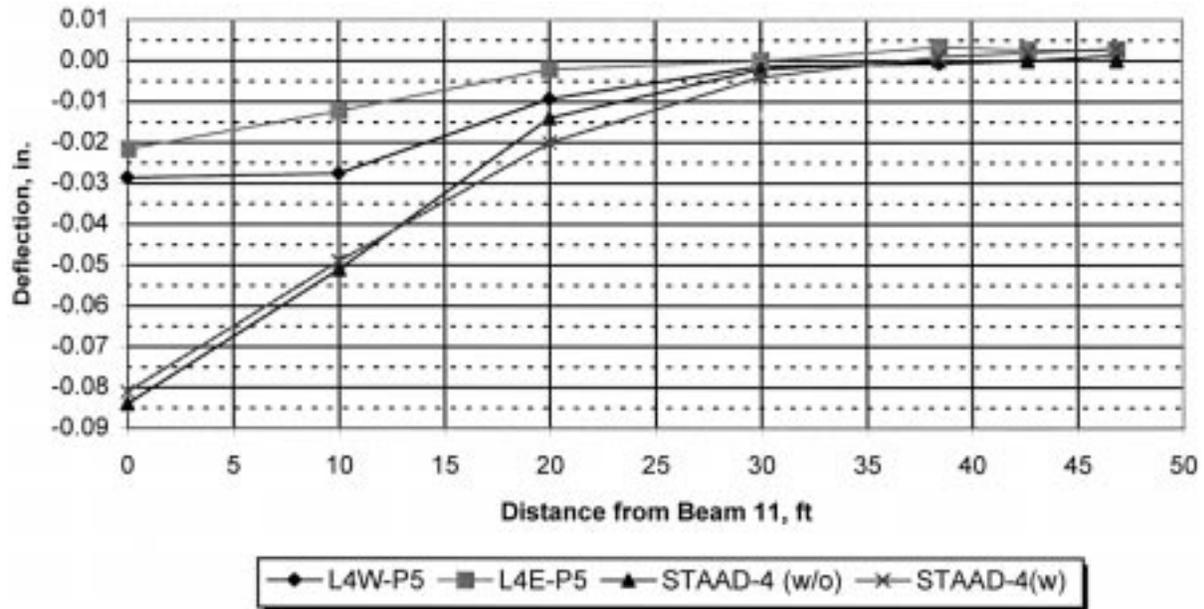
FIGURE 5 Transverse deflection, midspan, center span, lane 4 loaded.

Figure 5 illustrates a large difference in the experimental and analytical responses of the bridges. In this series of tests, truck IA-4280 was positioned to be 2' (610 mm) from the median rail. The damaged region of the westbound bridge would have little to no effect on this load location and the eastbound bridge is not known to be damaged at all. As expected, the bridges behaved similarly with the westbound bridge being somewhat softer in the transverse direction. However, there is a great disparity in the predicted and measured response. The predicted response on the median side is

expectedly larger than on the flared side due to the greater beam spacing. However, both the eastbound and westbound bridges deflected less on their median sides than the flared sides. The only explanation for this behavior is a much stiffer structure than analytically modeled. This stiffness is likely due to barrier rail participation and unaccounted for continuity effects.

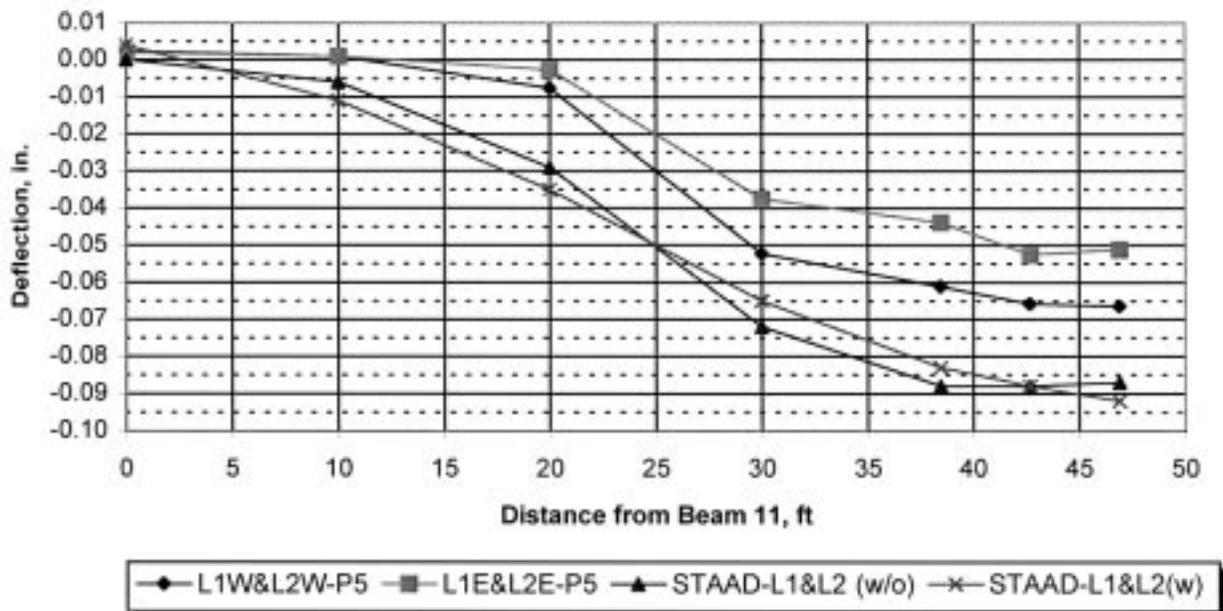
FIGURE 6 Transverse deflection, midspan, center span, lanes 1 and 2 loaded.

Figure 6 presents the analytical and experimental results for the case where both loaded test vehicles were placed side-by-side with their rear tandems at midspan. The westbound bridge appears somewhat softer than the eastbound, but the characteristic shape of the transverse response is the same. The analytical models are once again more flexible than the experimental response. It is of interest

to note that the intermediate diaphragms appear to once again have little effect on the transverse deflected shape (load distribution) pattern of the bridge. The effect is only a slight flattening of the transverse response with a correspondingly small increase in deflection and moment to the exterior beam.
