Best Practices for Bridge Approaches

tech transfer summary

Identification of the Best Practices for the Design, Construction, and Repair of Bridge Approaches (TR-481)

January 2005

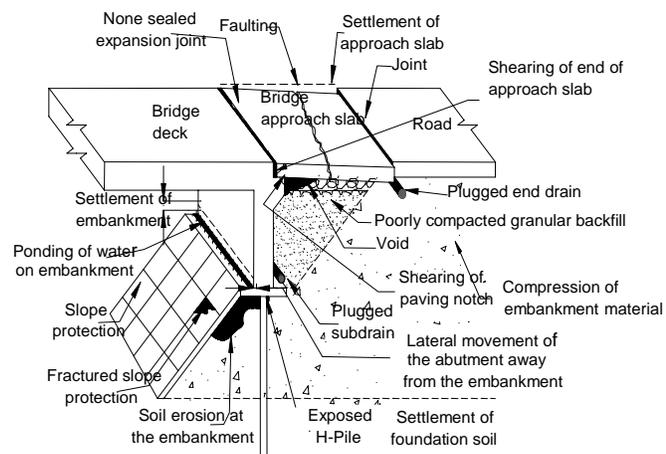
Common problems at bridge sites

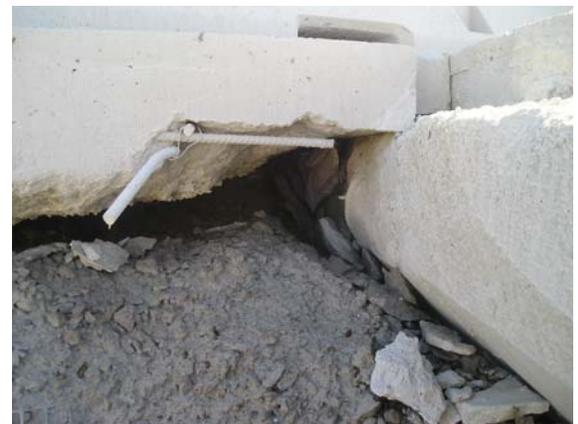
- Void development under the bridge approach was commonly observed on bridges within one year of construction, indicating insufficiently compacted and erodible backfill material.

A 9-inch void under the approach slab and spalling of concrete from the paving notch and the approach slab

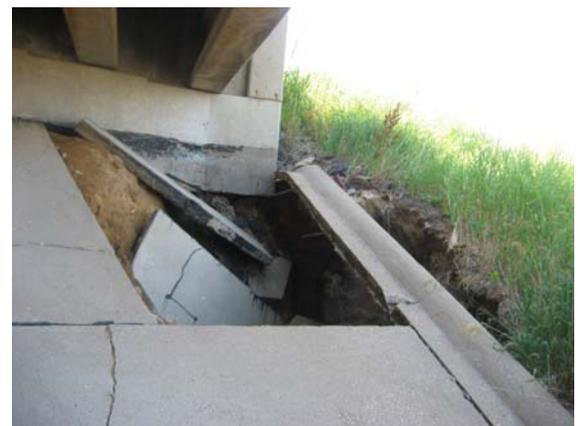
- Inadequate drainage, or otherwise poor water management, was a major problem at most of the bridges inspected. Erosion leads to void development under the approach slab, faulting of the approach slab, and failure of slope protection, and exposes the H-pile supporting the abutments, which can contribute to corrosion.

Failure of concrete slope protection due to erosion

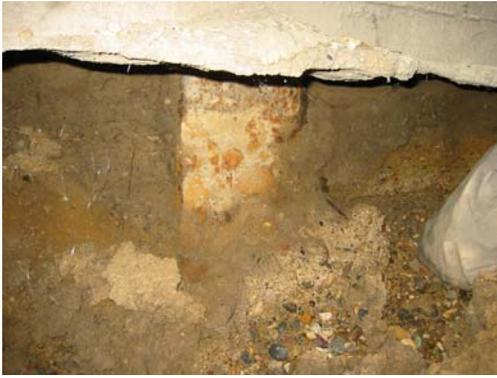
Exposed H-pile caused by soil erosion under the abutment

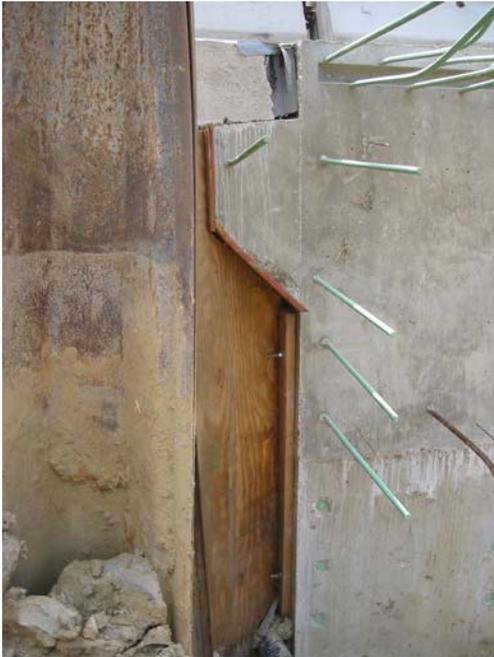
Inclined paving notch observed during construction of a new bridge

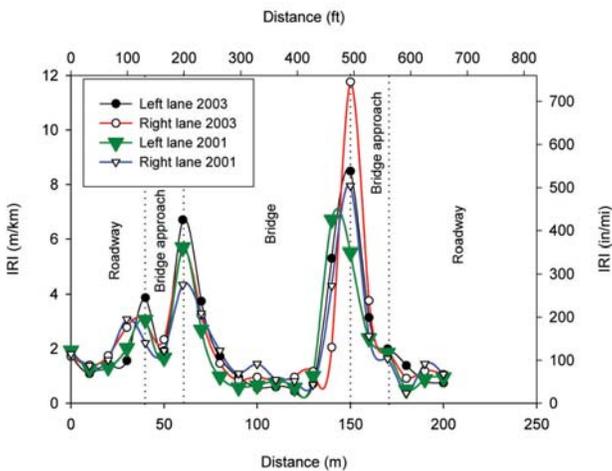
Increase of IRI with time

- Maximum values of IRI were observed at the transition between the bridge and the approach slab, and the approach slab EF joint.
- IRI values at the bridge approach increased with time, indicating progressive bridge approach settlement problems.
