Experimental Evaluation of Precast Channel Bridges

J. Scott Ingersoll

WHKS & Co.

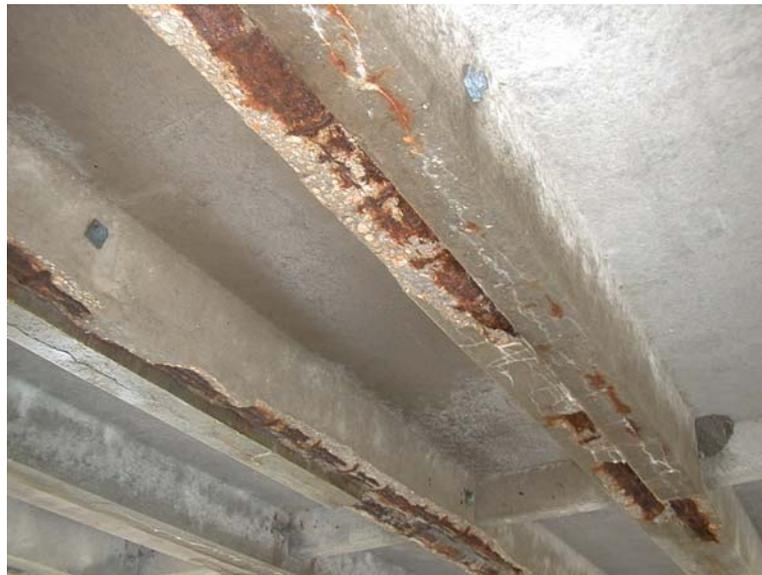
FIGURE 4. Typical PCB Deterioration

Many of Iowa's PCBs are heavily deteriorated. Typical deterioration consists of spalled concrete and significant corrosion of the primary reinforcing steel. In many cases, as shown in Figure 4, the bottom bars in a stem are exposed over almost the entire span. In other cases, longitudinal cracks and rust stains are often found on the bottom and side of the panel stems. The effects of this deterioration, such as loss of cross-sectional reinforcement area and bond, have led to concerns over the ability of a deteriorated PCB to safely support legal loads.

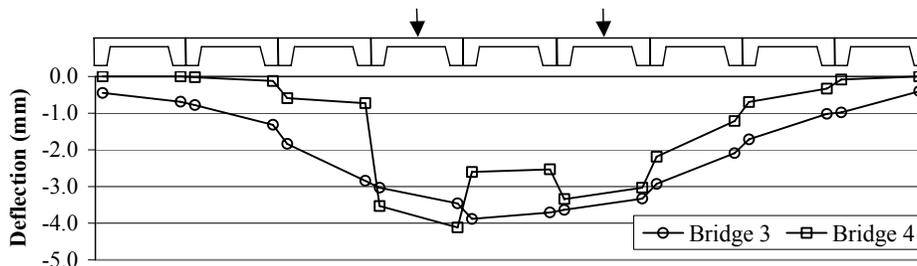
FIGURE 5. Transverse Centerline Deflections: Center Lane Loading

The load fractions varied greatly from bridge to bridge. This was due to variations in the connections between adjacent panels. Inspection of all four bridges revealed that the concrete-filled pipes were not in place on Bridge 2 and grout was not packed in the keyways on Bridge 4. The keyways on Bridge 4 contained only gravel from the gravel wearing surface.

When the shear connectors were not properly installed, the load fractions were greater than the design values. For Bridge 4, this difference was only marginal. The gravel in the shear keyways apparently aided in the transfer of shear to some degree. A larger difference occurred in Bridge 2 where the load fraction was 0.68, which was considerably greater than the design load fraction of 0.56. This is an important deficiency since a panel is supporting 21% more load than what it was designed to resist.

The effectiveness of these shear connectors is graphically show in Figure 5. This plot shows midspan deflection for Bridge 3 and 4 when the center lane was loaded. As one can see, the grout in the keyways of Bridge 3 prevented differential displacement across the panel joints. When the keyways were not grouted, significant joint slip occurred. Also, rigid joints transfer more load to neighboring panels and thus the load fractions for Bridge 3 were less than the load fractions for Bridge 4.

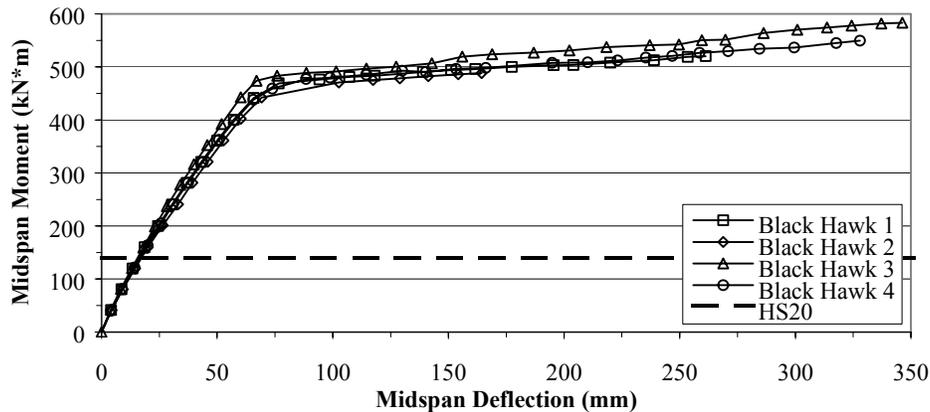
FIGURE 6. Moment Verses Deflection Plots For Black Hawk Beams

Midspan moment verses midspan deflection plots for the Black Hawk PCB panels are presented in Figure 6. As one can see, well defined regions of elastic and plastic behavior existed. This behavior was typical for all PCB panels tested. Elastic behavior occurred up to the point when the stress in the primary reinforcing exceeded its yield stress. The panels then deflected excessively while supporting only a small increase in load. This behavior continued until a compression failure occurred in the deck. Also shown in Figure 6 is the midspan moment induced by AASHTO HS20 loading. The magnitude of this loading is well within the elastic range and is considerably less than the ultimate strength of these panels.
