Laboratory and Field Testing of an Accelerated Bridge Construction Demonstration Bridge: US Highway 6 Bridge over Keg Creek

Final Report
April 2013

Sponsored by
Federal Highway Administration
Iowa Department of Transportation
(InTrans Project 11-411)

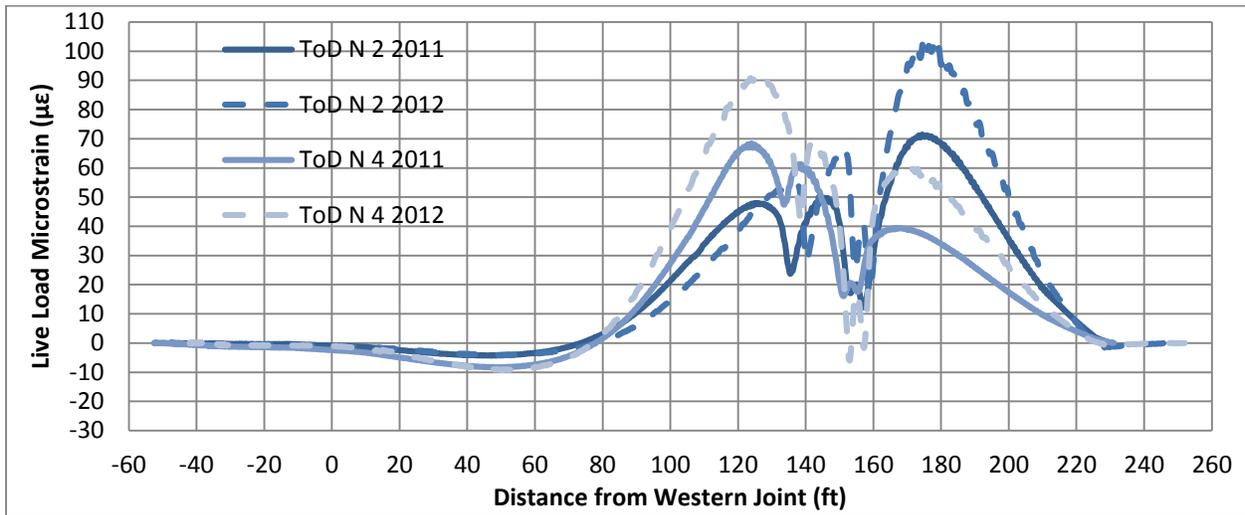
There also seems to be a consistent increase in maximum strain values between the 2011 and 2012 test with almost all maximum strains now being found at the HPC/UHPC interface locations. The most drastic increases in strains seem to be occurring at these interface locations

Figure 4.11. Comparison of live load strains from 2011 to 2012 of surface-mounted transducers spanning interface load path 2

A couple of things could cause the increase in strain from test to test. One explanation could be a relaxation of the post-tensioning utilized across the transverse joint. However, this scenario is not supported by the collected data. A decrease in compressive force from the post-tensioning rods would result in a significant increase in tensile strains for all gauges at the transverse joint, not only the gauges spanning the interface. Therefore, the increase of tensile strain from test to test is much more likely explained by a breaking down of the bond between the UHPC and HPC at the joint interface, which would localize the larger increases in strain to the joint interface as seen in the data.

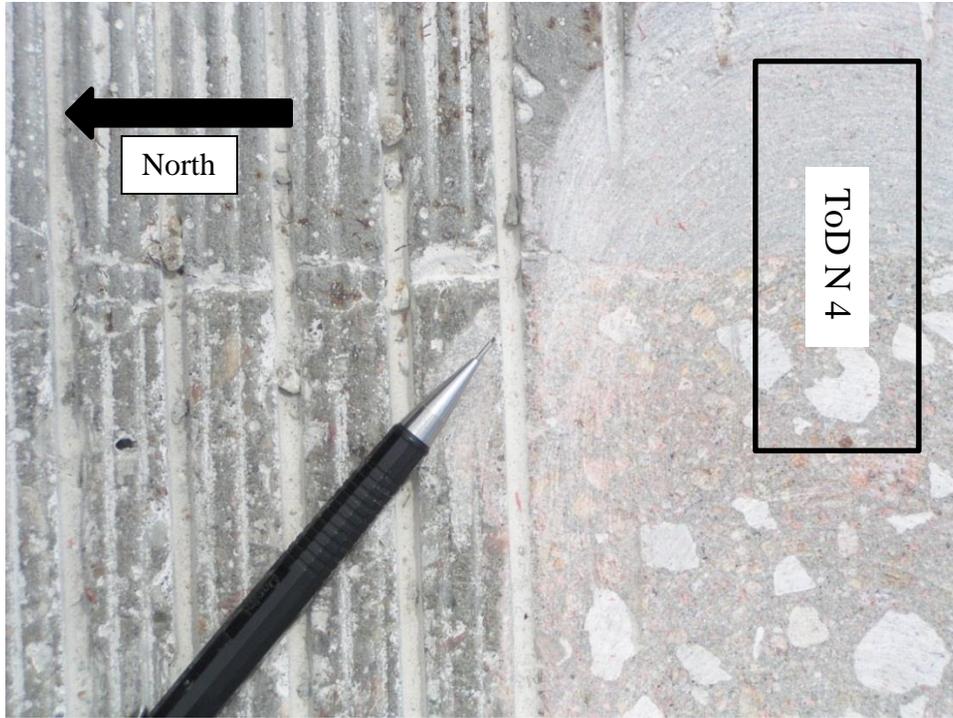
As recorded strain values have increased between the 2011 and 2012 test, the maximum tensile strains of the 2012 test ($\sim 106 \mu\epsilon$) have gotten much closer to the cracking strain of the HPC ($\sim 132 \mu\epsilon$). Upon visual inspection, many cracks were noticed on the top of the deck. A large majority of these cracks were noticed at the interface between the UHPC joints (both longitudinal and transverse) and the precast HPC deck modules.

Figure 4.13. Observed cracking at instrumented joint at location of ToD N 4 transducer

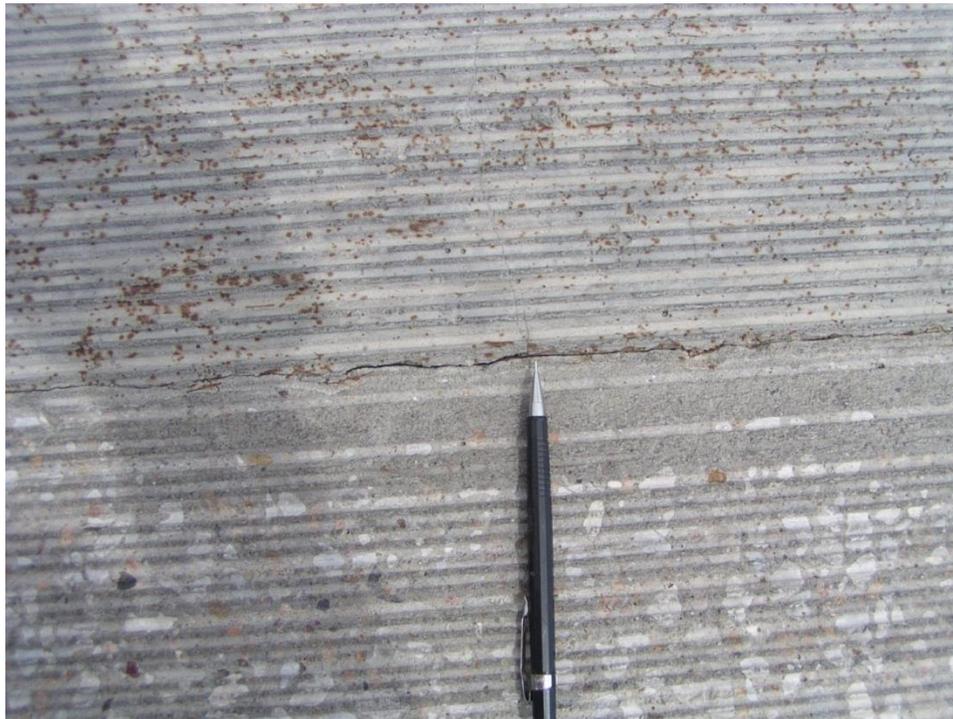
Figure 4.14. Observed cracking of longitudinal joint between modules 2 and 3

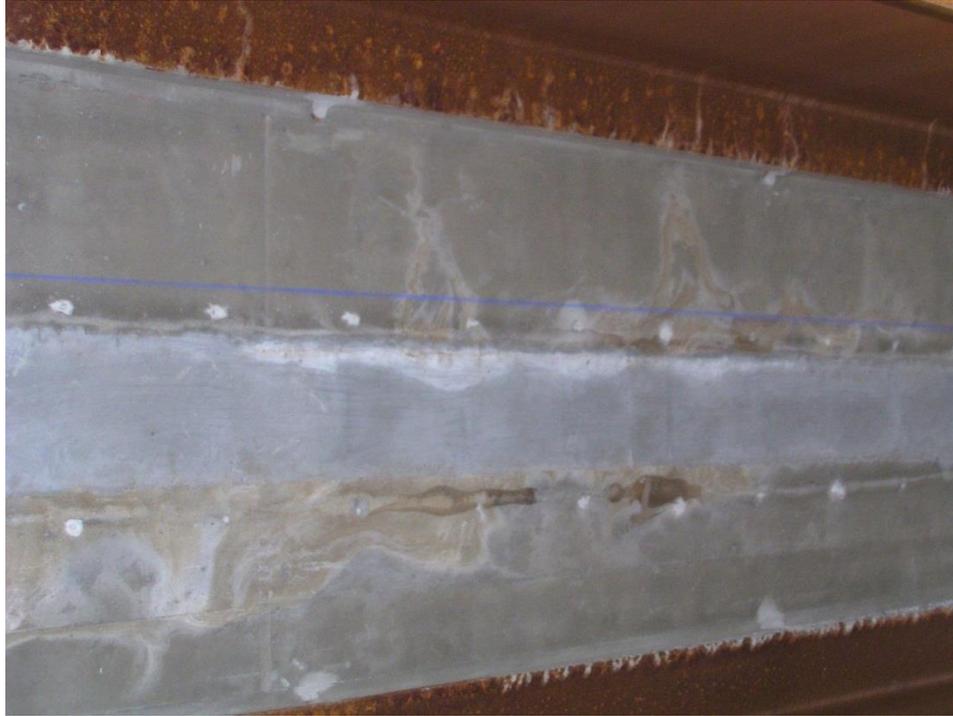
Visual inspection, as well as evaluation of the collected data, showed a breakdown of the bond between the interface of the HPC and UHPC at the joints. The breakdown of this bond resulted in cracking of the deck allowing an ingress of road salts, which is verified by the presence of efflorescence on the underside of the bridge deck at joint interfaces.

Figure 4.15. Observed efflorescence between modules 2 and 3 on bottom of deck

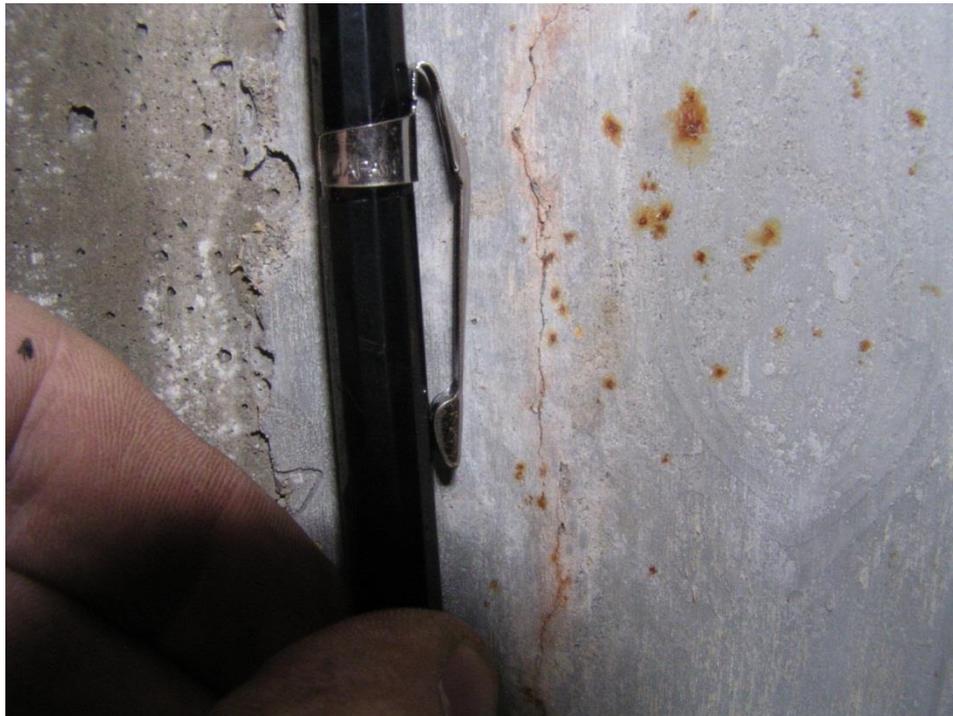
Figure 4.16. Close-up of cracking and efflorescence observed between modules 2 and 3 on bottom of deck

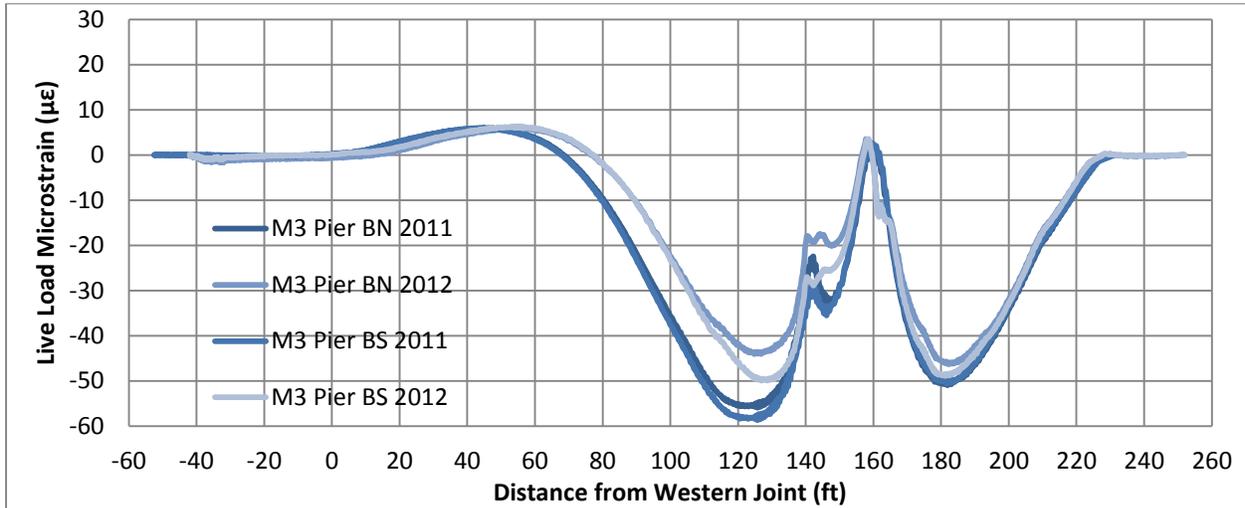
Figure 4.24. Comparison of live load strains from 2011 to 2012 of transducers on bottom flange of girder at pier for module 3 from load path 3

This loss of compressive strain shows a reduction in the magnitude of the negative moment seen at the pier. This is indicative of a loss of continuity to some degree at the east pier location and moving more toward a simply supported condition. This would also be supported by the indication of loss of bond between the precast HPC deck panels and the UHPC transverse joint as was reported previously.

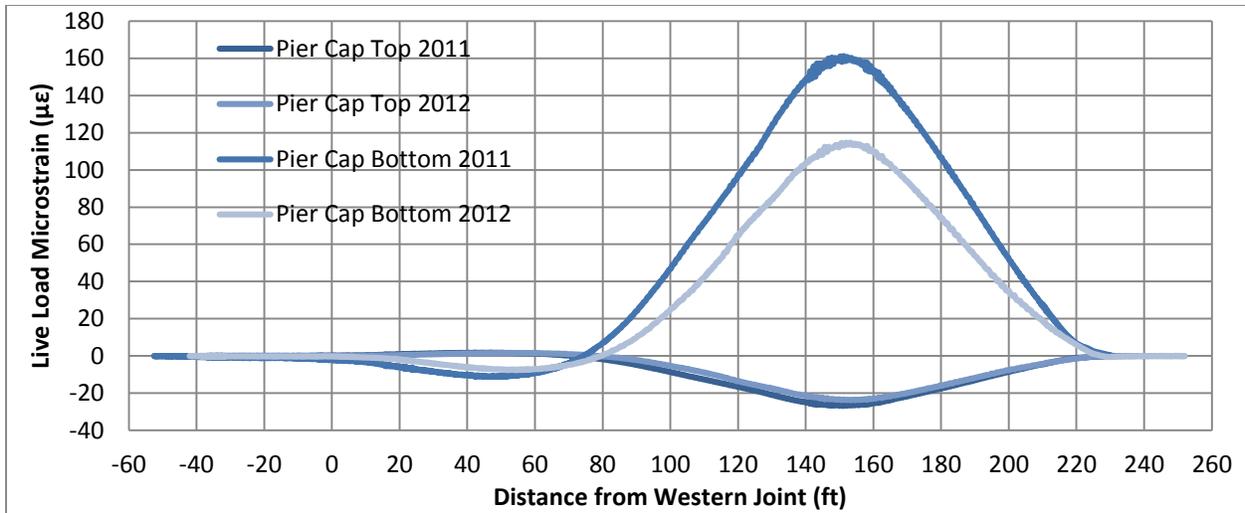
Figure 4.25. Comparison of live load strains of pier cap

The difference between tests can be explained by a couple of occurrences. First, it is possible that the transducer of the first test was located over a crack location, which would result in a greater strain value. Also, there could be strain relief occurring from the first test to the second test as a result of development of more cracks over time.
