Repair of Damaged Prestressed Concrete Bridges Using CFRP

F. Wayne Klaiber, Terry J. Wipf

Brian J. Kempers

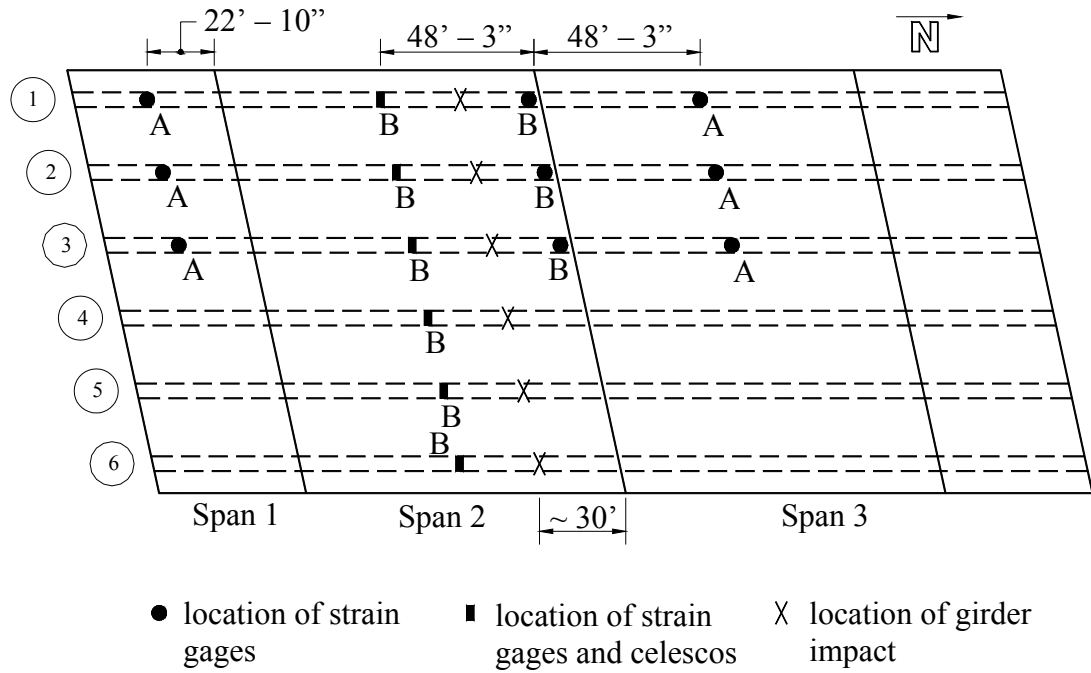
The bridge that was damaged was on the south bound portion of the IA Highway 65 bridge that crosses IA Highway 6 in the vicinity of Altoona, Iowa. This four span bridge consists of two 96.5 ft main spans and two approach spans – the north one 36 ft long and the south one 46 ft long. A cross-section of this bridge is presented in Fig. 1. All six of the LXD P/C girders in one of the main spans were damaged by an overheight vehicle traveling east on IA Highway 6. Although, as illustrated in Fig. 2, all 6 girders were damaged approximately 30 ft from the center pier, most of the damage was to the first two girders. Damage to Beam 1 consisted of spalling of concrete from the bottom flange and the severing of one strand. Damage to Beam 2 (shown in Fig. 3) was the most severe in that significantly more concrete spalled from the bottom flange exposing five strands two of which were severed.

FIGURE 2. Location of Damage, Strain Gages, and Deflection Transducers on the Altoona Bridge

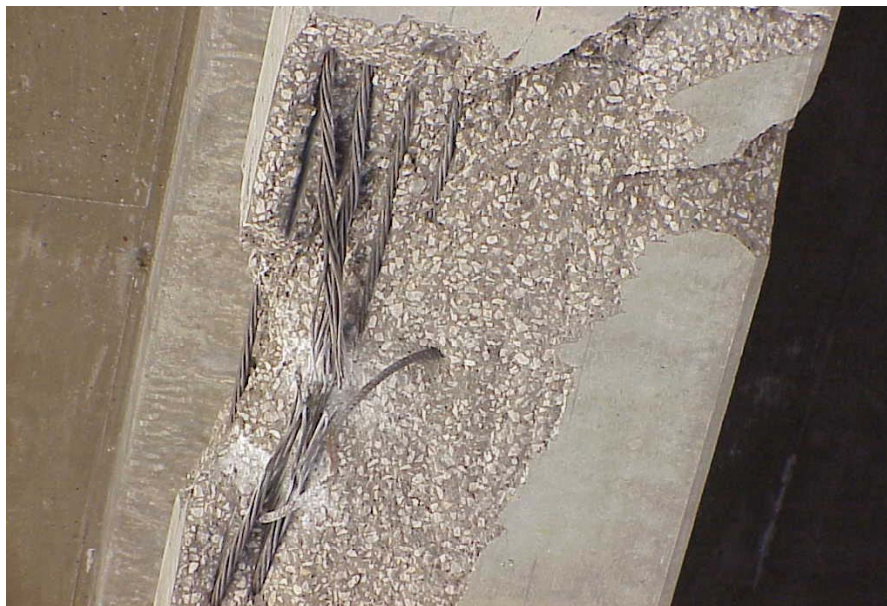
FIGURE 3. Photograph of the Damage to Beam 2 in the Altoona Bridge

Prior to installation of the CFRP, the manufacturer's recommended patching material and procedures were used to repair the spalled concrete on the various beams, CFRP plates were attached to the most heavily damaged beam – Beam 2 after the patch material had cured. Four 4-in. wide by 75 ft long protruded CFRP laminates (shown in Fig. 4) were installed on the bottom flange of Beam 2 using an epoxy-resin which was applied to both the laminate and the P/C girder. A rubber roller was used to enhance the bond. The tensile design strength of the CFRP laminates was 406 ksi. After installation of the four laminates, a CFRP wrap was installed in the vicinity of the patch (80 in. of the girder was wrapped) to confine the patch and to prevent any plate debonding. Five CFRP strips (approximately 6 ft long which was sufficient length to cover the bottom flange and all but approximately the top 1 in. of the web) were installed. Similar CFRP sheets were installed at the location of the patches in the other beams to assist in confining the patches.
