DETERMINE INITIAL CAUSE FOR CURRENT PREMATURE PORTLAND CEMENT CONCRETE PAVEMENT DETERIORATION

FINAL REPORT

Sponsored by the Project Development Division
of the Iowa Department of Transportation
and the Iowa Highway Research Board
Iowa DOT Project TR-406
CTRE Management Project 97-13

OCTOBER 2000

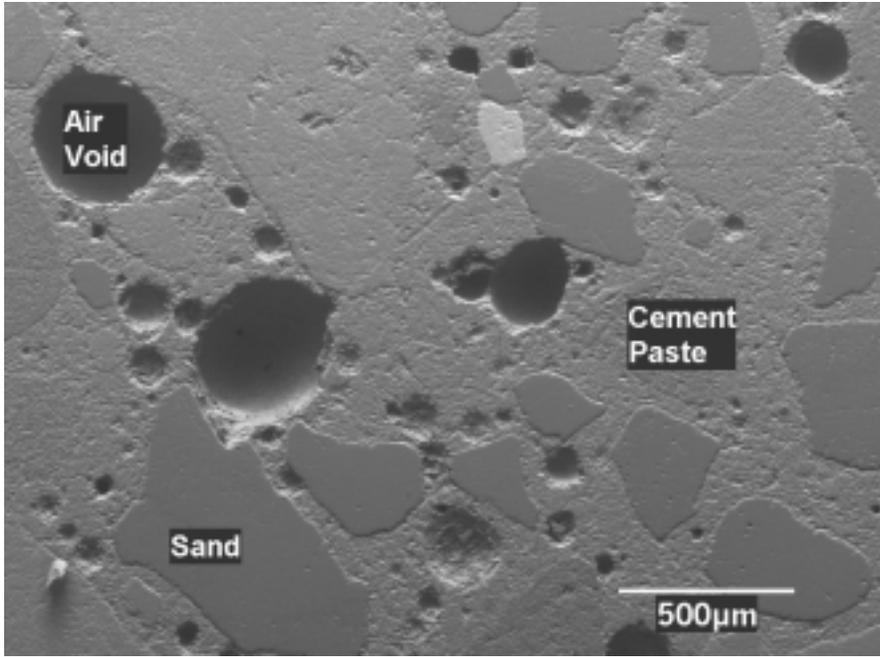
FIGURE 3 Good section of US 20.

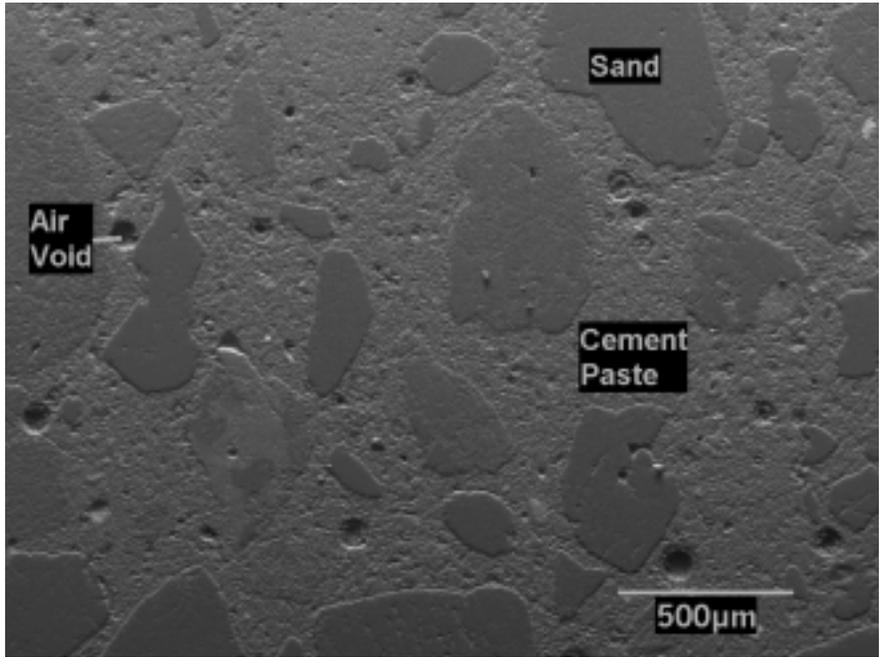
FIGURE 4 Bad section of US 20.

The most probable explanation for the premature deterioration of US 20 in Hamilton County (site 2) is freeze-thaw damage. This explains the large cracks that were subparallel to the top surface of the concrete slab. Image analysis indicated that the hardened air content of the pavement was poor to marginal and that most of the small

air voids had been filled with ettringite. The premature deterioration was most probably enhanced by excessive drying shrinkage in the top surface of the concrete slab, which increased the permeability of the top surface of the pavement. The increased permeability allowed the slab to become critically saturated. The pavement also shows some evidence of alkali-silica reaction (predominately shale in the fine aggregate with an occasional chert particle). The damage caused by ASR (i.e., cracking from the aggregate extending through the cement paste) was minimal.

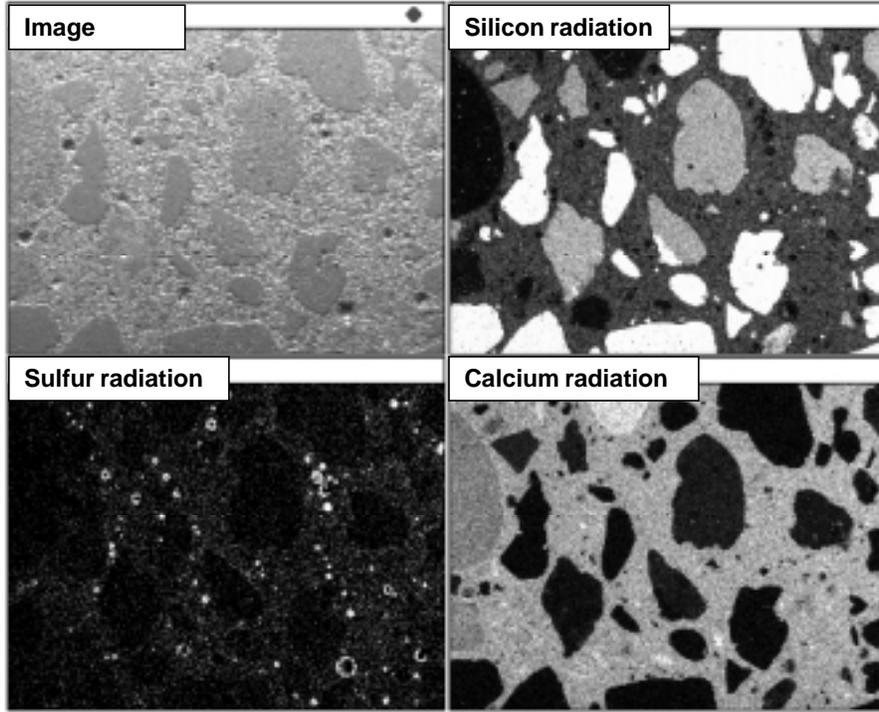
FIGURE 5 Illustration of the use of X-ray maps to highlight the ettringite-filled air voids.

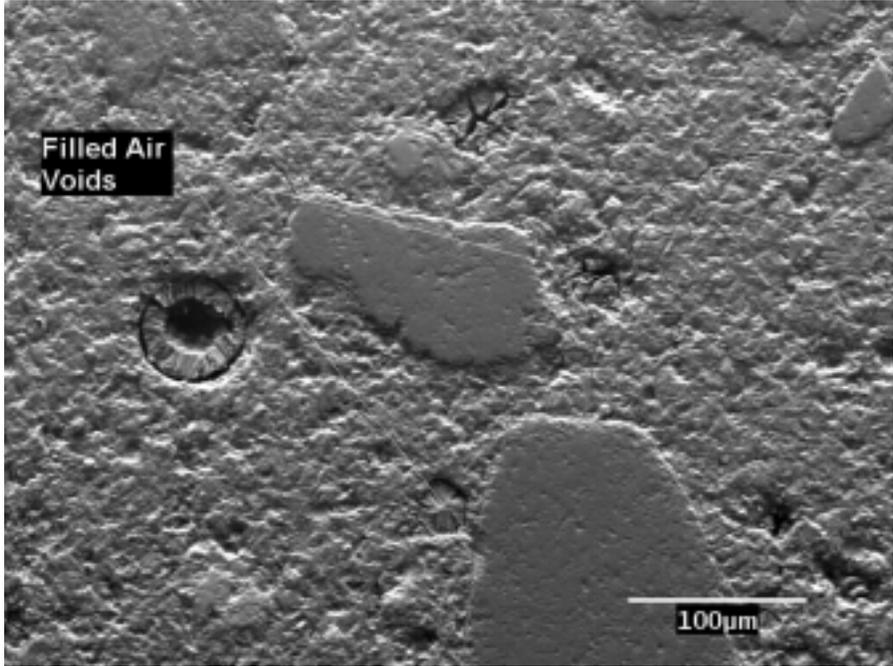
Higher magnification (see Figure 6) can also be used to distinguish the filled voids from the cement paste. However, this causes a dramatic increase in the number of images that need to be collected to provide a reliable estimate of the air content of the sample. The image shown in Figure 6 indicates that, in this particular specimen, most of the air voids with diameters less than about 100 microns have been filled with ettringite. This should have a negative impact on the freeze-thaw resistance of the concrete because it causes an increase in the spacing factor of the concrete.

FIGURE 6 Higher magnification image from Figure 4; note the filled voids.

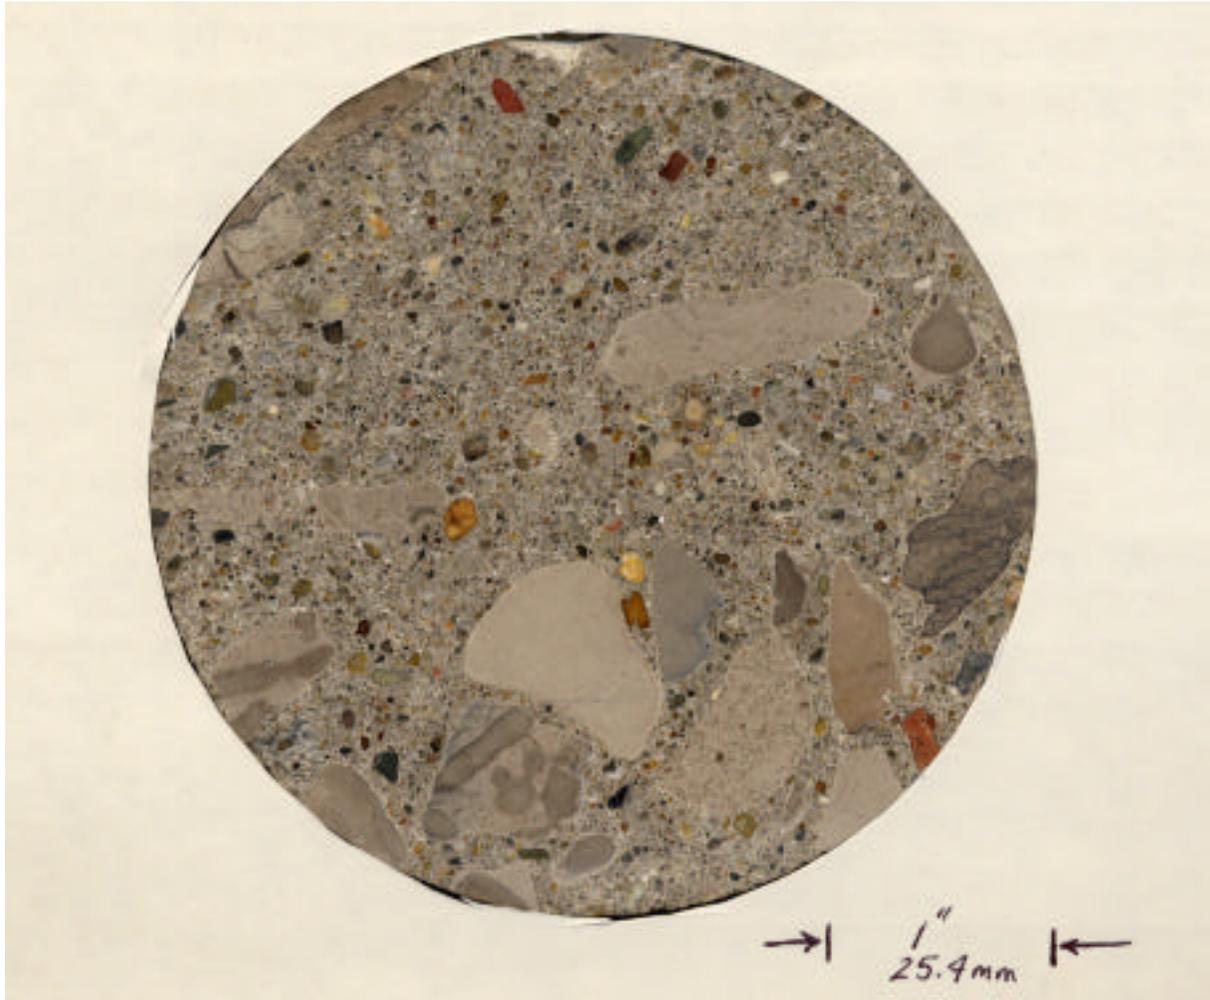
FIGURE 8 Illustration of segregation in a core extracted from I-80 in Iowa county.
