1. Report No. 0092-15-02	2. Government Accession No	3. Recipient's Catalog No	
4. Title and Subtitle Evaluation of Performance of Innovative Bridges in Wisconsin		5. Report Date July 2016

EVALUATION OF PERFORMANCE OF INNOVATIVE BRIDGES IN WISCONSIN

**Final Report
July 2016**

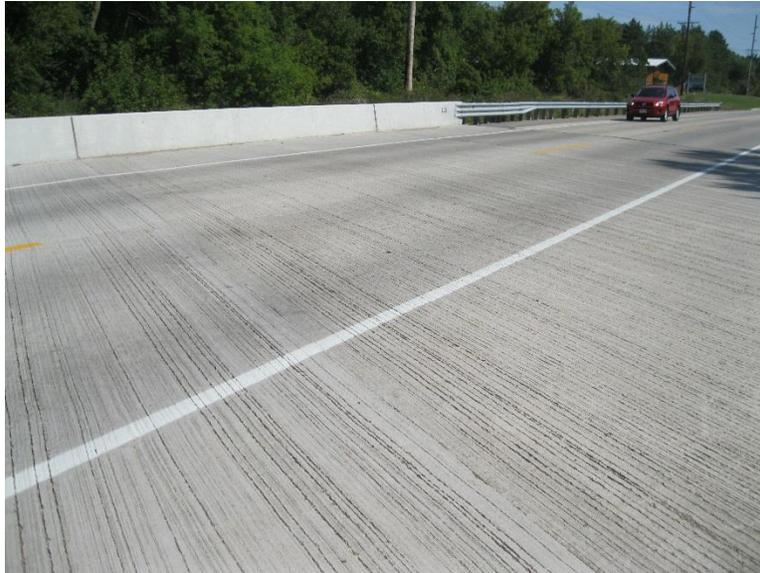
The overall surface of the deck was in very good condition as seen in Figure 2.

Figure 2. STH 19 over Token Creek Tributary surface condition of superstructure

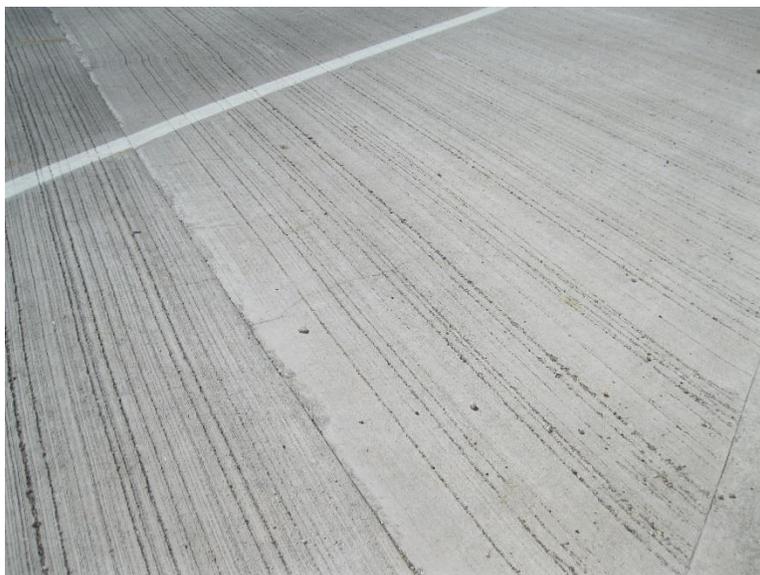
Only a few minor ($<1/32''$) cracks were observed at the interface between the approach slab and the bridge entrance. An example of these cracks is shown in Figure 3.

Figure 3. STH 19 over Token Creek Tributary minor cracking at bridge entrance

No top of deck cracks were observed at locations where reflective cracking might be expected. This indicates that the bridge is performing well with little to no differential displacement between adjacent inverted T beams.

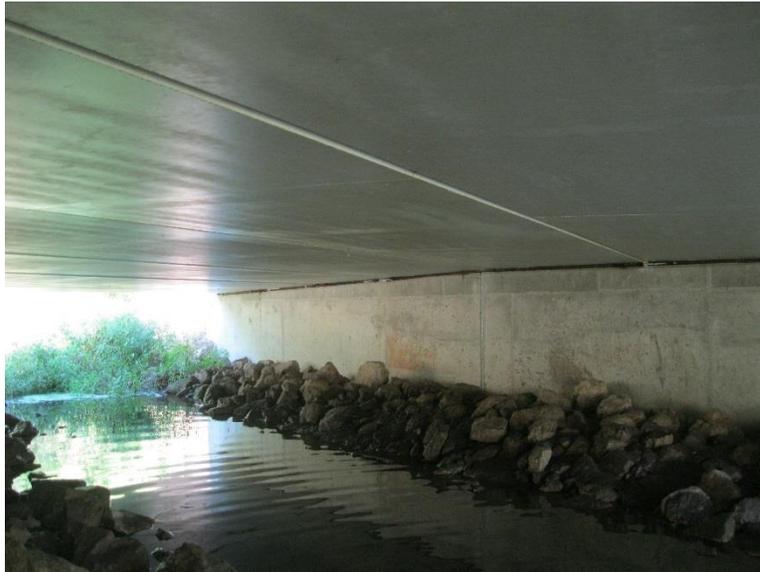
The underside of the superstructure was also in very good condition. There were no observable cracks. The underside is shown in Figure 4 with a close-up picture shown in Figure 5.

Figure 4. STH 19 over Token Creek Tributary overall underside condition

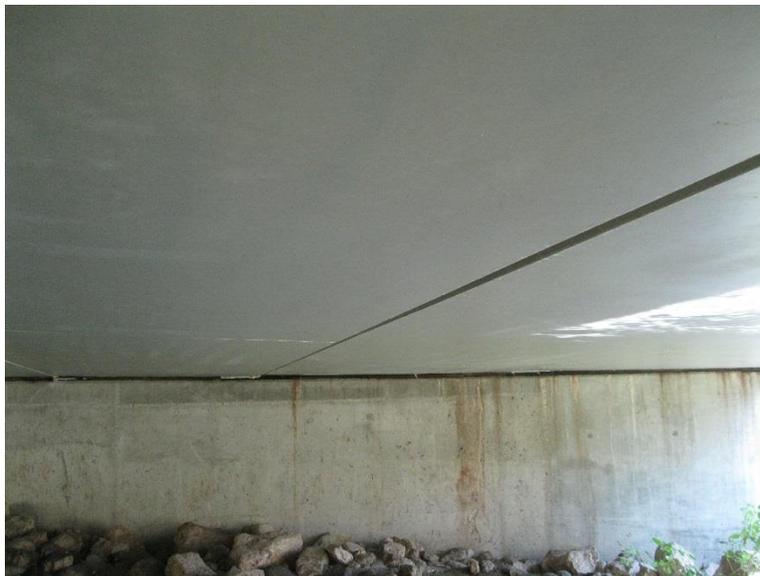
Figure 5. STH 19 over Token Creek Tributary underside of superstructure close-up

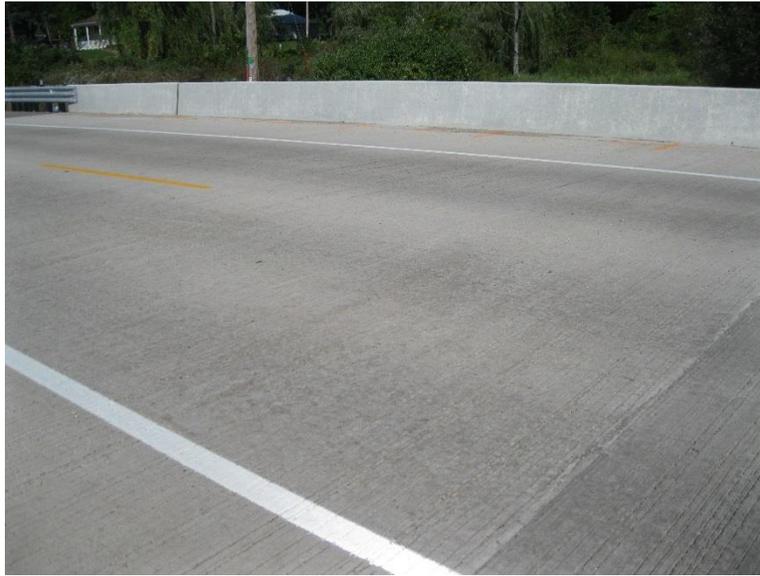
The surface of the deck was in very good condition and showed no signs of cracking (see Figure 7).

Figure 7. STH 19 over Token Creek surface condition of superstructure

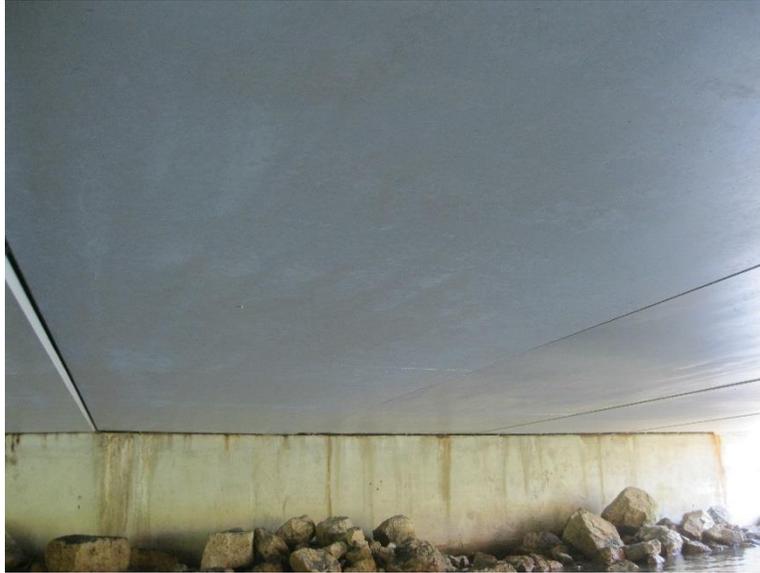
The underside of the superstructure also appeared in very good condition as there were no observable cracks. The underside is shown in Figure 8.

Figure 8. STH 19 over Token Creek underside of superstructure

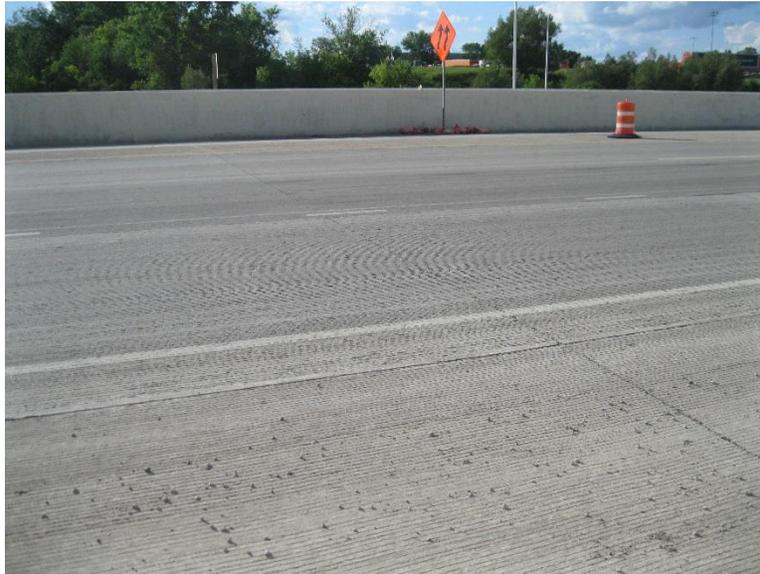
Visual inspection was completed of the top and underside of the bridge deck. The inspection revealed no signs of distress or cracking in either location. However, the top side inspection was limited to the vantage point from the roadway shoulder given that traffic was not controlled and the roadway was in use. See Figure 26.

Figure 26. US 41 over Ashwaubenon Creek roadway surface condition

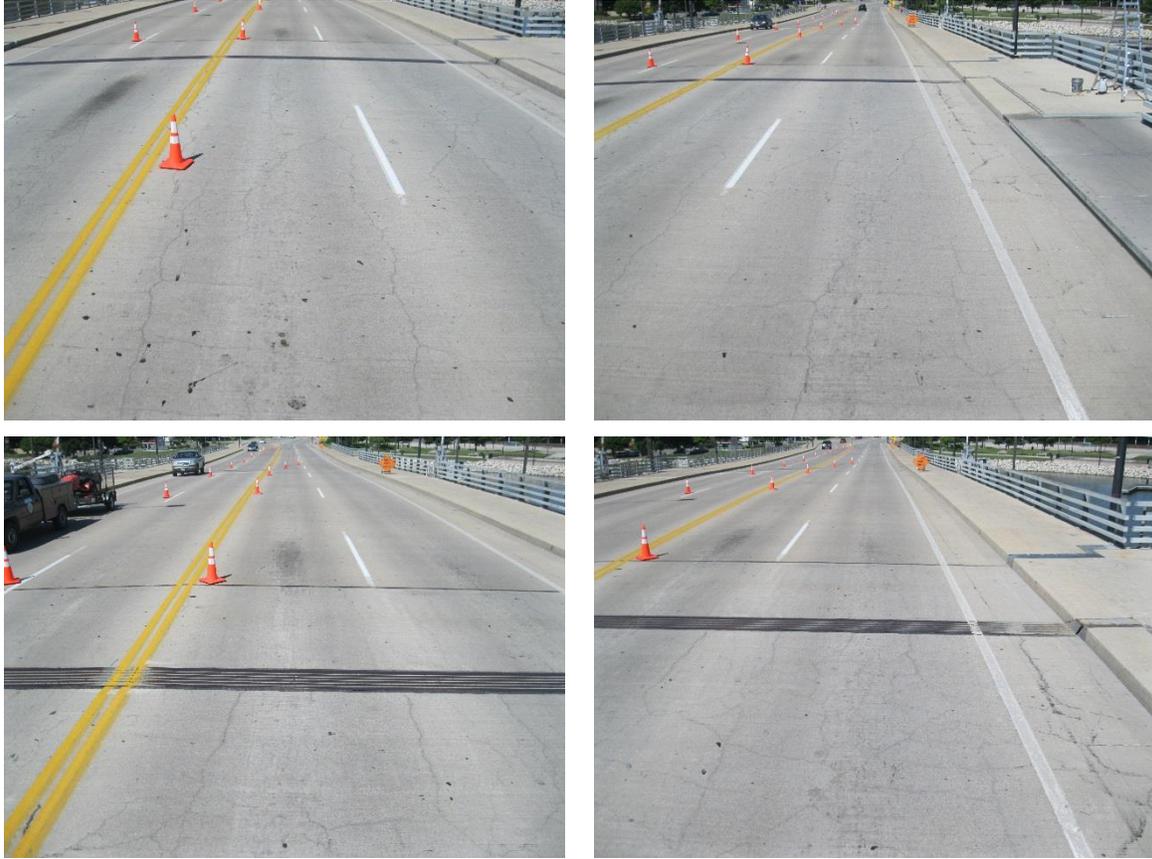
Figure 38. US 141-Main Street over the Fox River westbound lanes looking west

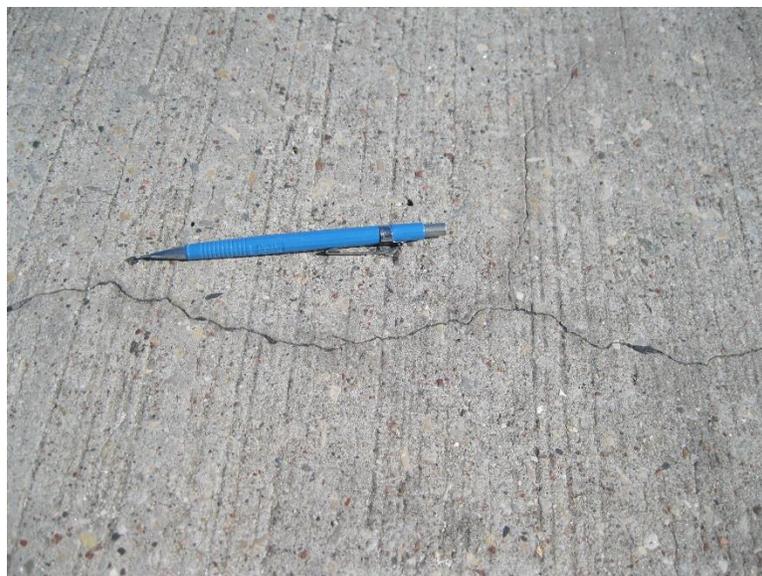
A close-up of a typical crack is shown in Figure 39 along with a mechanical pencil so one can more closely gauge the size.

Figure 39. US 141-Main Street over the Fox River typical crack size observed

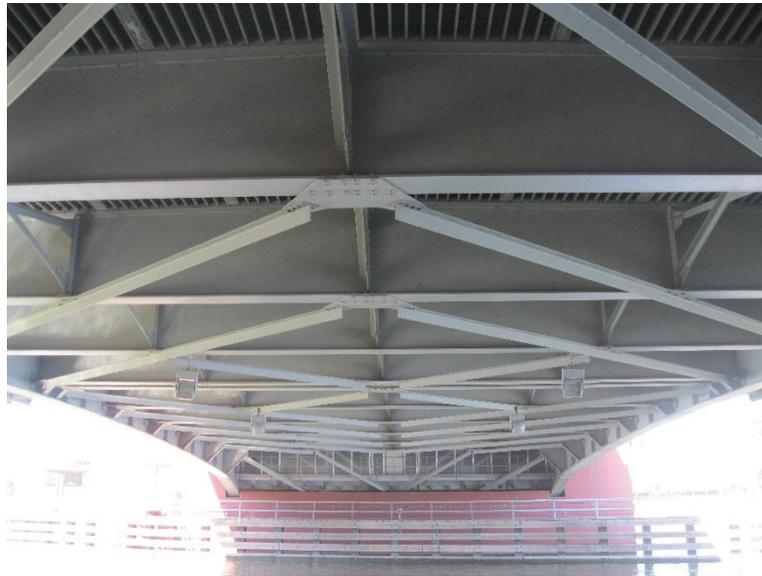
Due to the limited access to the underside of the deck, many areas of the exodermic deck construction were not visible (see Figure 40).

Figure 40. US 141-Main Street over the Fox River exodermic bridge deck

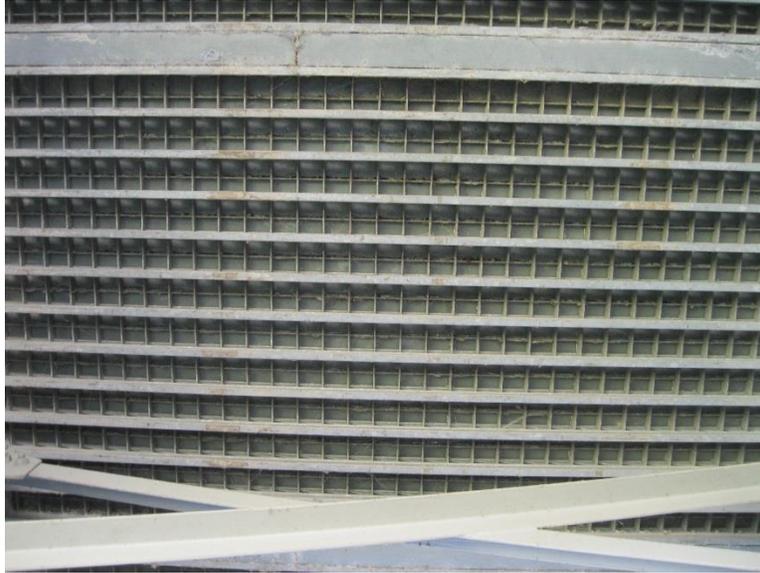
As such, only a cursory review of what was visible could be completed. The visible areas, generally those areas directly above the walkways, as shown in Figure 41 did not indicate any distress or cracking and appeared to be in quite good condition.

Figure 41. US 141-Main Street over the Fox River underside of bridge deck

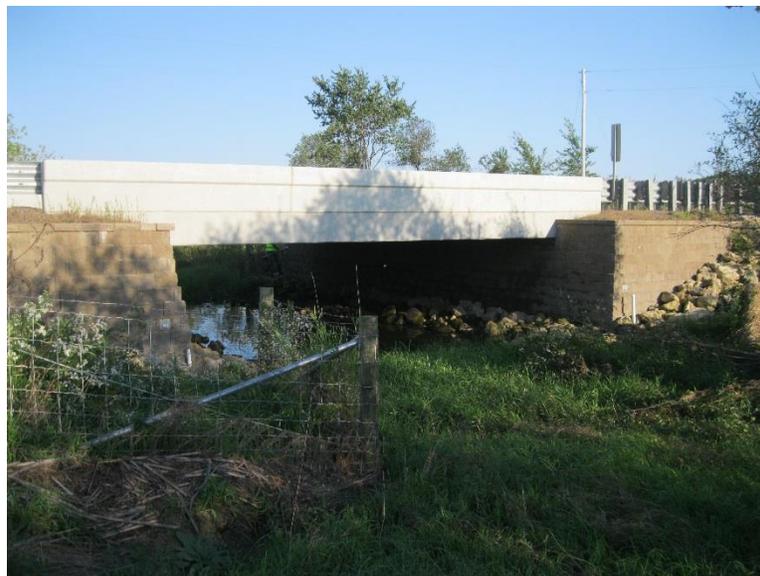
On September 15, 2015, the bridge was visited and a visual inspection was completed. The inspection consisted of a cursory review of the GRS abutments, shown in Figure 49, and a more in depth inspection of the cast-in-place slab superstructure.

Figure 49. SH 40 over Hay Creek general bridge condition

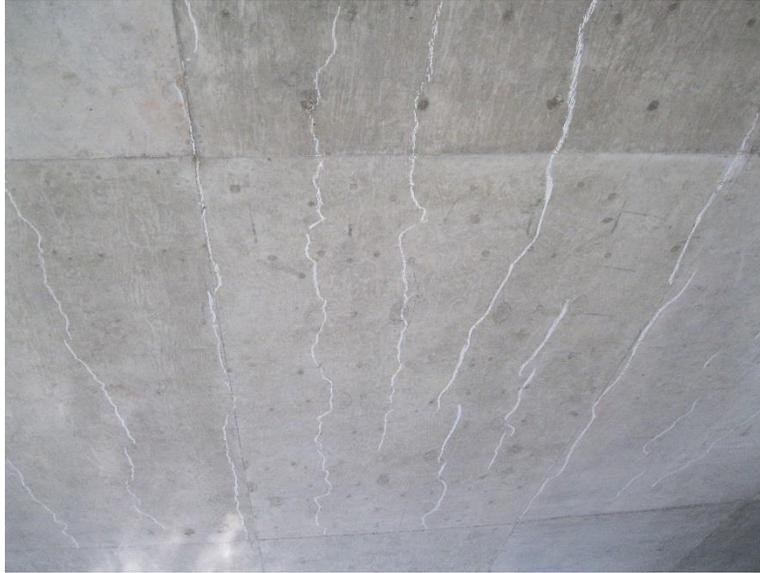
The GRS abutment showed no signs of distress and appears to be performing quite well. In contrast, there is considerable and extensive transverse hairline cracking on the underside of the superstructure (see Figure 50 and Figure 51).

Figure 50. SH 40 over Hay Creek transverse cracking on superstructure underside

The superstructure faults do not appear to be a direct reflection of the abutments upon which it is founded. Rather, it appears to be a function of the superstructure design and the loading to which it has been subjected. A review of the design and appropriate modifications should be made to reduce or eliminate the transverse cracking. In future applications of the superstructure, consideration should be given to at least one of the following design changes: deeper cross section, more reinforcement, or the addition of post-tensioning. If implemented correctly, these design modifications may help to lessen the extent of load induced cracking. For the current bridge, it may be advisable for a thin polymer overlay to be applied to the bridge. Such an overlay does not add much additional dead load and, when successfully installed, provide good protection against moisture intrusion.

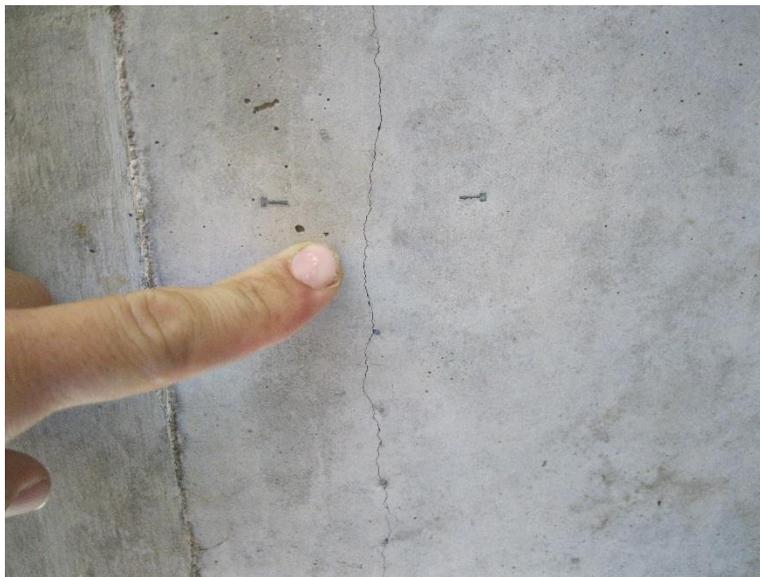
Figure 51. SH 40 over Hay Creek typical size of transverse cracking

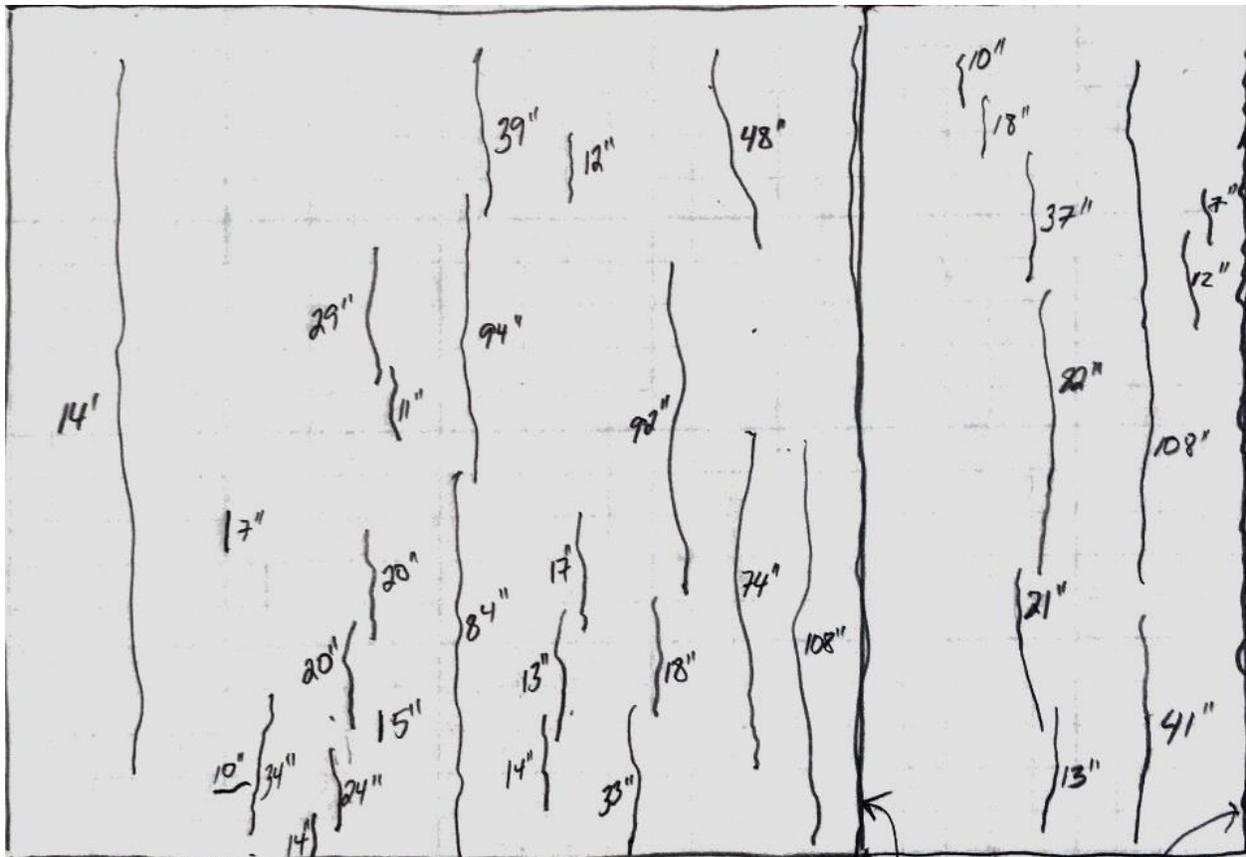
Crack mapping was completed on the underside of the southwest quarter of the bridge (18'-6" x 19'-1 1/2"), which was representative of the remaining bridge condition. A total of 156' of transverse cracking was measured. The crack map is shown in Figure 52. Similar cracking was observed throughout the entire bridge length.

Figure 52. SH 40 over Hay Creek crack map

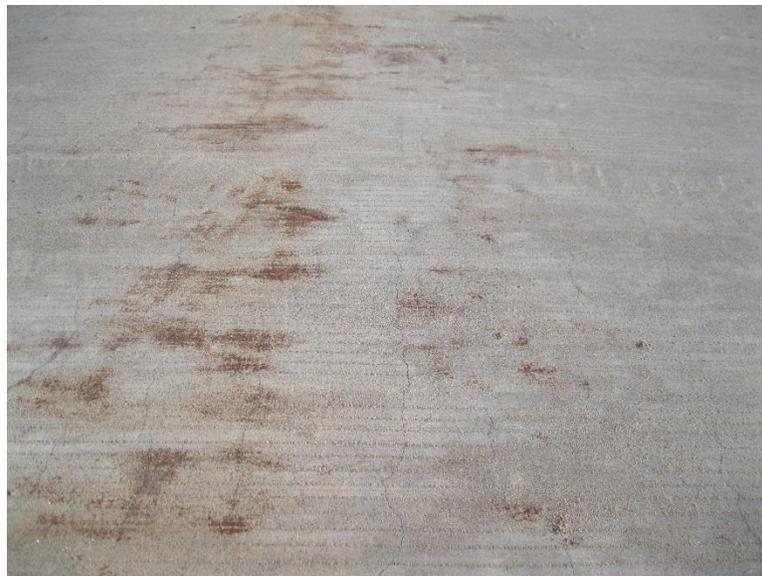
In contrast to the bottom surface of the superstructure, longitudinal cracking was observed on the top surface, although not to the extent of that seen on the underside (see Figure 53).

Figure 53. SH 40 over Hay Creek longitudinal cracking on deck surface

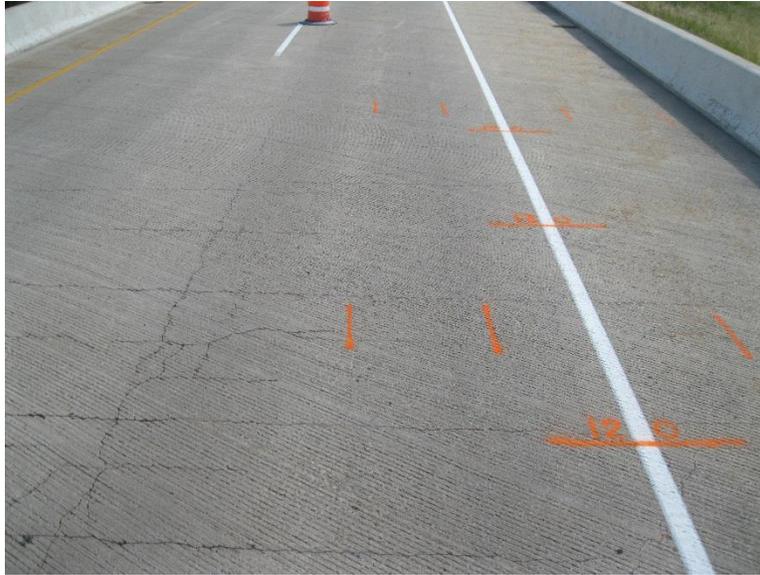
Observation of the deck surface revealed numerous cracks less than 1/16" in width primarily in the transverse direction, although several in the longitudinal direction existed (see Figure 56).

Figure 56. US 151 northbound over STH 26 Service Road bridge deck surface cracking

Maintenance on the bridge has included the use of a crack sealant. The benefit of sealing a deck without concrete is probably minimal and, at best, probably helps void freeze-thaw related deterioration. A majority of the observed cracks have been sealed and, to this point, the sealant appears to be performing well (i.e., fully intact within cracks). It is unknown if the cracking is a direct result of the FRP reinforcing. However, a direct contrast to the adjacent bridge where traditional reinforcing was used would indicate that it is not. Figure 57 shows the deck surface of the adjacent bridge and similar crack patterns exist. As expected, no signs of deck delamination were found.

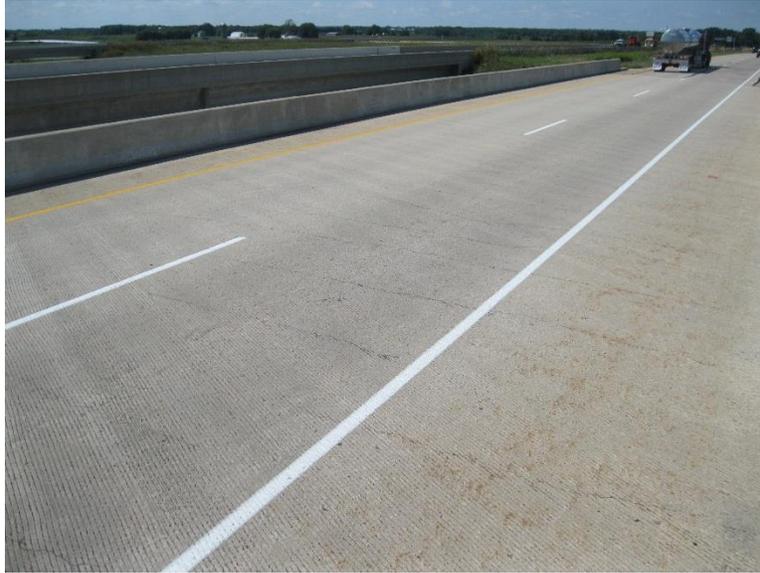
Figure 57. US 151 northbound over STH 26 Service Road surface of adjacent bridge

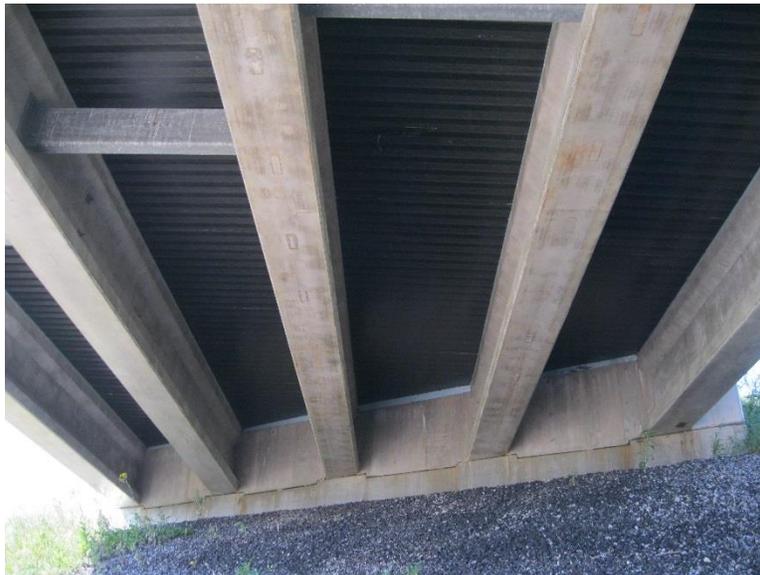
Aside from the surface cracking that was observed, the remaining components of the bridge appeared in excellent condition with little wear or signs of distress apparent. See Figure 58.

Figure 58. US 151 northbound over STH 26 Service Road condition of underside of bridge

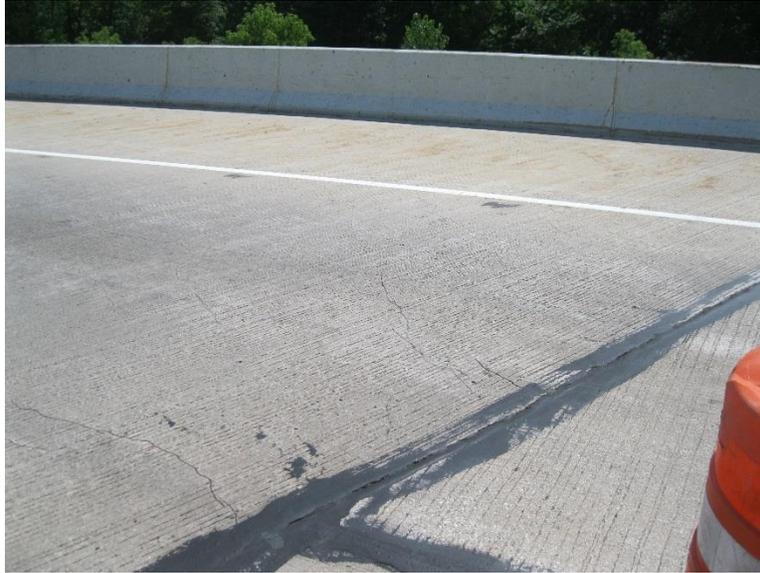
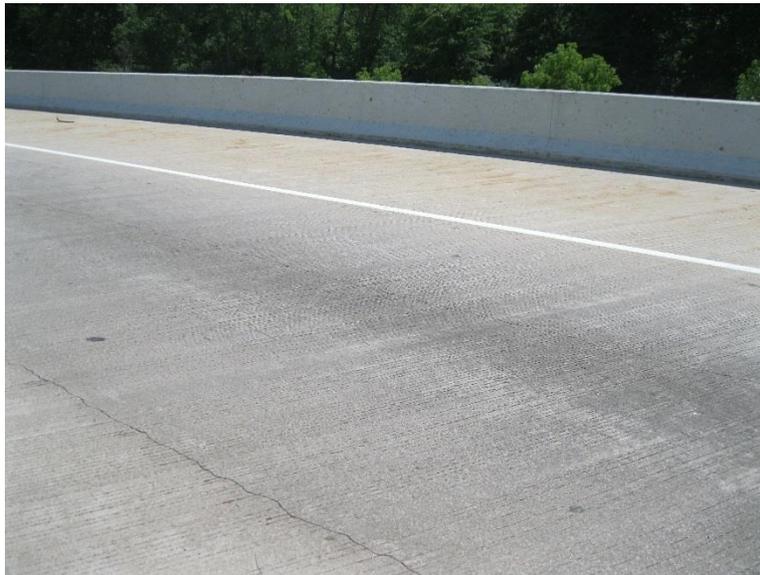
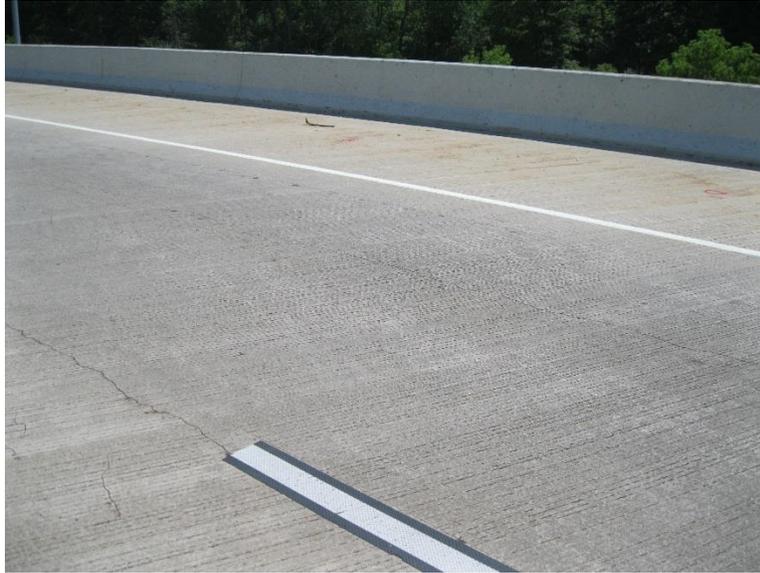
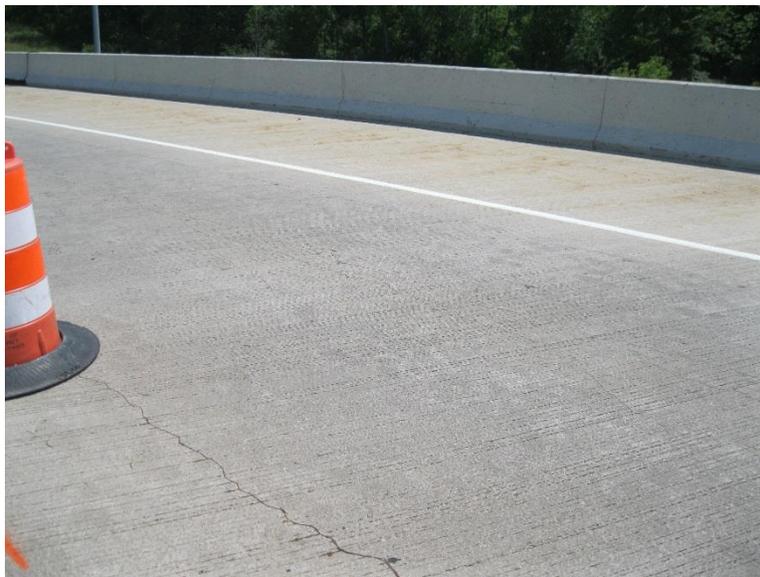
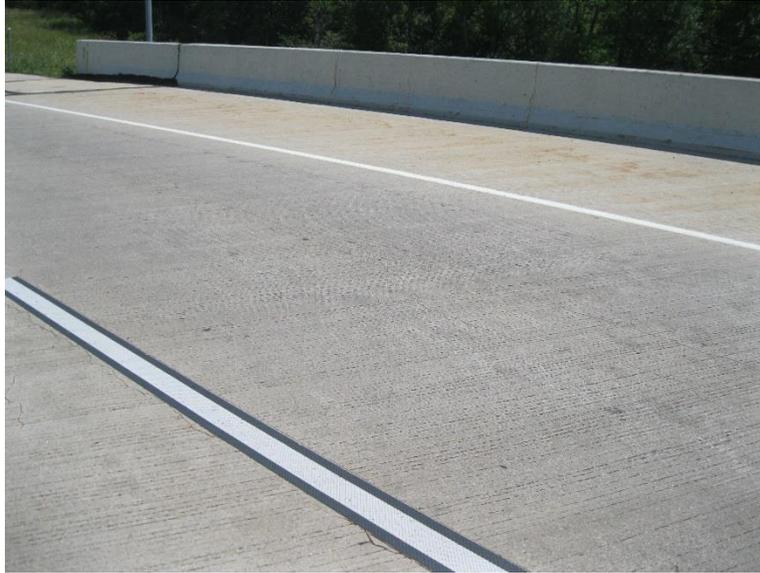
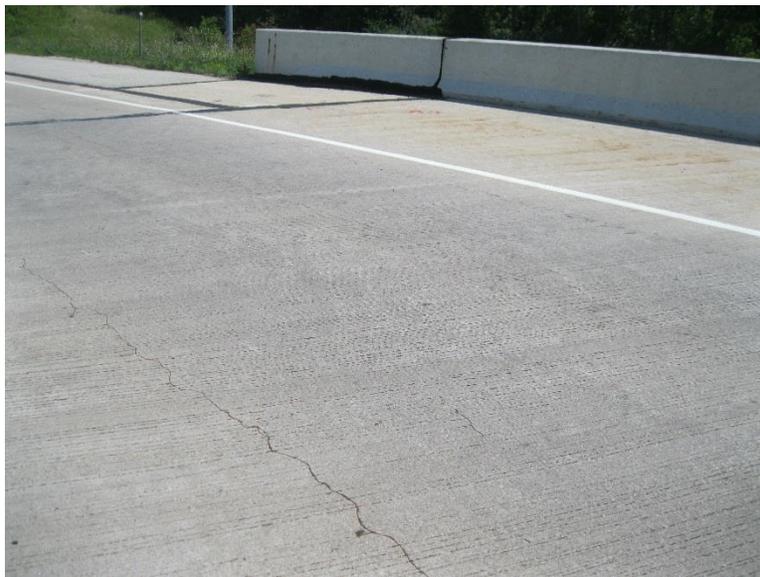
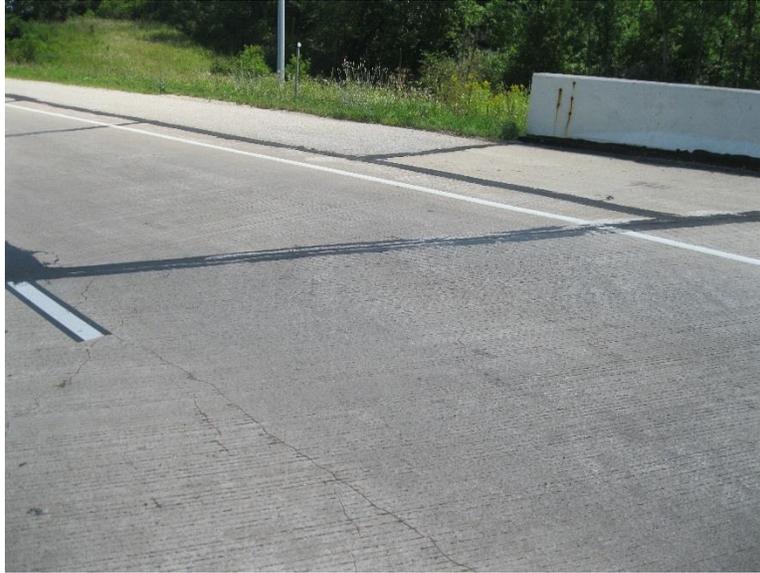
Figure 86. US 151 over De Neveu Creek deck surface condition – 1

Figure 87. US 151 over De Neveu Creek deck surface condition – 2

Figure 88. US 151 over De Neveu Creek deck surface condition – 3

Figure 89. US 151 over De Neveu Creek deck surface condition – 4

Figure 90. US 151 over De Neveu Creek deck surface condition – 5

Figure 91. US 151 over De Neveu Creek deck surface condition – 6

Figure 92. US 151 over De Neveu Creek deck surface condition – 7

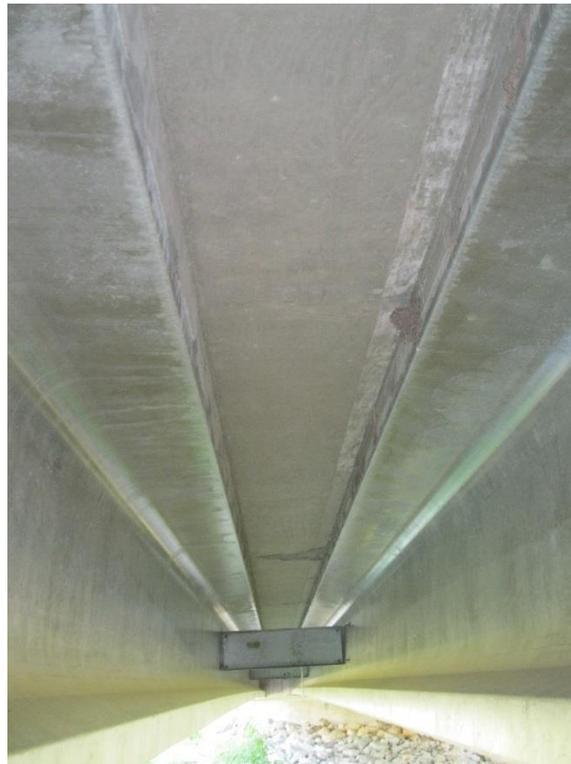
Figure 93. US 151 over De Neveu Creek underside condition

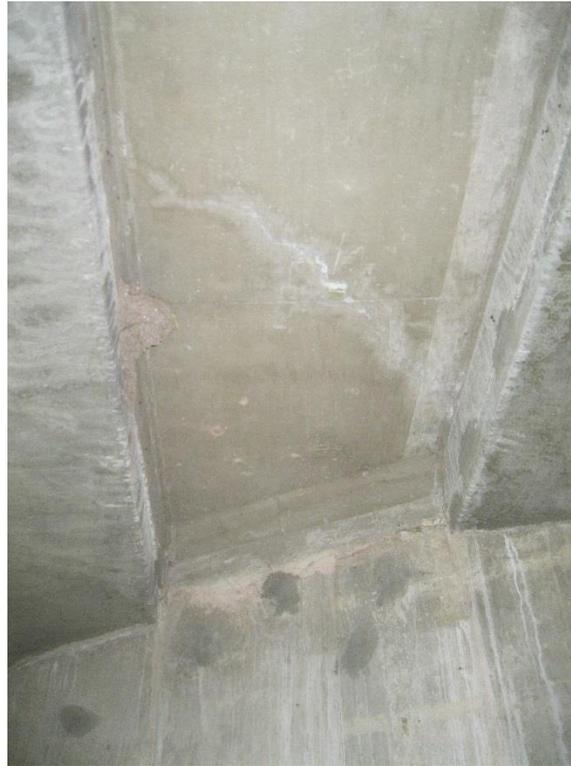
Figure 94. US 151 over De Neveu Creek hairline cracking at bridge end

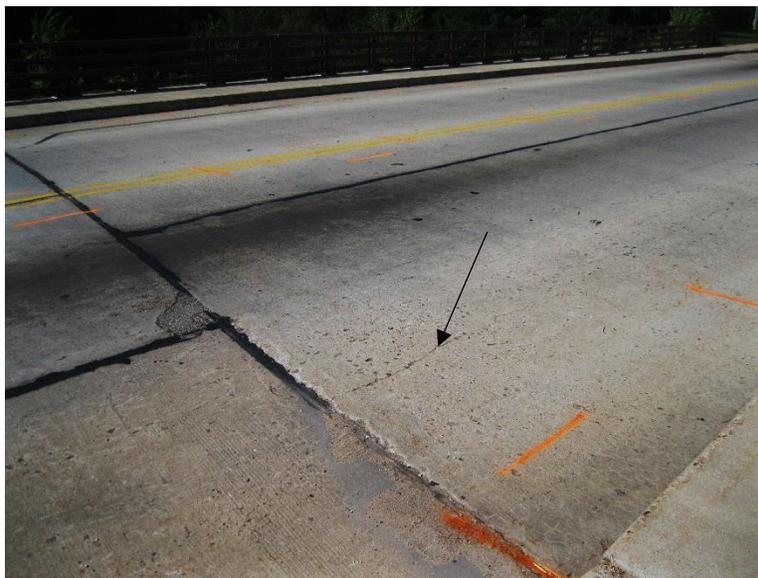
Figure 103. US 12 over Coffee Creek deck crack – 1

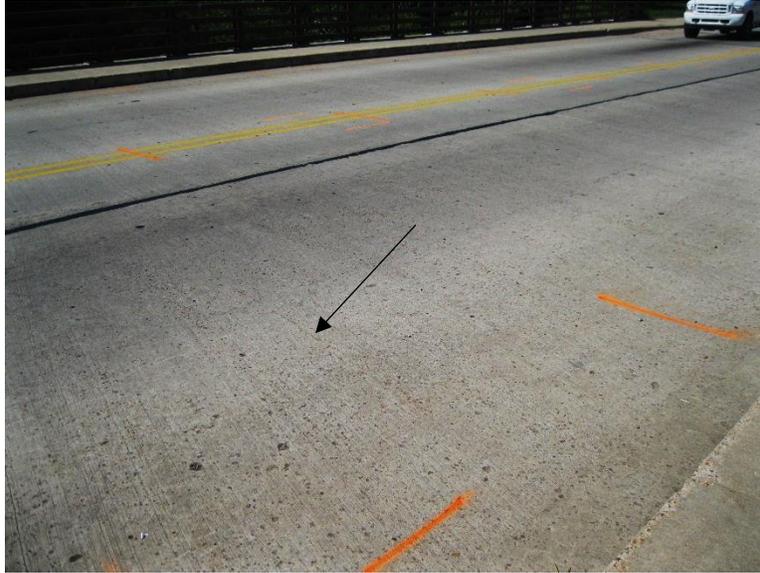
Figure 104. US 12 over Coffee Creek deck crack – 2

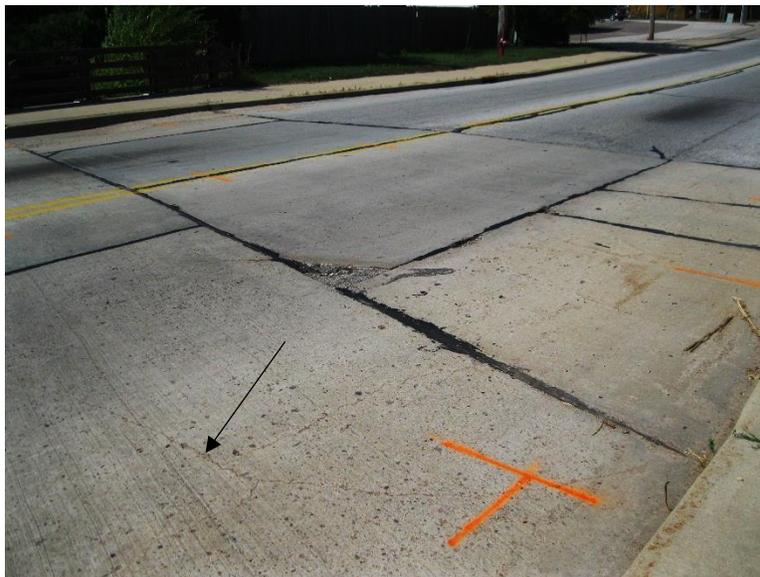
Figure 105. US 12 over Coffee Creek deck crack – 3

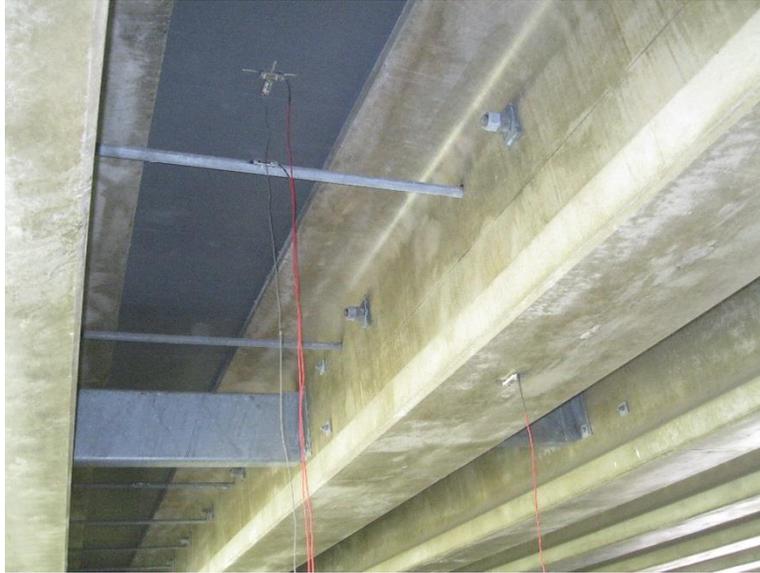
Figure 106. US 12 over Coffee Creek underside condition of superstructure

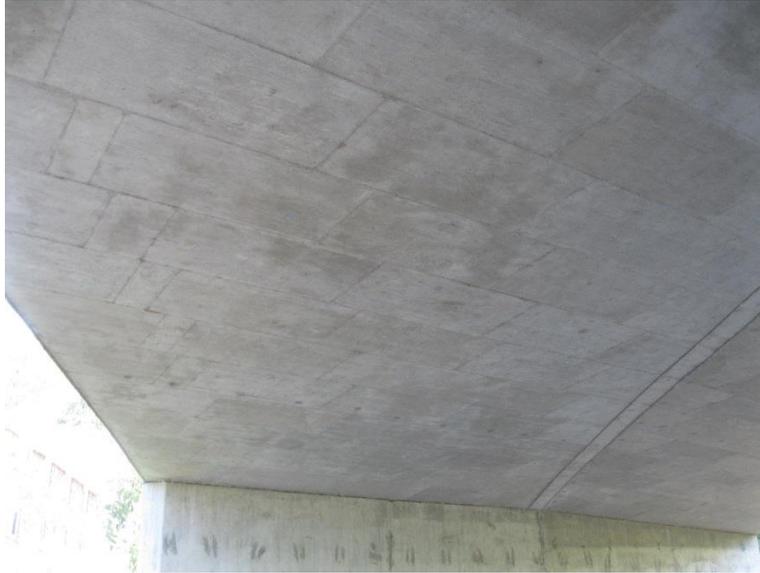
Figure 121.STH 33 over the Milwaukee River surface condition of superstructure – south side Span 2

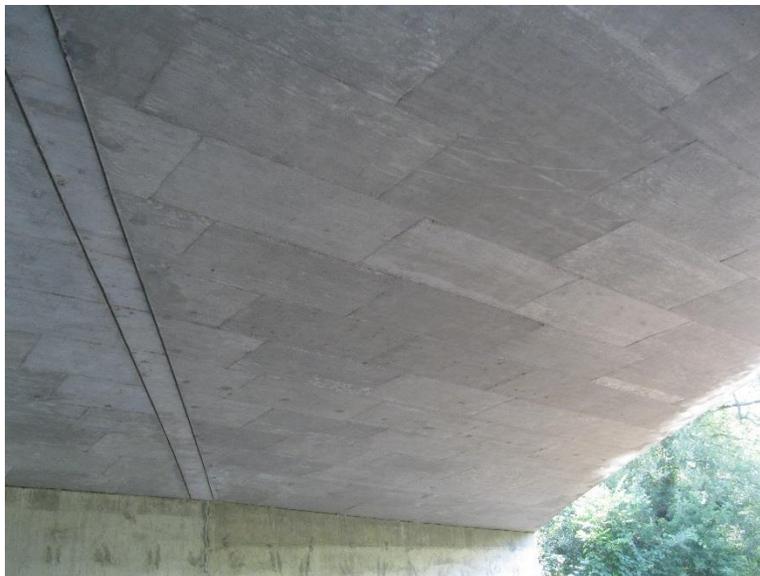
Figure 122.STH 33 over the Milwaukee River minor cracking at bridge entrance – north side Span 2

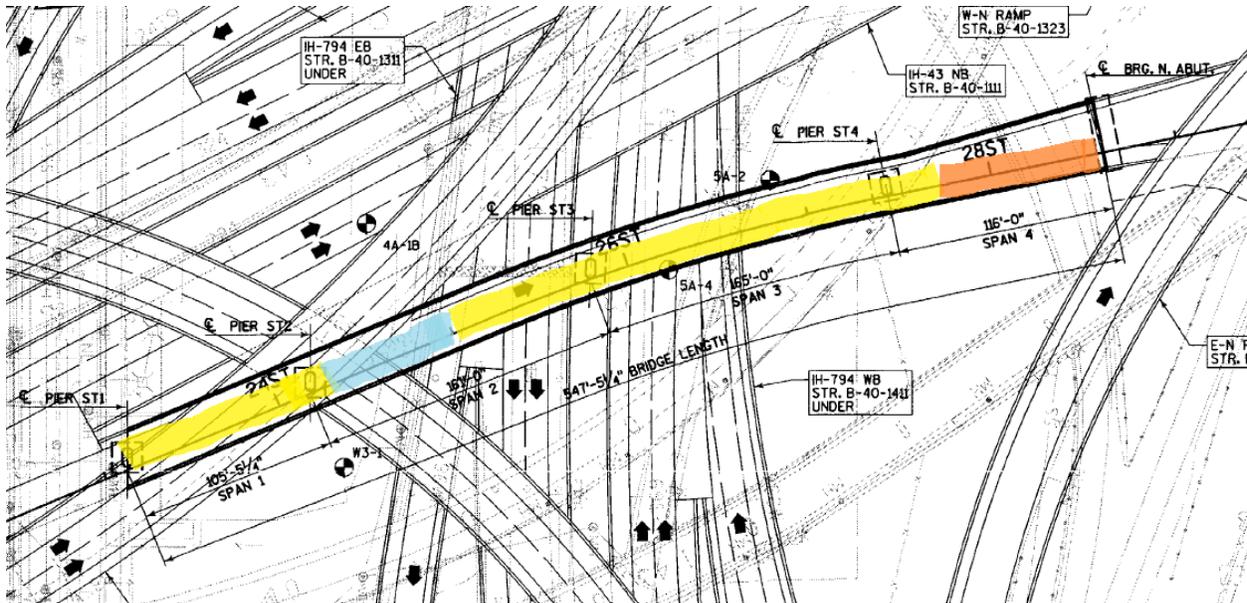
Figure 126. IH 43 northbound to Michigan Avenue transverse crack pattern

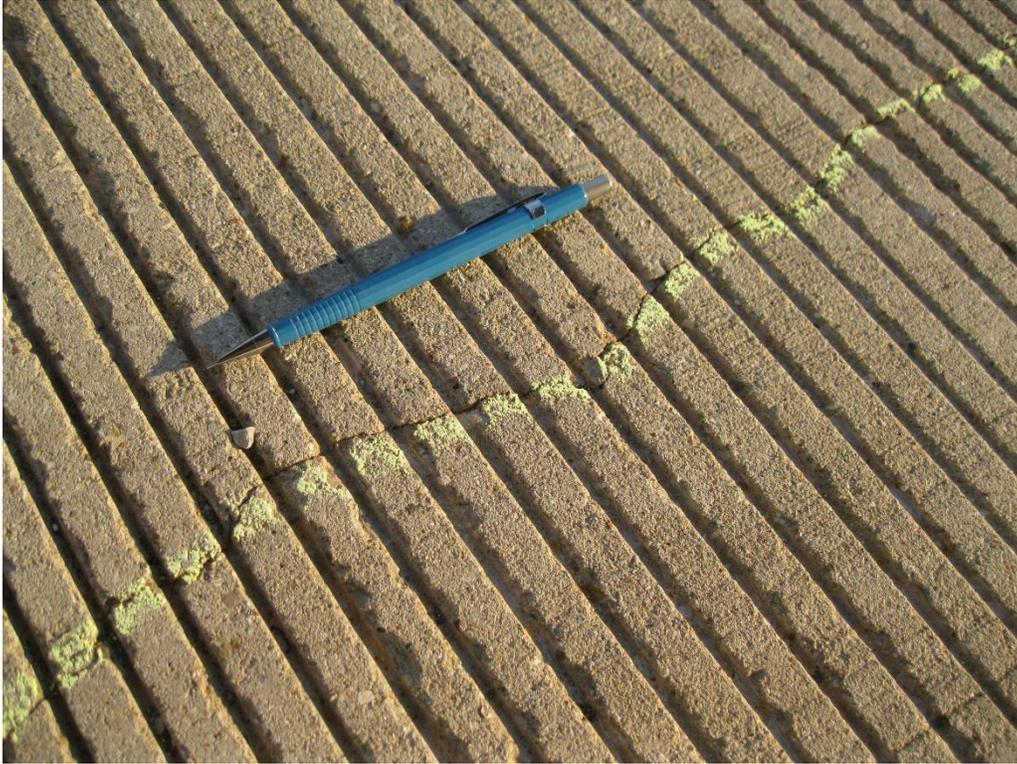
Figure 127. IH 43 northbound to Michigan Avenue typical transverse crack size

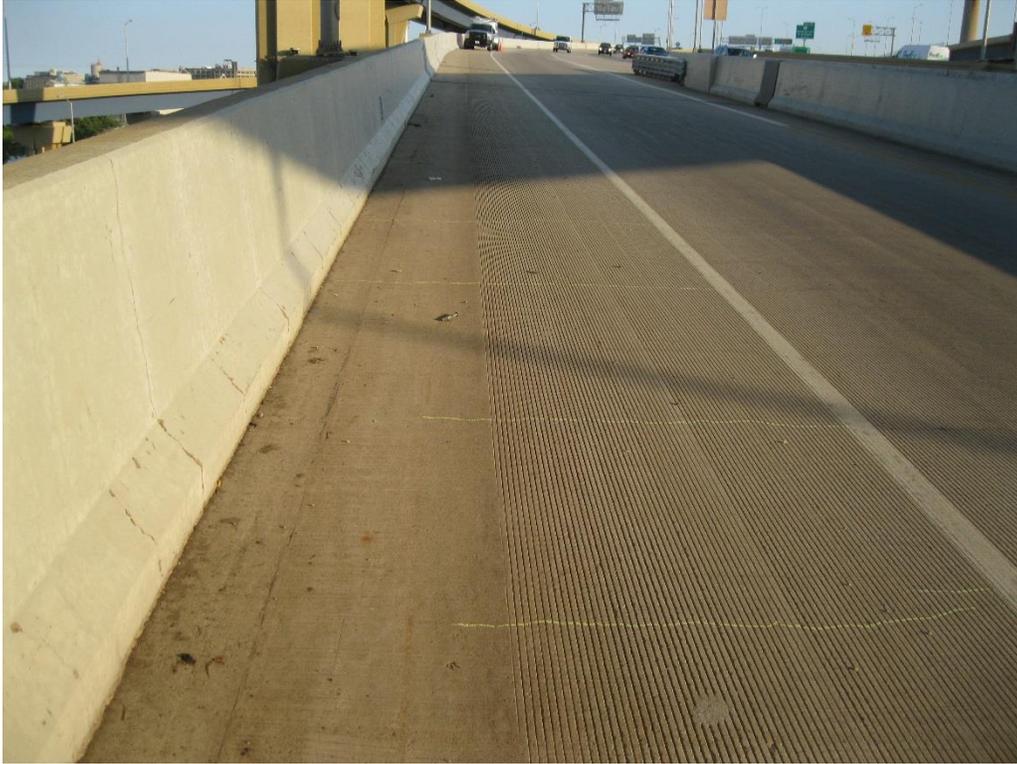
Figure 128. IH 43 northbound to Michigan Avenue Span 1 transverse cracks

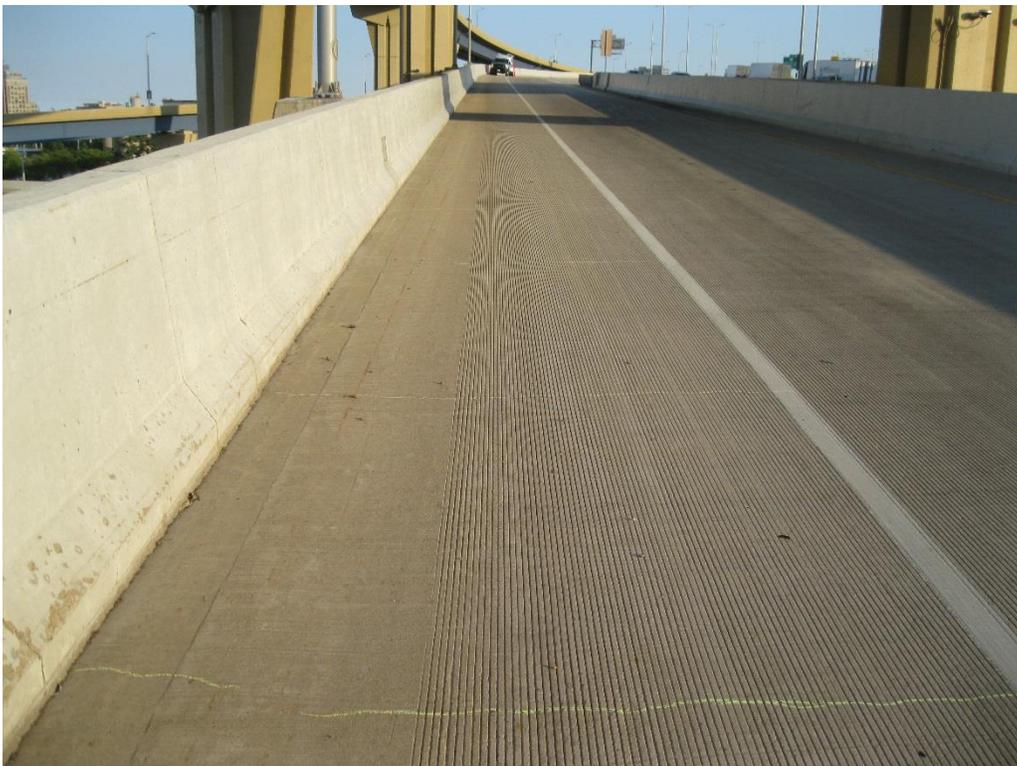
Figure 129. IH 43 northbound to Michigan Avenue south end of Span 2 transverse cracks

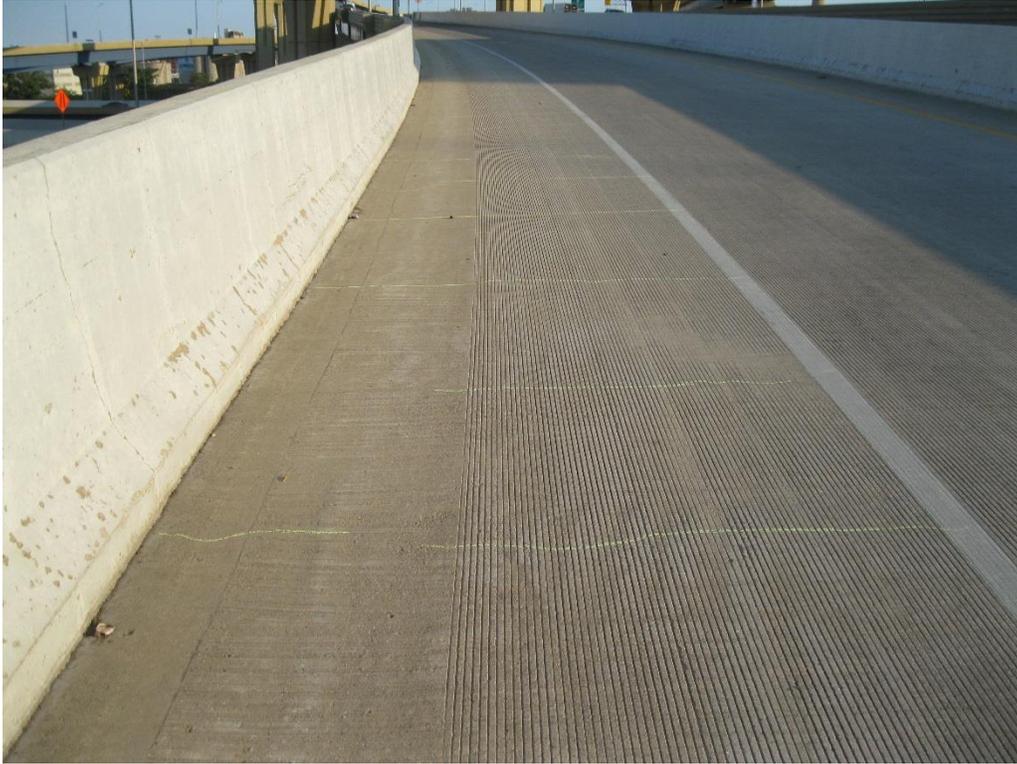
Figure 130. IH 43 northbound to Michigan Avenue Span 3 transverse cracks

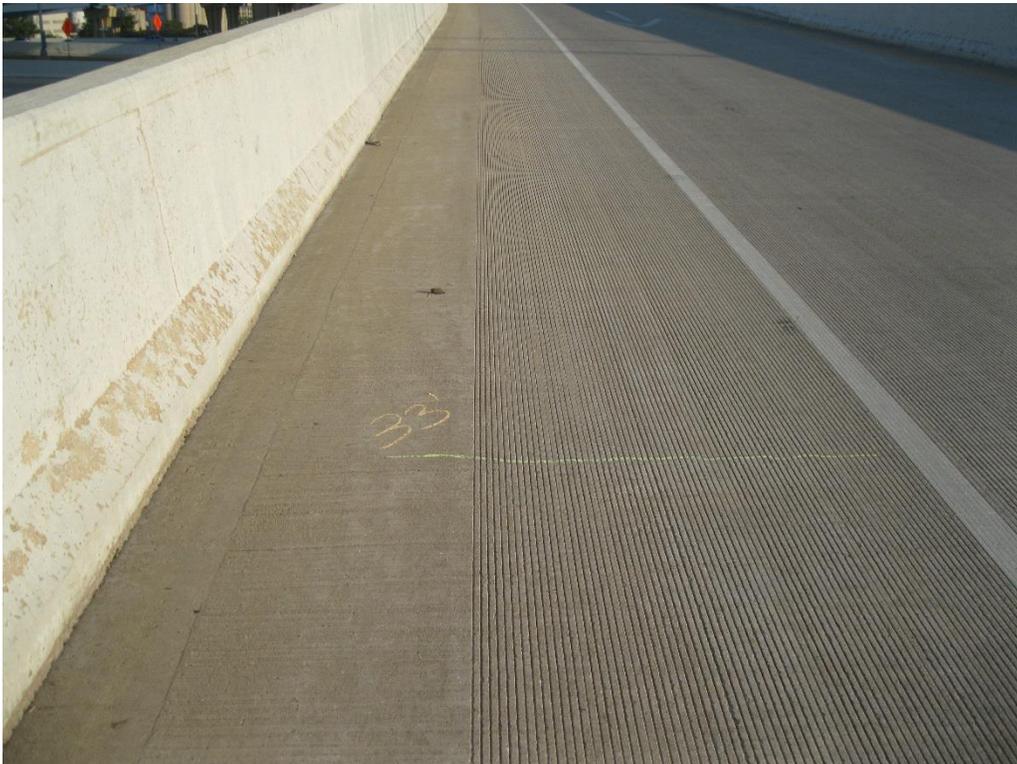
Figure 131. IH 43 northbound to Michigan Avenue Span 4 transverse cracks
