1. Report No. 0092-15-02	2. Government Accession No	3. Recipient's Catalog No	
4. Title and Subtitle Evaluation of Performance of Innovative Bridges in Wisconsin		5. Report Date July 2016

EVALUATION OF PERFORMANCE OF INNOVATIVE BRIDGES IN WISCONSIN

**Final Report
July 2016**

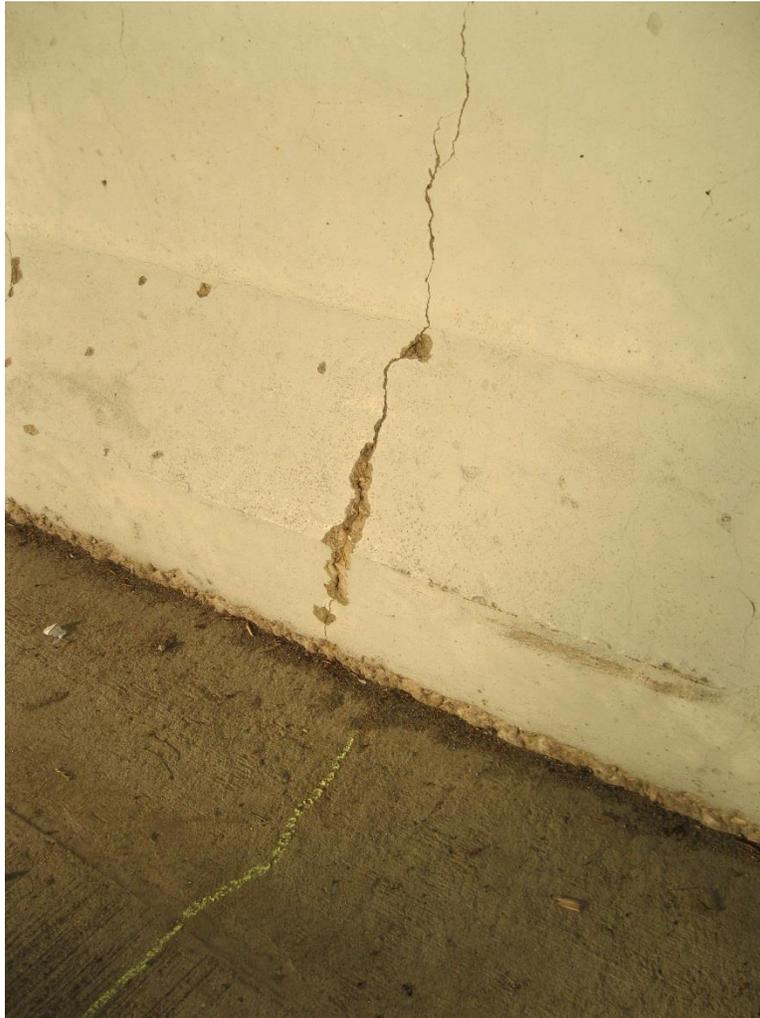
Figure 132. IH 43 northbound to Michigan Avenue parapet wall crack

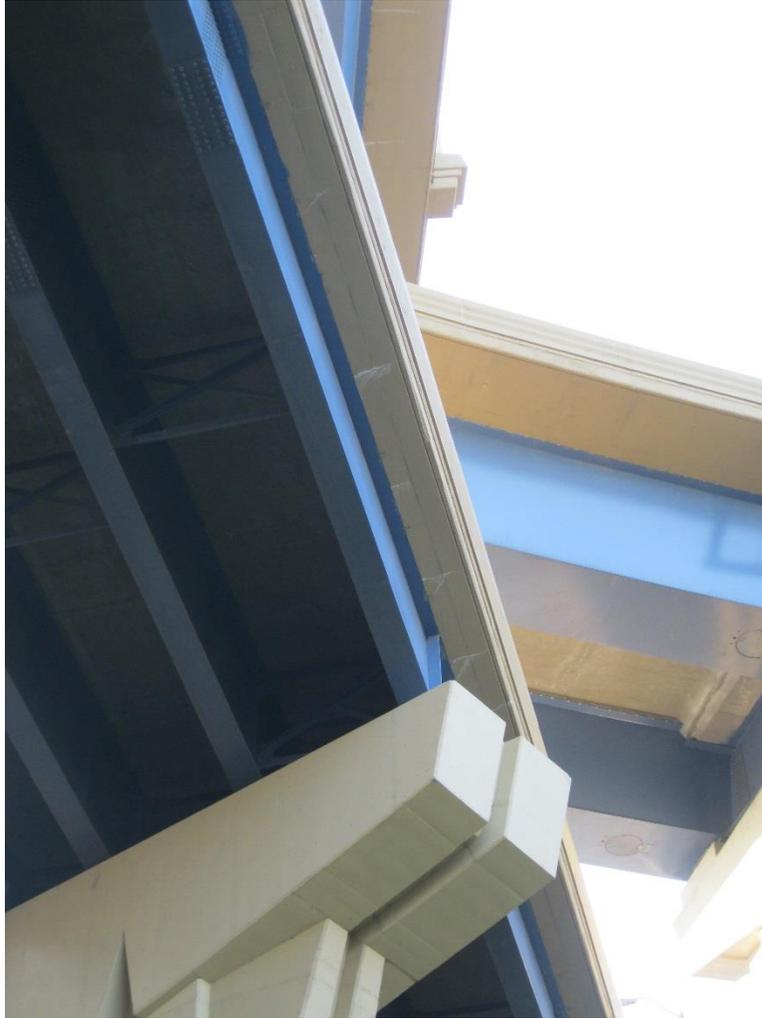
Figure 133. IH 43 northbound to Michigan Avenue chloride leaching

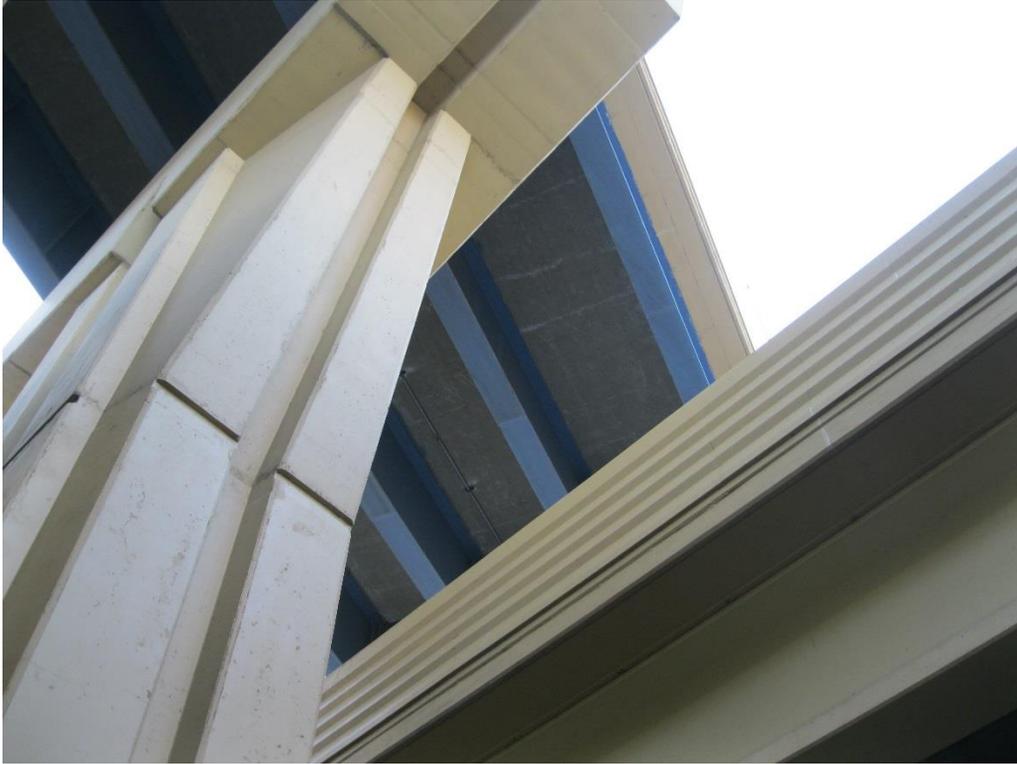
Figure 134. IH 43 northbound to Michigan Avenue chloride staining on deck underside – 1

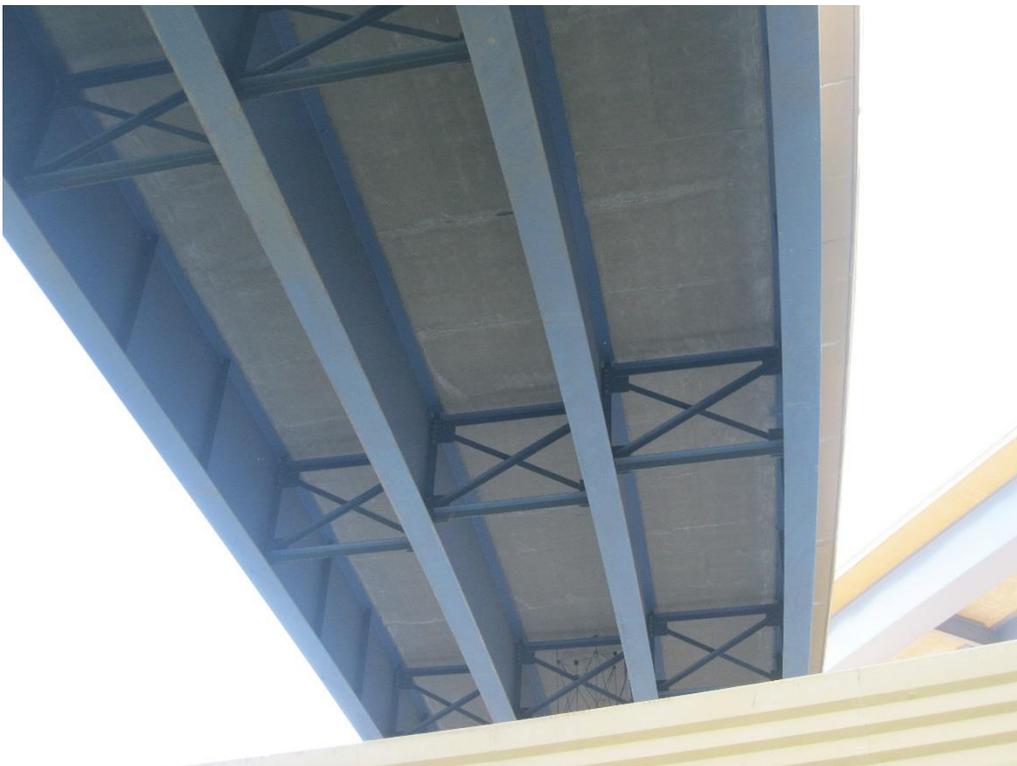
Figure 135. IH 43 northbound to Michigan Avenue chloride staining on deck underside – 2

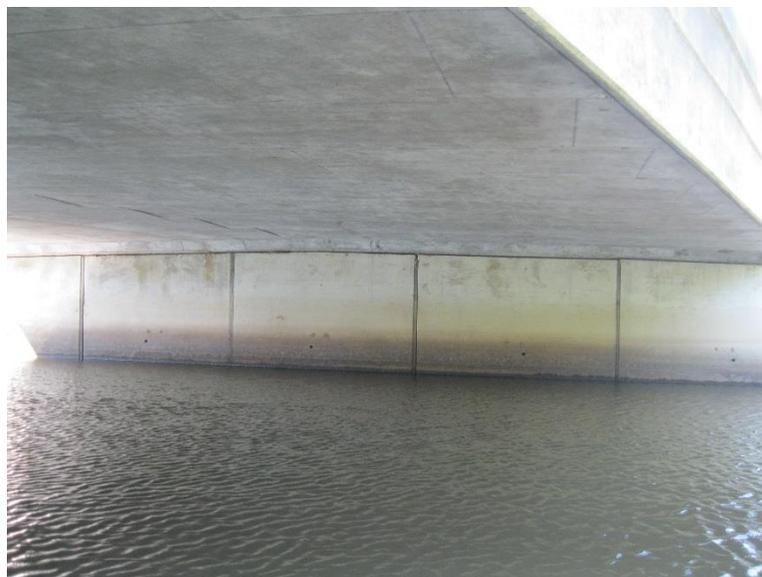
Figure 137. US 63 over the Rush River overall condition of precast panels

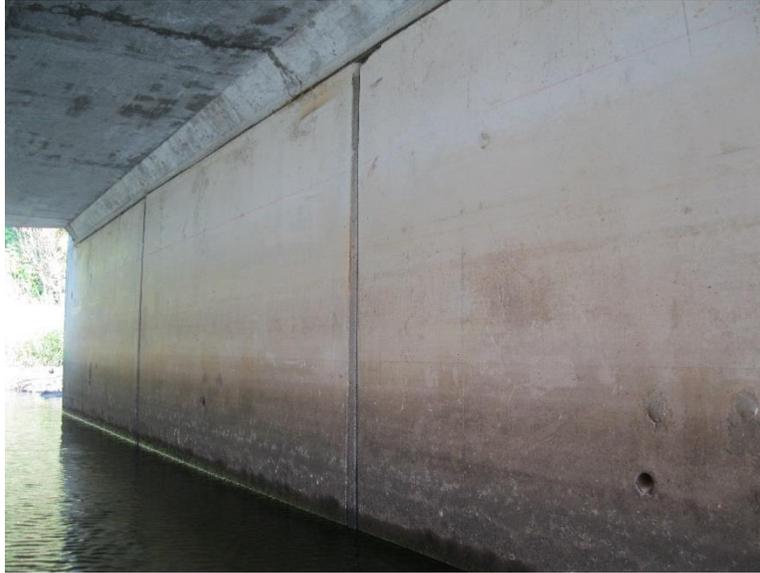
Figure 138. US 63 over the Rush River close-up condition of precast panels

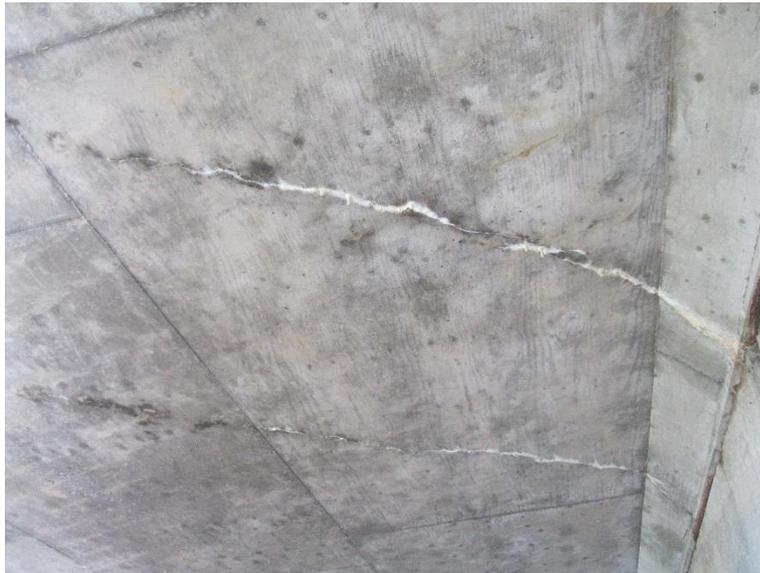
Figure 139. US 63 over the Rush River cracking in cast-in-place deck at abutment

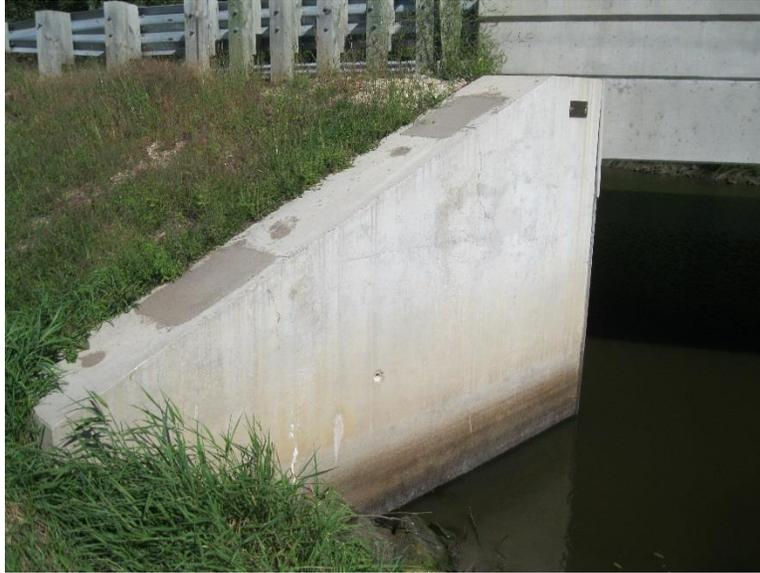
Figure 140. US 63 over the Rush River wingwall-exposed grout pockets

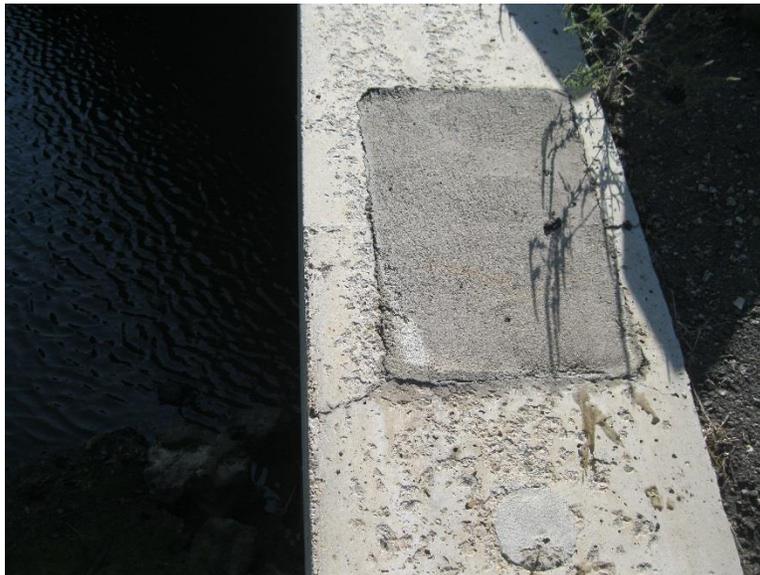
Figure 141. US 63 over the Rush River wingwall cracking at grout pocket top surface

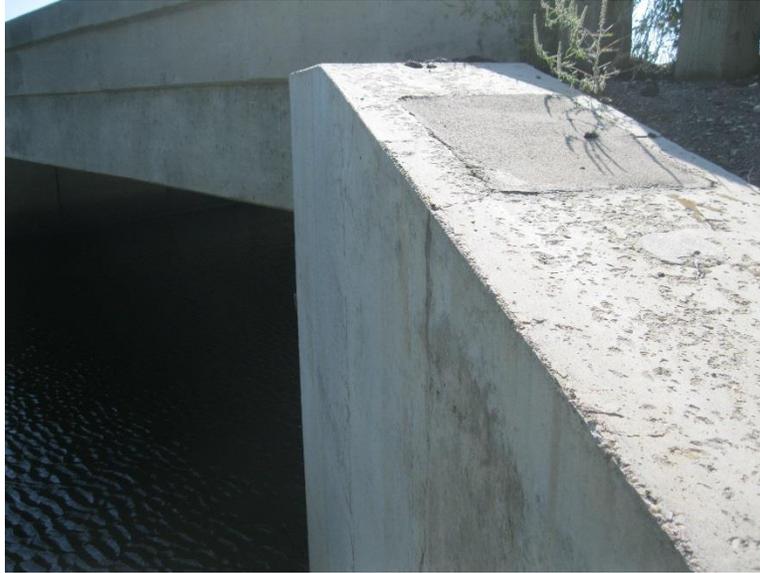
Figure 142. US 63 over the Rush River wingwall cracking at grout pocket vertical surface
