Evaluation and Repair of Damaged Prestressed Concrete Girder Bridges

FRANCESCO M. RUSSO, TERRY J. WIPF, F. WAYNE KLAIBER, AND RYAN PARADIS

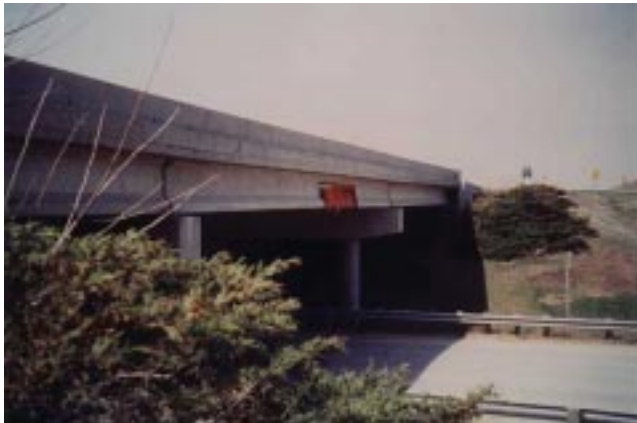
FIGURE 1 Elevation view of WB bridge, looking West (damaged Beam 1W in center span)

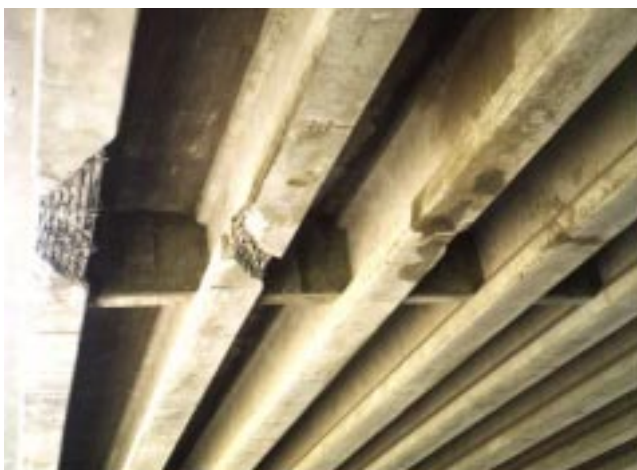
The impetus for this research project was the collision of an unknown vehicle with the north three beams of the overhead WB structure in July 1996 (see Figure 2). Damage was centered ± 5 ft (1.5 m) west of the midspan diaphragm of the center span. The damage to the WB bridge was such that approximately 6 ft (1.8 m) of the bottom flange was spalled or fractured from the north fascia beam, Beam 1W, exposing numerous prestressing strands. Several of the strands in Beam 1W seemed to be lax; however, no strands were severed during this collision. There was a preexisting severed strand from a 1993 collision. There was less damage on the first interior beam, Beam 2W. Significant cracking of the bottom flange as well as fracturing of the core concrete was present in both beams, but to a lesser extent on Beam 2W. Web cracking spread over the west half of Beams 1W and 2W. Cracking seems to have been arrested by the midspan cast-in-place concrete diaphragm. The second interior beam, Beam 3W, was also damaged, but not as severely, with the damage consisting of the spalling of a patch installed following prior collisions with the bridge.

FIGURE 2 Underside of damaged WB bridge, Beam 1W on left

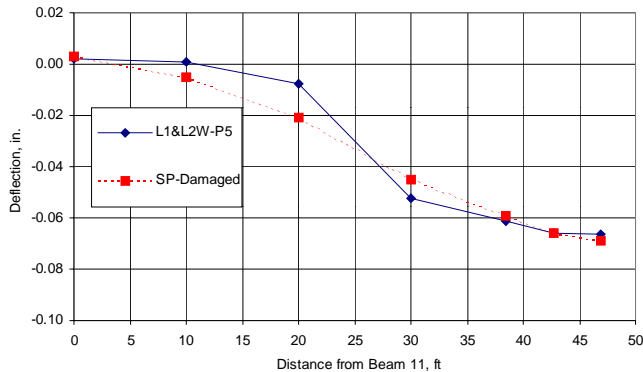
analytical results indicates that for the isolated main members in this bridge, that is to Beams 1W and 2W, for loads placed over the damaged beam lines, a significant redistribution of moment occurs, much of it being taken up by the adjacent curb and rail as well as the nearest undamaged beam lines. The amount of load carried by beams remote from the damage is insignificant. The primary means of load redistribution is via transverse flexure of the slab.

FIGURE 6 Damaged WB bridge experimental vs. analytical deflections; L1 and L2-P5

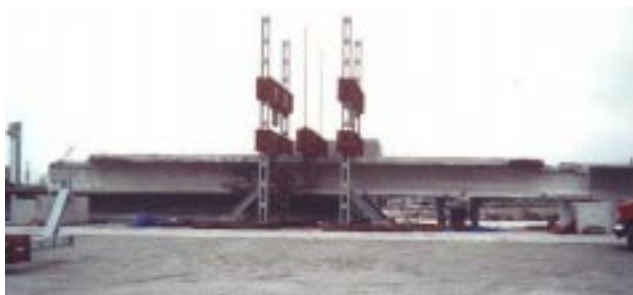
FIGURE 7 Beam 1W in test frame; damage under left (west) actuator

At the time of the test, Beams 1W and 2W were inspected for the first time since the original damage inspection approximately two years prior. Following the initial damage and eventual removal of the beams from service, a protective tarp was installed to prevent loose debris from falling onto the county road under the bridge. It is known that the beams were hit several more times prior to removal due to the presence of several tears in the tarp. The amount of additional damage could not be documented. The notes from one of the researchers written the day of the test indicated that it was possible to see completely through the web. "With a minor amount of effort it would have been fairly easy to create a large void in the web simply by removing the fractured concrete." The researcher goes on to communicate that "the tension region damage is extreme...one load point is right over the damage. The damage extends over three stirrups and most of the three stirrups are exposed...I think this will be the source of failure in this test." These comments indicate damage much more severe than apparent from the initial inspection photos and description.

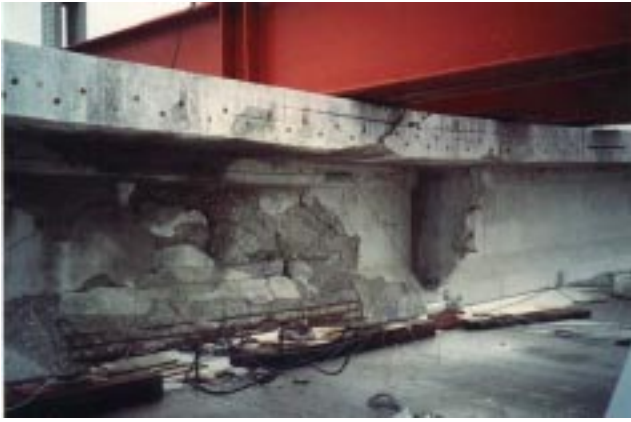
Figure 8 depicts Beam 1W at the ultimate applied load. At ultimate load, the live load moment was 2,067 ft-kips (2,802 kN-m) and the midspan deflection was 8.62 in. (219 mm); the response of the beam was ductile. Failure of the beam was through the development of a large shear crack under the actuator placed over the damaged region of the beam. At ultimate load, the overlay partially debonded from the original slab. The flexural strength of this beam was 14% greater than that predicted by standard AASHTO code equations for a beam with three severed strands.

FIGURE 8 South face of Beam 1W in the damaged region following the ultimate load test

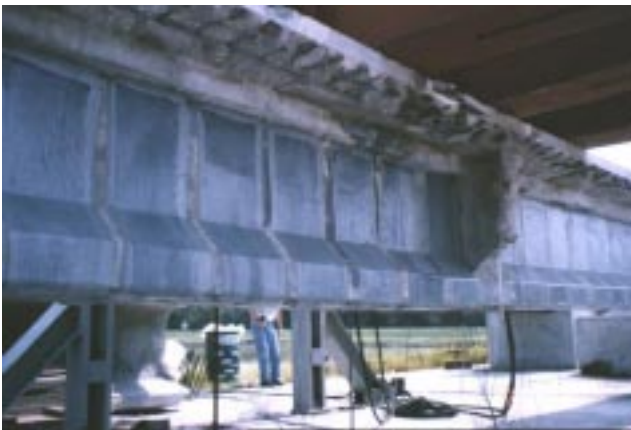
FIGURE 9 Beam 2W after repair with CFRP longitudinal plates (not shown) and CFRP stirrups

The purpose of testing Beam 2W was to determine the effectiveness of CFRP retrofit techniques on the strength of a damaged and repaired P/C beam. Beam 2W was first further damaged by severing several strands then patched with a cementitious patching material,

CFRP longitudinal plates to replace the tensile capacity of the severed strands, and CFRP stirrups to help maintain bond between the longitudinal plates and the concrete (see Figure 9).

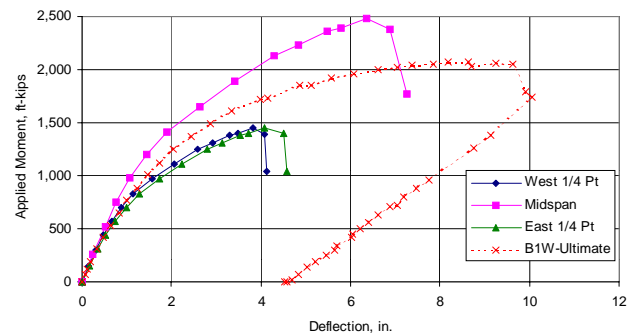
During the ultimate load test, the load vs. deflection response for repaired Beam 2W was substantially stiffer than for the baseline specimen Beam 1W (see Figure 10). This is due to the repair. At a load per actuator slightly more than 105 kips (467 kN), a midspan/damaged region live load moment of 2,480 ft-kips (3,362 kN-m), the beam failed catastrophically. Beam 2W completely collapsed at ultimate load. Although the failure of the beam was catastrophic, significant inelastic behavior and large deflections preceded the failure. The mode of failure is somewhat analogous to that observed in Beam 1W, failure of the beam directly under the west load point in the damaged region. At the time of failure, the overlay in this beam had partially debonded and spalled. However, this was not until the ultimate load was approached. The failure was sudden so a primary cause of fail-

ure was not observed though it appeared from assessment of the beam following the test that a combined shear/compression failure occurred in the damaged region. Up to near collapse, the longitudinal plates appeared to be well-bonded to the beam. The numerous external confinement stirrups were effective at ensuring bond between the plates and beam though numerous sounds were heard throughout the load test as the epoxy bonding the stirrups and plates to the beam cracked. It appears that at maximum load, the plates began to debond. This is evident by the decreasing strain in the plates following maximum load. The strains in the three longitudinal 5 in. x 0.08 in. (127 mm x 2 mm) CFRP plates bonded to the underside of the bottom flange were an average of $+7,200\mu\epsilon$, approximately 85% of the failure strain of the cured laminate. The composite stress in the laminate was computed to be 122,400 psi (844 MPa) and the total force in the three plates, close to 147 kips (654 kN), equivalent to the capacity of approximately 3.5, $\frac{1}{2}$ in. ϕ (12.7 mm), 270 ksi (1860 MPa) prestressing strands. Having only removed 2 strands from the section, this retrofit attained its design goal of replacing the lost tensile capacity of the damaged strands. A lesser amount of CFRP would have also achieved this objective and ensured a greater amount of displacement ductility.

FIGURE 10 Load vs. deflection response; repaired Beam 2W vs. baseline specimen 1W
