Stabilization Procedures to Mitigate Edge Rutting for Granular Shoulders – Phase II

Final Report
January 2011

IOWA STATE UNIVERSITY
Institute for Transportation

Sponsored by
Iowa Highway Research Board
(IHRB Project TR-591)
Iowa Department of Transportation
(InTrans 08-319)

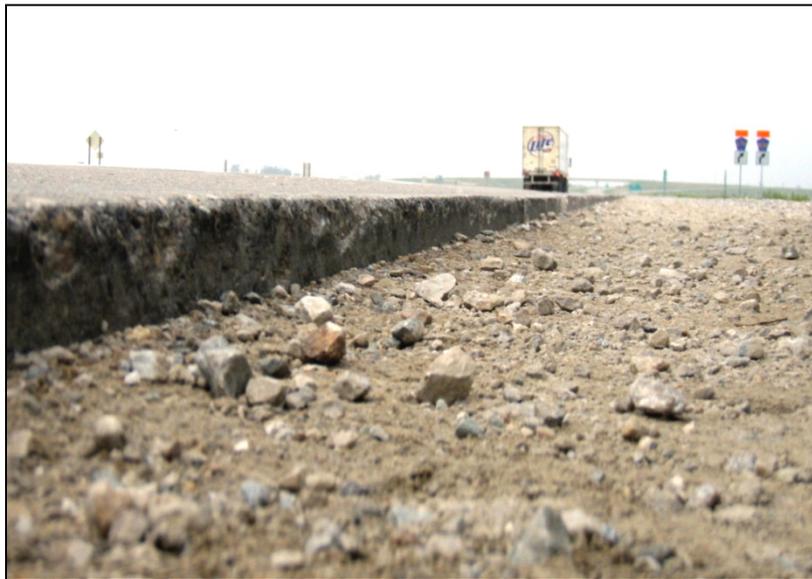
Figure 1. Shoulder drop-off near pavement edge Highway 18 milepost 195.95-196.2 westbound June 4, 2008

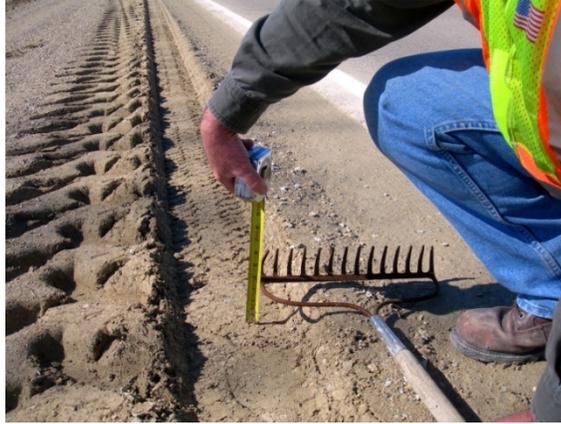
Immediately after construction, the full-depth reclaimed sections were sufficiently soft so that the rear tires of an unloaded 3/4-ton pickup truck sunk 3 to 4 in. into the shoulder surface (See Figure 16). The pull-behind compactor could not provide enough passes quickly enough, nor to the depth of compaction required, to stabilize the road surface. Because the truck could not back up with the compactor, it was necessary for the truck to take very long round trips from one exit to another on Highway 20 (with its controlled access design). Thus, few passes could be made in the available time.

Figure 16. Pickup truck tire rut that indicated the typically soft conditions one day after full-depth reclaiming

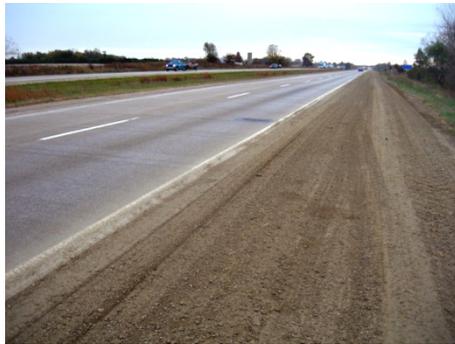
By the following week, much of the shoulder had stabilized, so it could support a 3/4 ton pickup truck (See Figure 17), but a few soft spots remained (See Figure 18).

Figure 17. Magnesium chloride full-depth after one week

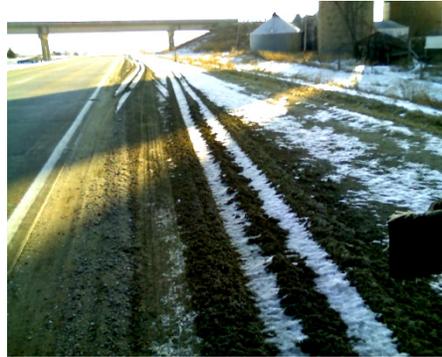
In February 2009 maintenance personnel notified the research team that some areas included in the test sections were experiencing heavy rutting during winter thaw periods. These areas were documented with photos. The locations were the full-depth reclamation areas for each of the stabilizing agents. In addition, Control Section 1 experienced some rutting (See Figure 20).

Figure 20. Rutting on Control Section 1 in February

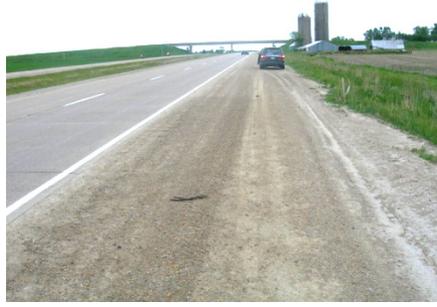
Figure 21. Mostly good calcium chloride full-depth 8 ft wide June 2009

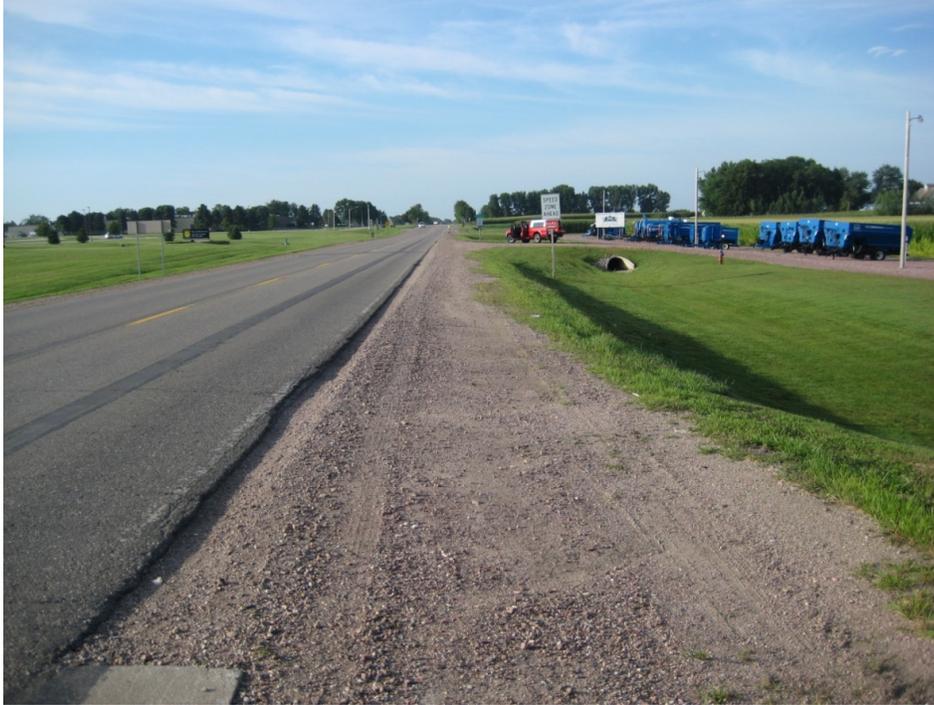
Figure 49. Shoulder condition at Test Area I before stabilization

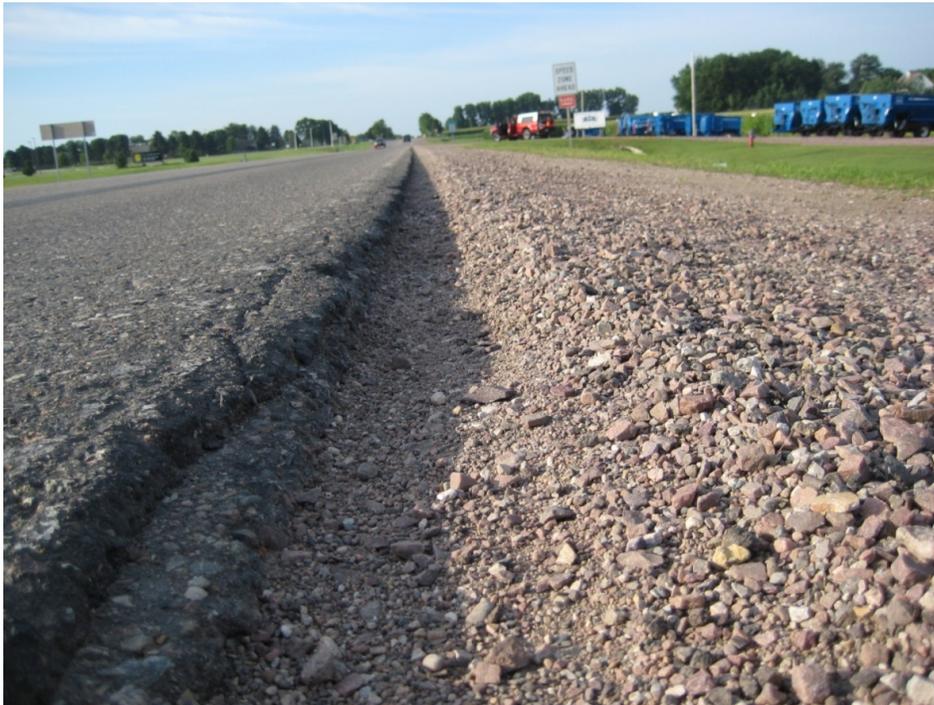
Figure 50. Shoulder rutting at Test Area I before stabilization July 28, 2009

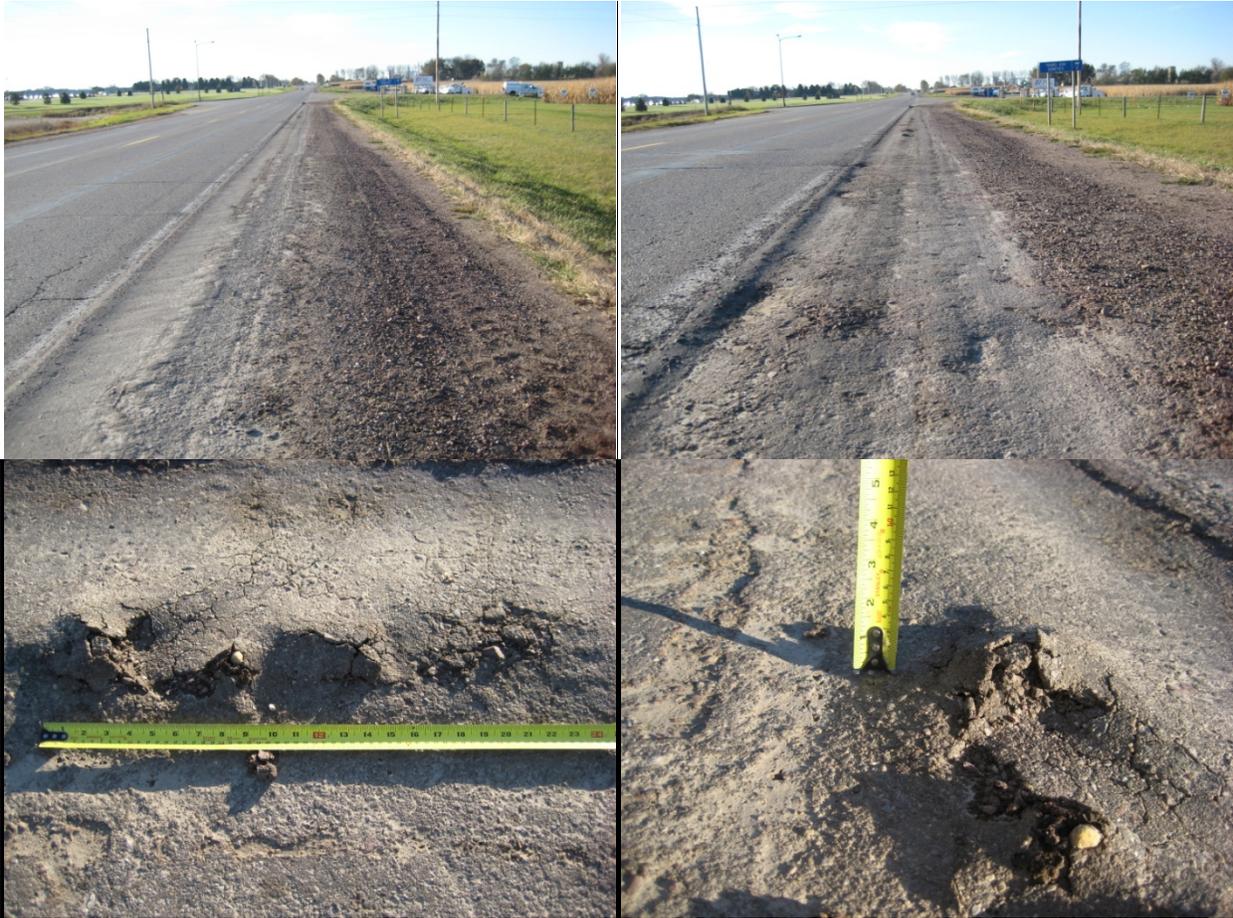
Figure 62. Stabilized shoulder surface October 27, 2009

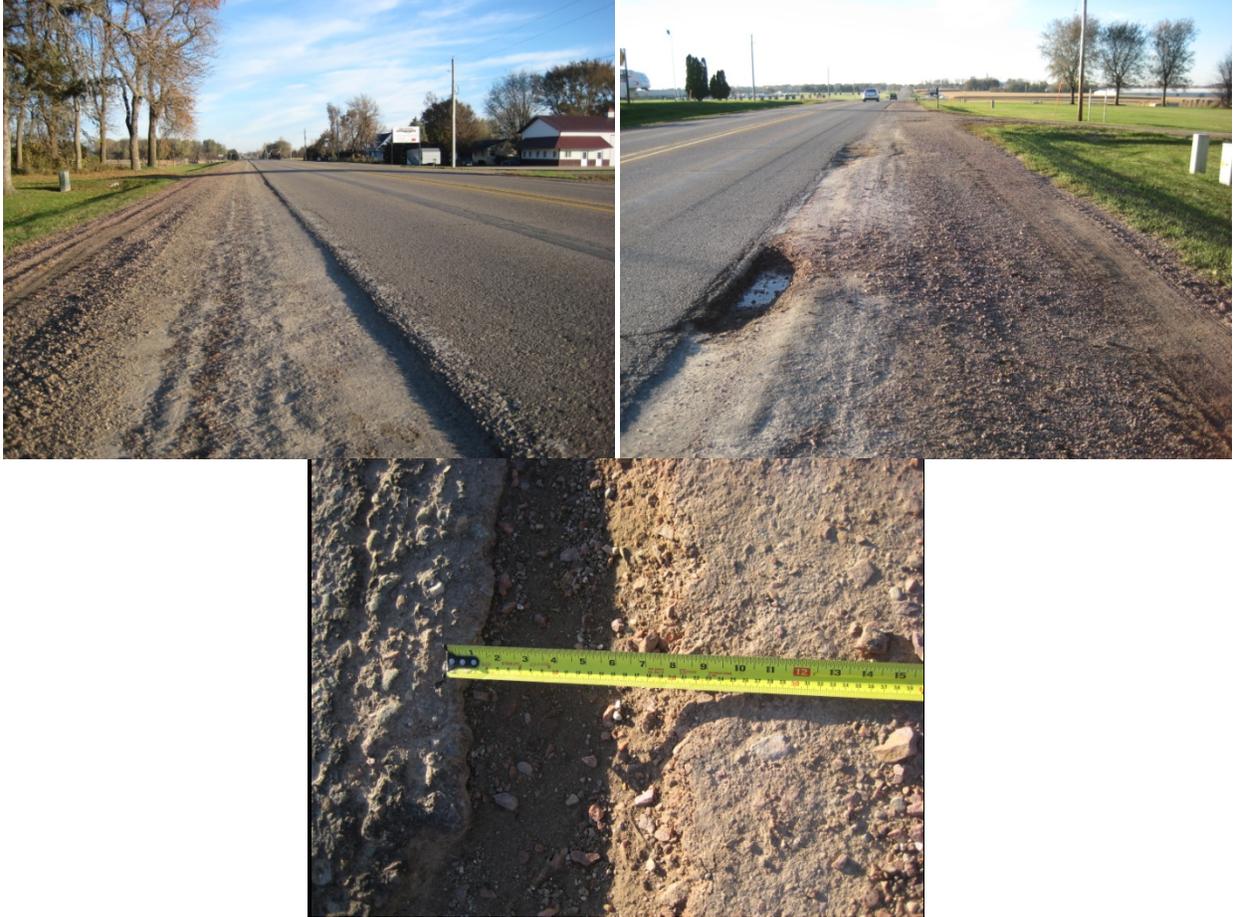
Figure 68. Shoulder condition of the Test Area III on the southbound shoulder of US 75 near Sioux Center, Iowa October 27, 2009

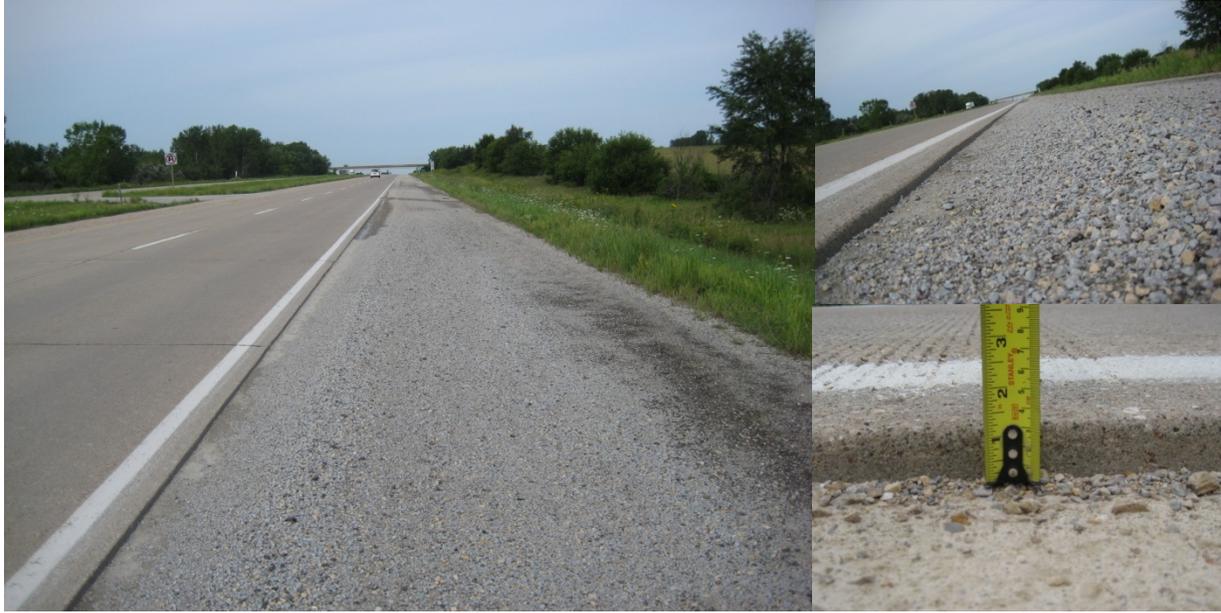
Figure 72. Shoulder conditions and edge ruts along the pavement slabs August 17, 2009

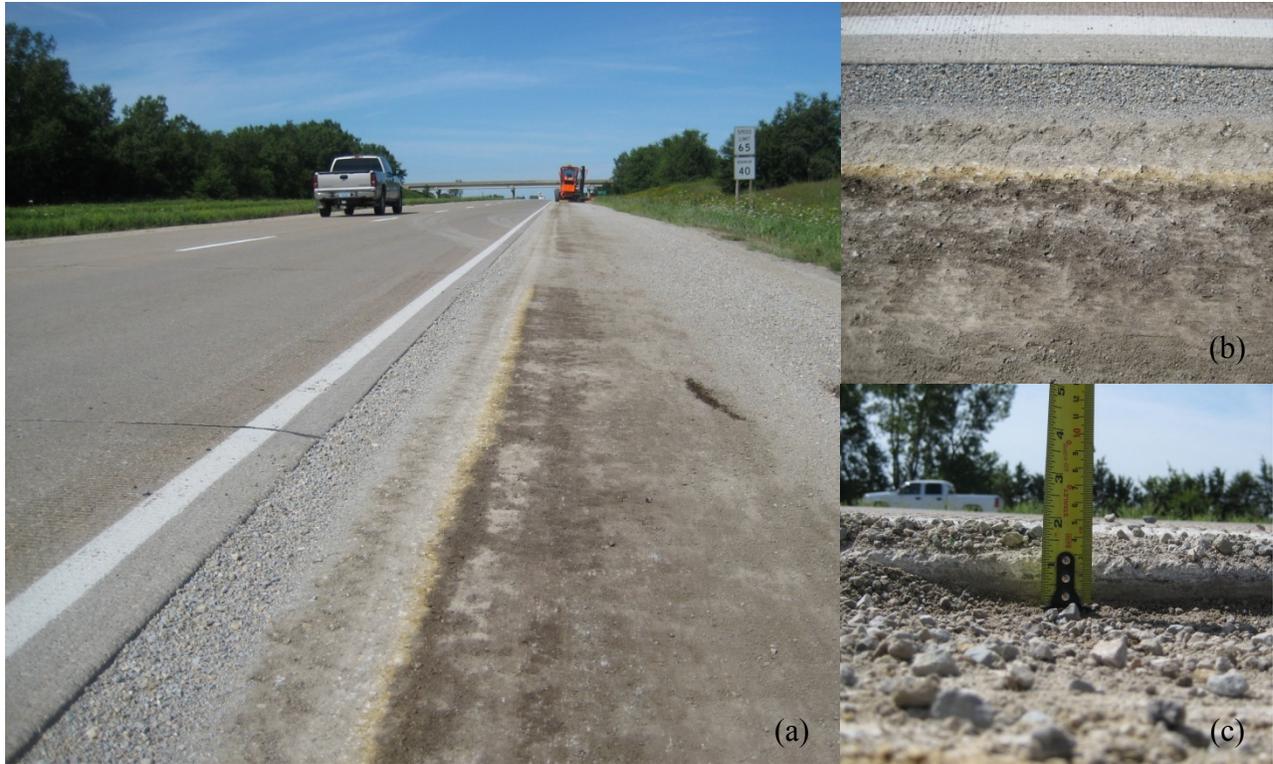
Figure 82. Section III: a) graded surface, b) side view of graded surface, and c) pavement edge drop off August 18, 2009

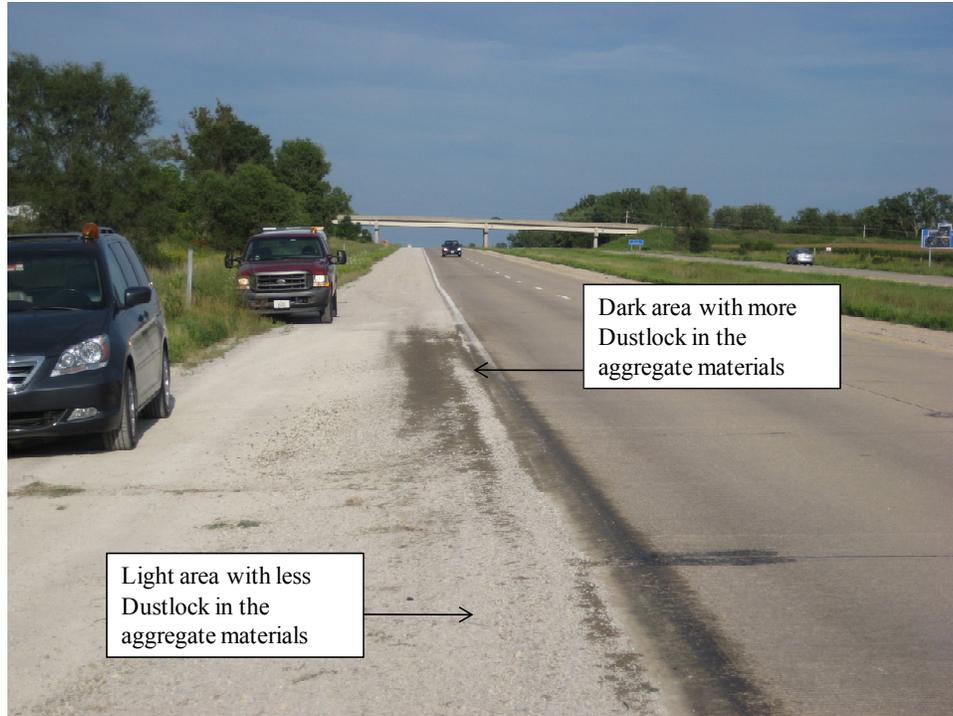
Figure 86. Uneven mixed of DUSTLOCK due to grading process in Section V August 18, 2009

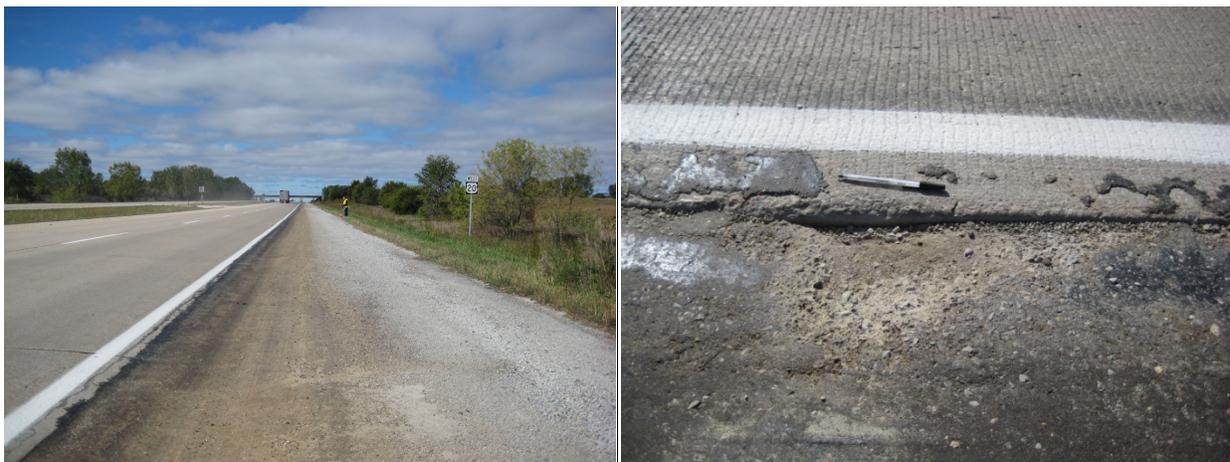
Figure 87. Stabilized shoulder using DUSTLOCK on US 20 westbound September 29, 2009

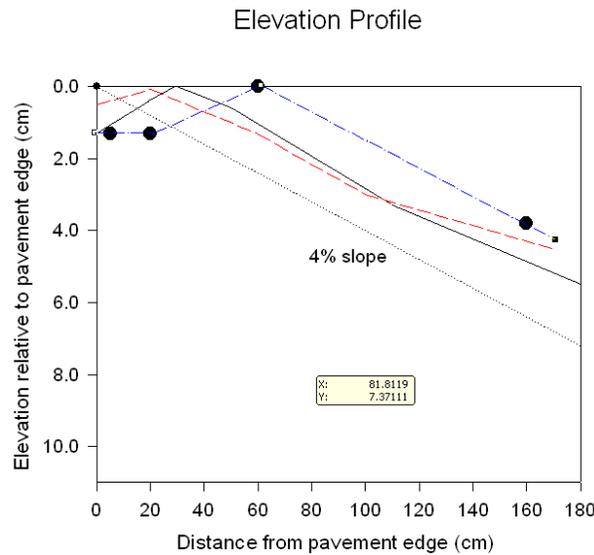
Figure 88. Elevation Profile of Section I Point 6 showing removal of DUSTLOCK from edge-rut area

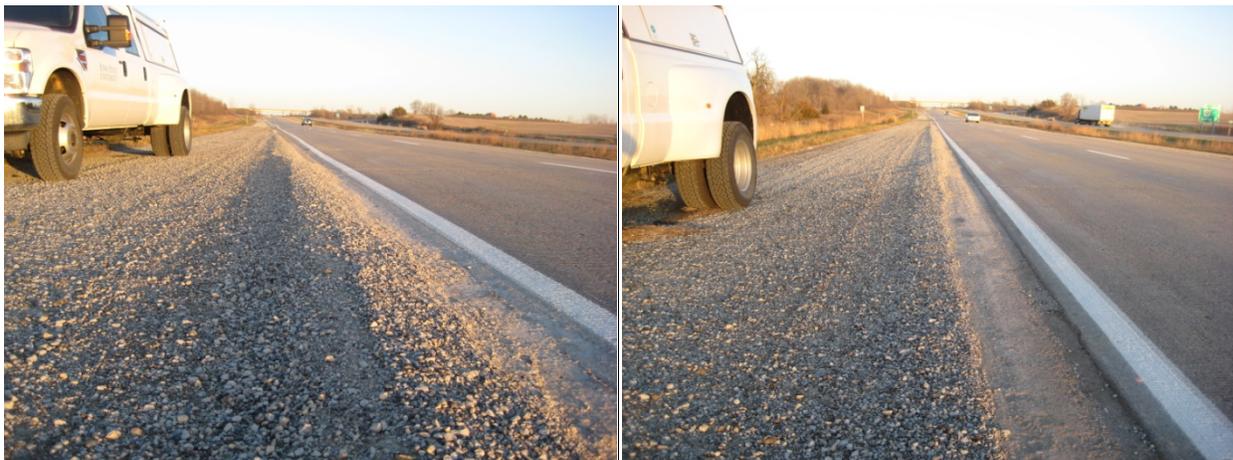
Figure 89. Stabilized shoulder using DUSTLOCK on US 20 westbound covered with course aggregate beyond edge-rut area November 7, 2009

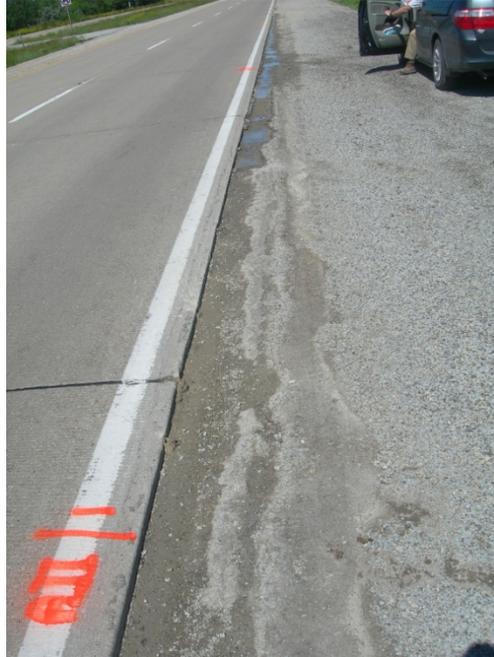
**Figure 90. Looking west from Area II Test Point I milepost 245 June 9, 2010
(approximately same location as in Preconstruction Figure 72)**

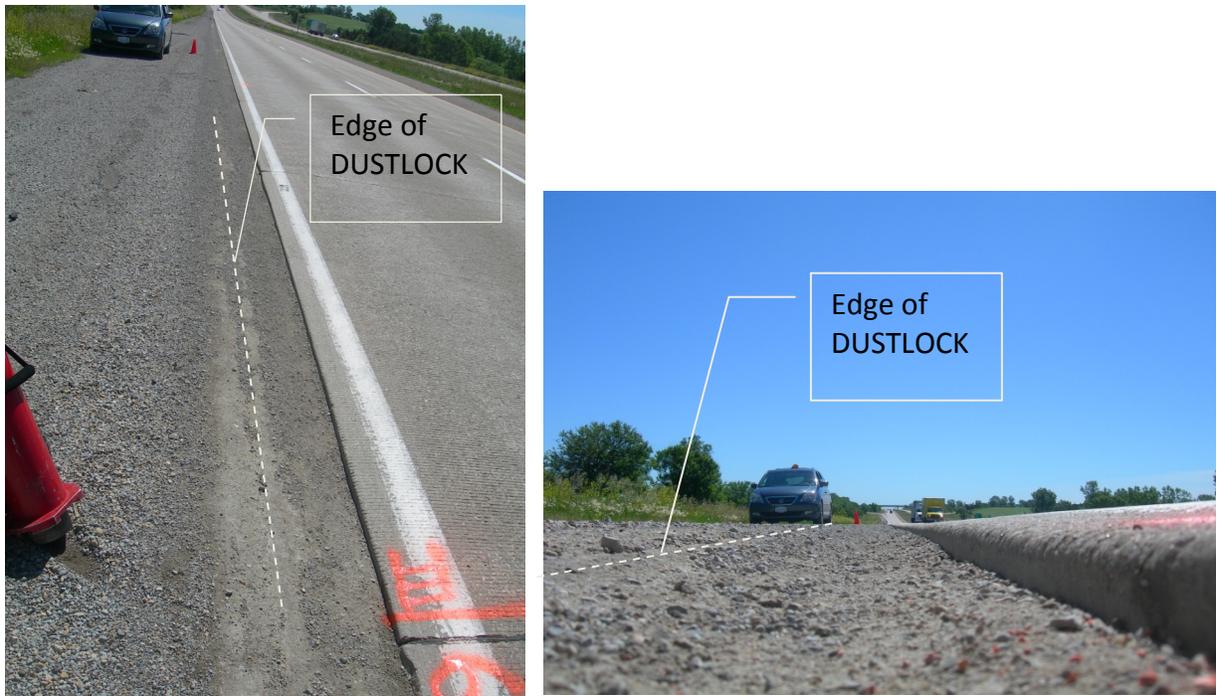
Figure 91. Removal of DUSTLOCK from edge rut area
