Field Testing and Evaluation of a Demonstration Timber Bridge

Final Report
February 2012

Sponsored by
Iowa Highway Research Board
(IHRB Project TR-604)
Iowa Department of Transportation
(InTrans Project 08-343)

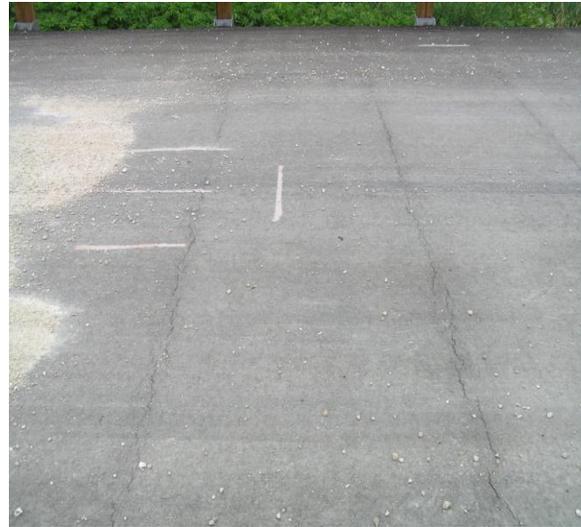
One month after the initial inspection and testing, a follow-up inspection was completed. The substructure and superstructure were, again, in excellent condition and unchanged. The wearing surface condition was unchanged as well, with the exception of one observation. On Span 1, additional minor cracking in the wearing surface was noted at the deck panel joints, in addition to the cracking at the transverse plywood joints noted a month earlier, as shown in Figure 5.2.

Figure 5.2. Transverse cracking two months post construction
