Timber Abutment Piling and Back Wall Rehabilitation and Repair

Final Report
September 2012

IOWA STATE UNIVERSITY
Institute for Transportation

Sponsored by
Iowa Highway Research Board
(IHRB Project TR-616)
Iowa Department of Transportation
(InTrans Project 10-372)

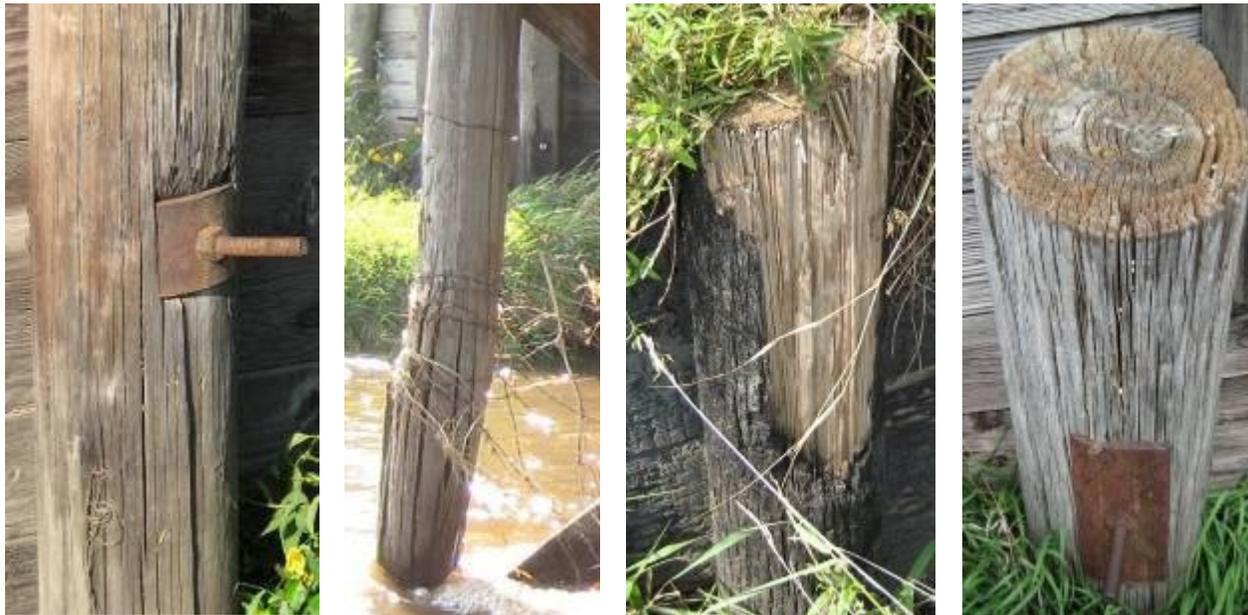
Figure 2-1 Breaks in preservative barriers by exterior damage leads to premature decay (Bigelow et al. 2007)

There are several forms of physical deterioration that occur in timber bridge piling and back walls, as shown in Figure 2-1. In almost all cases, the physical deterioration causes exterior damage that breaks down the protective preservative barrier and allows entry of biological decay mechanisms into the untreated wood. One of the most common types of physical deterioration is abrasion or debris damage. This generally occurs by the impact of floating debris and/or ice in a channel (White et al. 2007). The velocity of water moving past the pile and the quantity, shape, size, and hardness of particles being transported have been linked to the rate of abrasion (U.S. Army Corps of Engineers et al. 2001).

(a) Mechanical Damage

(b) Debris Damage

(c) Fire Damage

(d) Weathering/UV
Damage

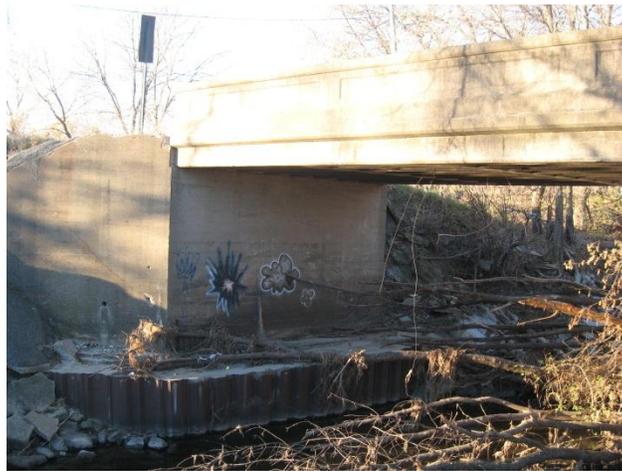
Figure 6-7 Sheet piling at abutment foundation

Polk County has used steel sheet pile to protect bridge abutments from scour problems. Bridge BR2433 with sheet pile placed to prevent scouring of the foundation is shown in Figure 6-7. Although the abutment in this bridge was reinforced concrete, the same solution can be applied to timber abutments. The sheet pile is placed on the stream side of the abutment. The area between the existing abutment and sheet piling was backfilled and capped with concrete to prevent erosion of the backfill material.

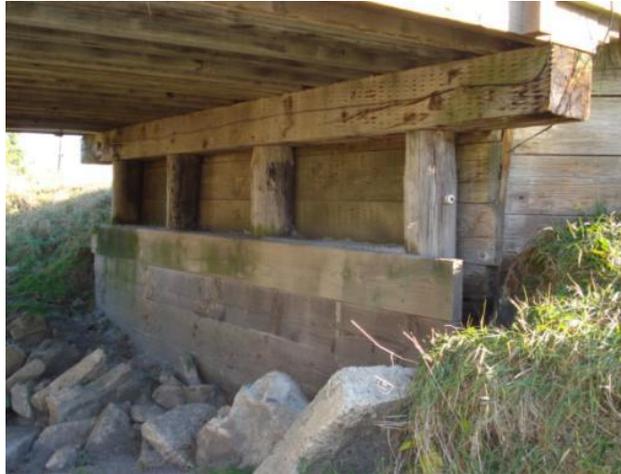
Figure 6-8 Abutment repair on stream side of existing timber abutment

Polk County has also used timber planks nailed to the front of the existing timber abutments to help protect from scour and deterioration of the existing backwall. Figure 6-8 shows the timber planks on the front of the existing timber abutment. The space created between the existing backwall and new backwall planking was filled with concrete. Additional rip-rap was placed on the stream bank and in front of the abutment to help prevent additional scour.

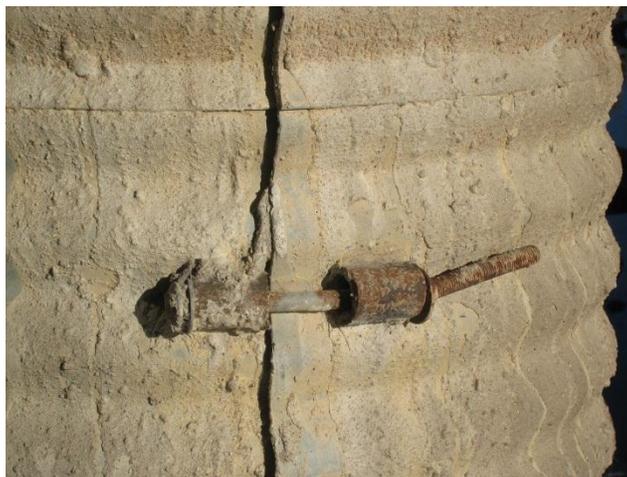
Figure 6-9 Corrugated metal pipe form connector

Polk County has used a combination of splicing and concrete encasement to repair deteriorated timber piles. The repair involves the removal of the decayed portion of the pile up to the pile cap. A new section is placed and is connected to the existing pile with four steel straps. The steel straps, approximately 1/4 in. thick, 1-1/2 in. wide, and 2 ft long, are spaced equally around the pile. The straps are lag screwed with 3 to 4 screws above and below the joints. The splice is then encased with concrete. A corrugated metal pipe (CMP) cut in half and clam shelled around the pile is used for the form. The two halves are connected together using pipe and bolts (Figure 6-9) spaced along the vertical seams of the CMP on approximately 32 in. spacing. The CMP form is extended below the splice straps a minimum of 1 ft and the annular space between the CMP form and the pile is then filled with C-4 concrete. The diameter of the CMP form is approximately 32 in. providing annular space around a 12 in. diameter pile of 10 in. The county did not place reinforcing in the annular space, however, did recommend it for future repairs. One drawback to the repair method stated by the county engineer was the pier bracing had to be reconfigured due the larger diameter of the encased piling. The finished repair is shown in Figure 6-10; this repair was completed in 2000 and is still in good condition.

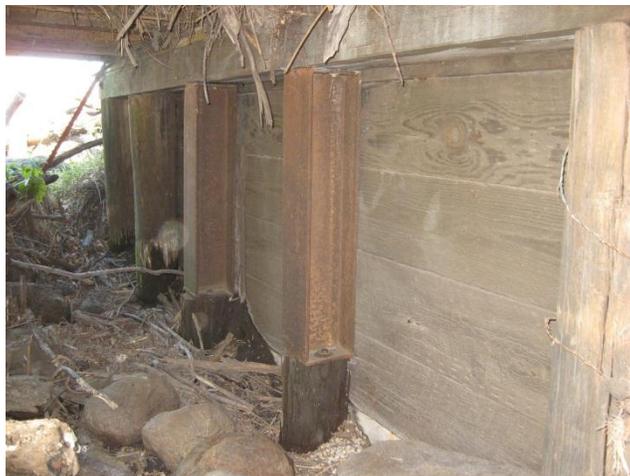
Figure 6-11 Posted piles using steel W shapes

Buchanan County has used steel “W” shapes to splice or post decayed or damaged piles. Figure 6-11 shows two repaired abutment piles. The deteriorated sections are removed and replaced with a “W”-shaped steel section with cap plates welded on each end. The steel section is lag screwed to the remaining pile and to the cap beam with two screws top and bottom. Buchanan County has used this repair on several bridge piles and has seen repairs lasting over 10 years. The one drawback, noted by the county engineer, is a reduction in lateral load capacity and concerns that the abutment could push the wall out. Buchanan County has also used timber sections for repair, however, the longevity of using new timber pile sections was found to be less than that of the steel sections.

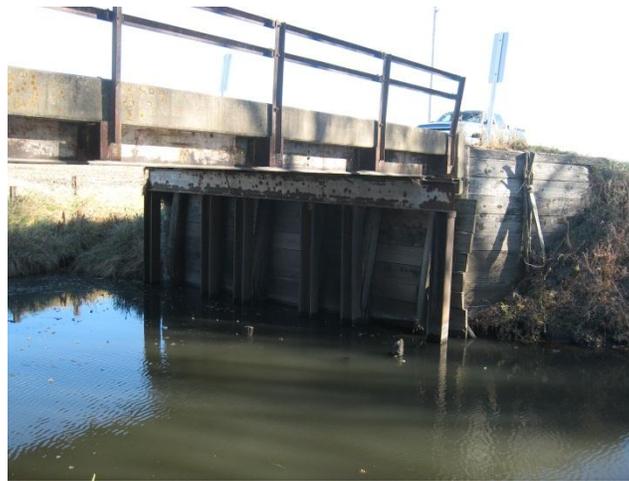
Figure 6-12 Steel piles driven

the openings. The new piles, however, did not provide lateral support for the bridge back wall. The backwall was not shimmed against the new piling. After sufficient deterioration of the existing timber piles took place, the back wall buckled. The county engineer suggested the piles be driven as close to the back wall as possible and shims placed between the new piles and existing backwall in order to prevent the backwall movement.

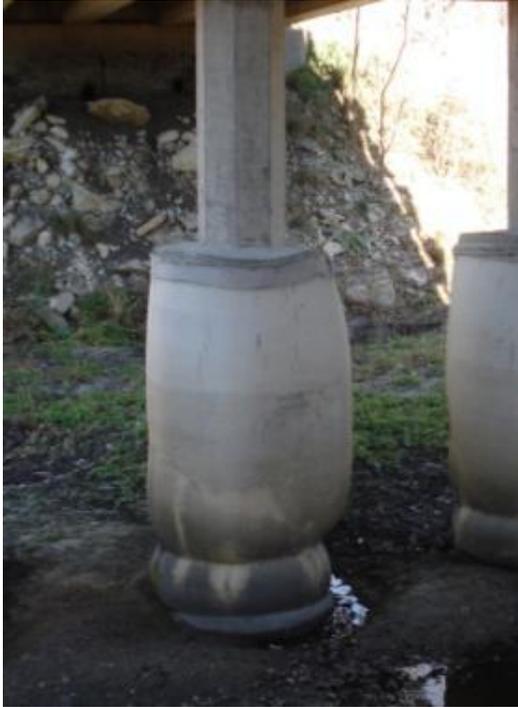
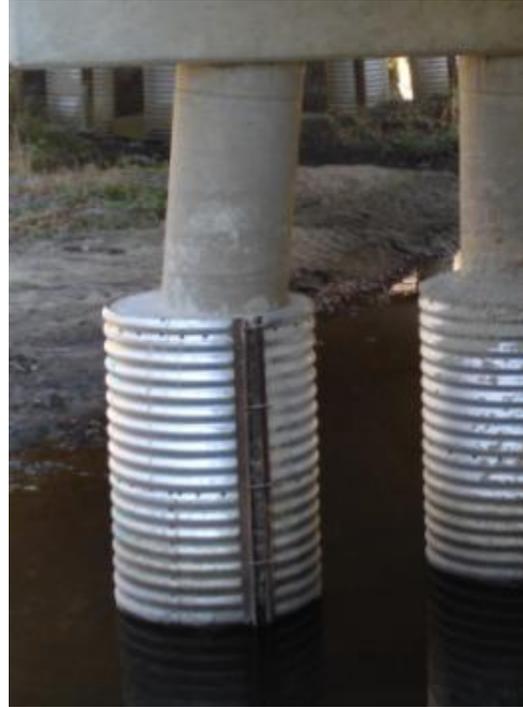
Buchanan County also uses concrete encasement for repairing deteriorated piles. Figure 6-13, shows the encasements the County has completed on concrete piles, however both systems can be applied to timber piles. The repair seen in Figure 6-13a uses a fabric sock that is placed around the pile and filled with concrete. The cost of using the fabric sock concrete encasement with the exclusion of excavating around the pile was approximately \$1800/pile in 1998; the fabric sock encasement was completed in 1998 and is still performing well. Similar to Polk County, Buchanan County also repaired piles using CMP as forms for concrete encasement. Figure 6-13b shows the CMP cut in half, reconnected using an angle welded to the CMP, then bolted together. The CMP encasement was completed circa 1998 and is also still performing well.

(a) Concrete repair sock

(b) CMP repair

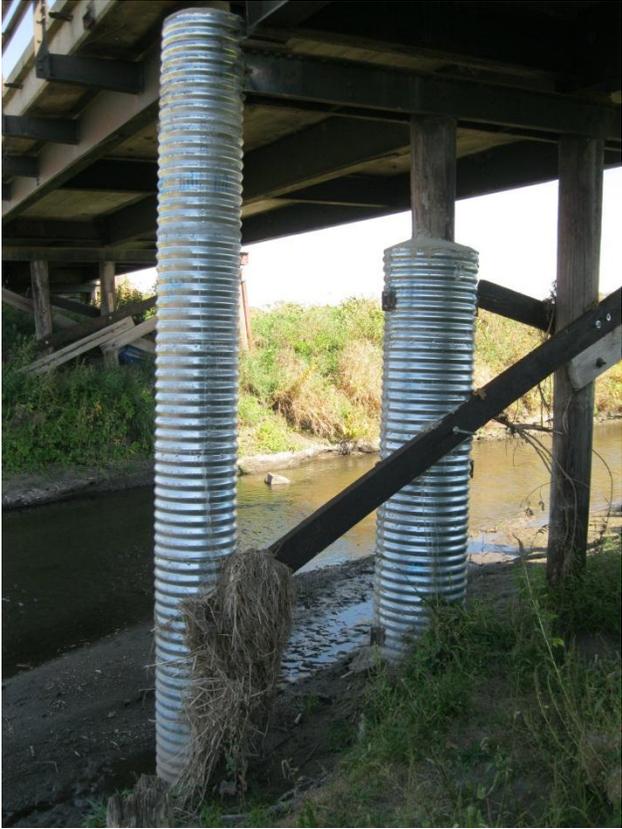
Figure 7-3 Repaired piles by concrete encasement

instrumented pier is shown in Figure 7-2. One of the repaired piles was completely encased, while the other was only partly encased (Figure 7-3).

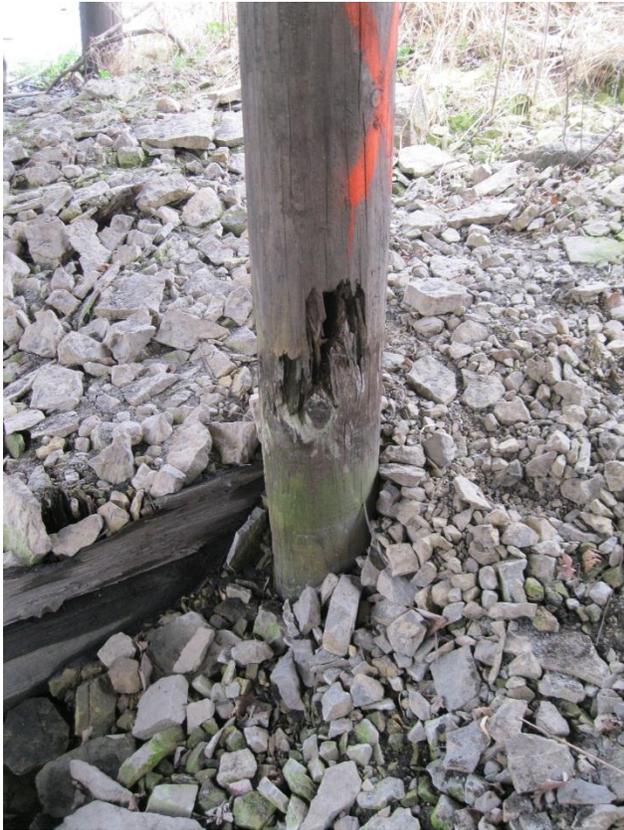
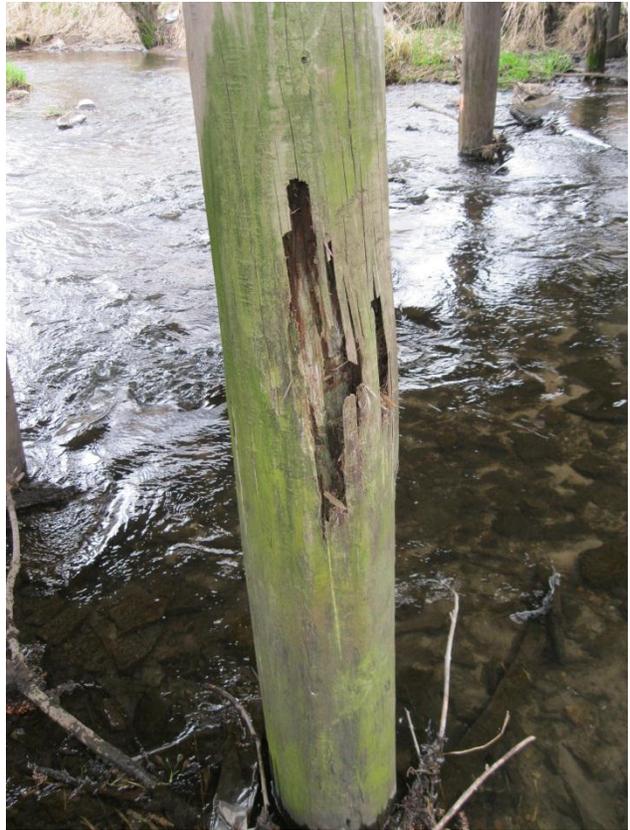
c) Damage and decay - 1

d) Damage and decay - 2
