Geo-Infrastructure Post-Flood Damage Assessment, Repair and Mitigation Strategies

tech transfer summary

September 2013

Western Iowa Missouri River Flooding
Geo-Infrastructure Damage Assessment, Repair
and Mitigation Strategies

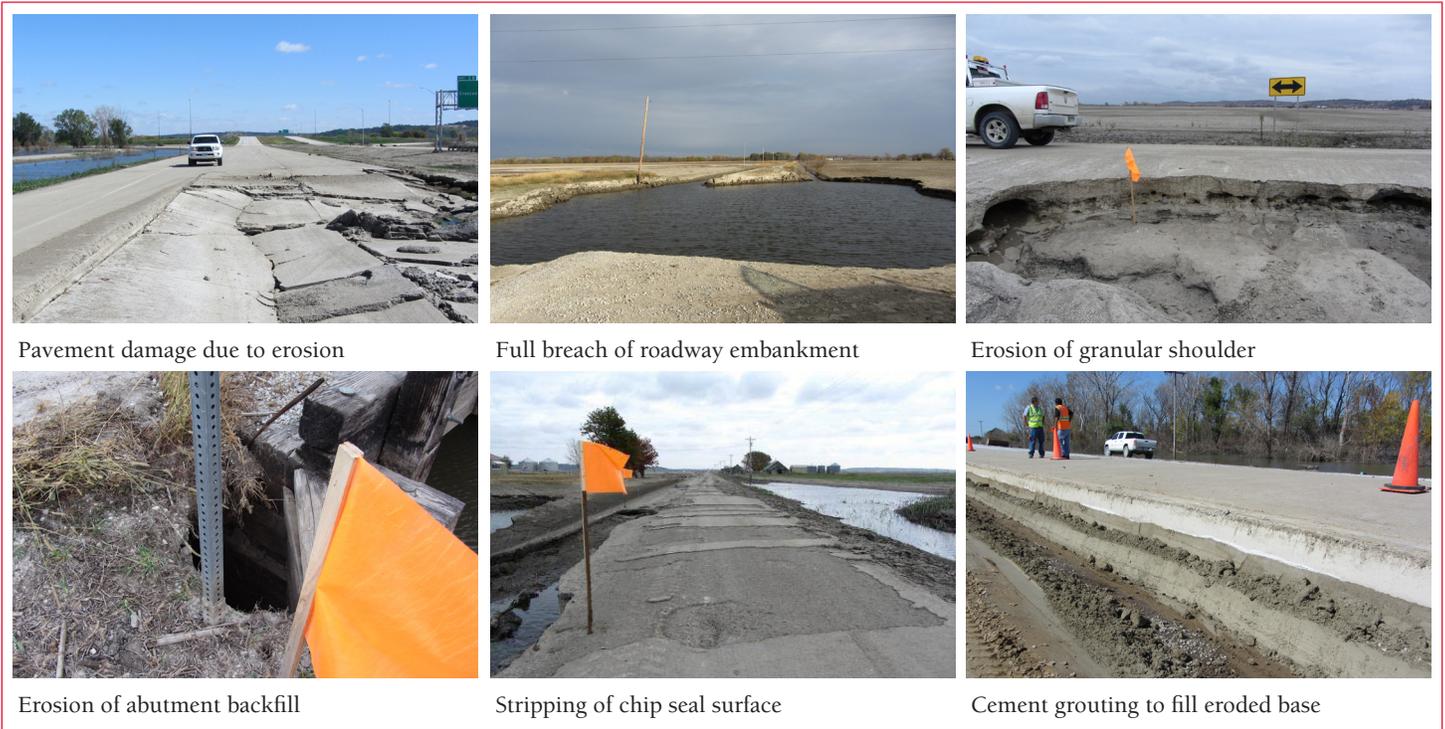
Pavement damage due to erosion

Full breach of roadway embankment

Erosion of granular shoulder

Erosion of abutment backfill

Stripping of chip seal surface

Cement grouting to fill eroded base

Figure 1. Post-flood damages

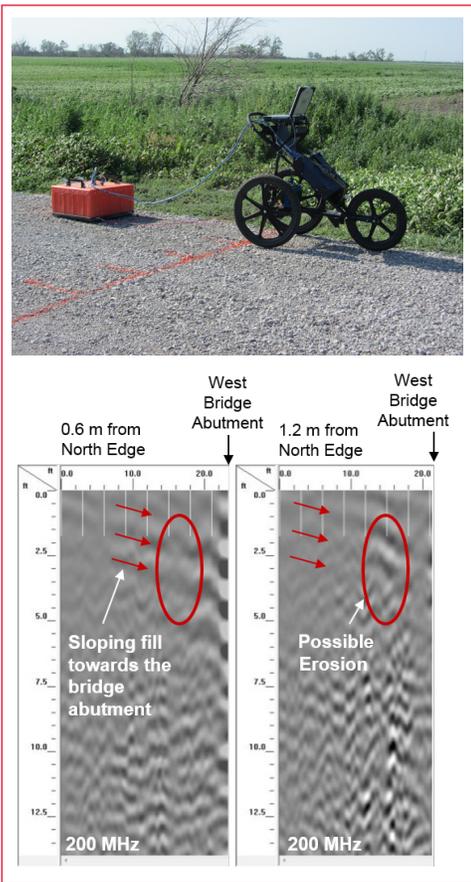
Figure 2. Ground penetrating radar scanning at a bridge site to identify subsurface voids/erosion in approach backfill

- Erosion of bridge approach backfill materials was observed at the two bridge sites assessed in this study, resulting in voids down to about 2 m (6.6 ft) below surface.

- Ground penetrating radar scanning identified changes in gravel layer thicknesses, culvert locations, weep holes under roadways, voids beneath pavements, and voids in bridge approach backfill materials.

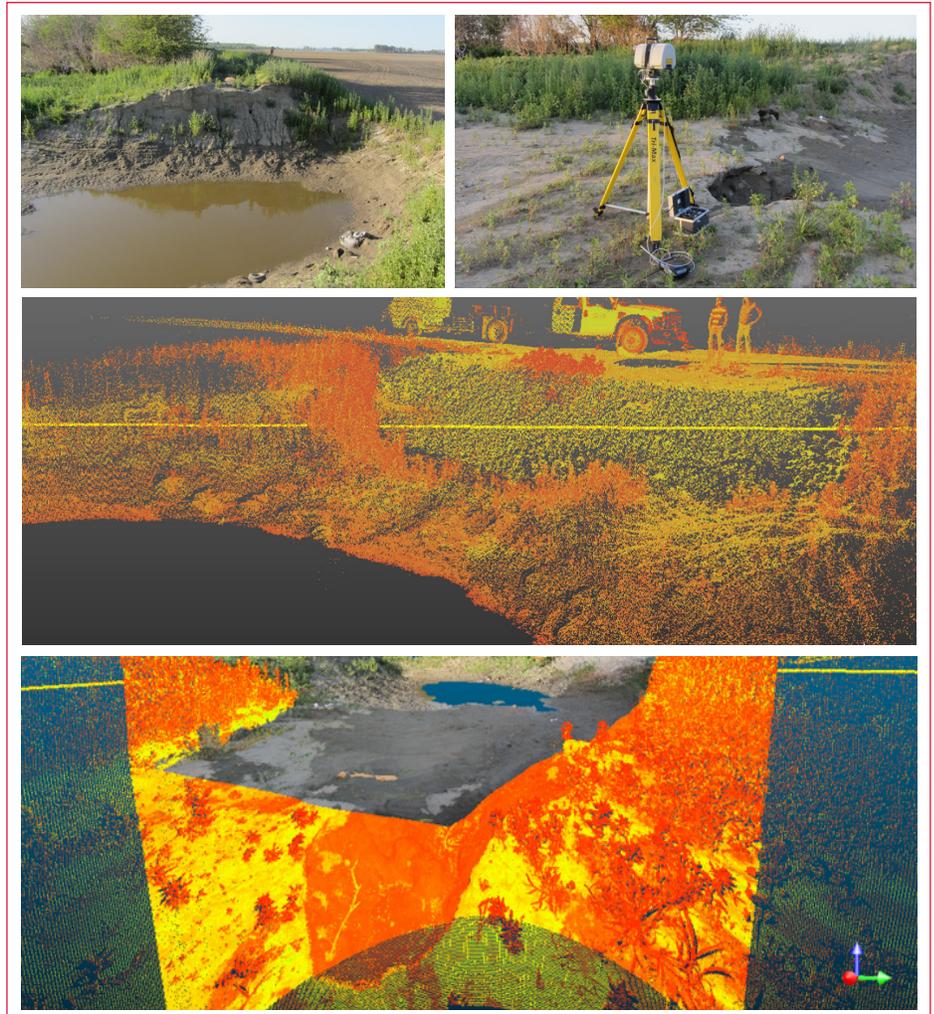
Figure 3. Laser scanning at a bridge site showing raw point cloud data and merged point cloud with photo

- Three-dimensional (3D) laser scanning was performed at a breach site to demonstrate rapid and accurate volumetric calculations.
- A flow chart relating the damages, assessment techniques, and 20 different potential repair/mitigation solutions was developed (Figure 6).

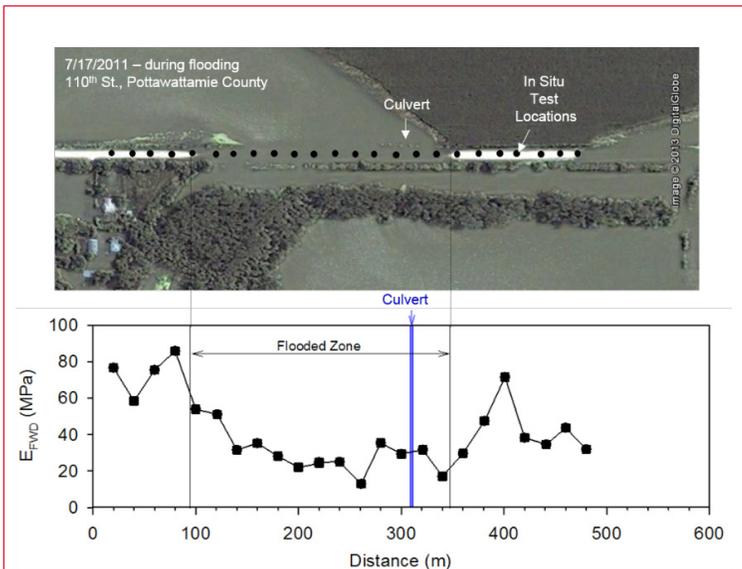
Figure 5. Aerial imagery (from Google Earth) and falling weight deflectometer (FWD) test results in flooded and non-flooded zones on 110th Street, Pottawatamie County

- FWD tests obtained shortly (< 30 days) after flooding indicated that the average modulus values in flooded zones were about 1.3 to 3.6 times lower than the values in non-flooded zones (see Figure 5 for example). In some areas, the foundation layers within the flooded zone gained strength over time, likely as the degree of saturation in the subgrade decreased. However, many sections did not show much improvement.
