Western Iowa Missouri River Flooding— Geo-Infrastructure Damage Assessment, Repair, and Mitigation Strategies

SEPTEMBER 2013

Final Report

Sponsored by
Federal Highway Administration
Iowa Highway Research Board
(IHRB Project TR-638)
Iowa Department of Transportation
(InTrans Project 11-419)

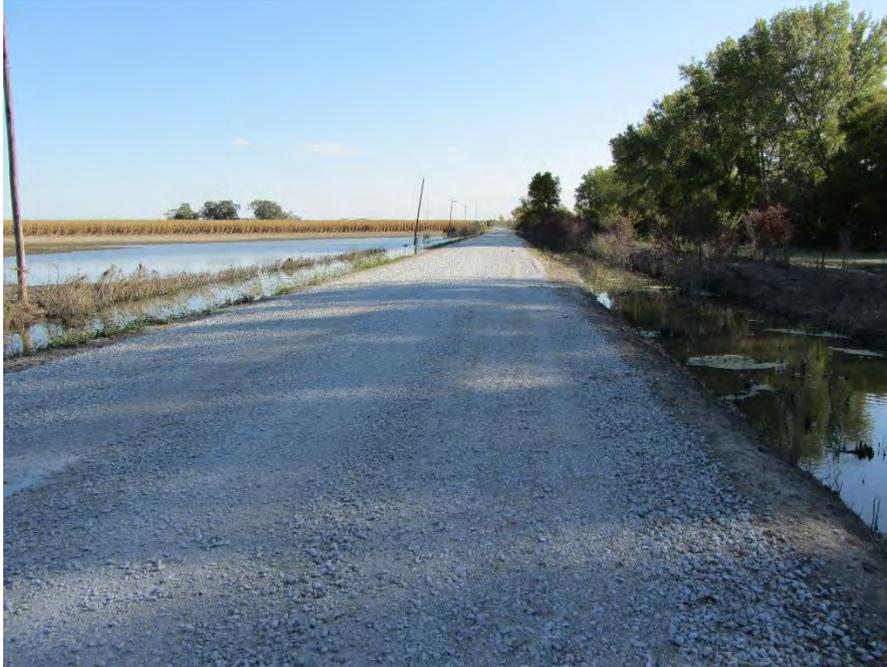
Figure 72. New gravel placed at the middle of the segment following flooding on TS3 (Photo taken on 9/21/2011) – Pottawattamie County

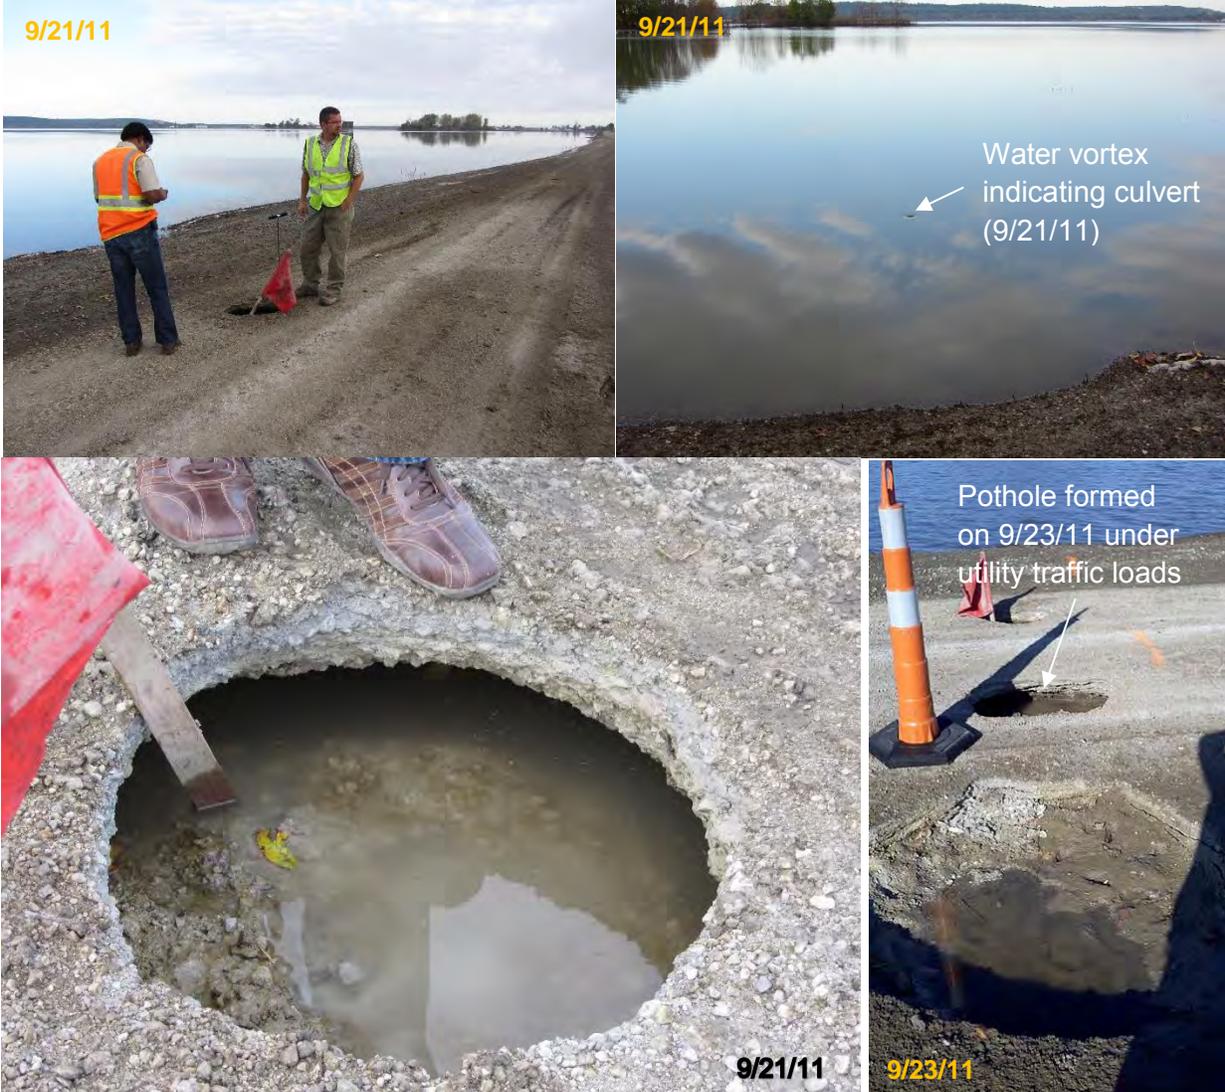
Figure 89. Potholes (with about 0.5 m (1.5 ft) diameter) under gravel road due to erosion of backfill material around a culvert located beneath the road TS 5 (Photos taken on 9/21/11 and 9/23/11) – Pottawatamie County

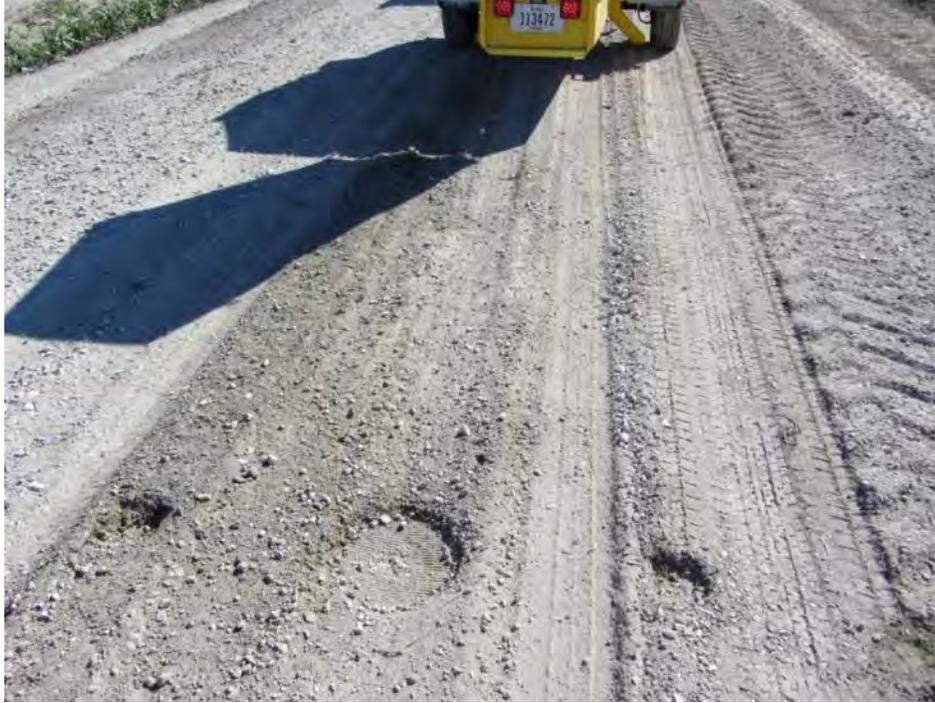
Figure 110. FWD plate depression and rutting under truck wheels near culvert (Picture taken on 9/23/2011) – Pottawattamie County

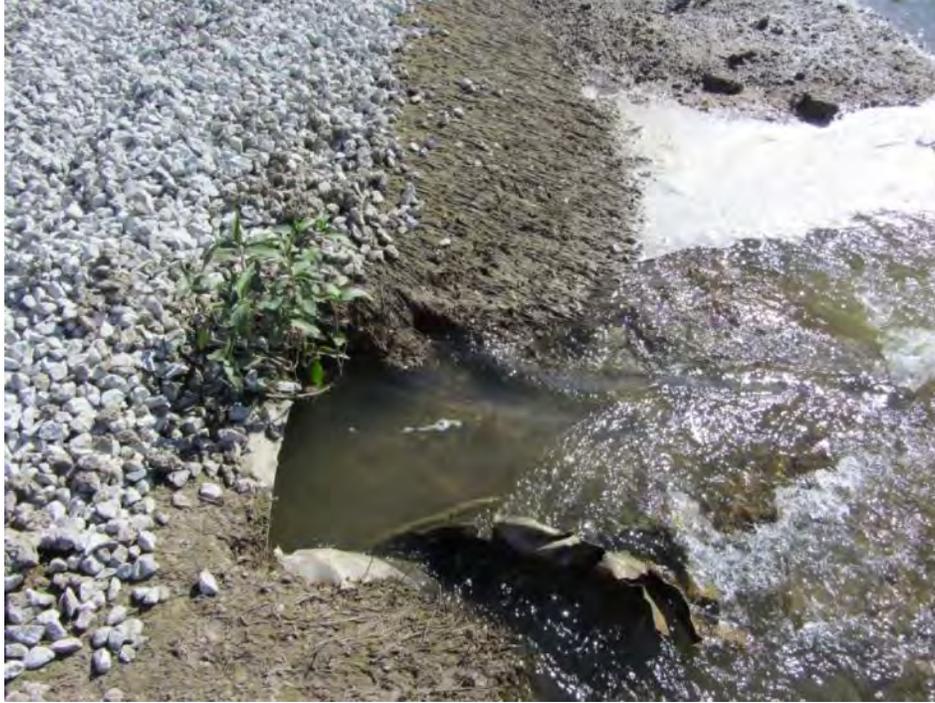
Figure 112. Replacement gravel cover over culvert (Picture taken on 9/23/2011) – Pottawattamie County

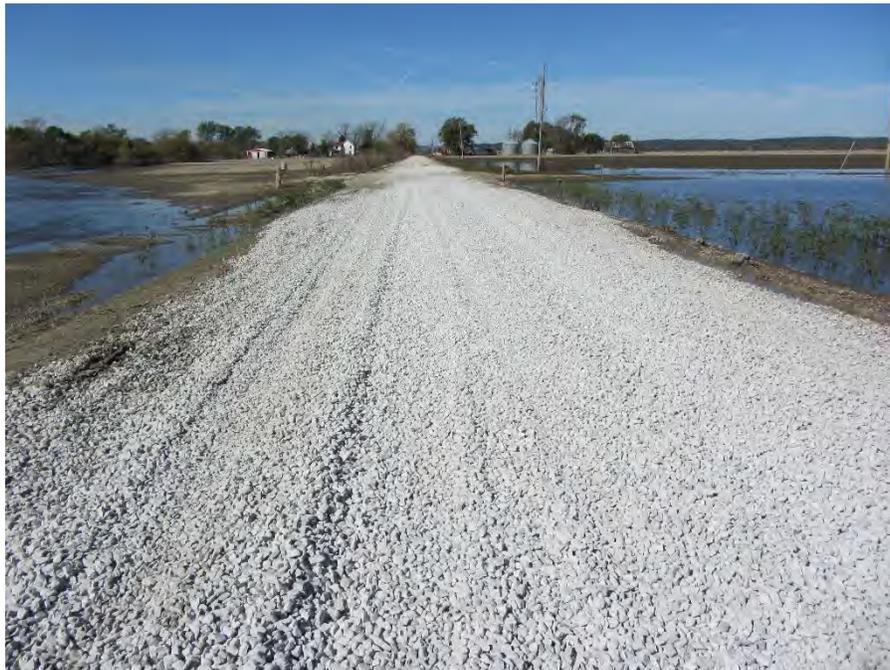
Figure 113. Location of newly placed gravel on TS6 over a metal pipe culvert (Picture taken on 9/23/11) – Pottawattamie County

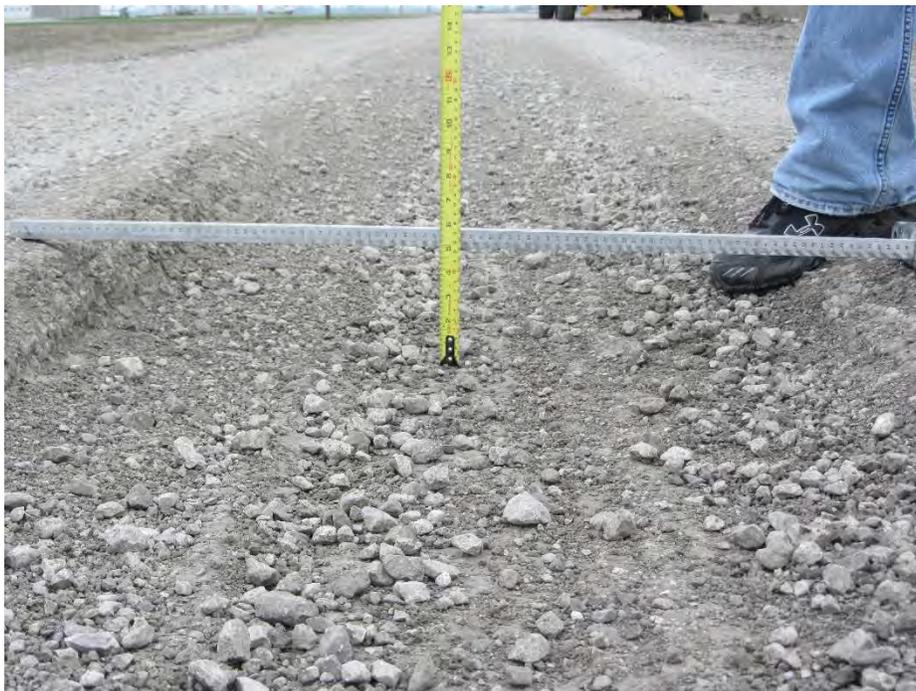
Figure 156. Rutting observed near 3000 m station on TS2 (Picture taken 4/4/12)
