Forest Products
Laboratory

Iowa State
University

Dynamic Field Performance of Timber Bridges

Final Report: Summary and Conclusions

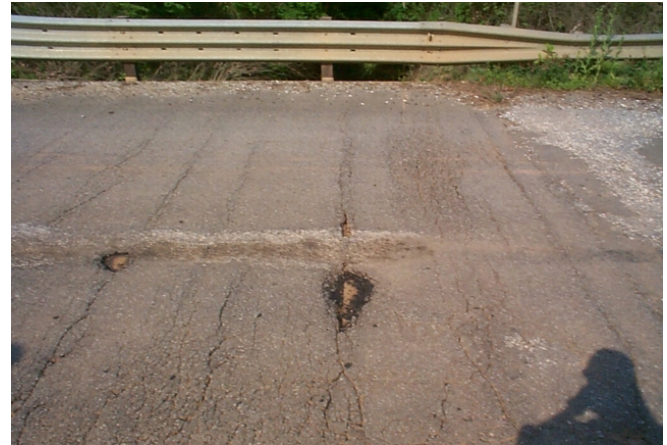
Figure 3. Chambers County Bridge wearing surface.

The Chambers County Bridge was also field tested in 2003 using only Load Case 3. The condition of the structural elements of the bridge at the time of testing was rated as good. The wearing surface, however, was in poor condition with very rough approaches and significant transverse cracking. The bridge deck can be seen in Fig. 3. During the testing, a maximum deflection of 0.588 in. was obtained. This deflection occurred at 29.6 mph and created a DAF of 1.05. Possible higher DAF values could have been obtained from the bridge if higher testing speeds were possible. Figure 4 shows the DAF in relation to velocities for all three load cases and is typical of the collected data. The fundamental frequency from the 2003 testing was found to be 6.2 Hz.

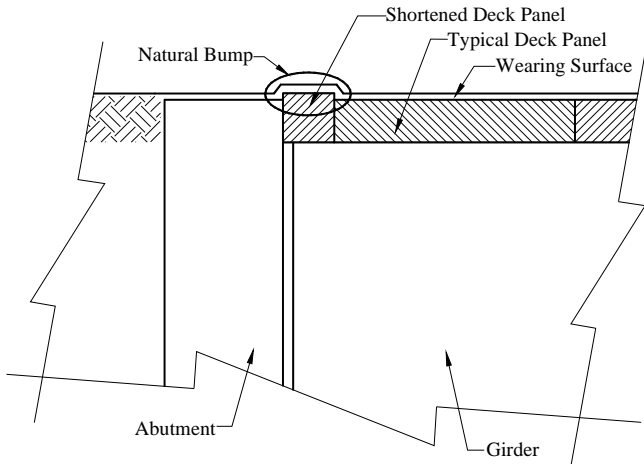
Figure 5. Bump at entrance of Russellville Bridge.

During the 1995 testing the bridge was characterized as being in good condition. It was noted, however, that the first deck panel created a natural bump at the abutment of the bridge. The bump was elevated approximately 0.75 in. above the natural road surface and is schematically illustrated in Fig. 5.

The condition of the bridge during the 2003 test was found to be satisfactory. The natural bump at the entrance of the bridge still existed, although did not appear to have worsened over time. The wearing surface also had prominent transverse cracking typically aligning with the deck joints. The structural condition of bridge generally appeared to be in good condition.

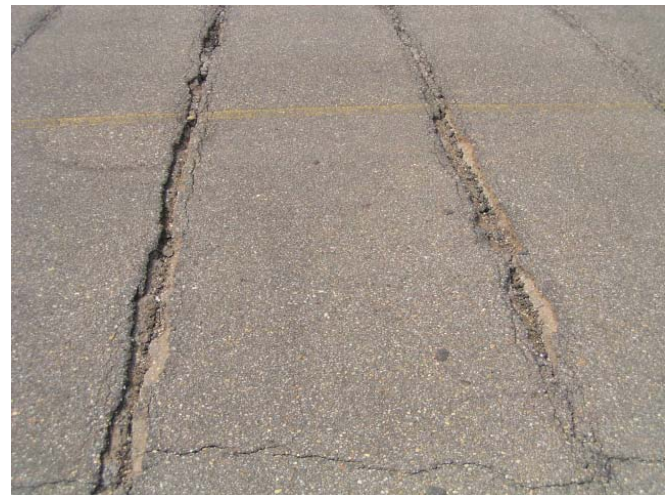
Figure 8. Butler County Bridge wearing surface cracking.

Field tests were conducted in 2003 on the west span of the Butler County Bridge. The condition of the bridge at that time was reported to be severe. The wearing surface was cracked in both the longitudinal and transverse direction with the most severe cracking in the transverse direction and varied from small cracks along the shoulder to cracks as large as 2.0 in. wide in the middle of the panels. These large cracks were located at deck joint locations. Figure 8 shows a typical example of the cracking and raveling of the deck surface. The deck panels of the bridge were found to be in poor condition. The panels were cupped and were separated by as much as 0.5 in. in some places. The upward cupping of the deck panels caused the bearing surface at the girders to be limited to only the center portion of each panel. The cupping also caused a rocking action of the individual panels as the vehicle traveled across the bridge. This rocking action is believed to be the cause of the severe deterioration of the wearing surface. Despite the deterioration of the deck, the girders appeared to generally be in good condition.

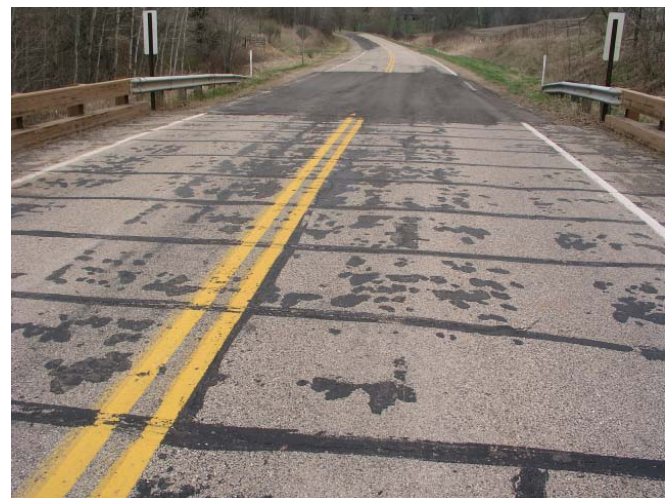
Figure 11. Erfurth Bridge wearing surface.

The wearing surface of the Erfurth Bridge at the time of testing was found to be in satisfactory condition. Significant transverse cracking existed along the length of the bridge. The transverse cracking was highly regular and was seen to generally occur above deck panel joints. Additionally, longitudinal cracking was found to be regular with the cracks aligning with the bridge girders. The wearing surface was found to be well maintained with the cracks being filled with bituminous sealant. Figure 11 shows the wearing surface.

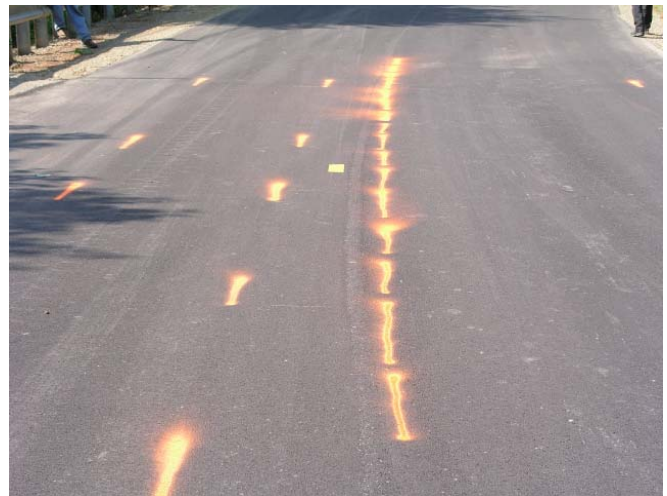
Figure 14. Angelica Creek Bridge 2003 wearing surface.

The bridge was in excellent condition during the 2003 testing. A new lift of asphalt had been placed on the approaches and bridge approximately two months prior to testing. This new asphalt surface, shown in Fig. 14, created an extremely smooth riding surface for the test vehicle. The

deck panels were found to be in good condition with the end panels still being warped as previously mentioned.

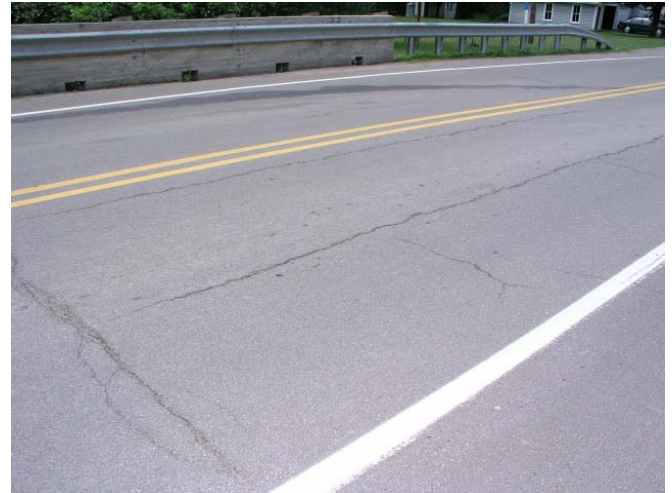
Figure 16. East Main Street Bridge 2003 asphalt wearing surface.

The bridge was found to be in good condition in 2003. The approaches showed no signs of excessive cracking or potholes. Transverse cracking did exist at the bridge abutments but the presence of a preexisting bump was not apparent. The bridge surface had two longitudinal cracks running the length of the bridge along with other areas of minor cracking. Two longitudinal cracks appeared to align with the deck panel joints. The east abutment cracking and typical longitudinal cracking is shown in Fig. 16.

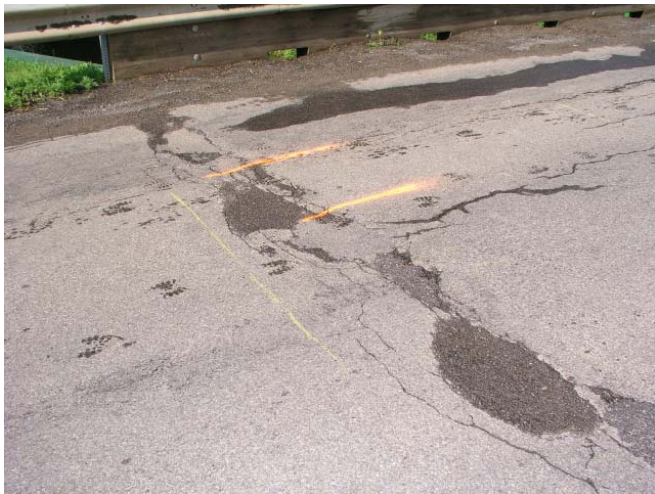
Figure 18. Bolivar Bridge 2003 entrance abutment.

The bridge condition during the 2003 testing was rated as fair. The abutment of the bridge, as shown in Fig. 18, had several areas of asphalt patching and transverse cracking. Although the settlement was not as apparent as it was in 1996, there was still a small bump. The bridge wearing surface had several longitudinal cracks and potholes forming on the surface. The longitudinal cracks formed mainly along the panel joints and typically had transverse cracks extending from them. The primary structural members were rated as in satisfactory condition. Swelling and crushing was still present at the abutments and crushing was also noted at the stiffener beam connection locations.
