Research
Paper
FPL-RP-570

Field Performance of Timber Bridges

16. North Siwell Road Stress-Laminated Bridge

James A. Kainz

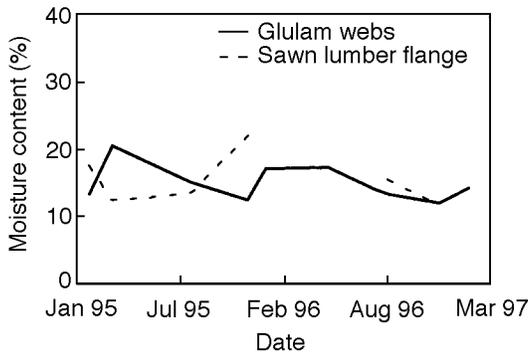
The average trend in electrical resistance moisture content readings is shown in Figure 15. As shown, there are slight variations between the readings for the glulam webs and the sawn lumber flanges. At the beginning of the monitoring period, the glulam web moisture content was approximately 12.5%. During the monitoring period, the moisture content exhibited seasonal changes of ±5%. At the end of monitoring, the moisture content was approximately 15%. The sawn lumber flange moisture content was slightly higher at the start of monitoring at approximately 17%. During the first year of the monitoring, the sawn lumber flange moisture content varied similarly at ±5%. Readings were not taken during the second half of the monitoring period except during the final quarter of 1996. Near the end of the monitoring period, the sawn lumber flange moisture content was approximately 12.5%. Both the glulam webs and the sawn lumber flange were installed at a moisture content less than the recommended value of 19%.

Figure 15—Average trend in electrical resistance moisture content readings.

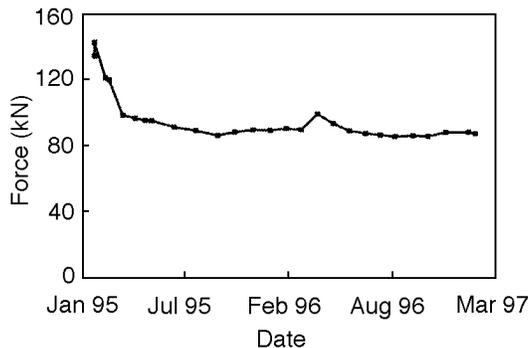
Figure 16—Average bar force from load cells installed after the third bar tensioning.

The average bar force based on load cell readings is shown in Figure 16. At the third stressing, all bars were tensioned to 142 kN (32,000 lb), which corresponds to a 848 kPa (123 lb/in²) interlaminar stress. Two months later, the bar force decreased to 98.2 kN (22,100 lb) or 579 kPa (84 lb/in²). The rate of loss declined, and the bar force then remained relatively stable for the remainder of the monitoring period. At the conclusion of monitoring, the average bar force was 87.6 kN (19,700 lb), which corresponds to a level of 490 kPa (71 lb/in²) interlaminar compression stress.

The observed bar force loss is most likely the result of stress relaxation in the sawn lumber flange laminations. Stress relaxation is a time-dependent phenomenon caused by the long-term compressive force of the steel bars acting on the wood microstructure. In the design of stress-laminated bridges, it is assumed that the bridges will lose approximately 60% of the interlaminar compression over the life of the structure as a result of stress relaxation. The stress relaxation behavior of this bridge was similar to previous monitored bridges (Wacker and Ritter 1995; Ritter and others 1995, 1996). However, the amount of stress relaxation in the North Siwell Road bridge was affected by the wood moisture content. Recent monitoring completed on a bridge installed with a moisture content greater than 19% (Kainz and others

Following the final design bar tensioning, the bridge lost approximately 47% of the bar force introduced to end at 87.6 kN (19,700 lb), which corresponds to 490 kPa (71 lb/in²) interlaminar compression stress. This decrease in bar force was most likely attributable to transverse stress relaxation in the wood laminations. The acceptable bar force level at the end of monitoring is a result of retardation of the stress relaxation rate caused by the low moisture content in the wood laminations. The introduction of a high initial bar force level that resulted in a high interlaminar compressive stress also contributed to the acceptable ending bar force performance of this bridge. To maintain this performance, bar force should be checked as part of the routine inspection program.
