Rehabilitation of Concrete Pavements Utilizing Rubblization and Crack-and-Seat Methods: Phase II - Performance Evaluation of Rubblized Pavements in Iowa

National Concrete Pavement
Technology Center

Final Report
April 2008

Sponsored by
the Iowa Highway Research Board (IHRB Project TR-550)

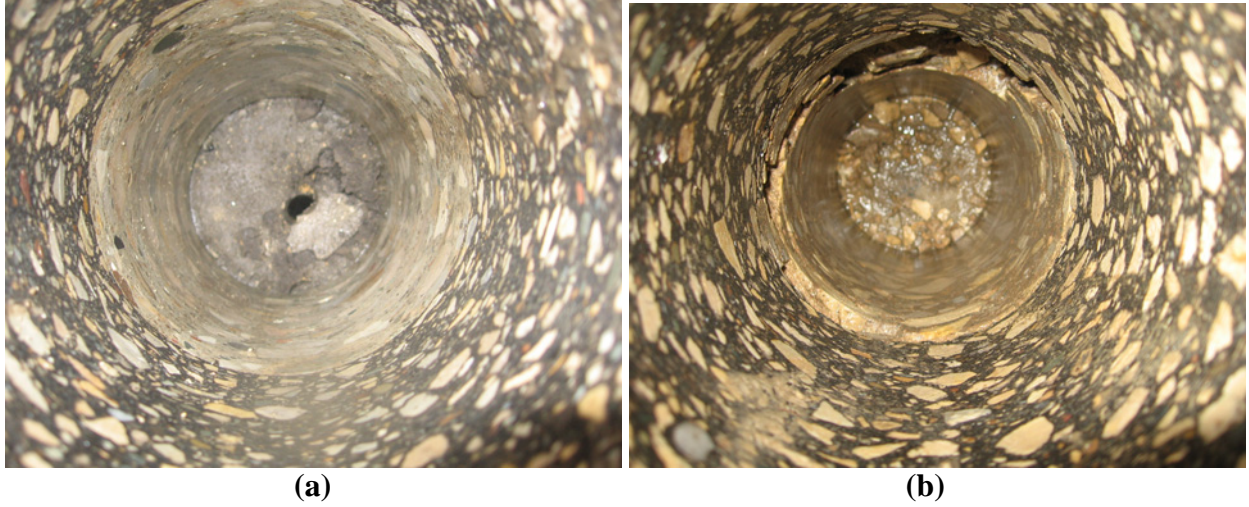
Figure 7. Layer condition underneath HMA after coring; (a) PCC layer without rubblization (IA-139 in Winneshiek County), (b) Rubblized PCC layer (IA-3 in Delaware County)

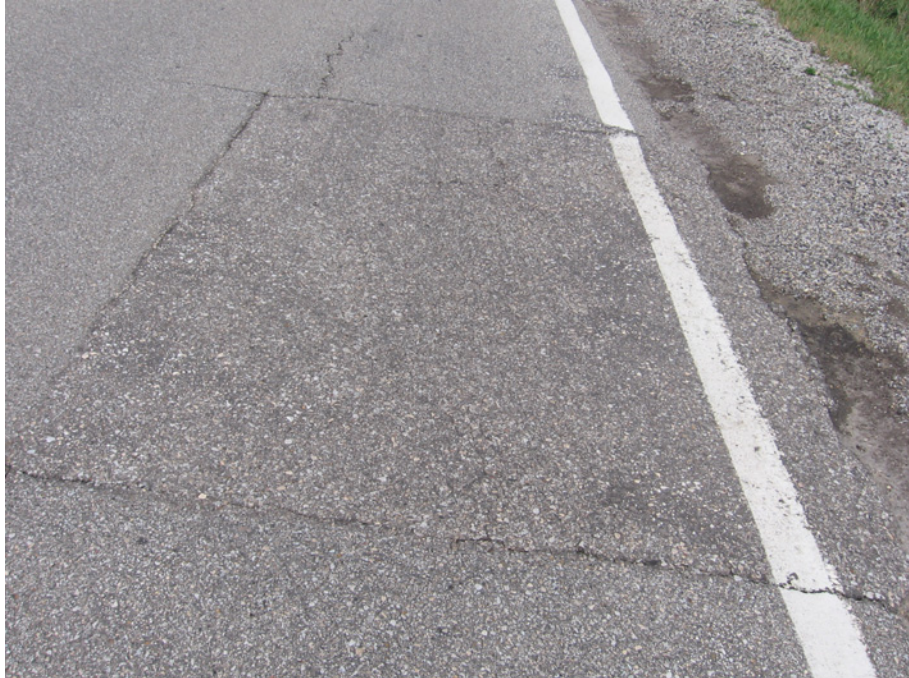
Figure C.10. Block Crack on V43 in Black Hawk County, IA (I.D. No. 13): Rubblization

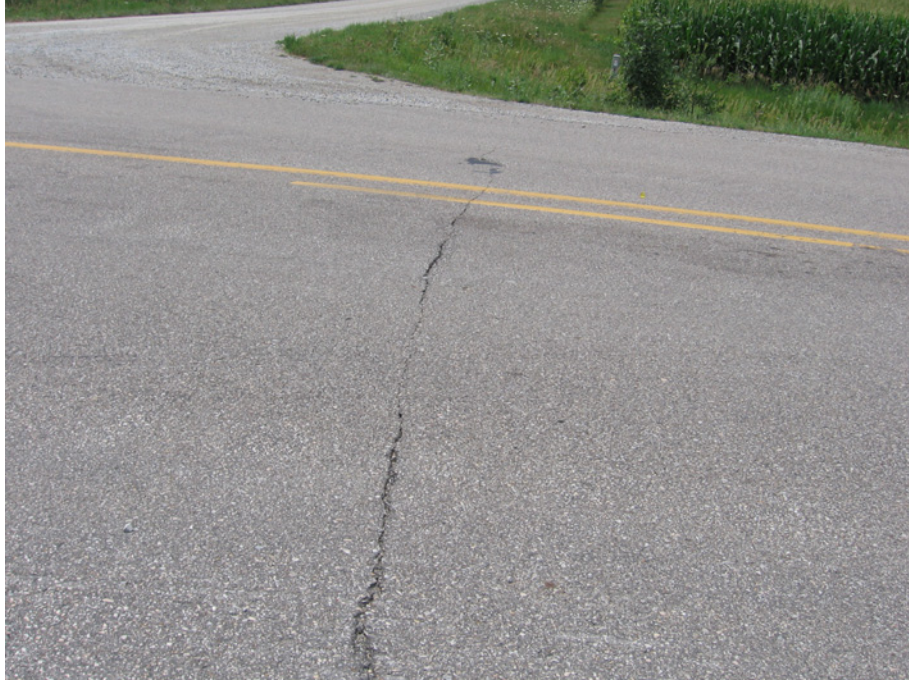
**Figure C.11. Low Temperature Crack on V43 in Black Hawk County, IA (I.D. No. 13):
Rubblelization**

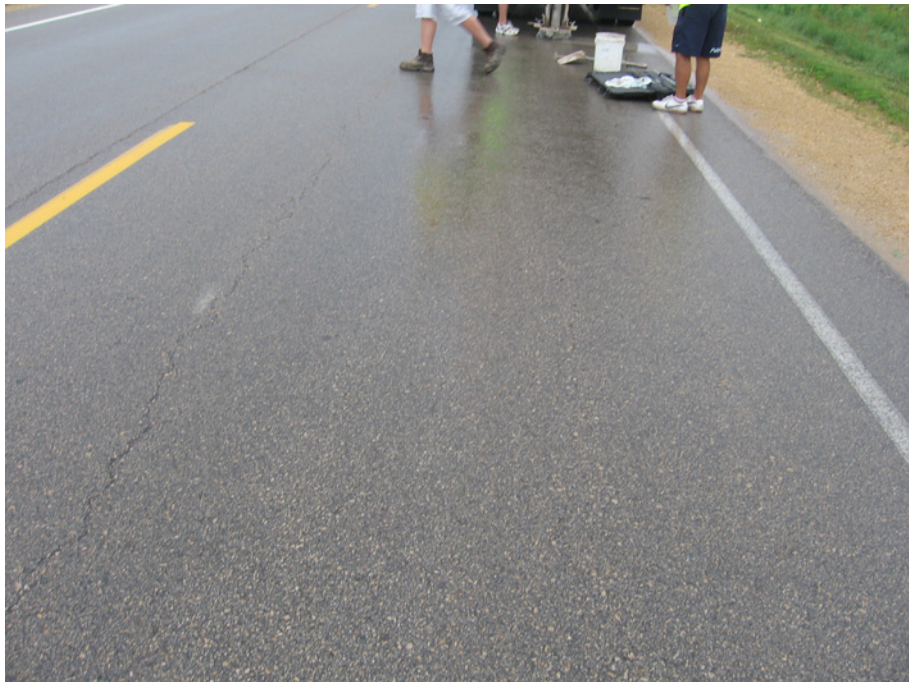
**Figure C.16. Longitudinal Crack on IA3 in Delaware County, IA (I.D. No. 21):
Rubblization**

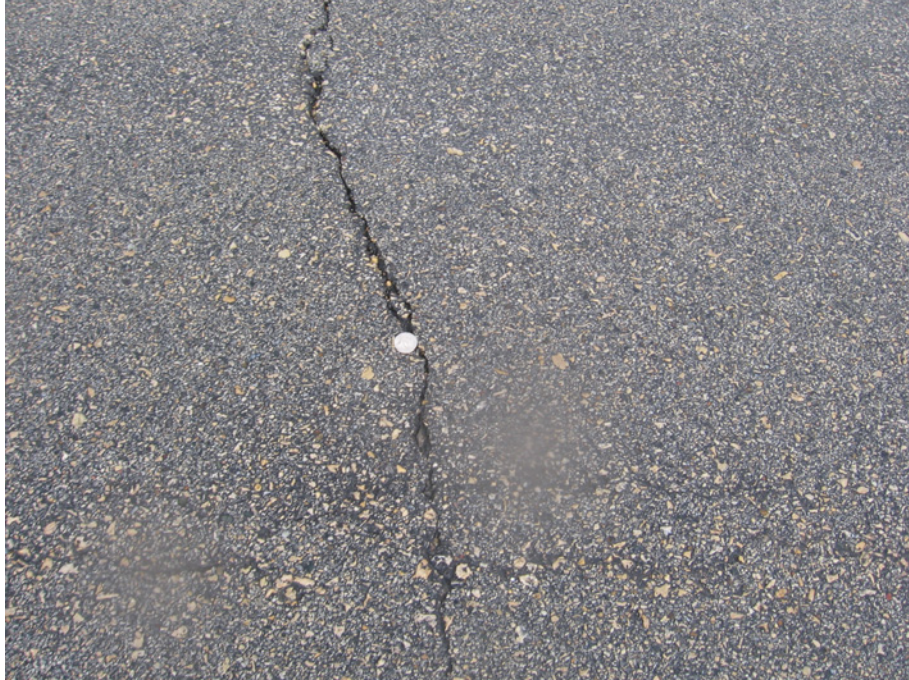
**Figure C.17. Low Temperature Crack on IA3 in Delaware County, IA (I.D. No. 21):
Rubbblization**

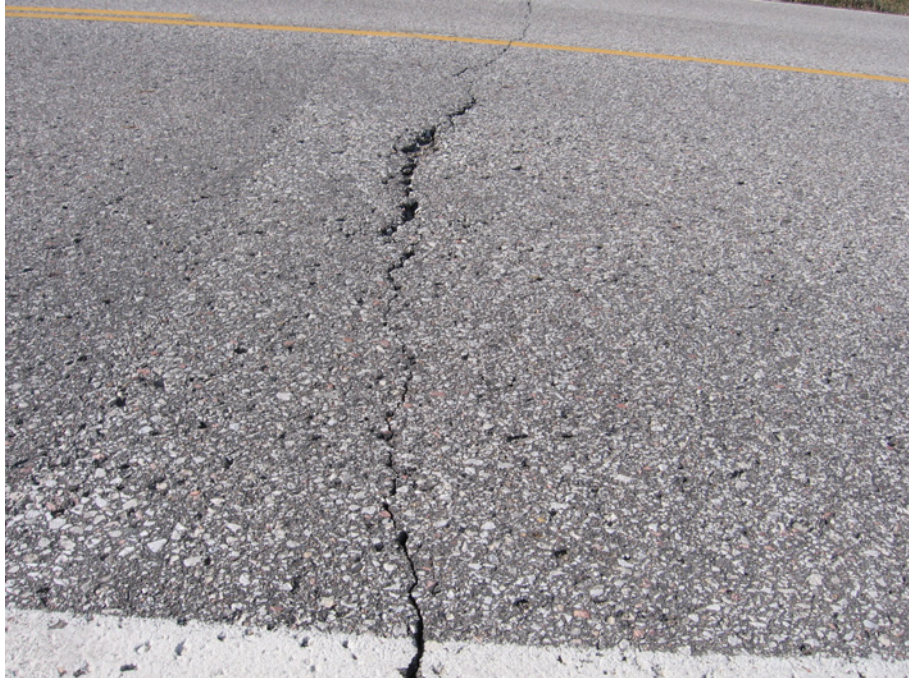
**Figure C.26. Low Temperature Crack on L55 in Mills County, IA (I.D. No. 32):
Rubblization**
