Exploration of Ultrasound for the Evaluation and Preservation of Structures

**Final Report
January 2021**

Sponsored by
Iowa Highway Research Board
(IHRB Project TR-757)
Iowa Department of Transportation
(InTrans Project 18-671)

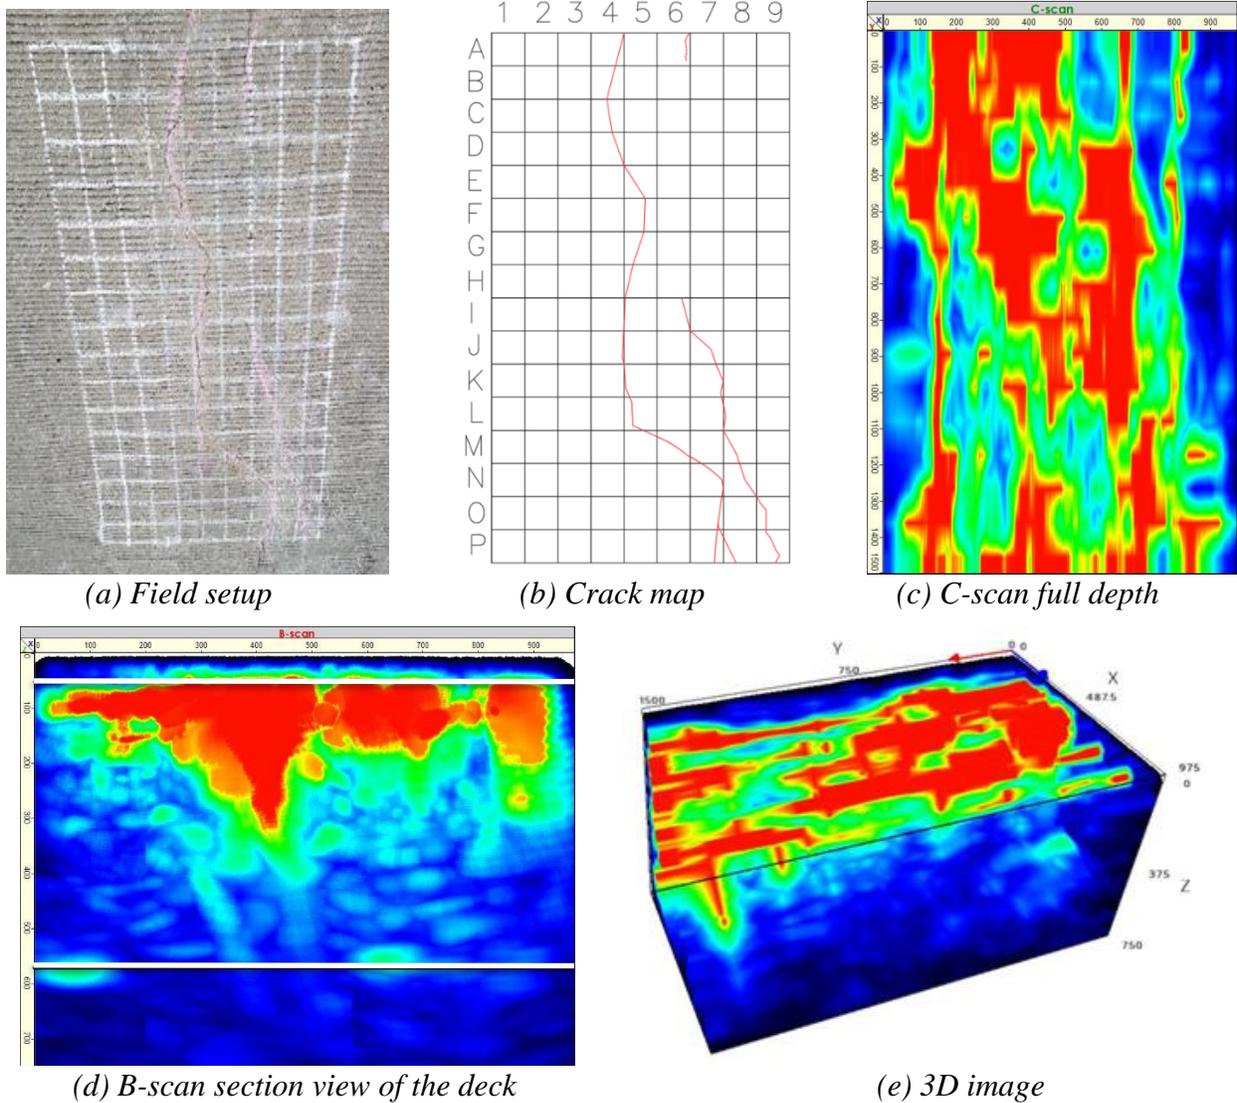
Figure 9. Test setup and results for Grid 1 on Mingo Bridge

This test location was over Pier 1, as shown in Figure 8, and included several cracks in the bridge deck, as shown in Figure 9b. Figure 9c and 9d show the C-scan and B-scan, respectively, and Figure 9e shows the 3D image for the scanned area. The original bridge plans show that rebar is present in the top layer of this test location (see Figure 7). Figure 9e shows that there are rebar-like shapes running along the y-axis. However, the configuration of each rebar is not clear in the scans.

Based on the information in the bridge plans, a white line marks the interface between the overlay and substrate in Figure 9d. The overlay is about 1.75 in. thick. Recall that MIRA's measurement range of the depth of the flaw location is from 2 to 16 in. This indicates that the cracks in the overlay cannot be accurately captured in the scans because the entire thickness of the overlay is within the first 2 in. of the concrete depth. As is evident from this scan, red shading extends from the rebar level to approximately the mid-depth of the slab. This demonstrates that

there are defects in the substrate beneath the overlay. The bottom surface of the deck is also marked with a white line in Figure 9d based on information in the bridge plans. However, the scans do not clearly capture this interface.

However, when the overlay exhibits significant cracking (as in Grid 1 and Grid 3), the scans show a large shaded area that extends from the level of the top rebar to the mid-depth of the deck. At these locations, it is impossible to identify the top and bottom layer reinforcement and the deck thickness.

According to the field inspection, the results of which are shown in Figure 9a and 9b to Figure 13a and 13b, Grids 1 and 3 had the worst cracking and were therefore rated as 5, while Grids 2 and 4 were in the best condition and were rated as 1. Grid 5 had minimal cracking (two visible

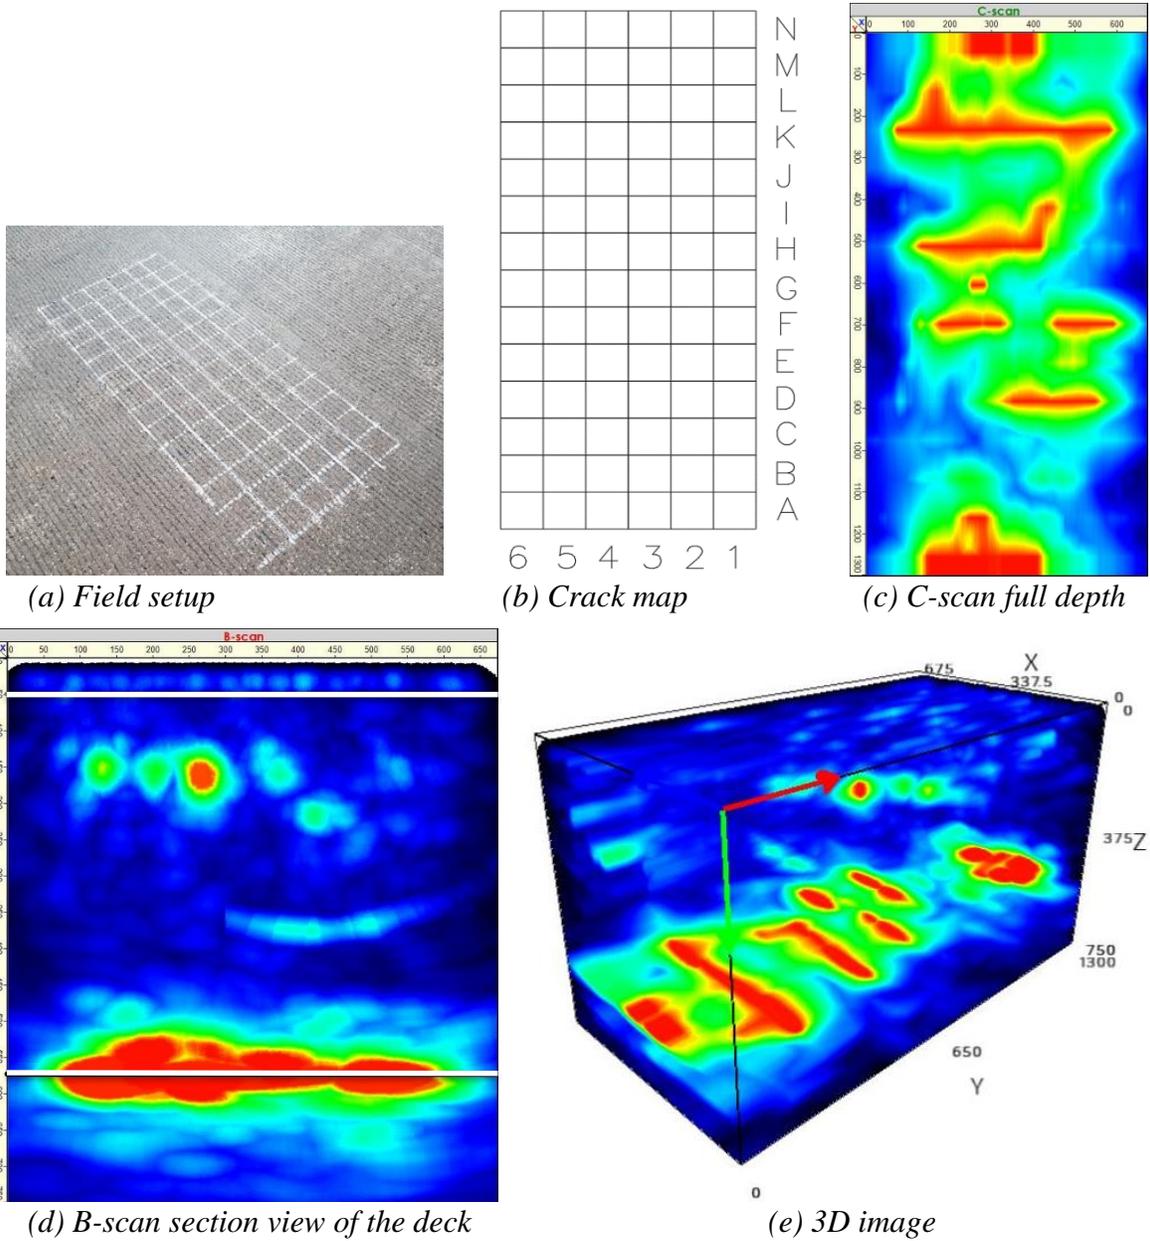
Figure 10. Test setup and results for Grid 2 on Mingo Bridge

The second test setup was a 56 in. by 24 in. grid that contained no visible cracks in the bridge deck, as shown in Figure 10a and 10b.

Figure 10c and 10d show the C-scan and B-scan, respectively, and Figure 10e shows the 3D image for the scanned area. Similar to the first location, white lines in Figure 10d mark the interface between the overlay and substrate and between the substrate and the bottom of the deck. It can be seen that the MIRA scans do not show the location of the interface between the overlay and substrate. However, a red area is visible at the bottom the deck. According to the bridge plans, the deck at this location has a depth of 22.5 in. (570 mm). In the MIRA scan, the red area is between 21.7 in. (550 mm) and 22.6 in. (575 mm) deep. In this case, MIRA was able to give a general range of the slab thickness. However, the intensities in the scan do not clearly distinguish between the bottom of the slab and the reinforcement. Additionally, this test was located near the abutment/mid-span, where the bridge plans indicate that no top reinforcement is present (see Figure 7). The scans confirm that no top reinforcement is present. Figure 10d and 10e show a red region located 6 in. (150 mm) below the surface that may indicate the location of a potential defect.

The results indicate that MIRA is good at detecting the location and relative size of the top layer reinforcement in the deck through a 1.75 in. overlay when the overlay is in good condition (see the results from Grid 2 and Grid 4).

It was also found that although the MIRA scans for Grid 2 and Grid 4 showed a large red area near the bottom of the deck (about 575 mm below the surface), it could not clearly distinguish between the bottom surface of the deck and the bottom layer reinforcement.

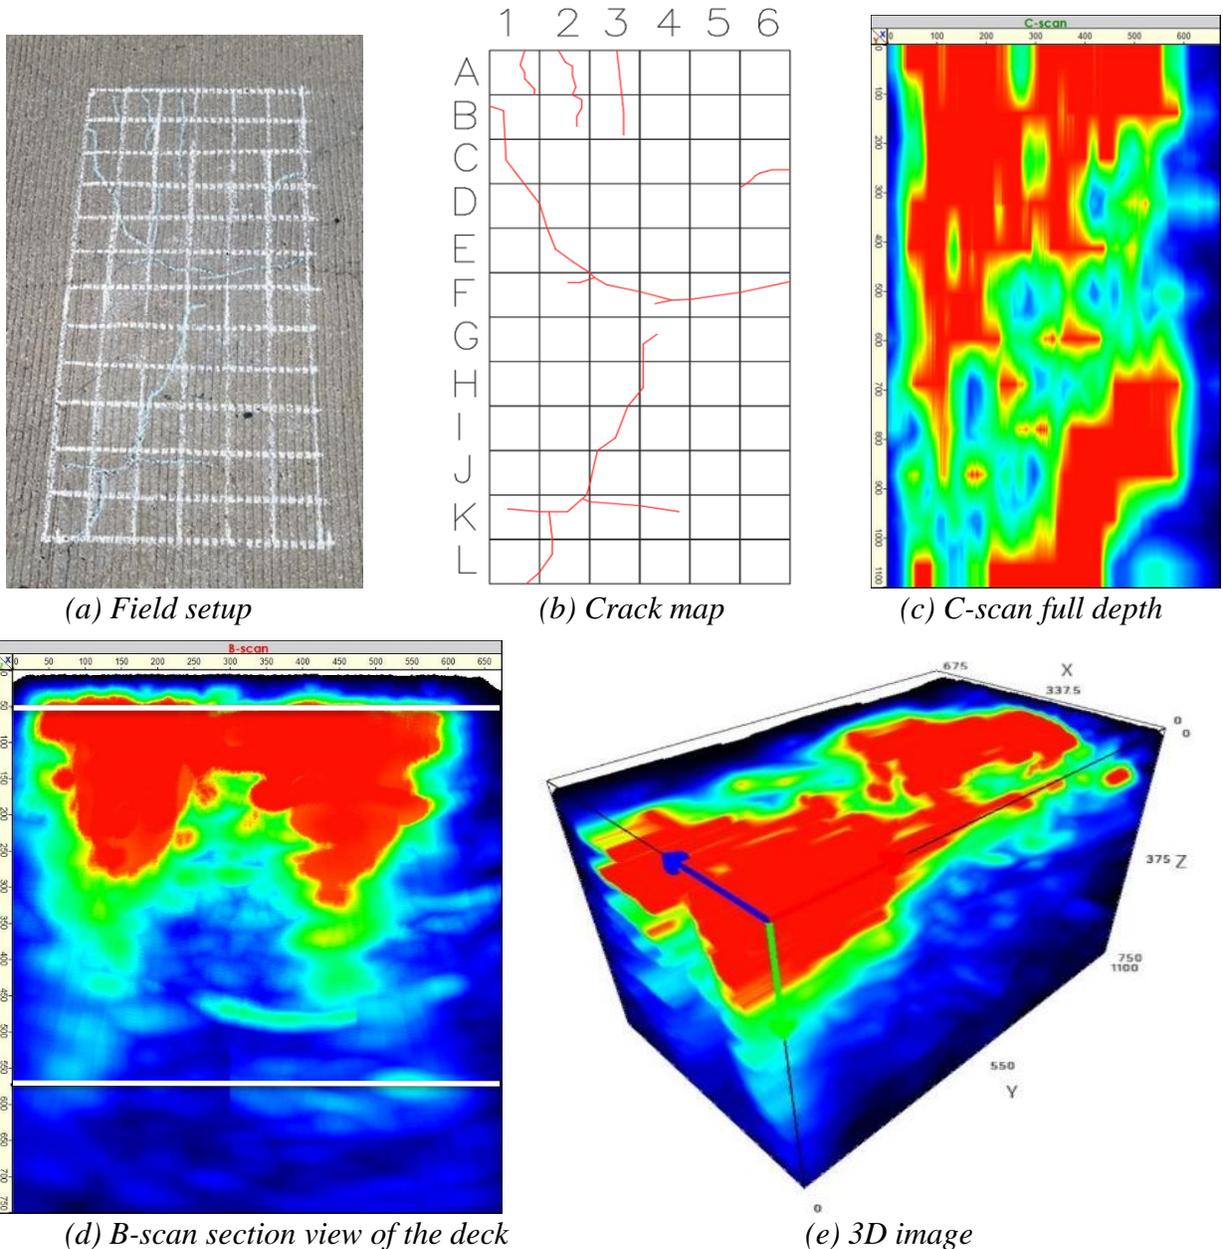
Figure 11. Test setup and results for Grid 3 on Mingo Bridge

The third setup was a 48 in. by 24 in. grid that included several visible cracks in the bridge deck, as shown in Figure 11a and 11b.

Similar to the scans for Grid 1, the scans for Grid 3 show a large red area at the level of the top rebar that extends down to the mid-depth of the deck, as shown in Figure 11c, 11d, and 11e. Since MIRA detected several defects in the top portion of the bridge deck, the bottom of the slab could not be detected. This low-depth attenuation, or the presence of damage, can be thought of as “noise” that is not allowing the waves to penetrate to the full depth of the deck. As the cases for Grids 1 and 3 illustrate, if significant low-depth damage is present, the depth of the deck cannot be accurately captured in the scans.

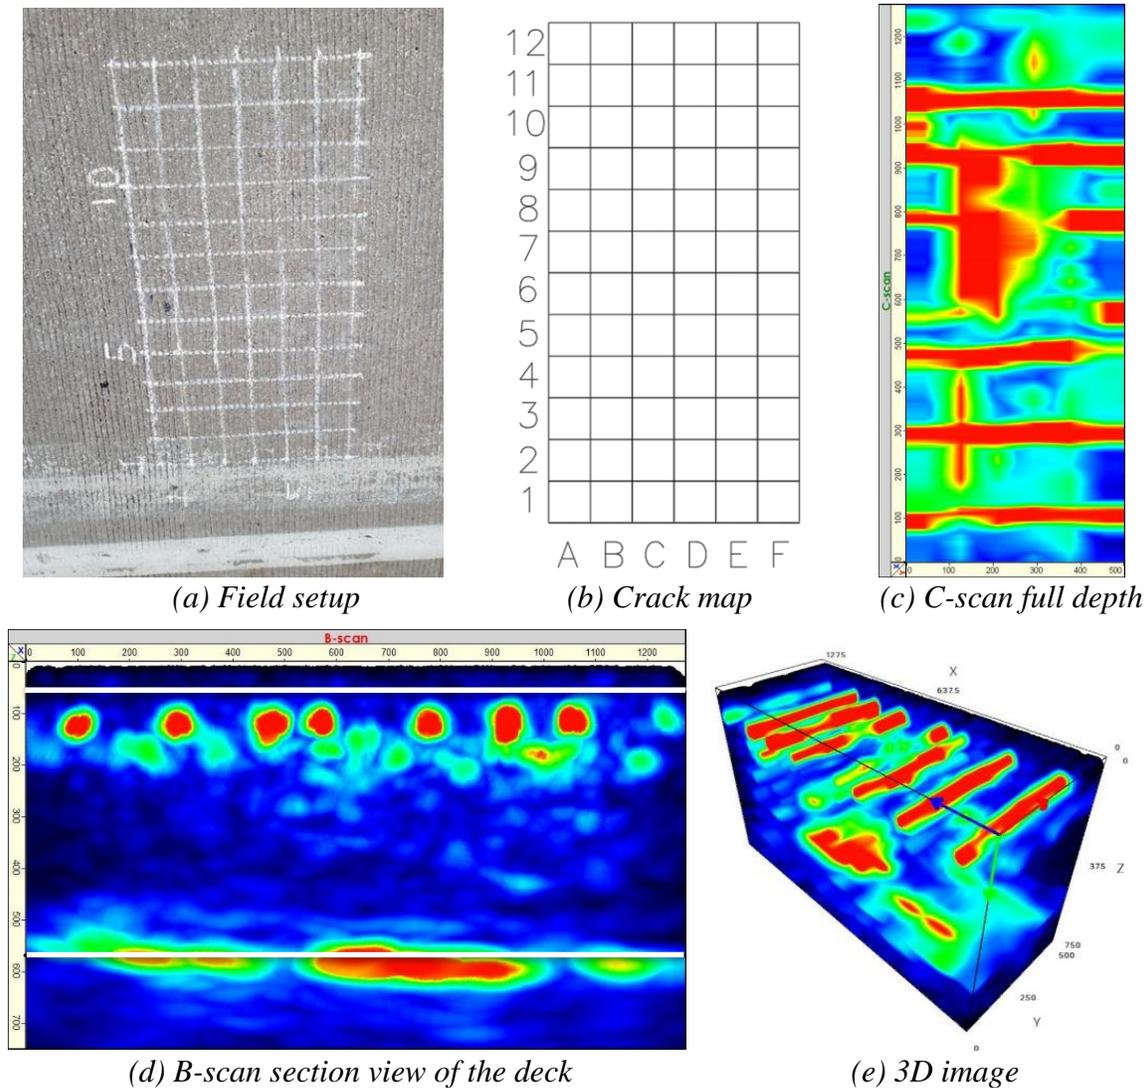
Figure 12. Test setup and results for Grid 4 on Mingo Bridge

The fourth setup was a 48 in. by 24 in. grid that included no visible cracks in the bridge deck, as shown in Figure 12a and 12b.

In this grid, the MIRA scans were able to locate the top layer of reinforcement, as shown in Figure 12c, 12d, and 12e. This grid was located over a pier, and the bridge plans confirm that top reinforcement is present at this location. The plans locate the reinforcement approximately 3.75 in. below the surface, which was confirmed by the MIRA scans. Moreover, the MIRA data show that the diameters of the red areas are around 1.5 in. (38.1 mm). The plans indicate that #11 rebar is located in this area, which has a diameter of 1.41 in. (35.8 mm). This indicates that MIRA has the ability to determine the location and relative size of rebar near the surface when extensive low-depth damage is not present. It is important to note, however, that the size of the area shown

in the scan is highly dependent upon threshold selection and can therefore be misleading. In addition, red shading is visible at a depth that coincides with the bottom of the deck, showing that MIRA can also identify the thickness of the deck when extensive damage is not present. The plans indicate that bottom reinforcement is located in this area, but because the top reinforcement blocked most of the shear waves, the bottom reinforcement could not be clearly scanned.

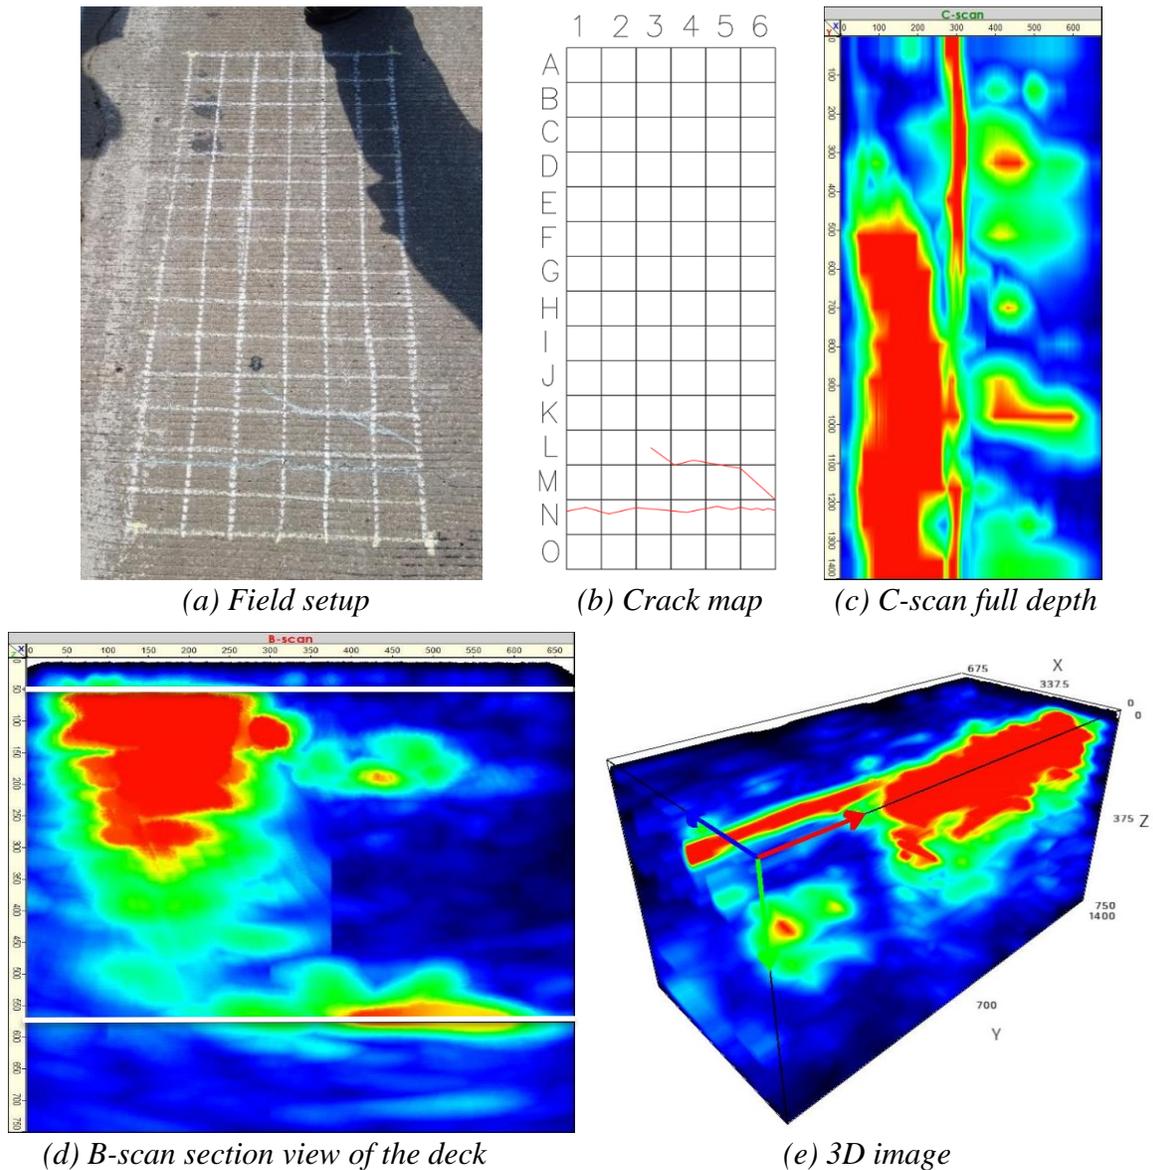
Figure 13. Test setup and results for Grid 5 on Mingo Bridge

The fifth setup was a 60 in. by 24 in. grid that included some minor visible cracking on one side of the grid, as shown in Figure 13a and 13b.

As shown in Figure 13c, the scans did show red areas in the bottom left corner of the grid. Figure 13d and 13e indicate that this red area extends from the top to the mid-depth of the deck. According to the bridge plans, no top reinforcement is present in this area. These scans appear to indicate that the damage seen at the surface, i.e., the two cracks, extends through the overlay and into the substrate. These scans could be useful for determining the extent of damage and could thus indicate the level of repair necessary.

cracks) and was rated as 3. These ratings are based solely on the external condition observed on the top surface of the bridge deck.

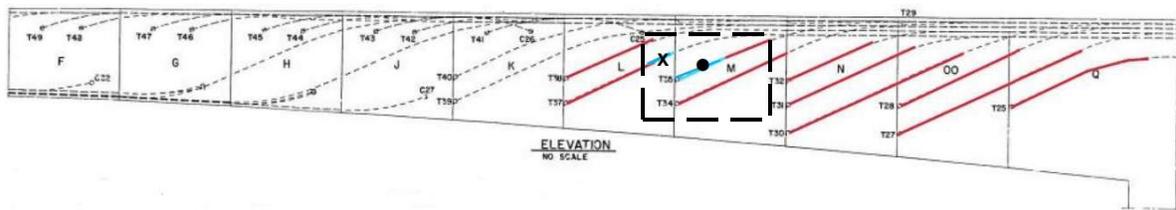
Figure 15. Detailed tendon layout for T-34 and T-35

VCS identified potential defects in T-35 using impact echo. The area of the defects is depicted in Figure 15 by the blue line. Moreover, to confirm that there was, in fact, a void at the identified location, a borescope inspection was conducted at the location shown by the black dot in Figure 15. In the results, a void was indeed identified. The impact echo testing did not identify defects in T-34.

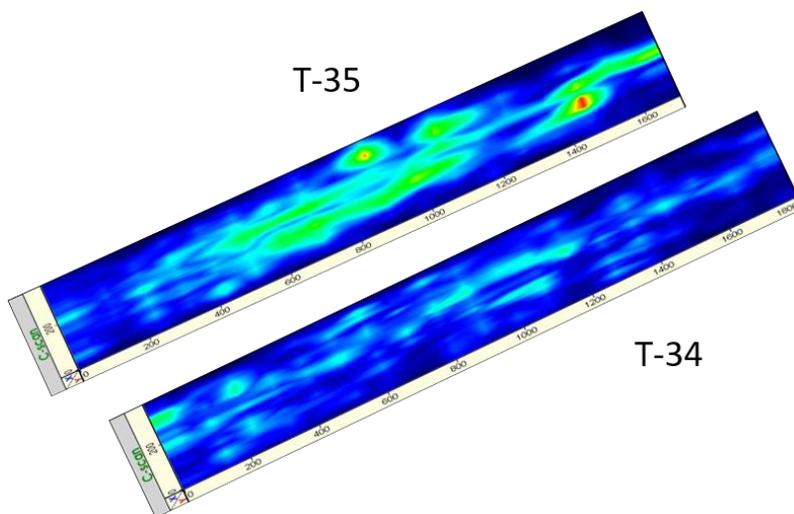
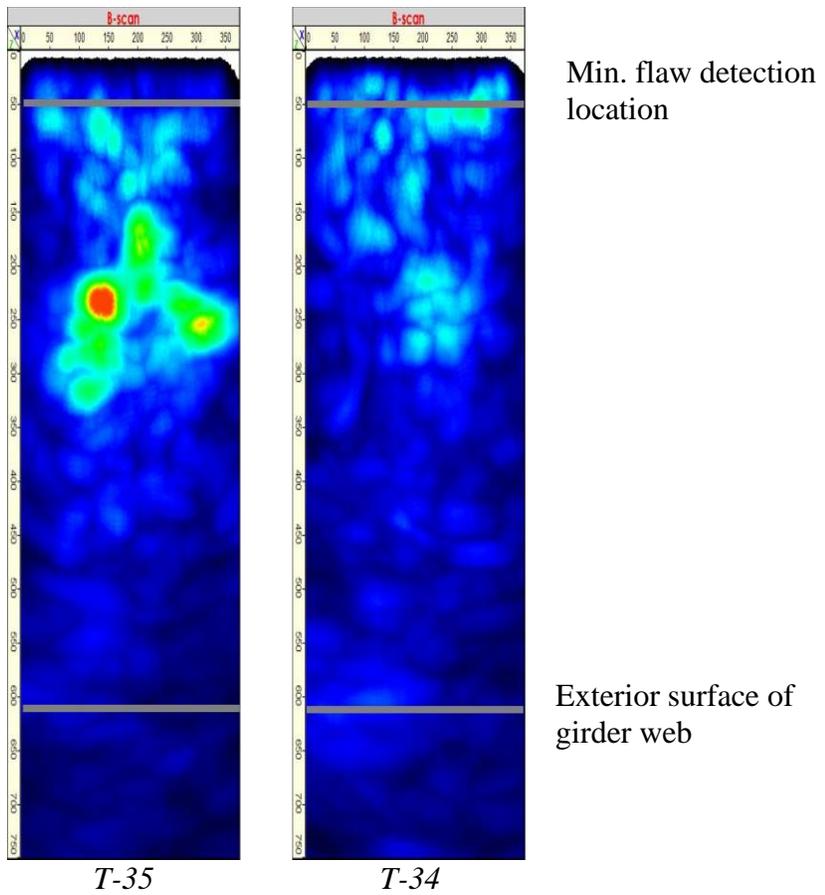
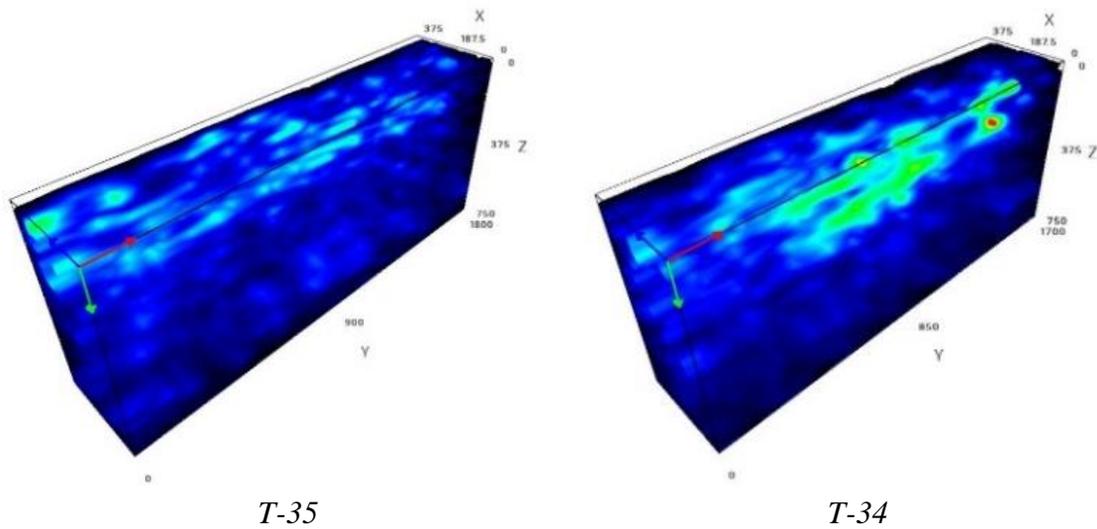
All MIRA scans showed a red area corresponding to the ducts for T-35, while no red area was found corresponding to the ducts for T-34. This result shows good agreement with the findings from the VCS inspection report, indicating that voids were present in duct T-35.

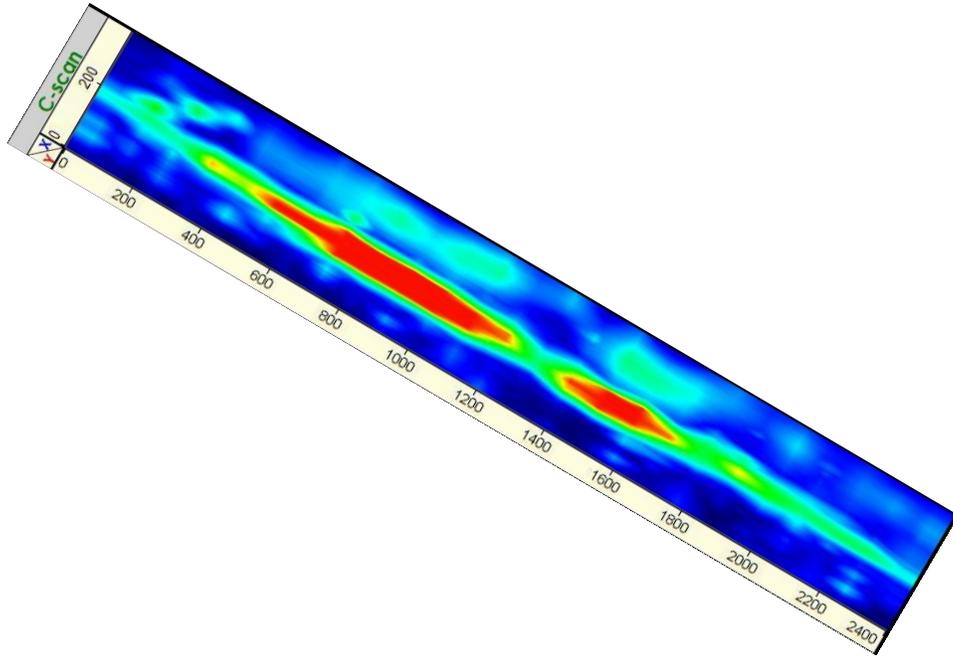
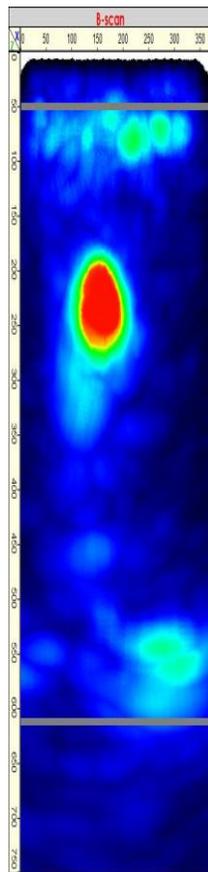
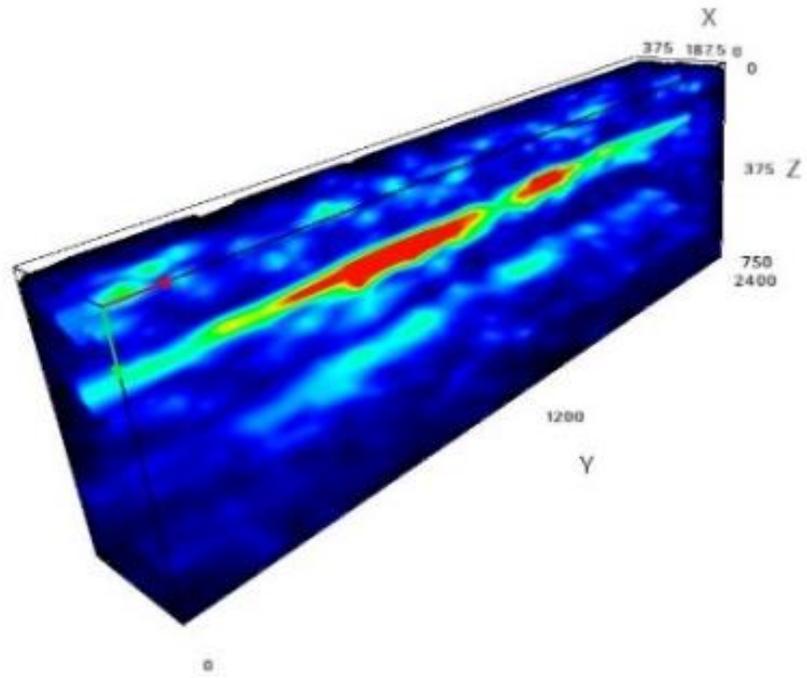
T-30 was the second void location determined by VCS. Figure 22, Figure 23, and Figure 24 show the C-scan, B-scan, and 3D image for T30, respectively.

A red area is visible in the MIRA scans and confirms the void in the tendon duct.
