# **INSPECTION OF LOUISIANA TIMBER BRIDGES**

**Vijaya (VJ) Gopu, Ph.D., P.E**

**International Conference on Timber Bridges, Las Vegas, NV,  
September 30, 2013**

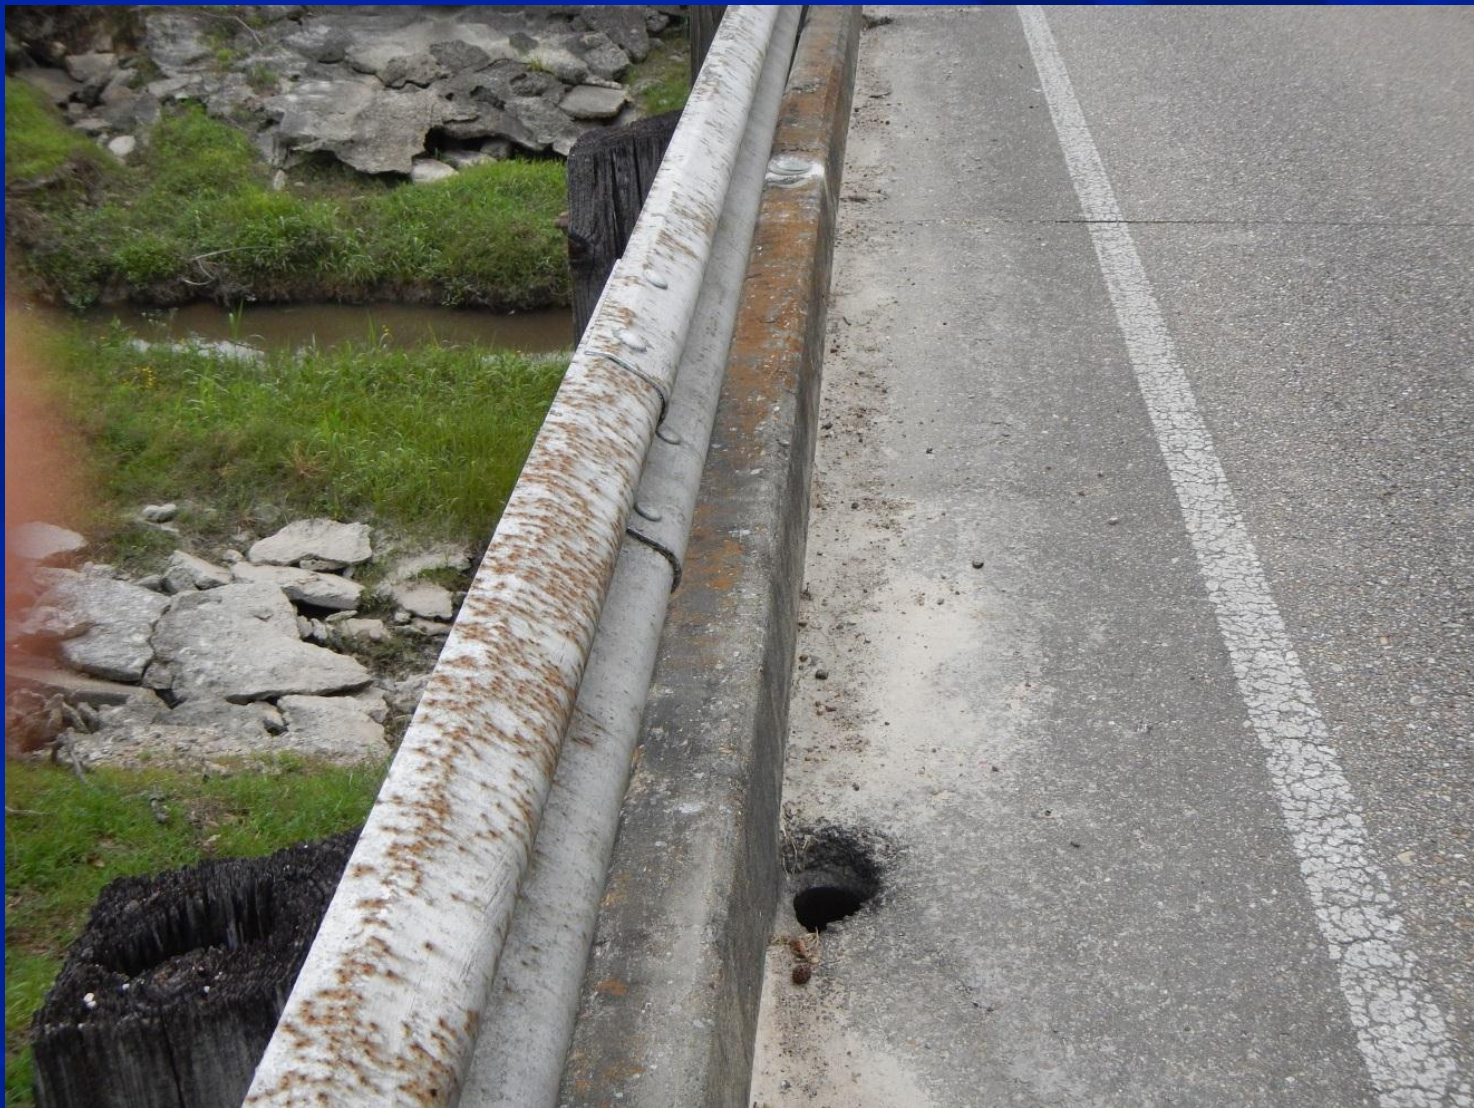
**Bridge 62-2, Drains in  
Concrete Deck**

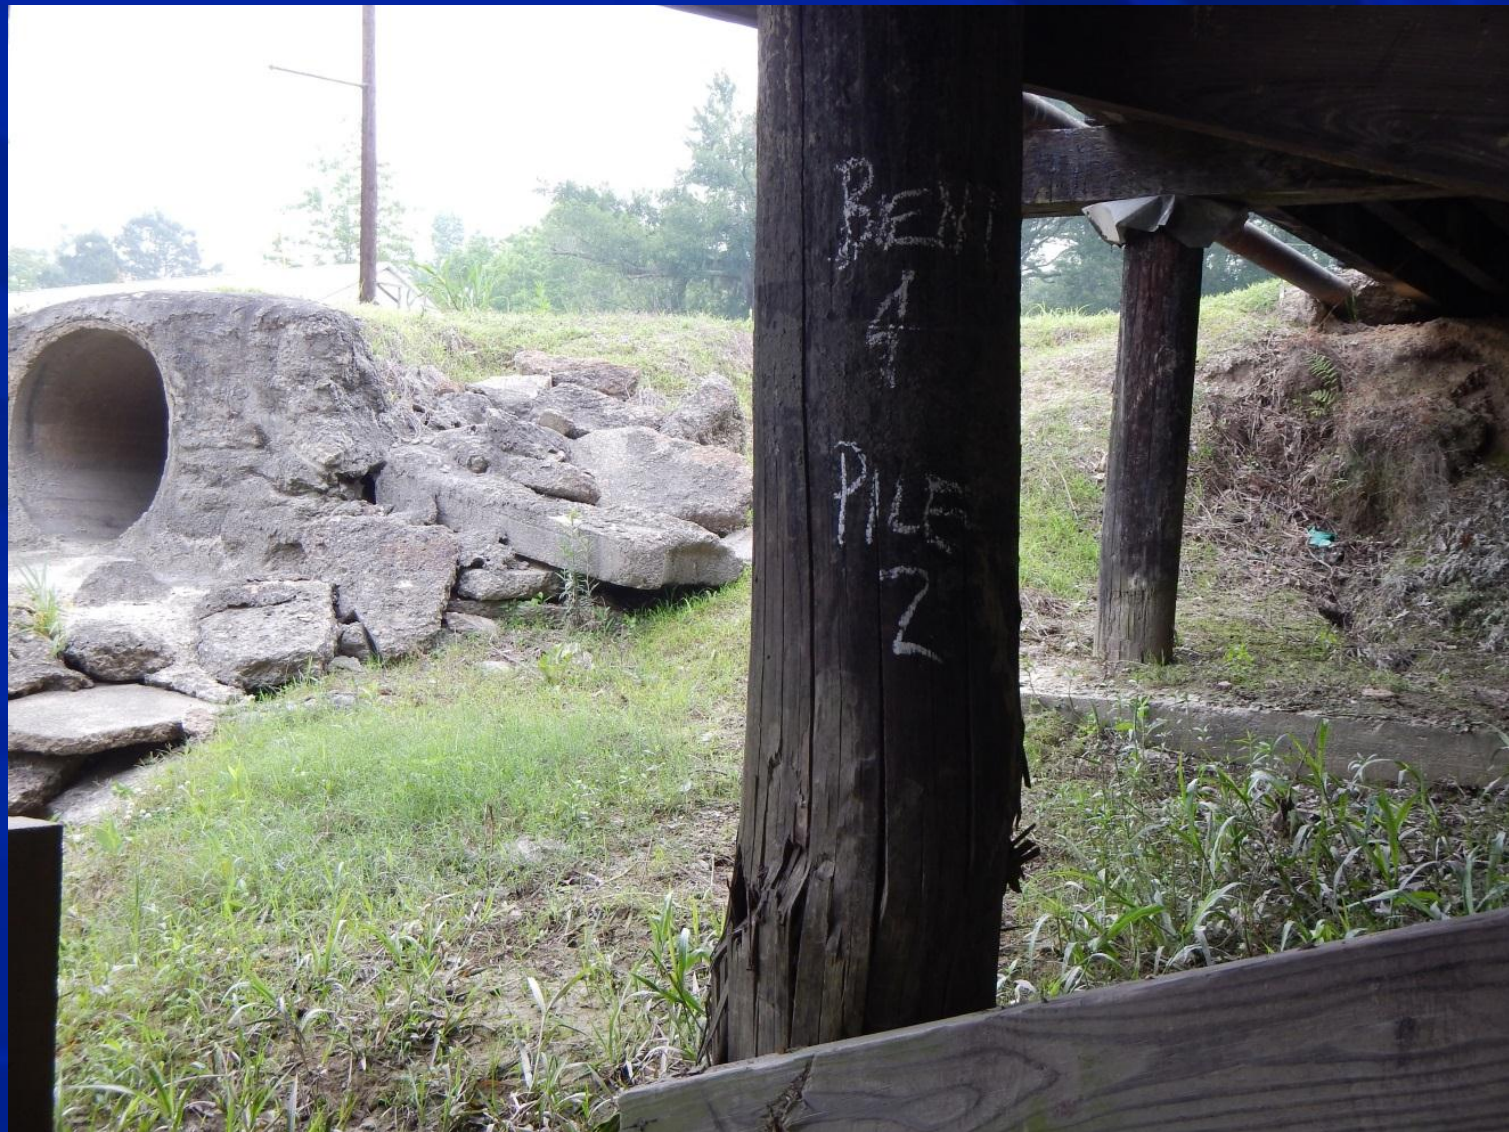
**Bridge 62-2, Damaged Pile**

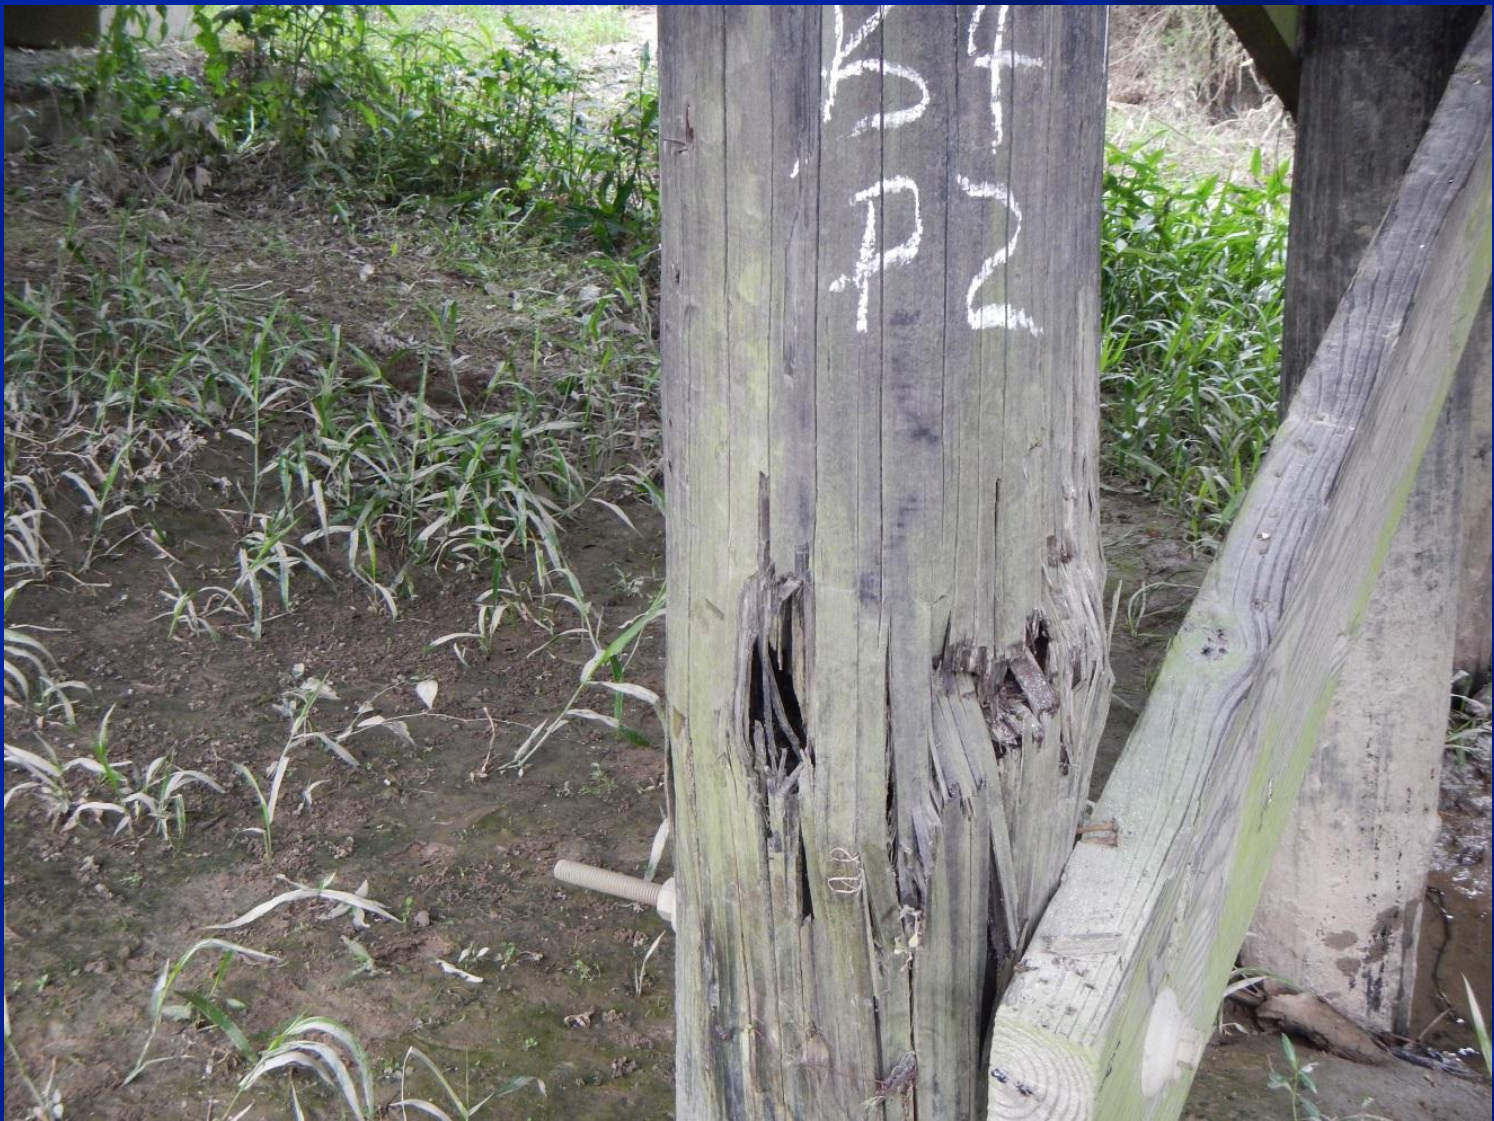
**Bridge 62-2, Pile Damage**

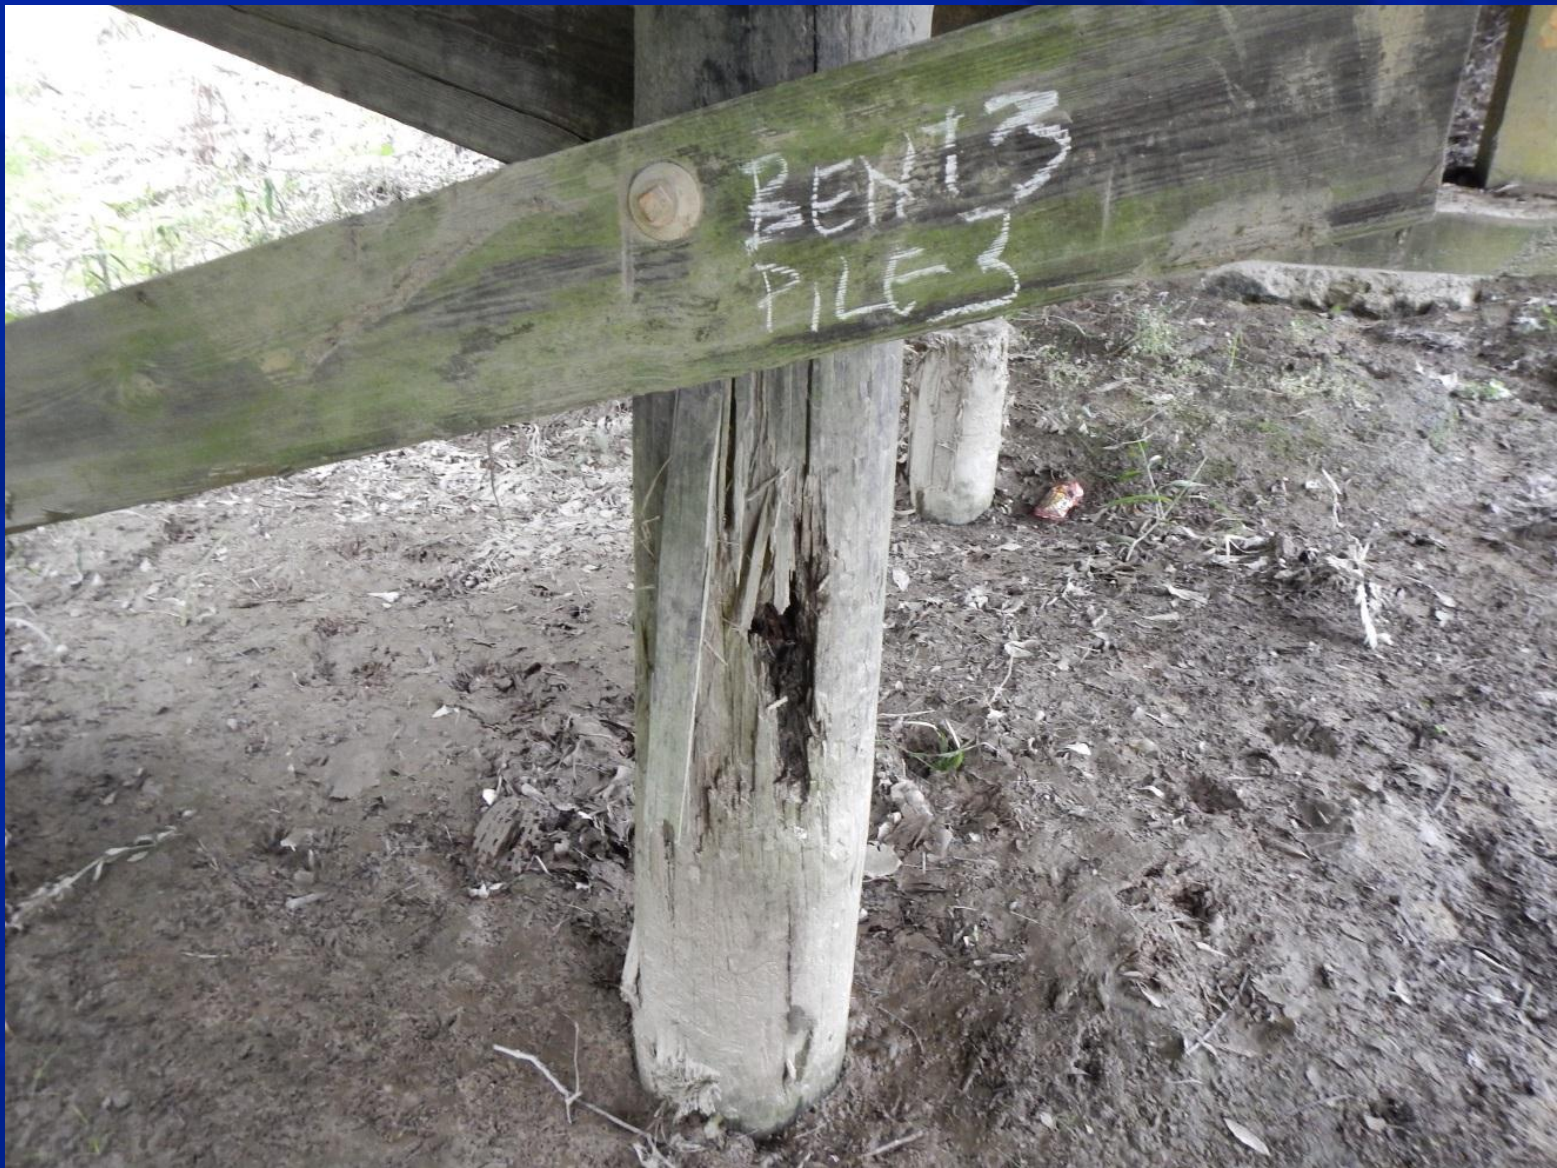
**Bridge 62-1, Decayed Pile**

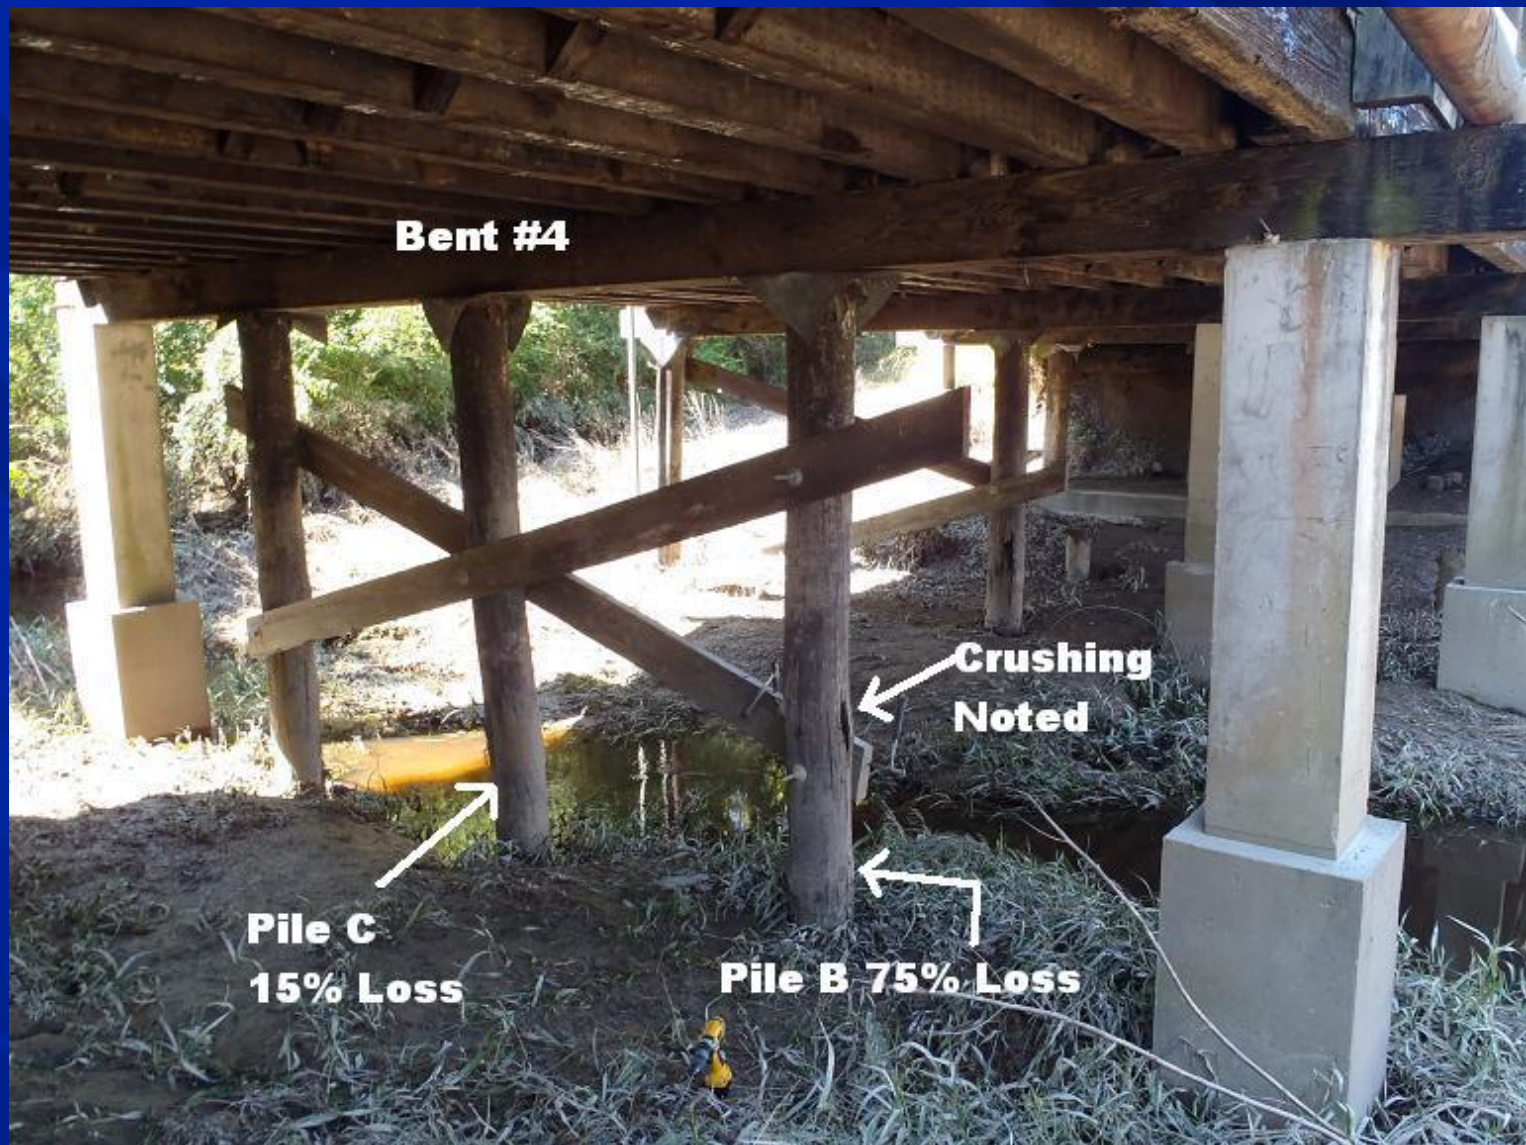
**Bridge 62-2, Pile Damage**

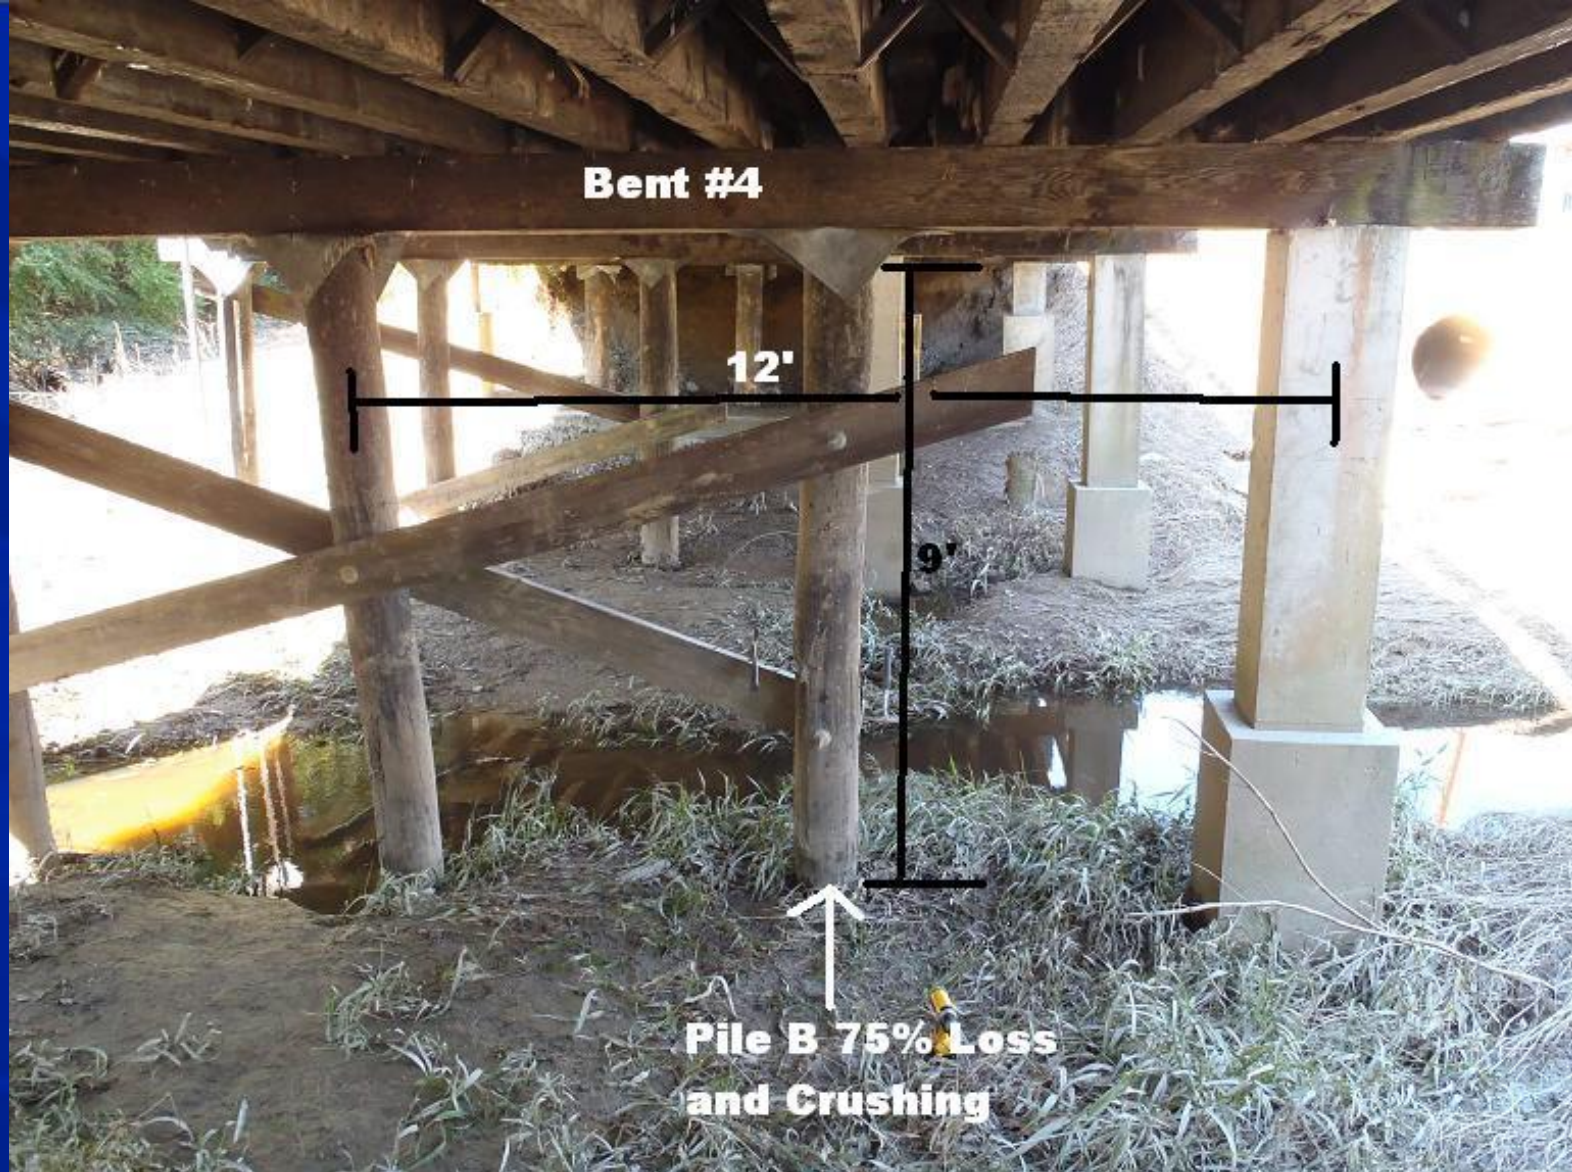
**Bridge 62-2, Pile Damage**

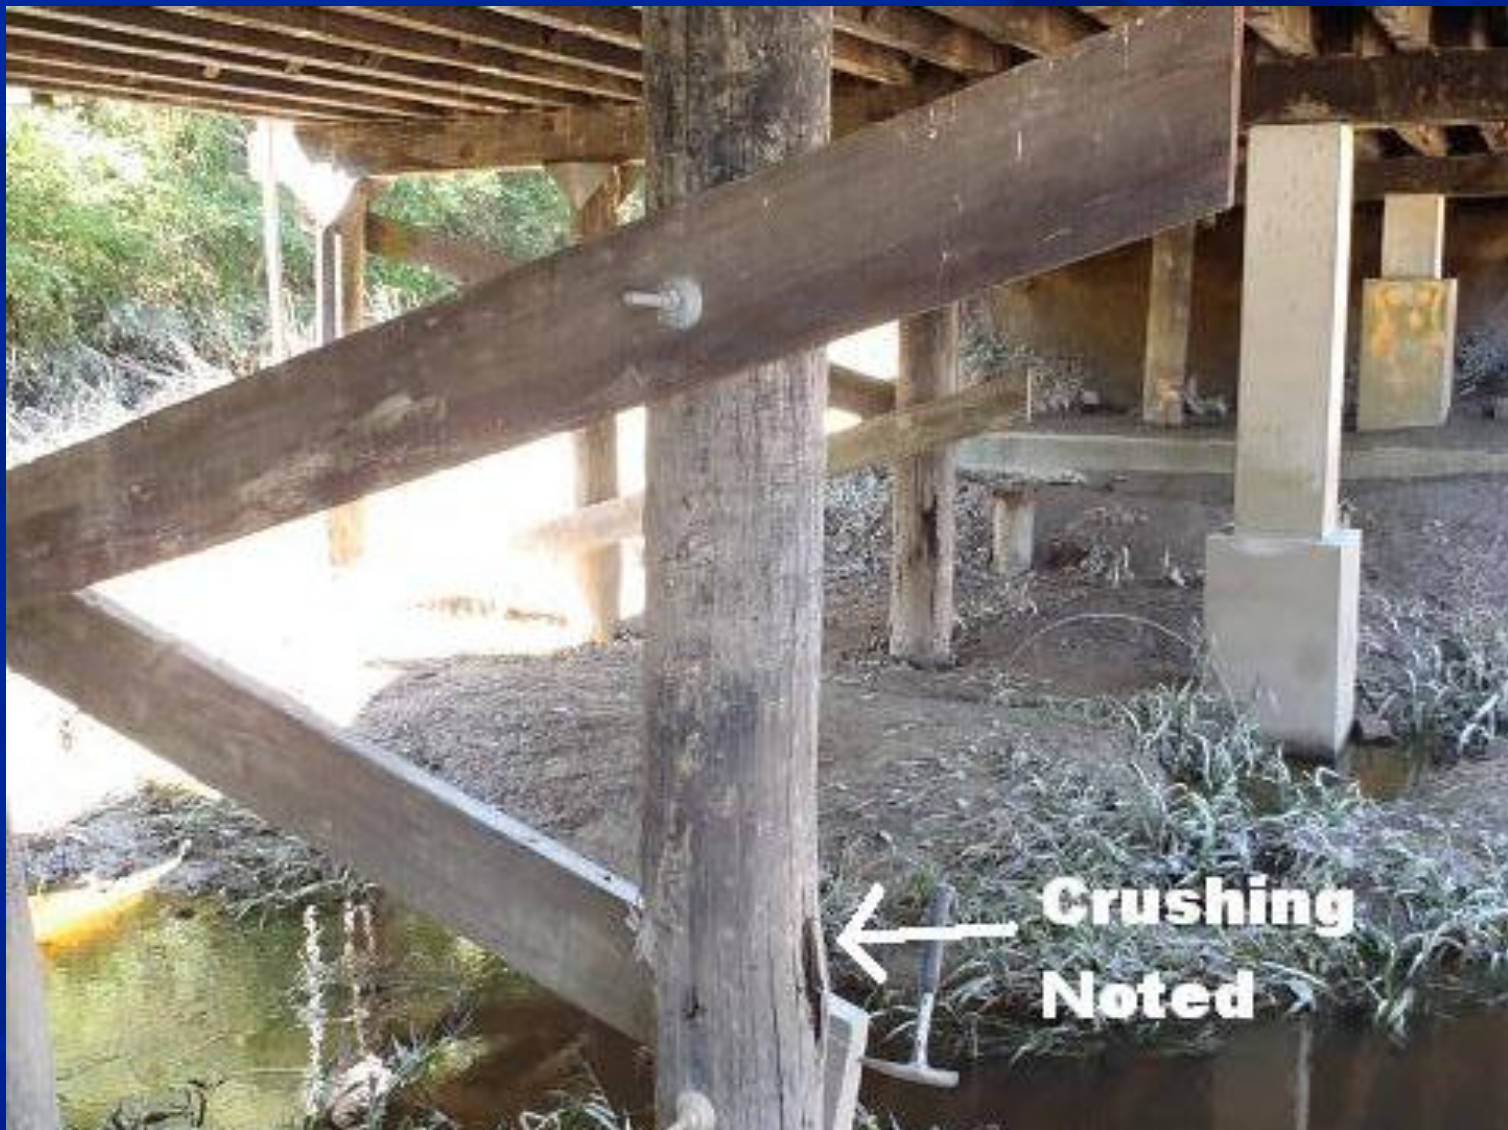
**Bridge 62-1, Pile Damage**

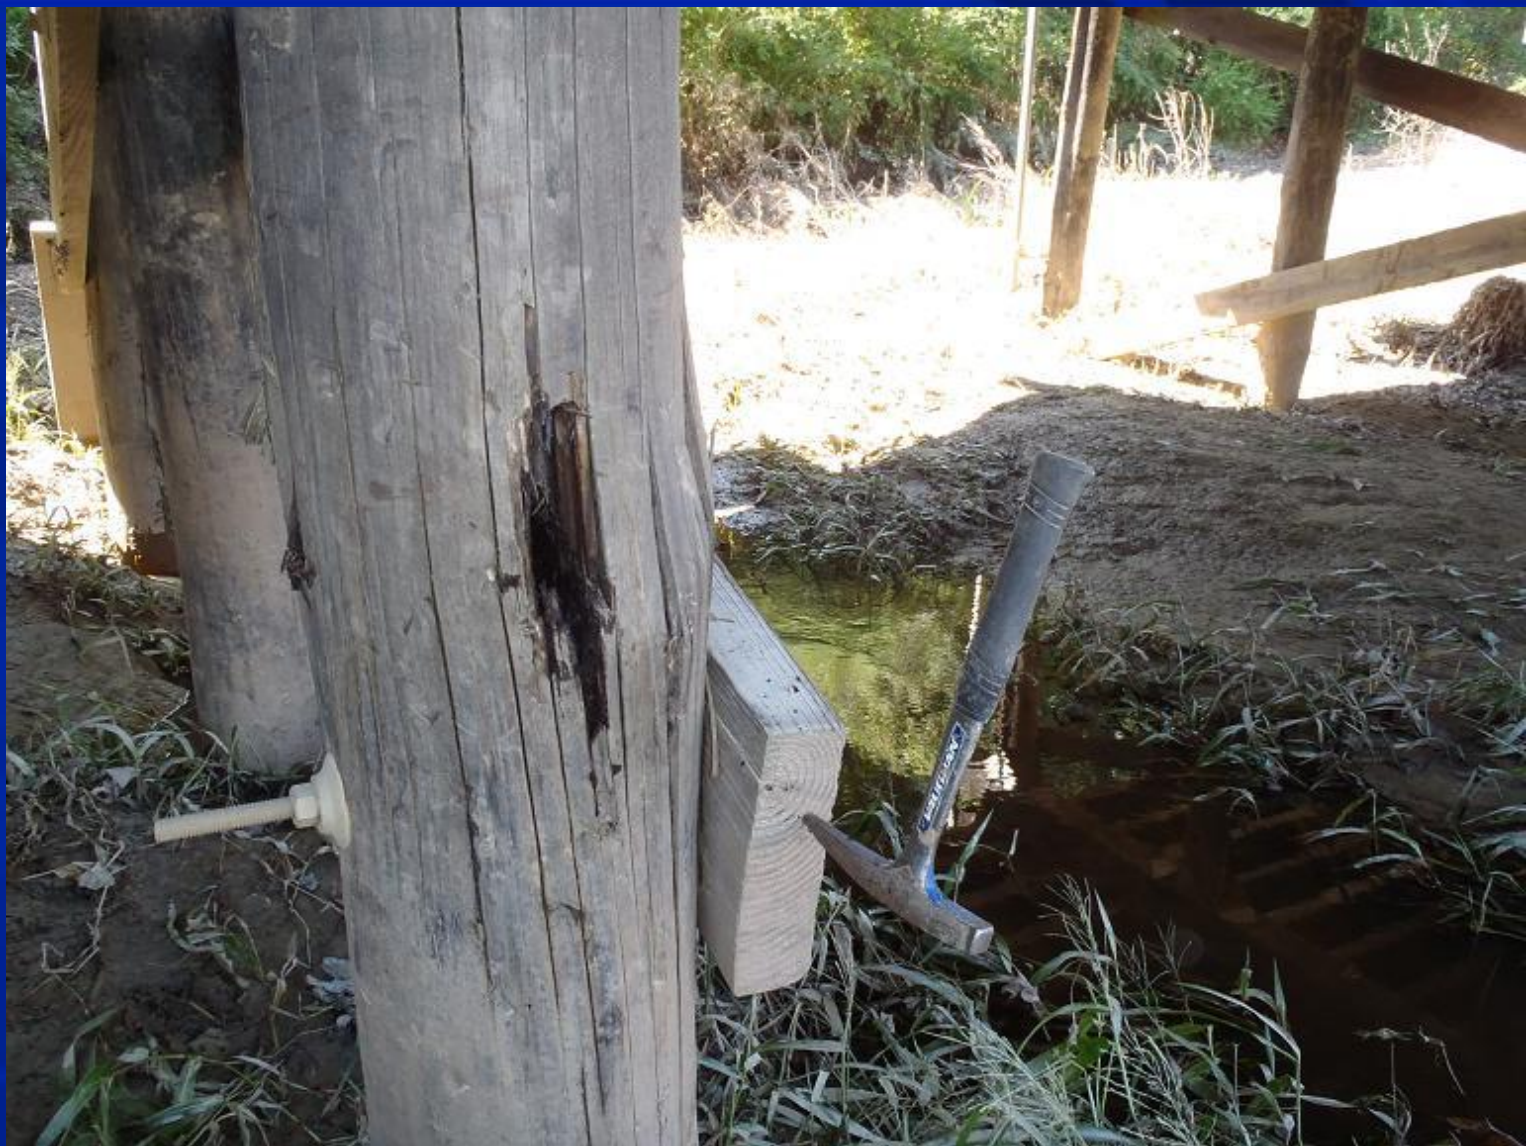
## Bridge 62-1, Pile Damage

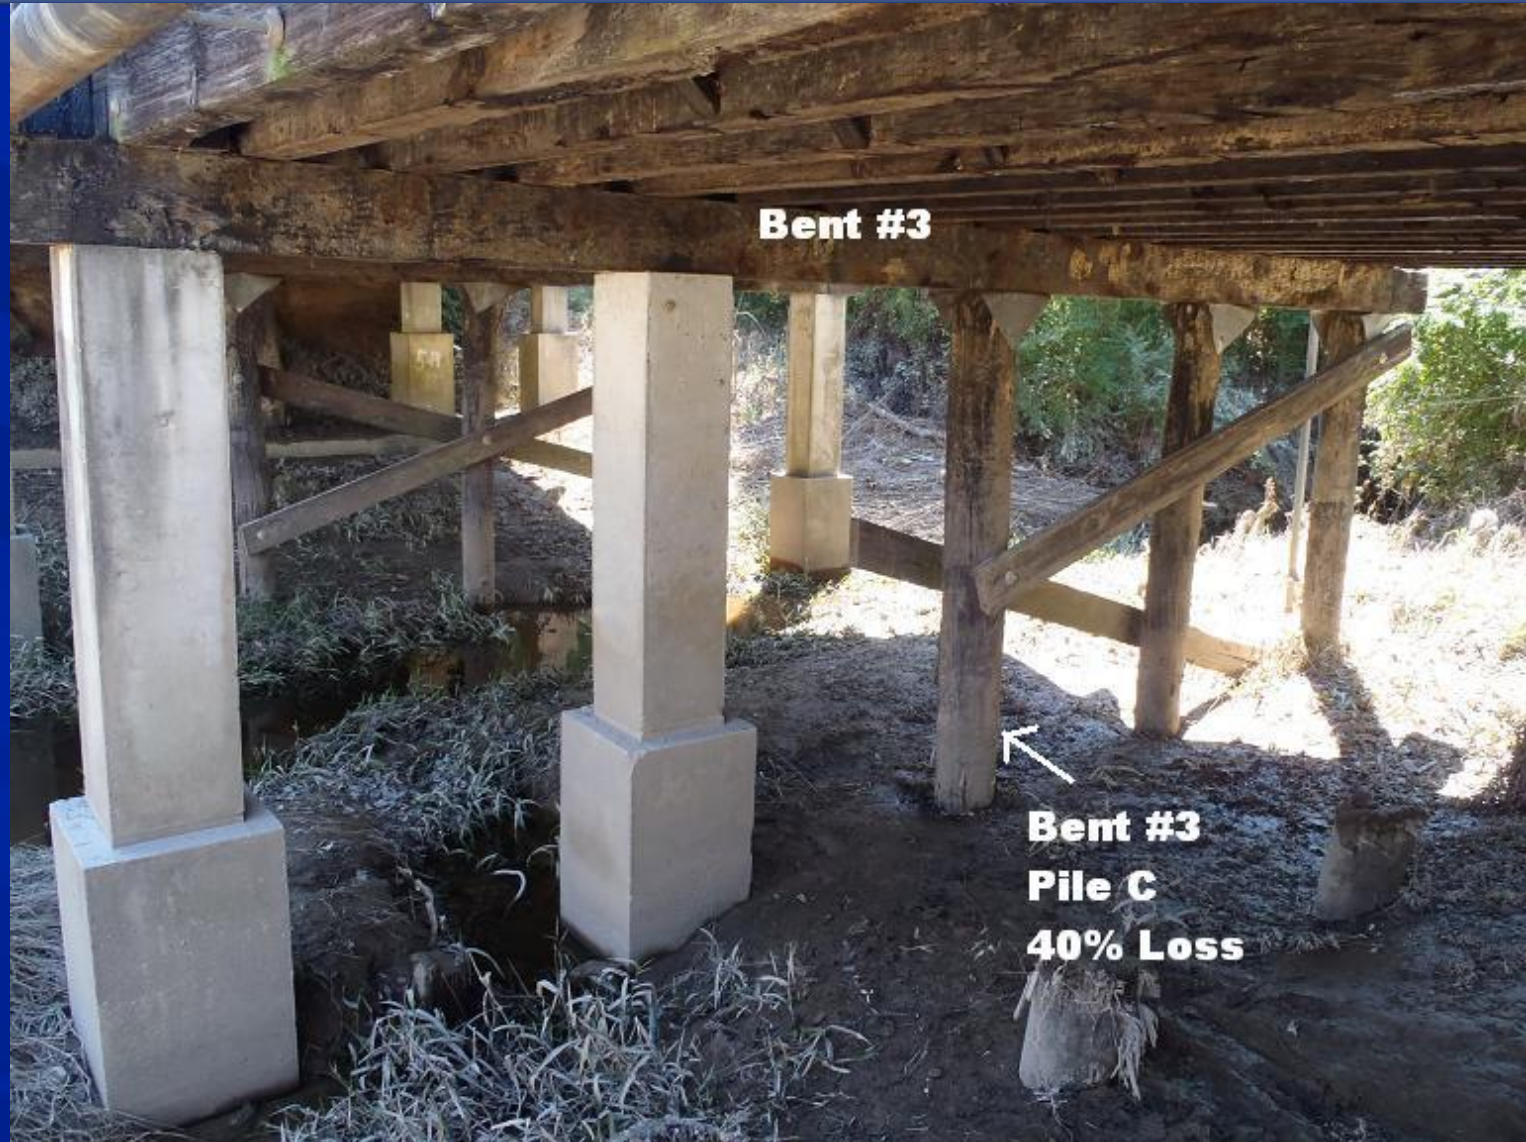
## Bridge 62-2, Pile Damage

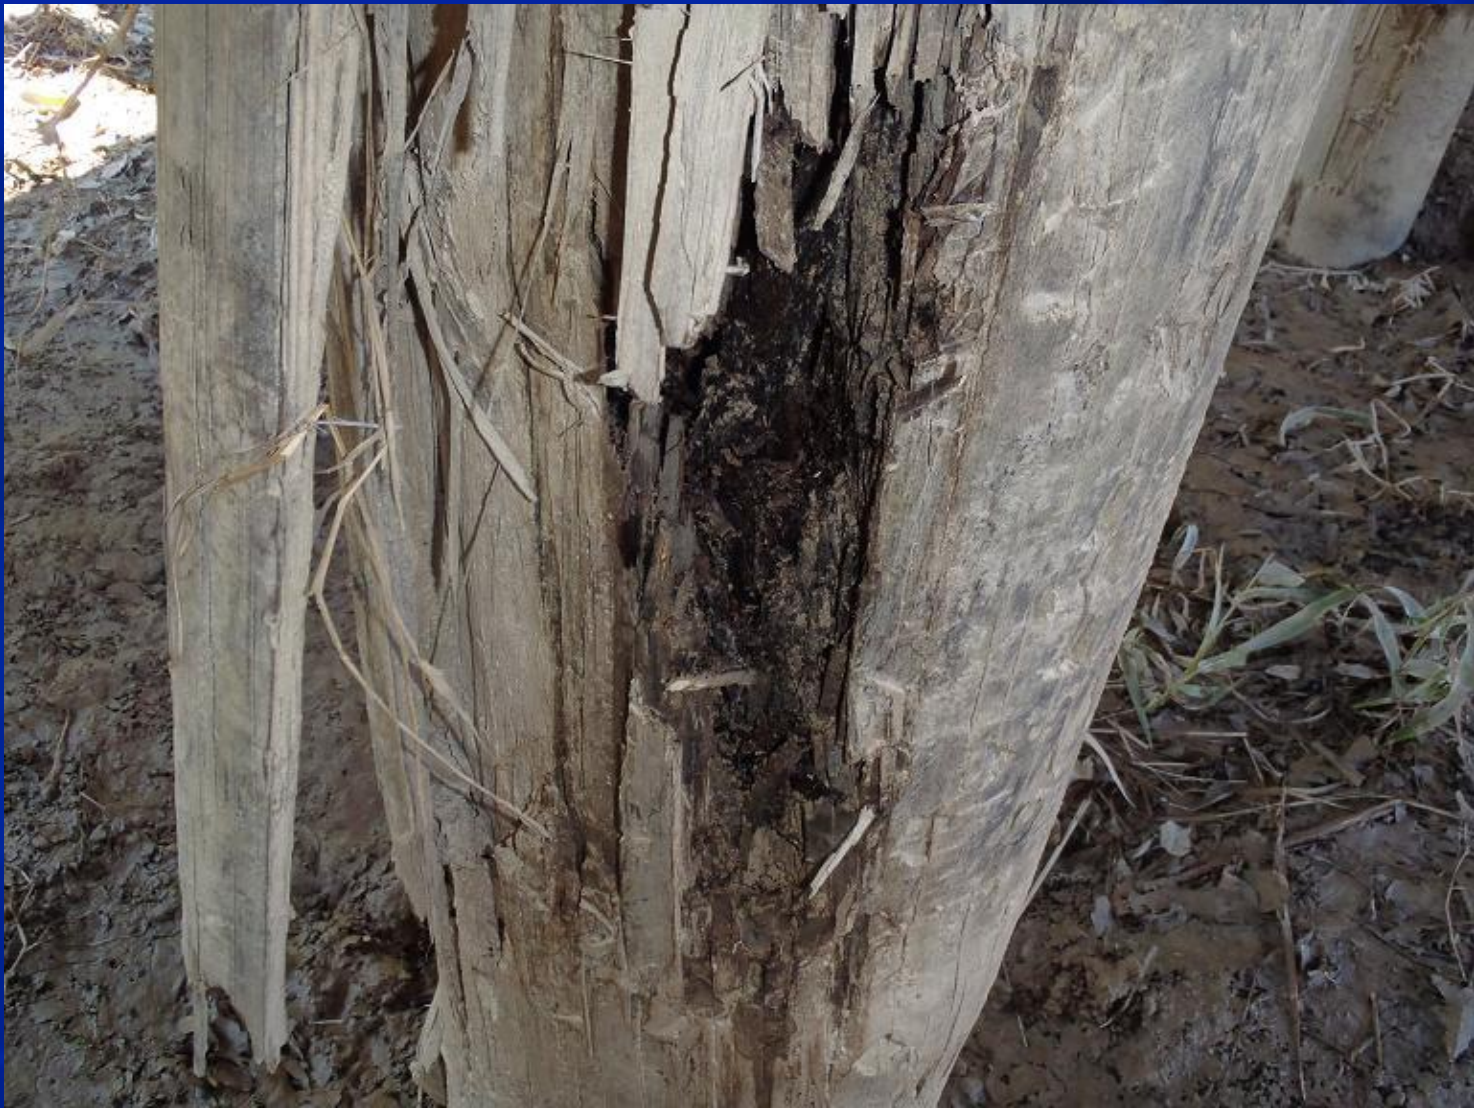
**Bridge 62-2, Pile Damage**

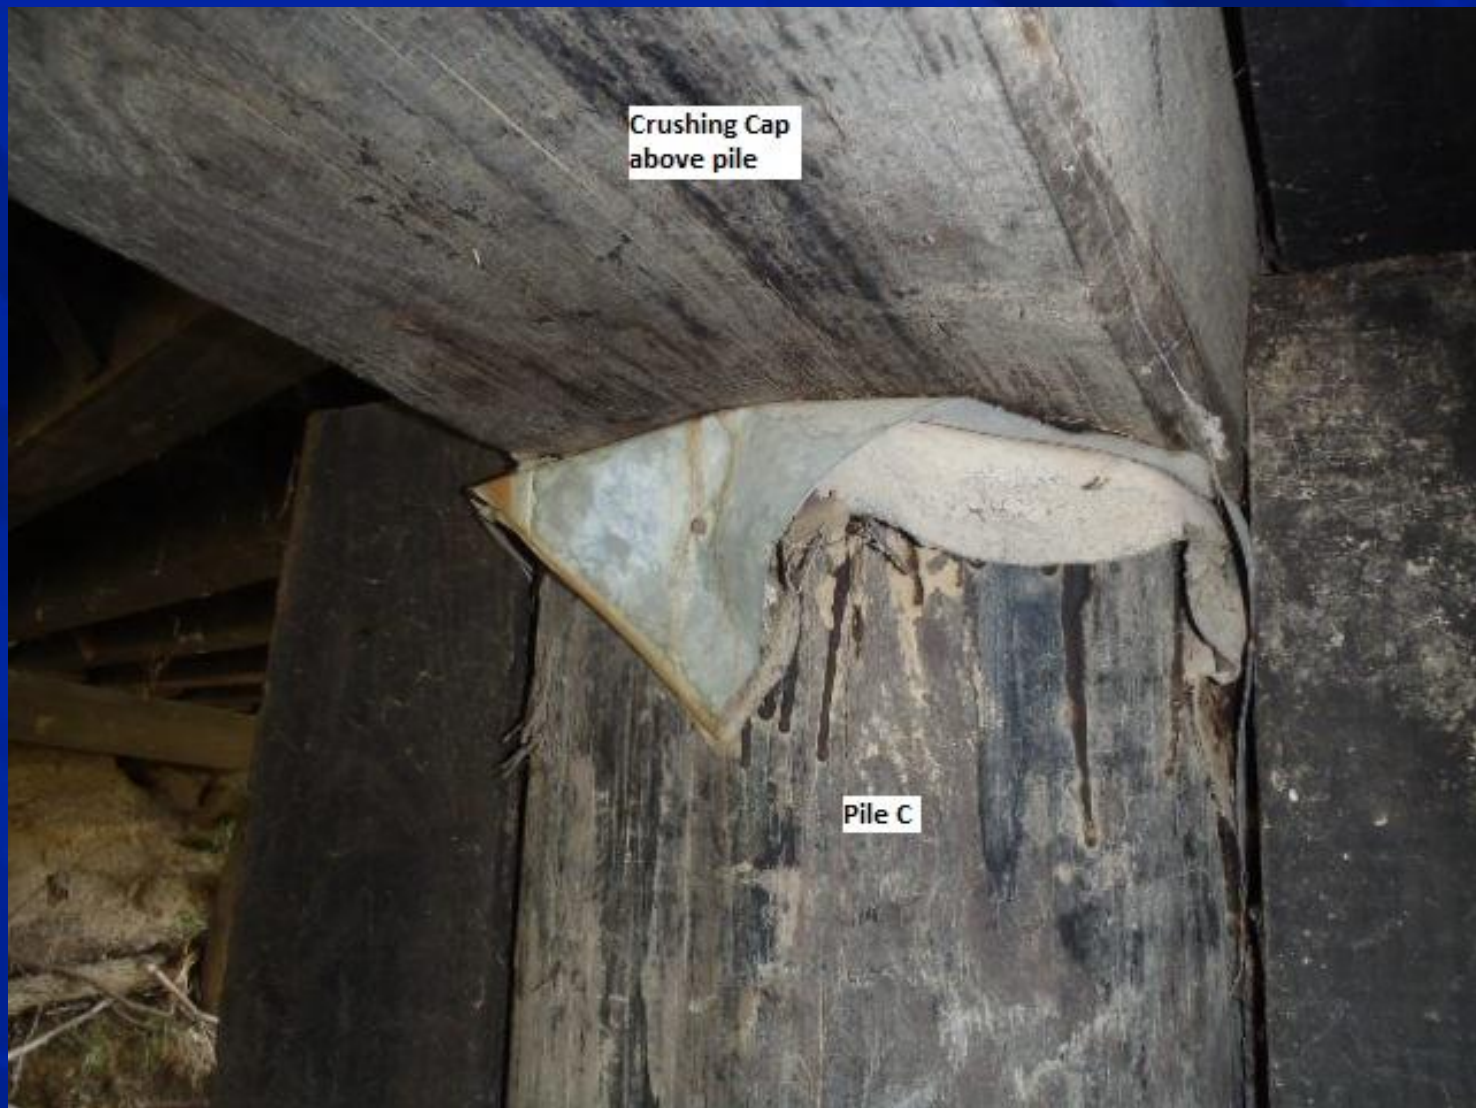
Pile C

Crushing Cap  
above pile
