**ICTB 2013**  
**Las Vegas, Nevada**

# **Inspection of Timber Bridges in the Pacific West**

**Tom Williamson, P.E.**  
**Lola Coombe, P.E.**  
**David Strahl, P.E.**

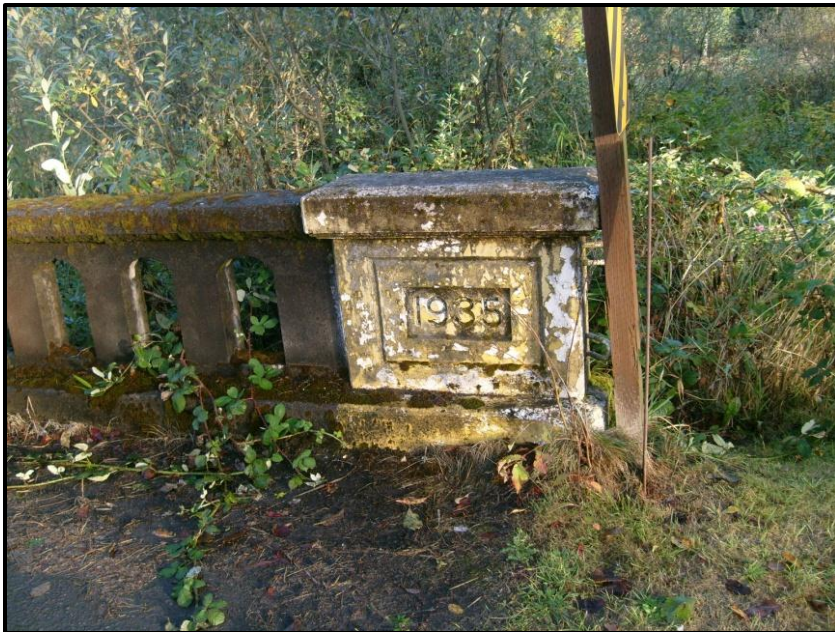
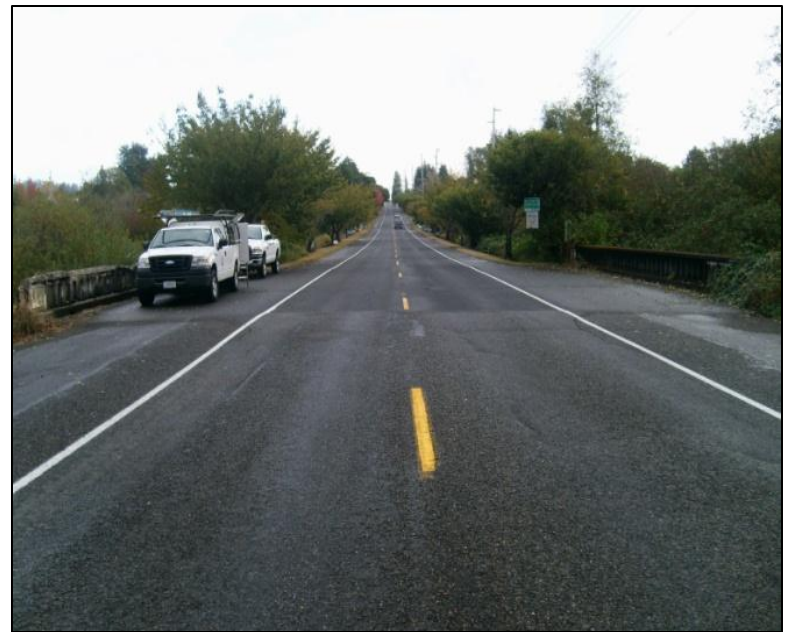
## Sylvia Creek Bridge

- Erected in 1935 - in continuous service for 78 years
- Carries an ADT of over 4000 vehicles
- 3 spans with a total of 169 sawn timber girders - no signs of significant decay or deterioration
- NBI rating of 7 for the sawn timber girders

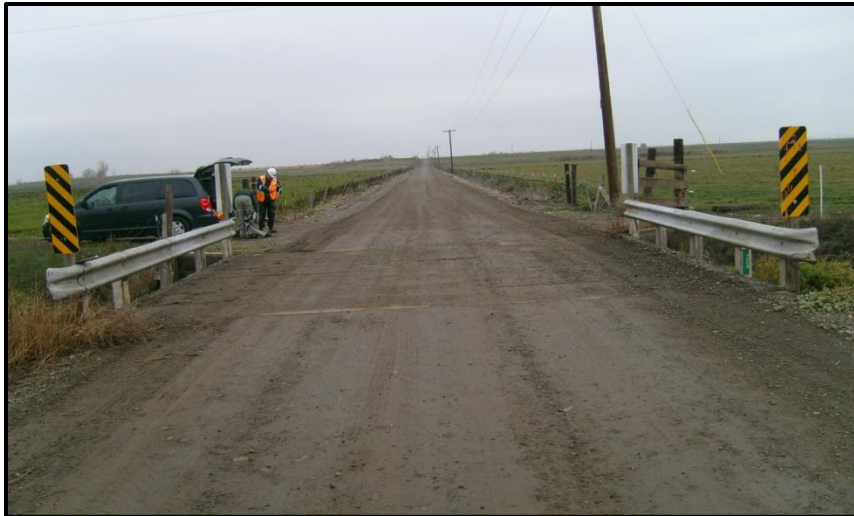
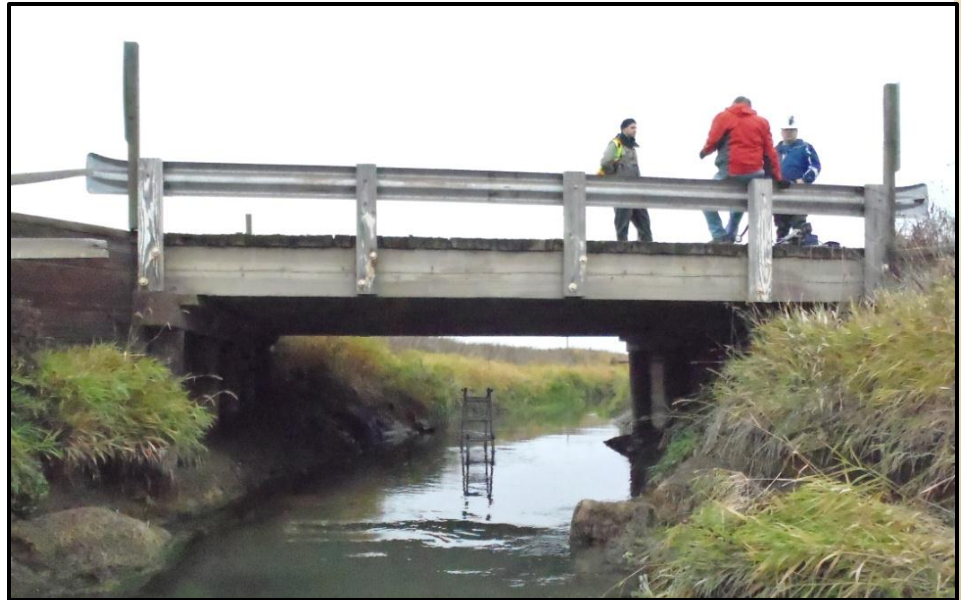
## Bridge 724

- Erected in 1959 – in service for 54 years
- **Untreated** DF girders and deck
- No asphalt wearing surface
- Lowest recorded NBI ratings of all bridges inspected in this region

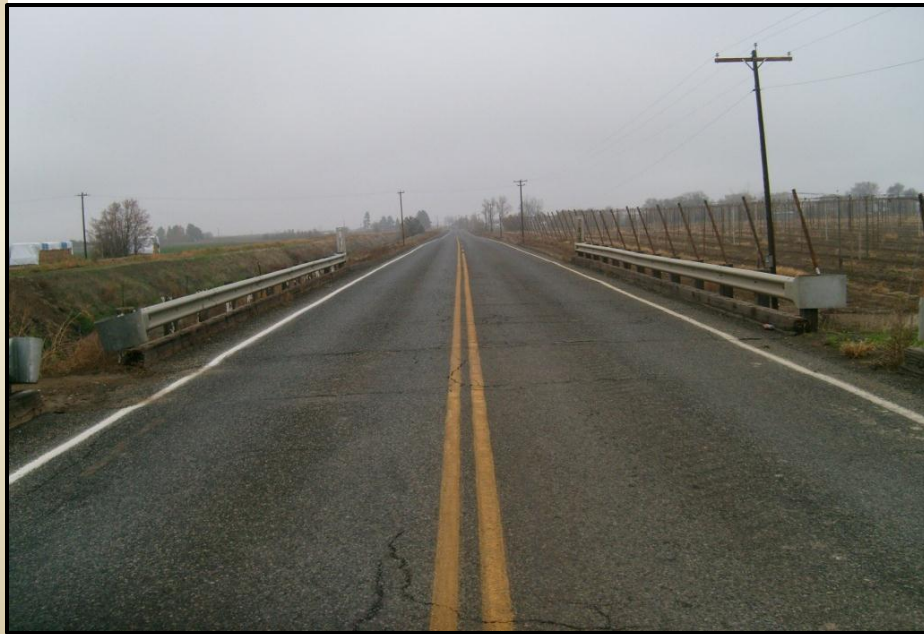
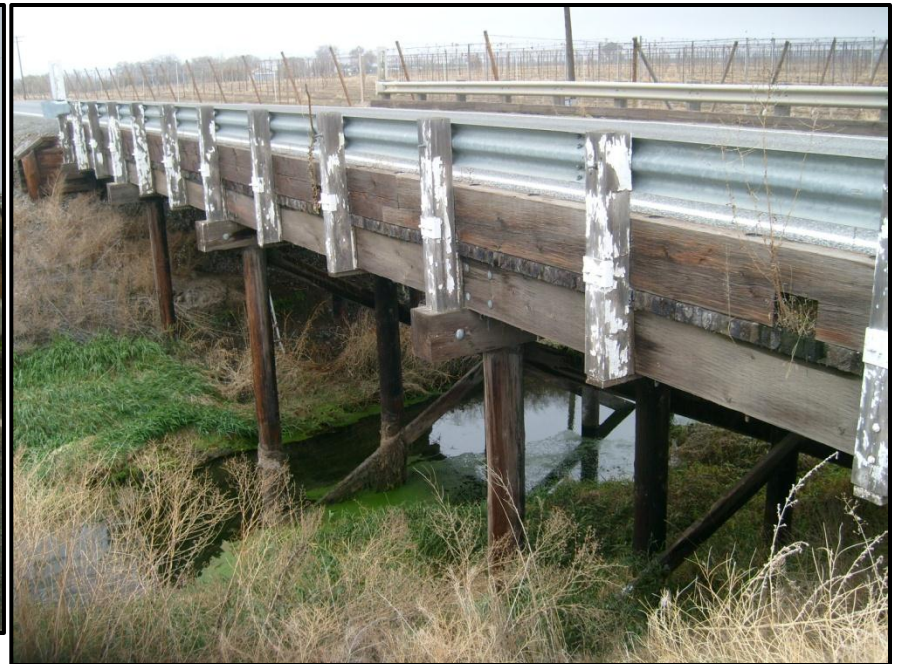
## Bridge 739

- Erected in 1939 – in service for 74 years
- 4 spans with total length of 22 m or 75 ft.
- Carries an ADT of over 1600 vehicles
- NBI ratings of 6 for deck and girders

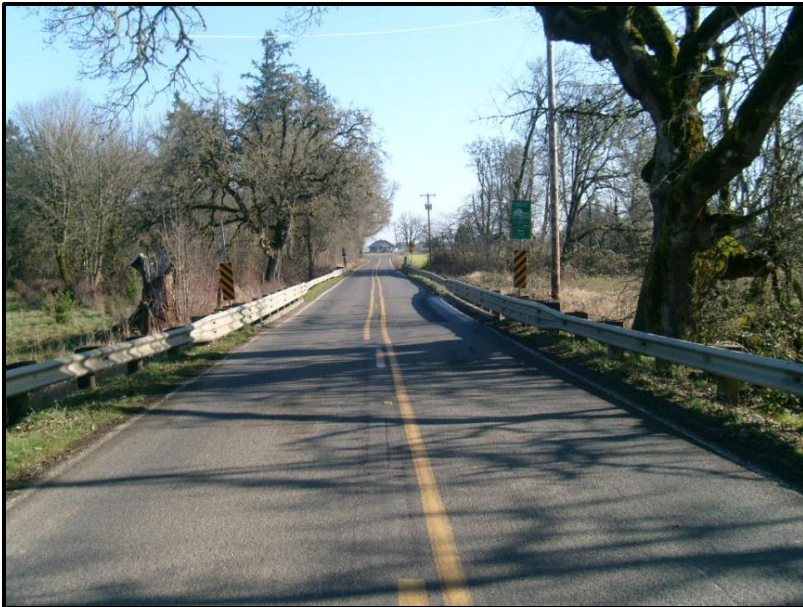
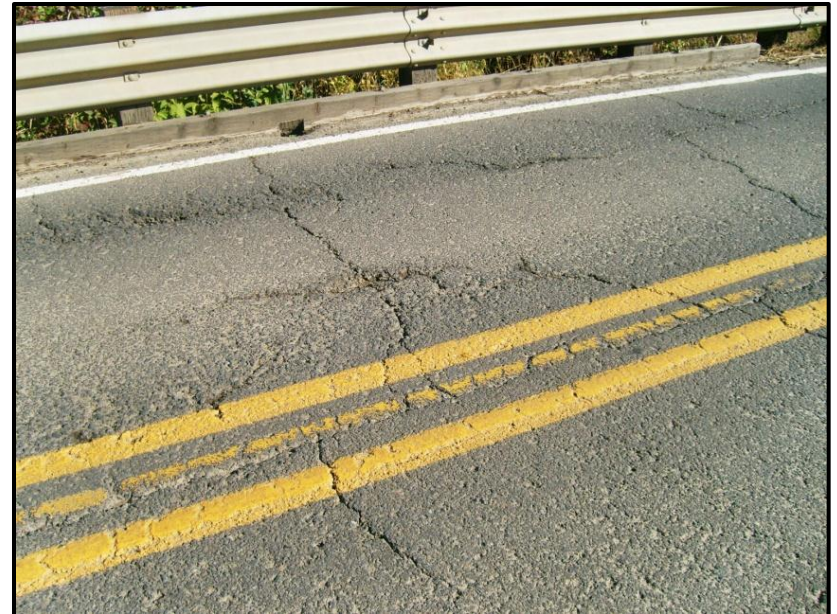
## Bridge 1298

- Erected in 1960 – in service for 53 years
- 3 spans with total length of 14 m or 48 ft.
- NBI ratings of 7 for sawn timber deck and girders
- One outside girder replaced in 2010
- Carries an ADT of over 1100 vehicles

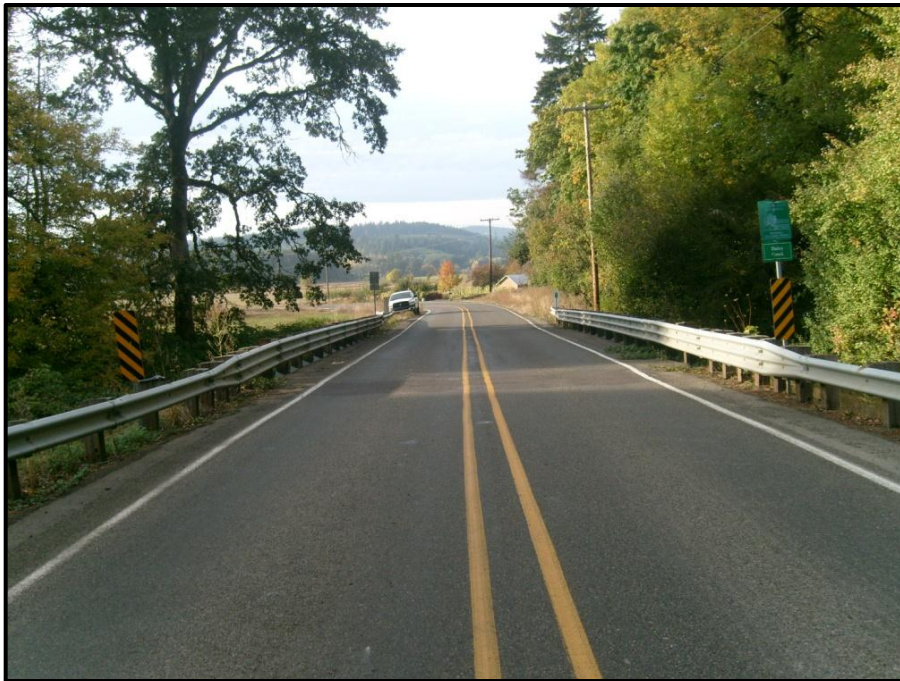
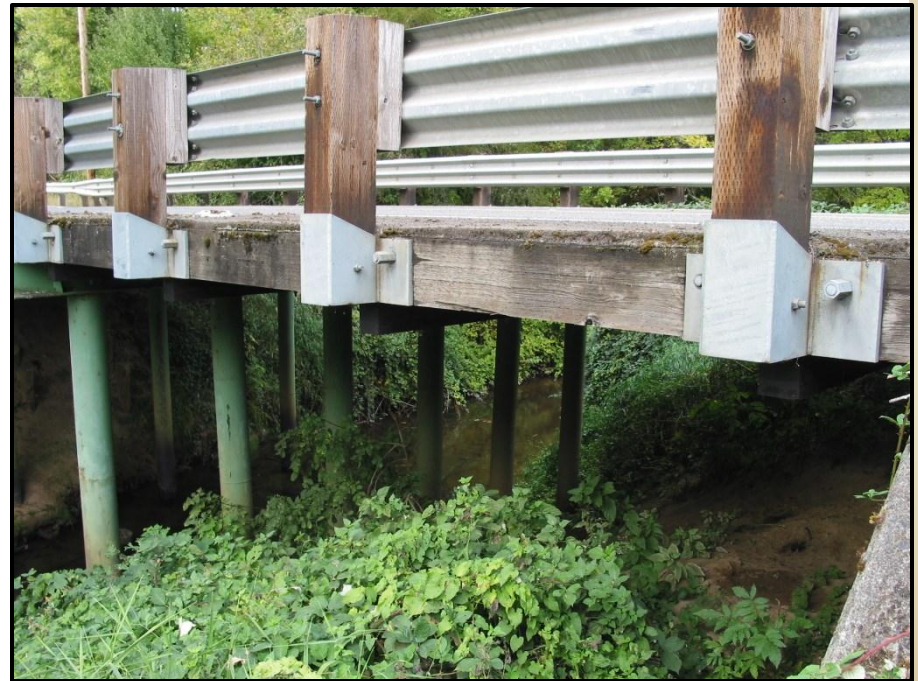
# Washington County, OR Bridge 1358

- Erected in 1992 – in service for 21 years
- 3 spans with total length of 22 m or 75 ft.
- Longitudinal glulam deck with NBI rating of 8
- Carries an ADT of over 1500 vehicles

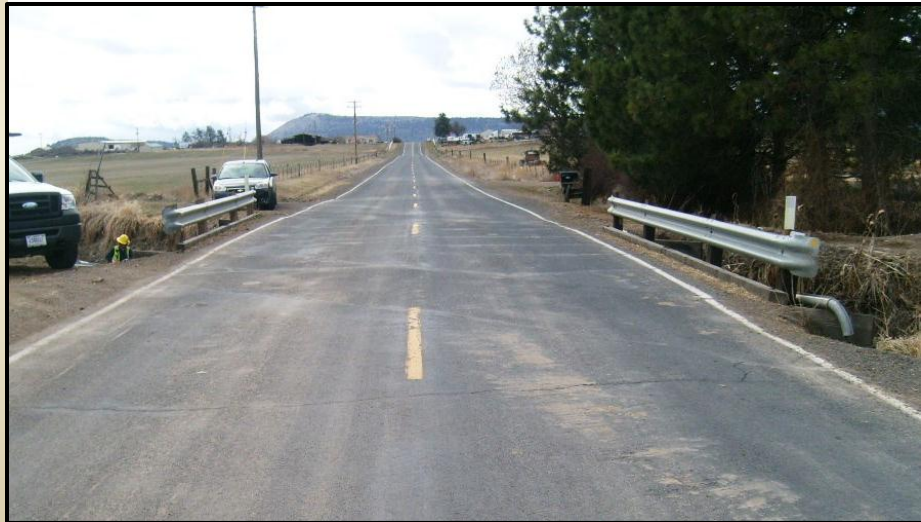
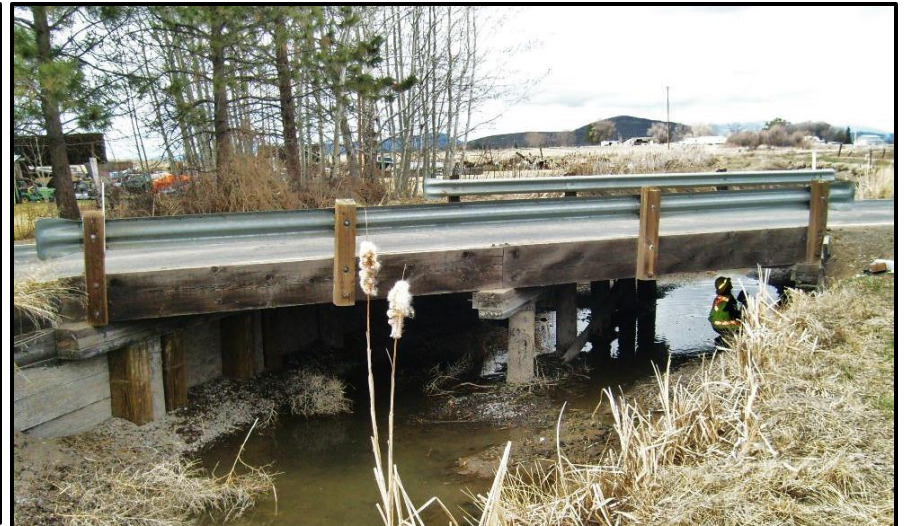
## Homedale Road Bridge

- Erected in 1963 – in service for 50 years
- 2 spans with total length of 13.5 m or 46 ft.
- Longitudinal sawn lumber slab deck with NBI rating of 7
- Carries an ADT of over 300 vehicles

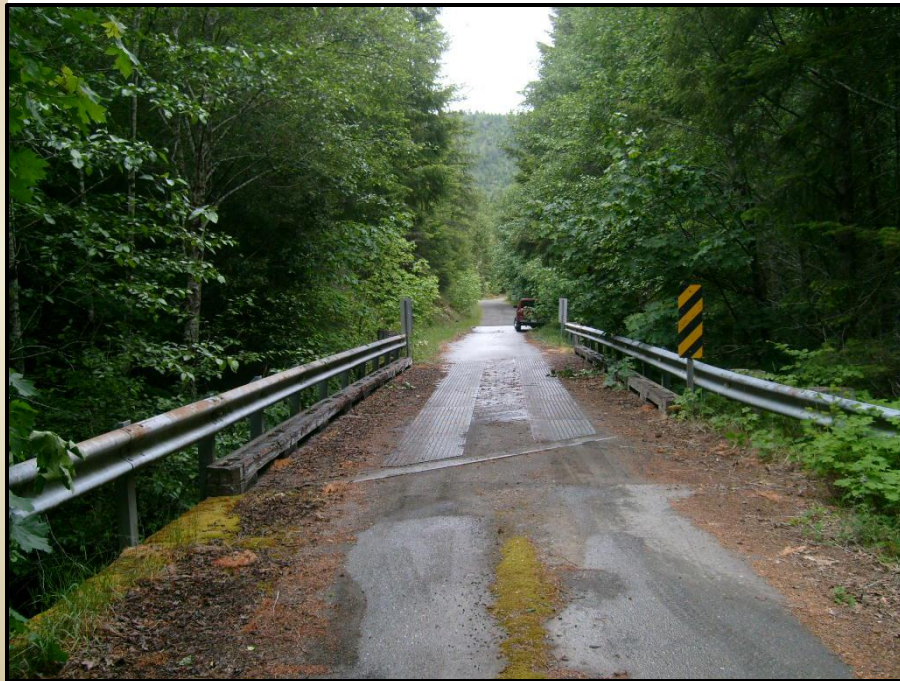
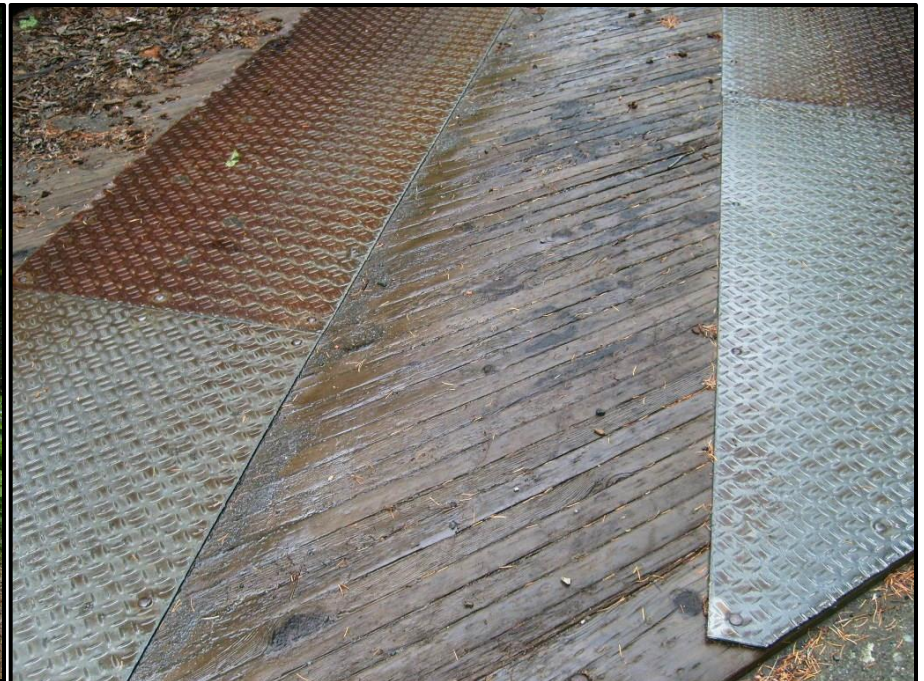
## Knopki Creek Bridge

- Erected in 1967 – in service for 46 years
- Glulam girders with transverse sawn timber deck
- Simple span with length of 14 m or 48 ft.
- NBI ratings of 7 for girders and 8 for deck

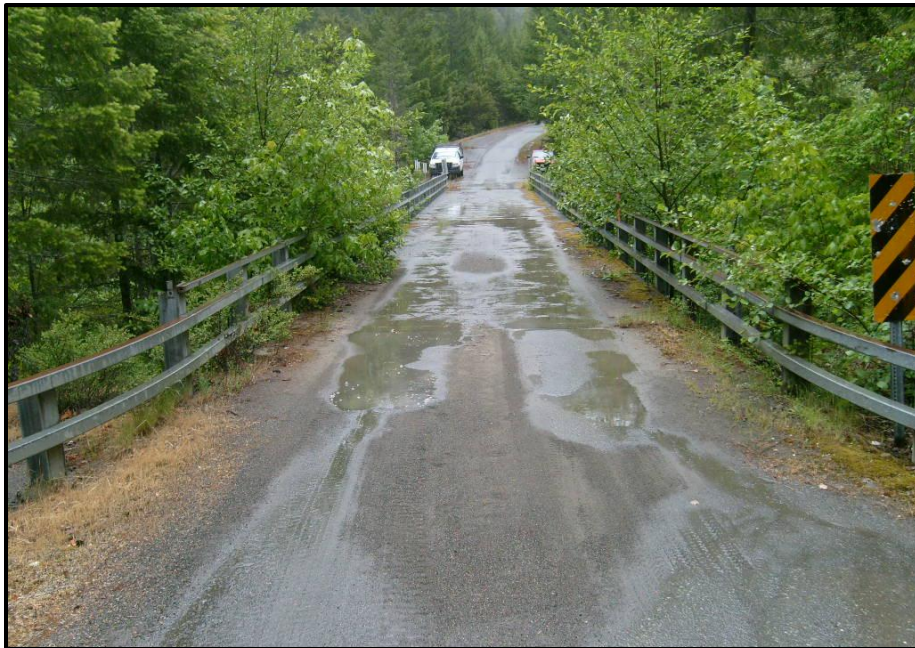
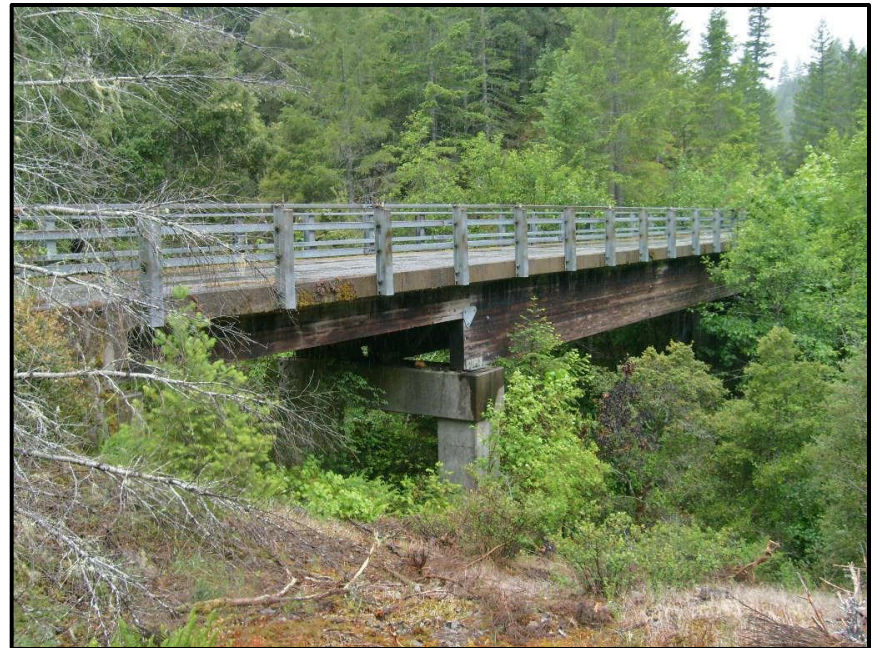
## Middle Fork #2 Bridge

- Erected in 1973 – in service for 40 years
- Glulam girders with cast in place concrete deck
- Three spans with total length of 38.5 m or 130 ft.
- NBI ratings of 7 for girders and deck

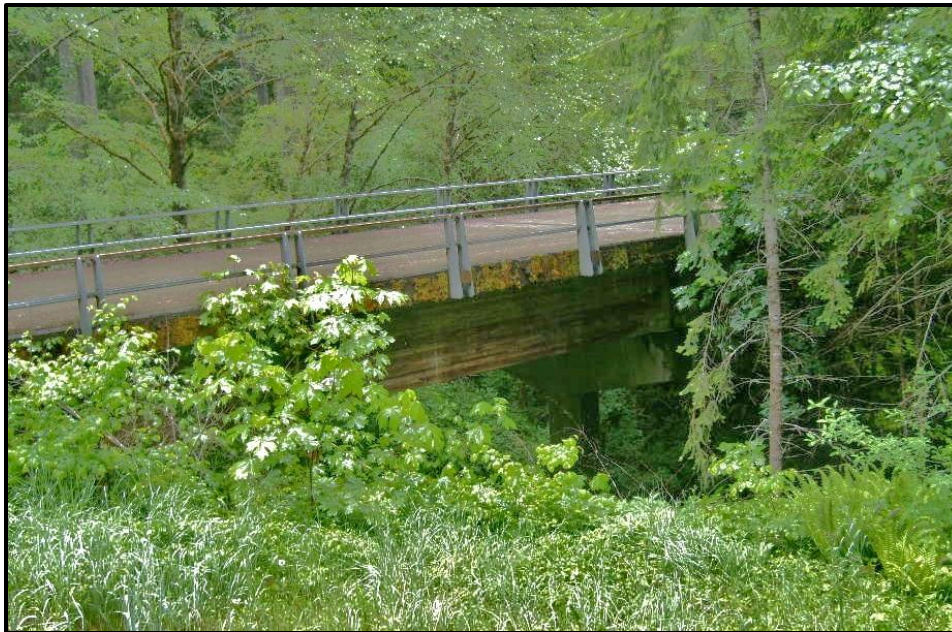
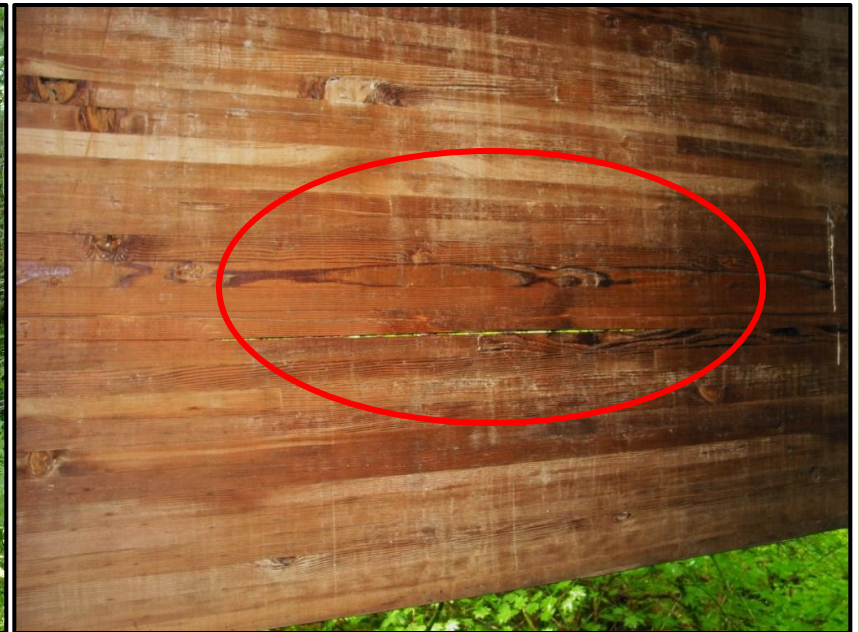
## Griffin Creek Bridge

- Erected in 1978 – in service for 35 years
- Glulam girders with cast in place concrete deck
- Two spans with total length of 34.5 m or 116 ft.
- Low NBI rating due to shear failure in one girder

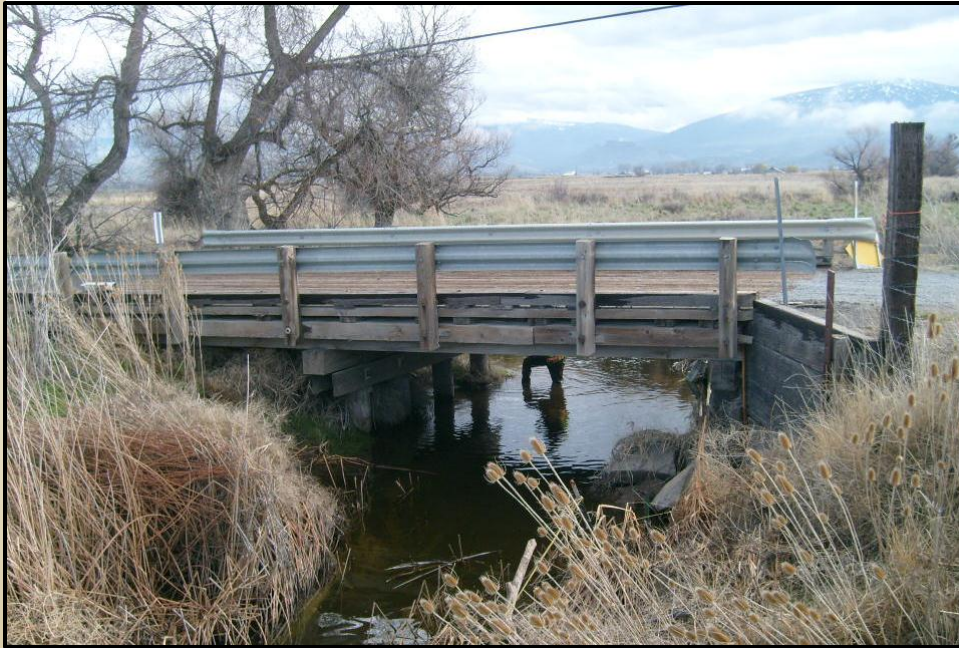
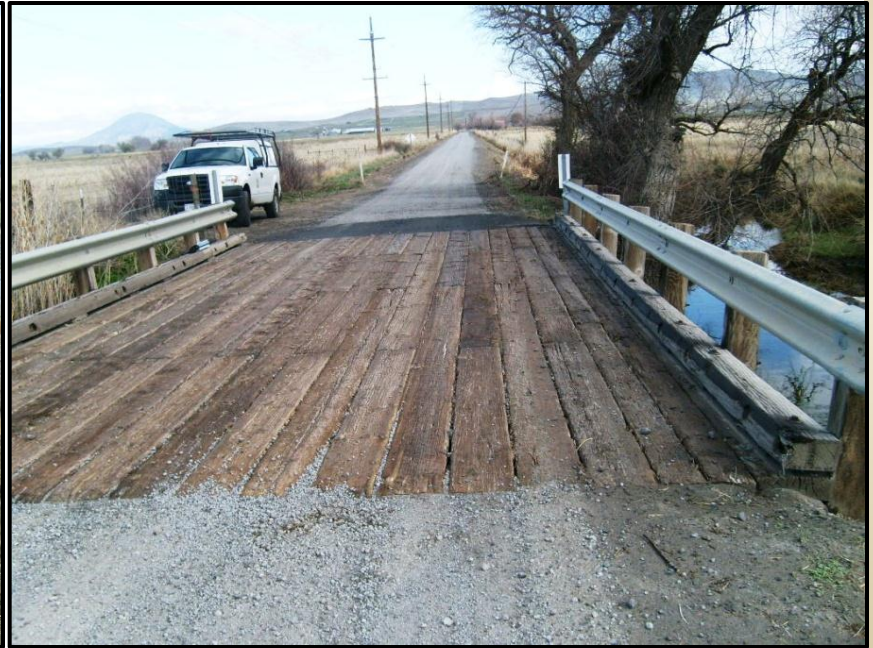
## Red Bridge

- Erected in 1959 – in service for 54 years
- Sawn timber girders with transverse stringers and longitudinal running planks
- NBI ratings of 6 for girders and deck

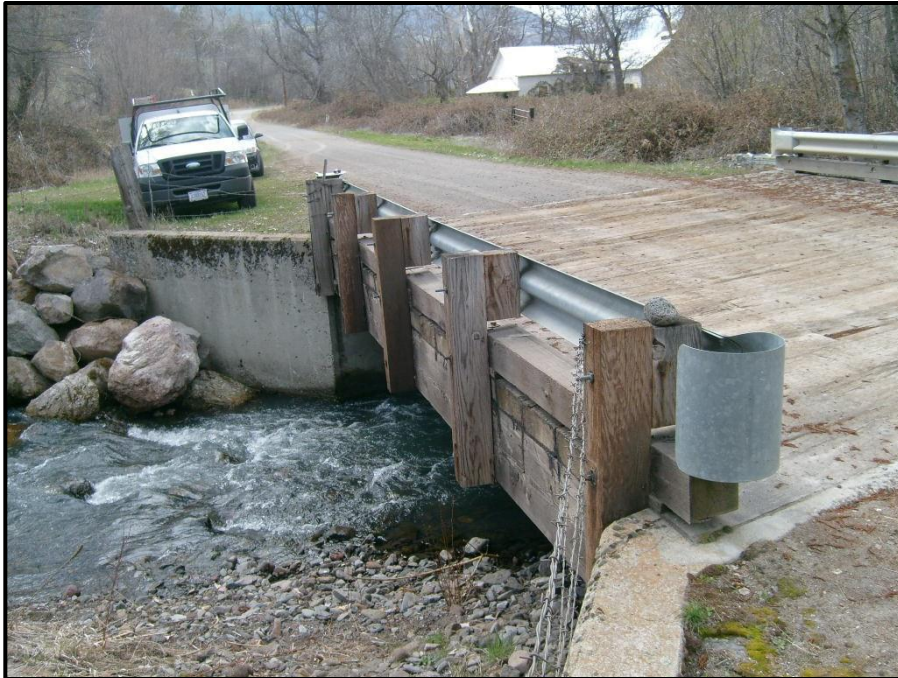
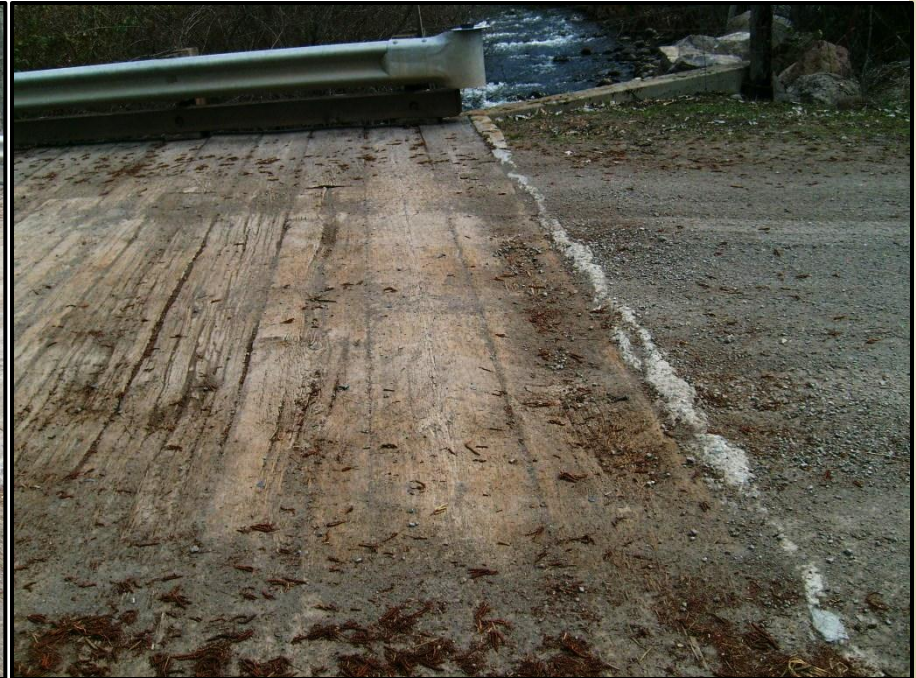
# Siskiyou County, CA Shovel Creek Bridge

- Erected in 1977 – in service for 36 years
- Sawn timber girders with 6x16 transverse timber deck used as wearing surface
- NBI ratings of 5 for girders and deck

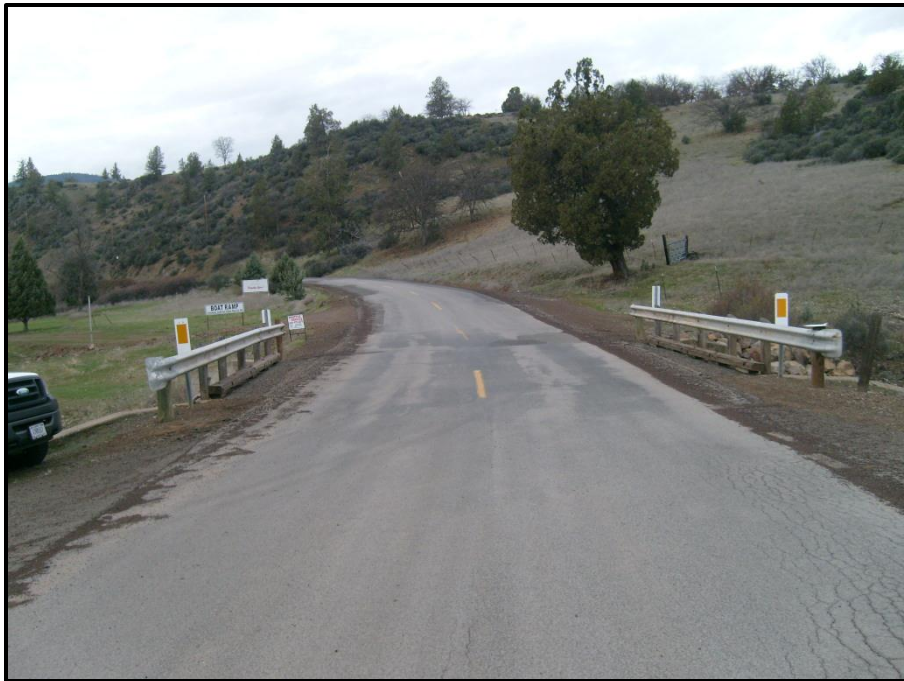
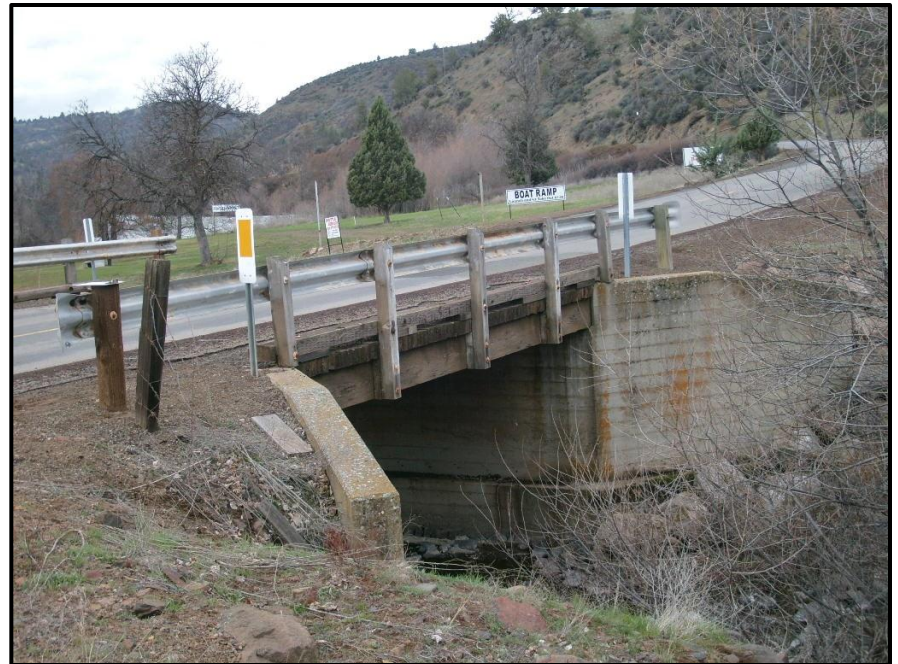
## Fish Hook Bridge

- Erected in 1960 – in service for 53 years
- Sawn timber girders with 5x6 transverse timber deck
- NBI ratings of 7 for girders and deck
- Carries high volume of heavy RV vehicles
