Presentation to  
Second National Covered Bridge Conference

# GOODPASTURE COVERED BRIDGE REHABILITATION

**165-foot-long  
heavy timber  
Howe truss  
main span**

**Bridge Location:  
Vida, Oregon**

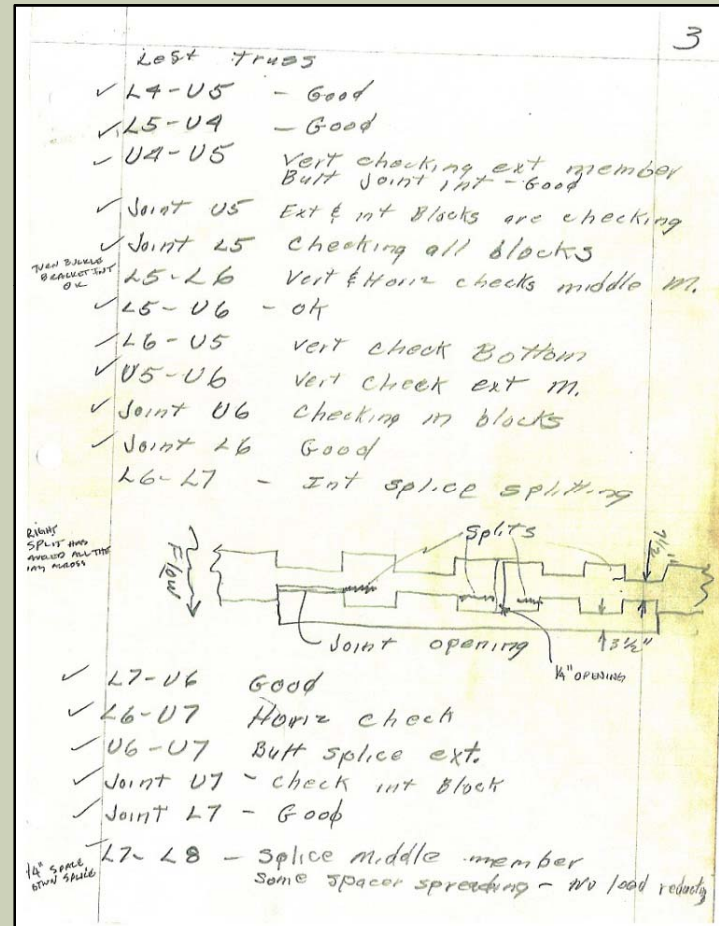
Inspector's notes documenting broken bottom chord splices

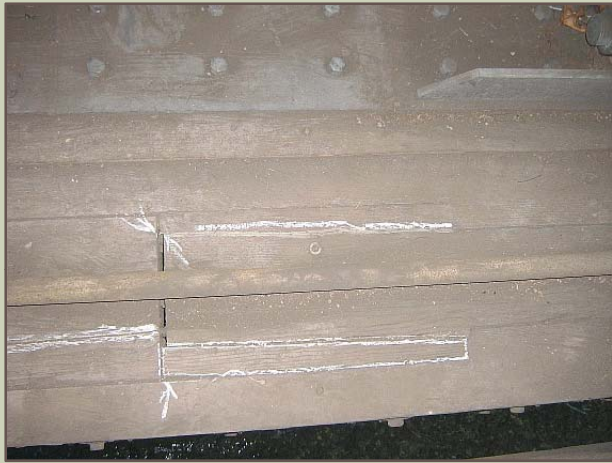
# REPAIR ADDED >7 TONS OF DEAD LOAD BUT WAS ONLY MARGINALLY EFFECTIVE

Broken splices leaving gaps to  $\frac{1}{2}$ "

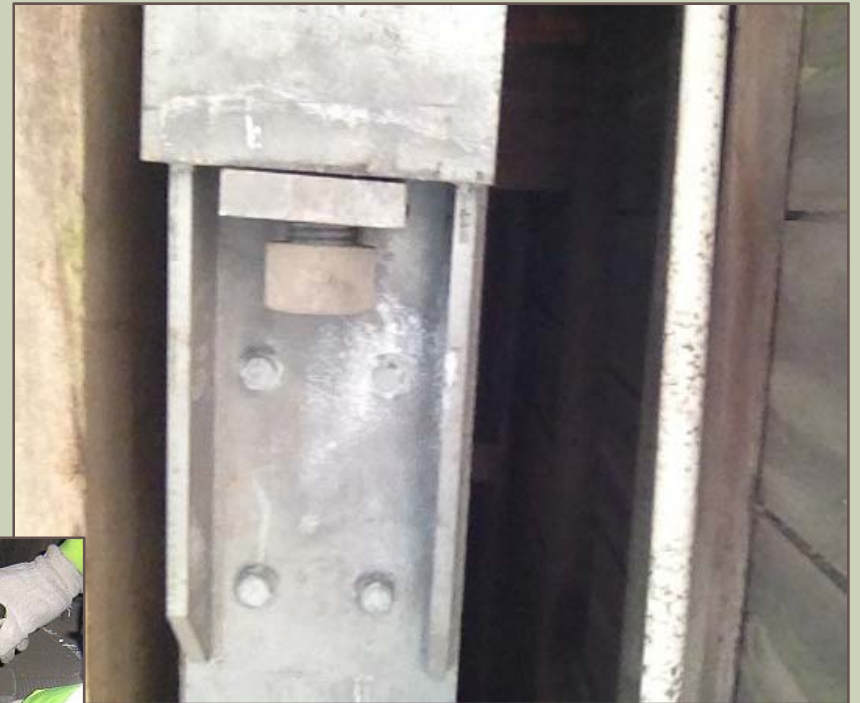
Some rods were never engaged

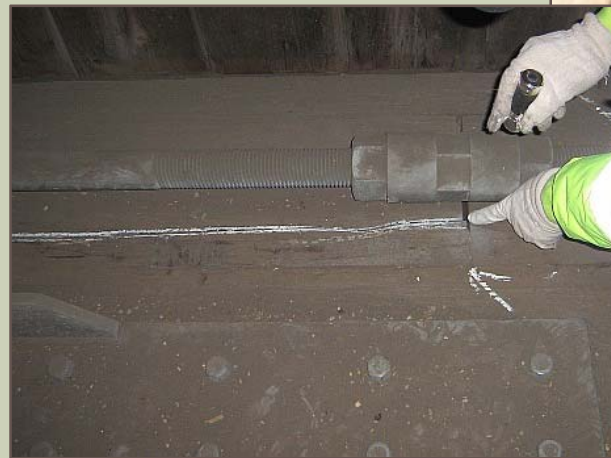
Gaps were not  
closed by the  
tie rods

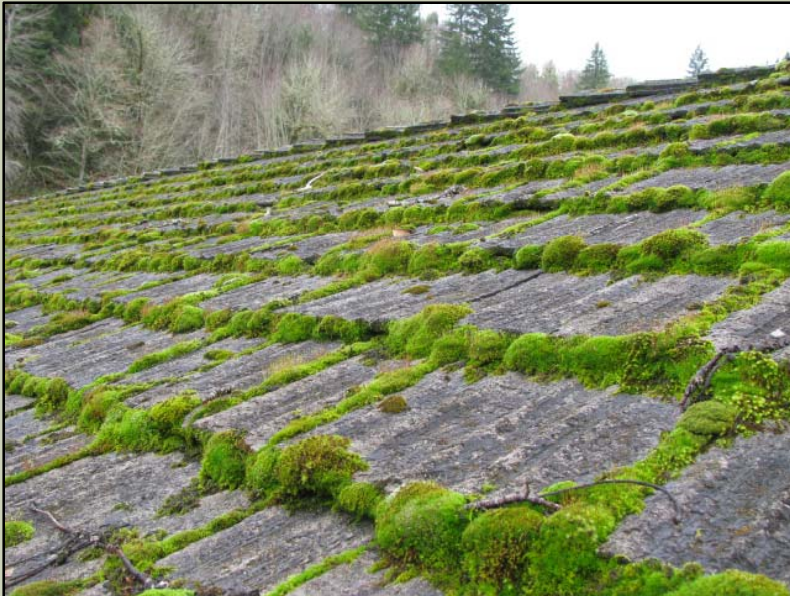
Very heavy cement/wood fiber composite roofing was leaking

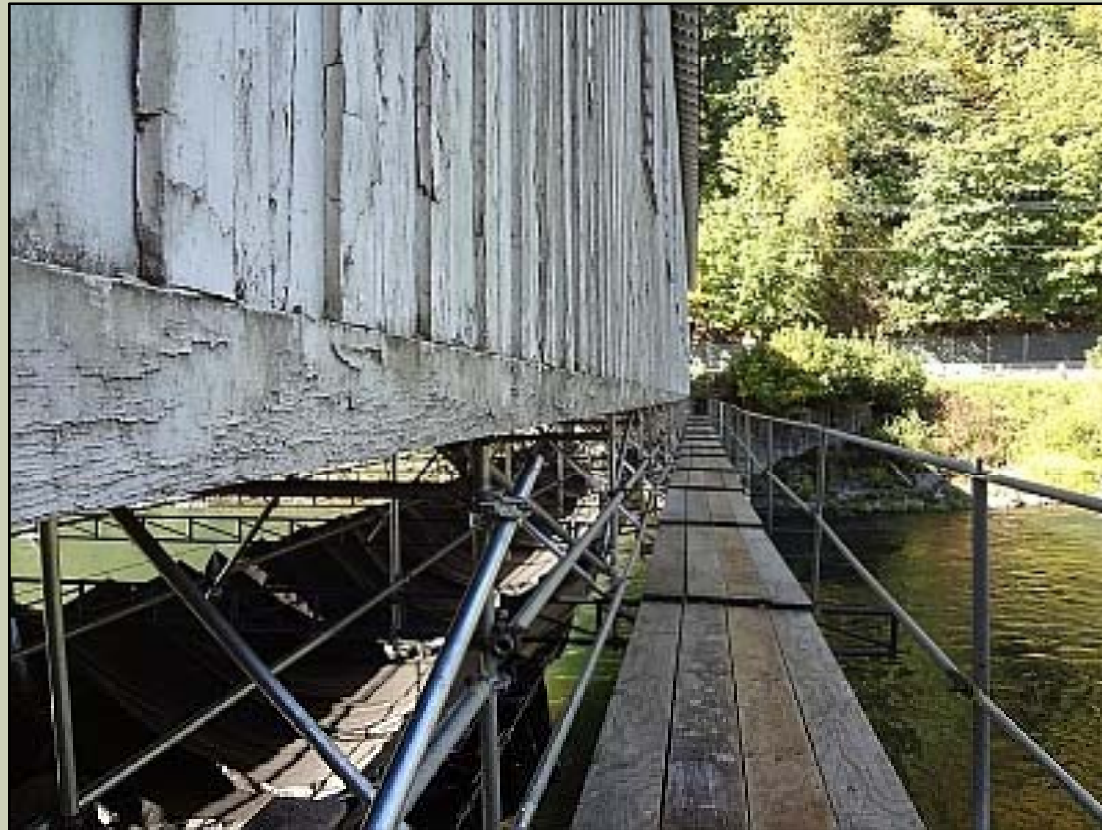
2012 photo

# 4-INCH SAG AT MID-SPAN EVEN WITH LIGHTER ROOF

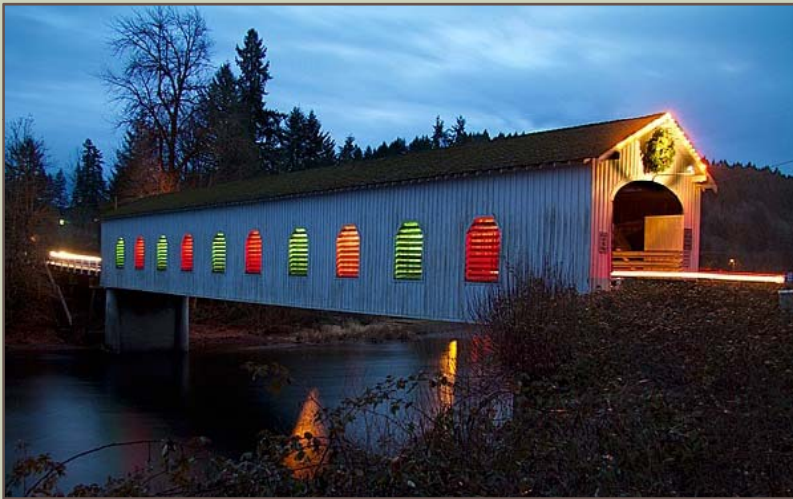
Prior to rehabilitation local residents strung lights with extension cords
