Kings Covered Bridge Rehabilitation

Samer Petro, P.E Kings Covered Bridge Rehabilitation

Second National Covered Bridge Conference, Dayton Ohio 2013.

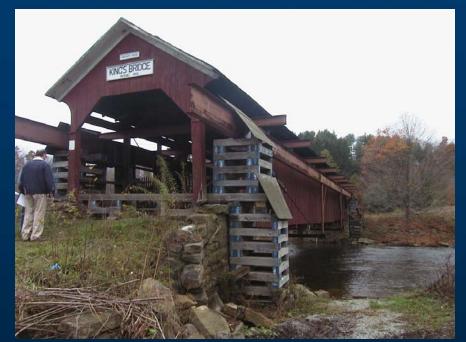
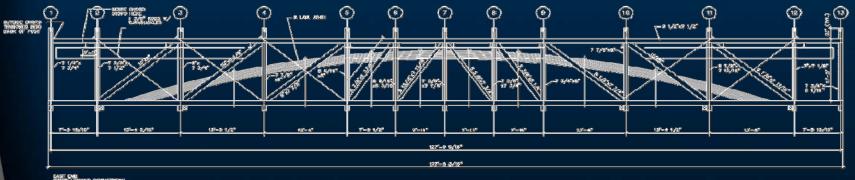
<u>Note</u> bay spacing and repair rods

EAST DAD INSIDE LOOKING DOWNSTREAM ELEVATION OF THE TRUSS

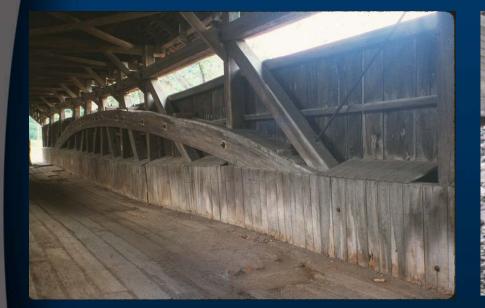
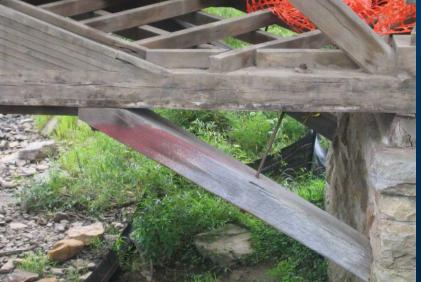
Multiple Kingpost Truss with arch added

- Retrofitted 1906 with nail-laminated arches creating "Arch-Truss"
 - Arches "tied" to bottom chord

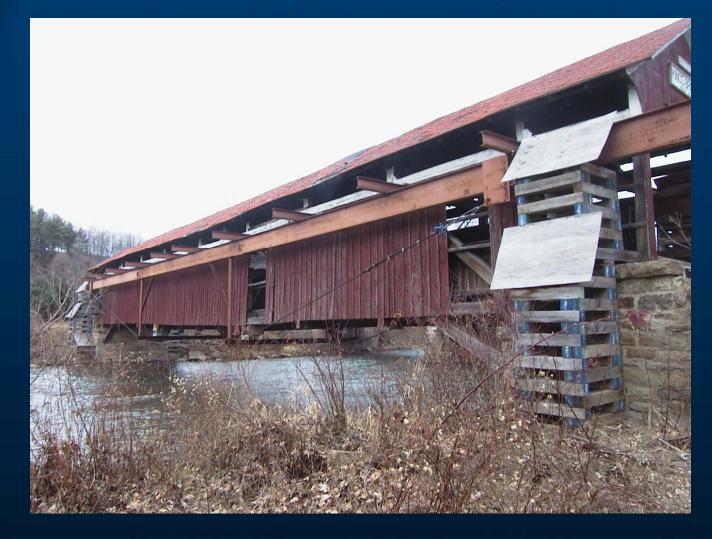
Both lower chords, some posts, some tie beams

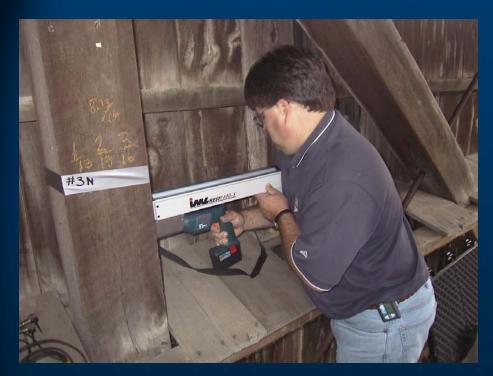
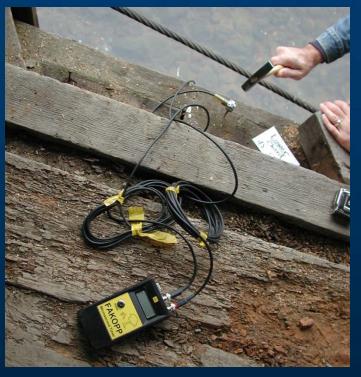
Resistance Drilling

Stress Wave Timer

Both chords had relative drilling resistance below 15%

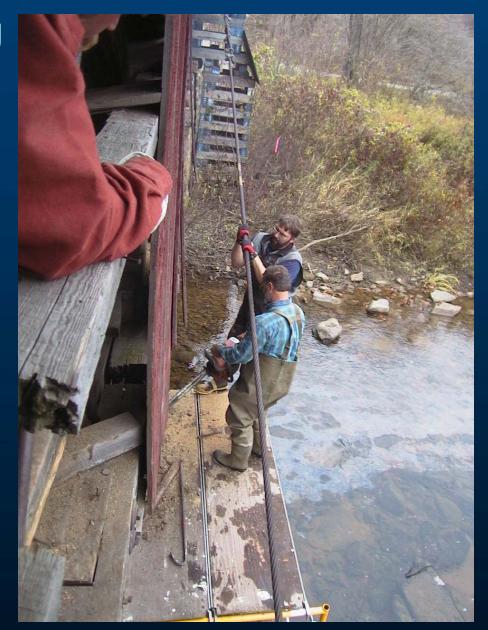
4-foot lower chordsegment removed forspecies analysis byForest ProductsLaboratory

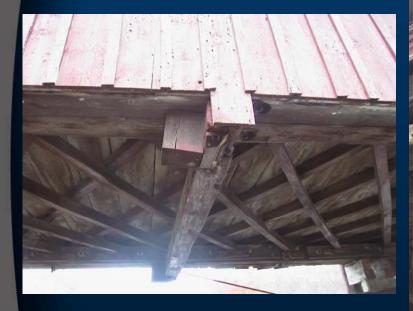
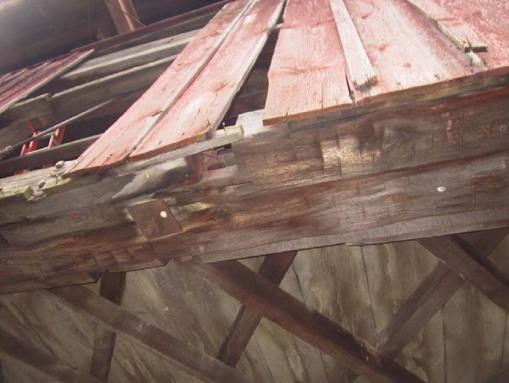
Lower tie beam / tail of truss Post Failure from compression force of truss brace

Lower Chord Location of failure

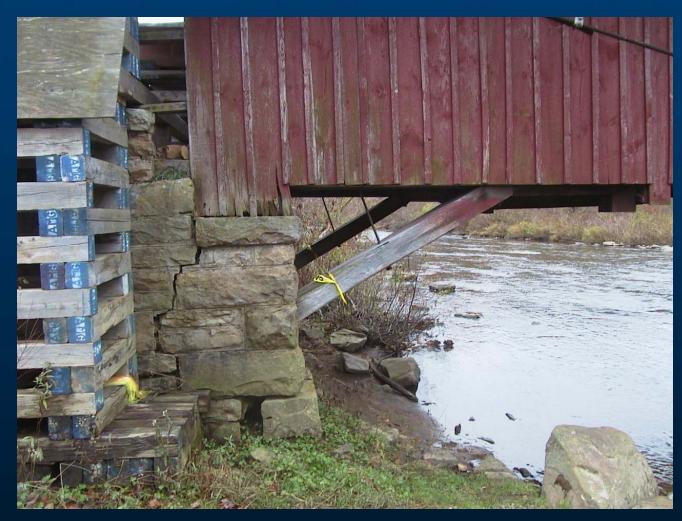
Horizontal thrust from broken chords, struts ceased to work

Bed timbers Note deformation

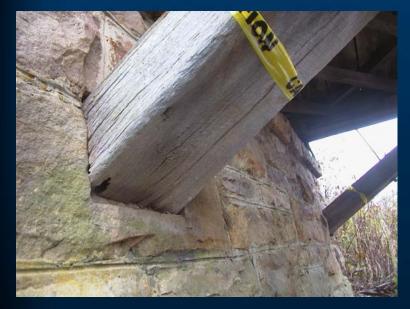
Retrofitted Struts Typical failure at seats

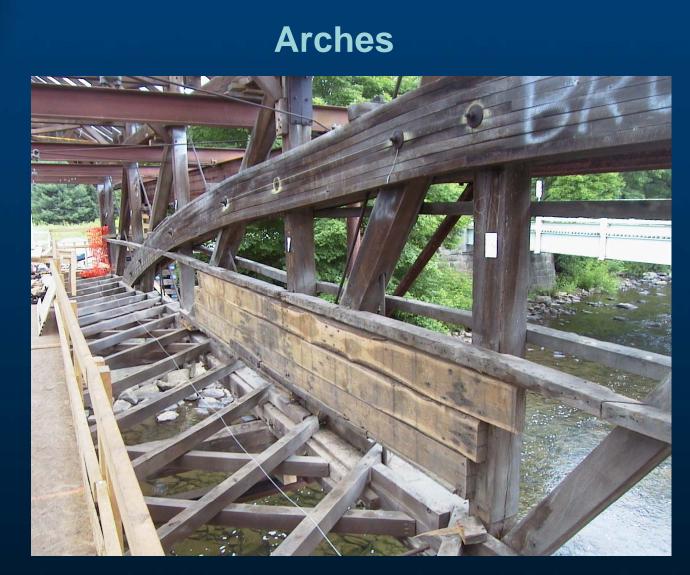
Deformation and previous interventions

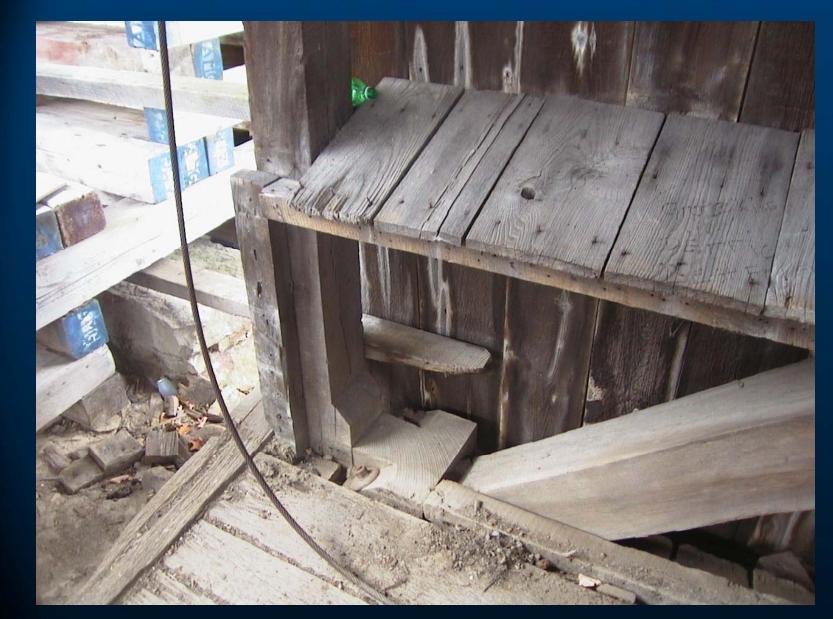
Chord – abutment seat

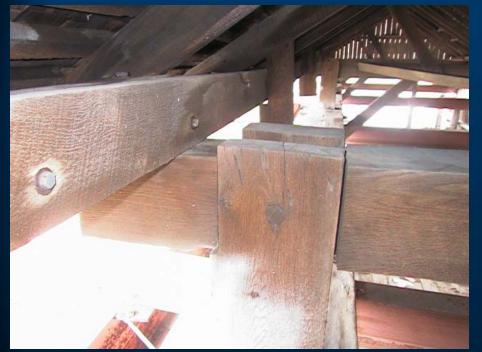
Post - upper tie beam, rafter sill Cantilevered tie beams failed where leaks occurred

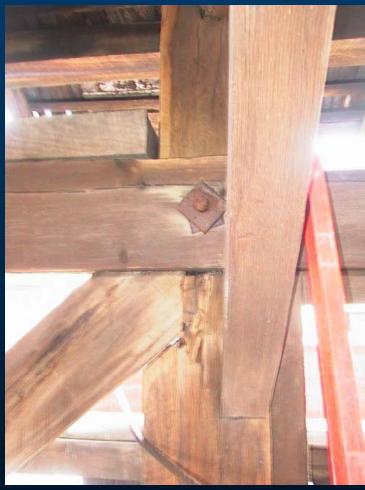
Truss Bracing water damage at truss post

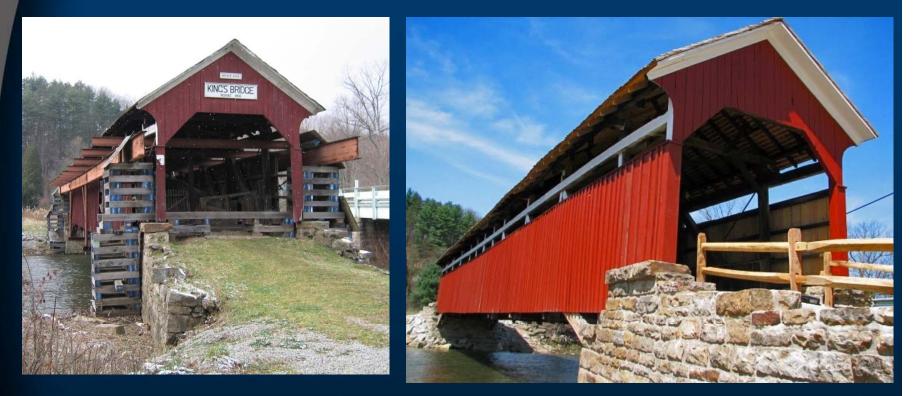
Before – stabilized

After – restored
