LANGLEY COVERED BRIDGE REHABILITATION: Practical Solutions for Rehabilitation of a Historic Covered Bridge

National Covered Bridge Conference

Dayton, Ohio, June 7, 2013

by Thomas E. Nehil PE, Principal, Nehil•Sivak PC

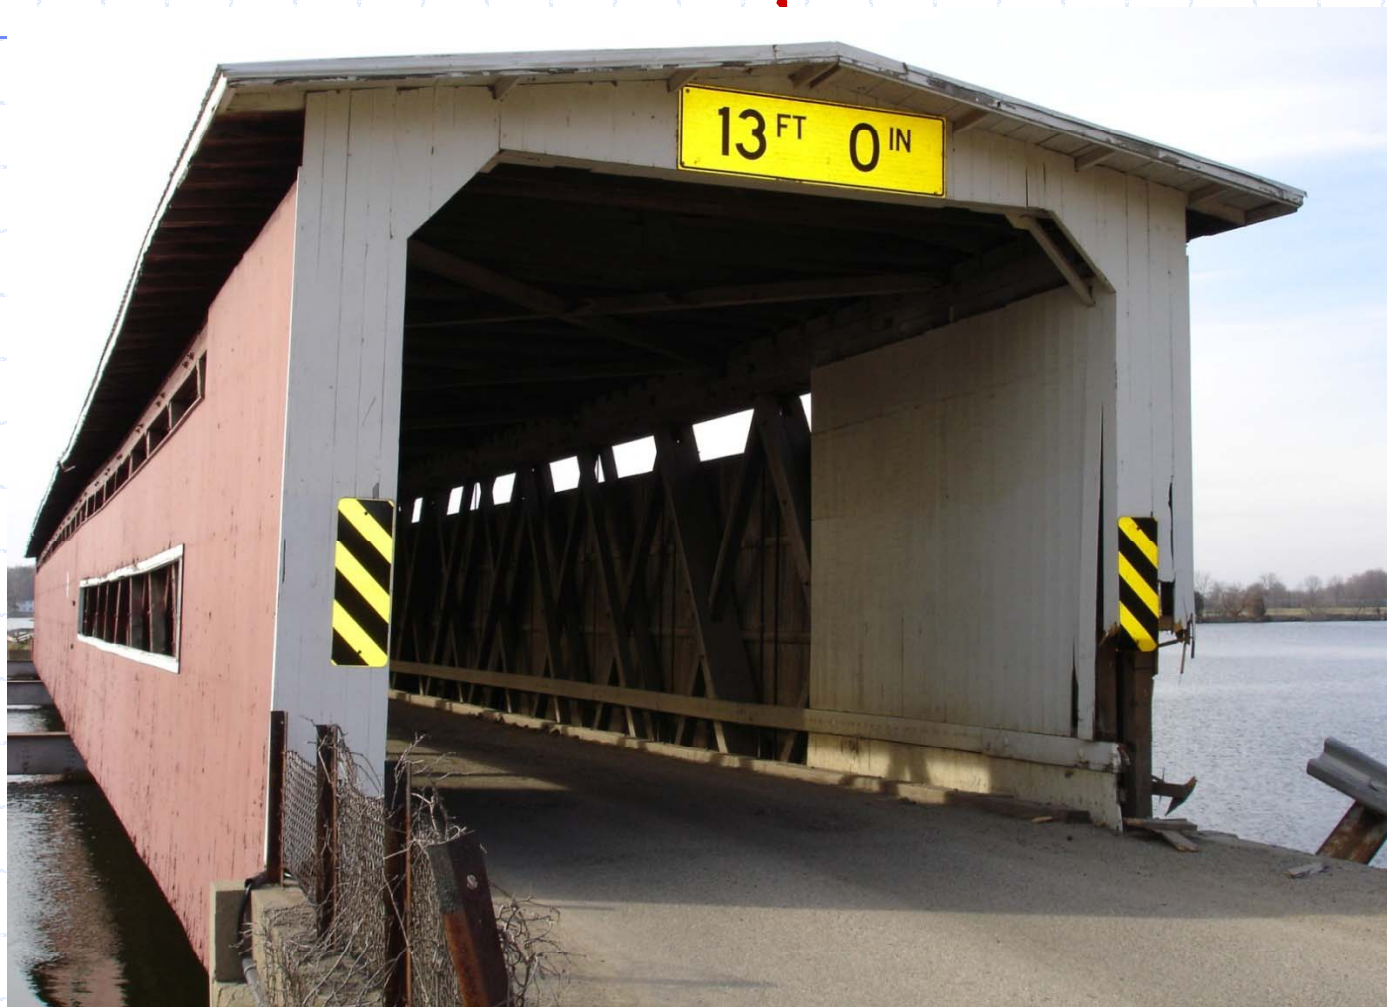
Recent Vehicle Impact

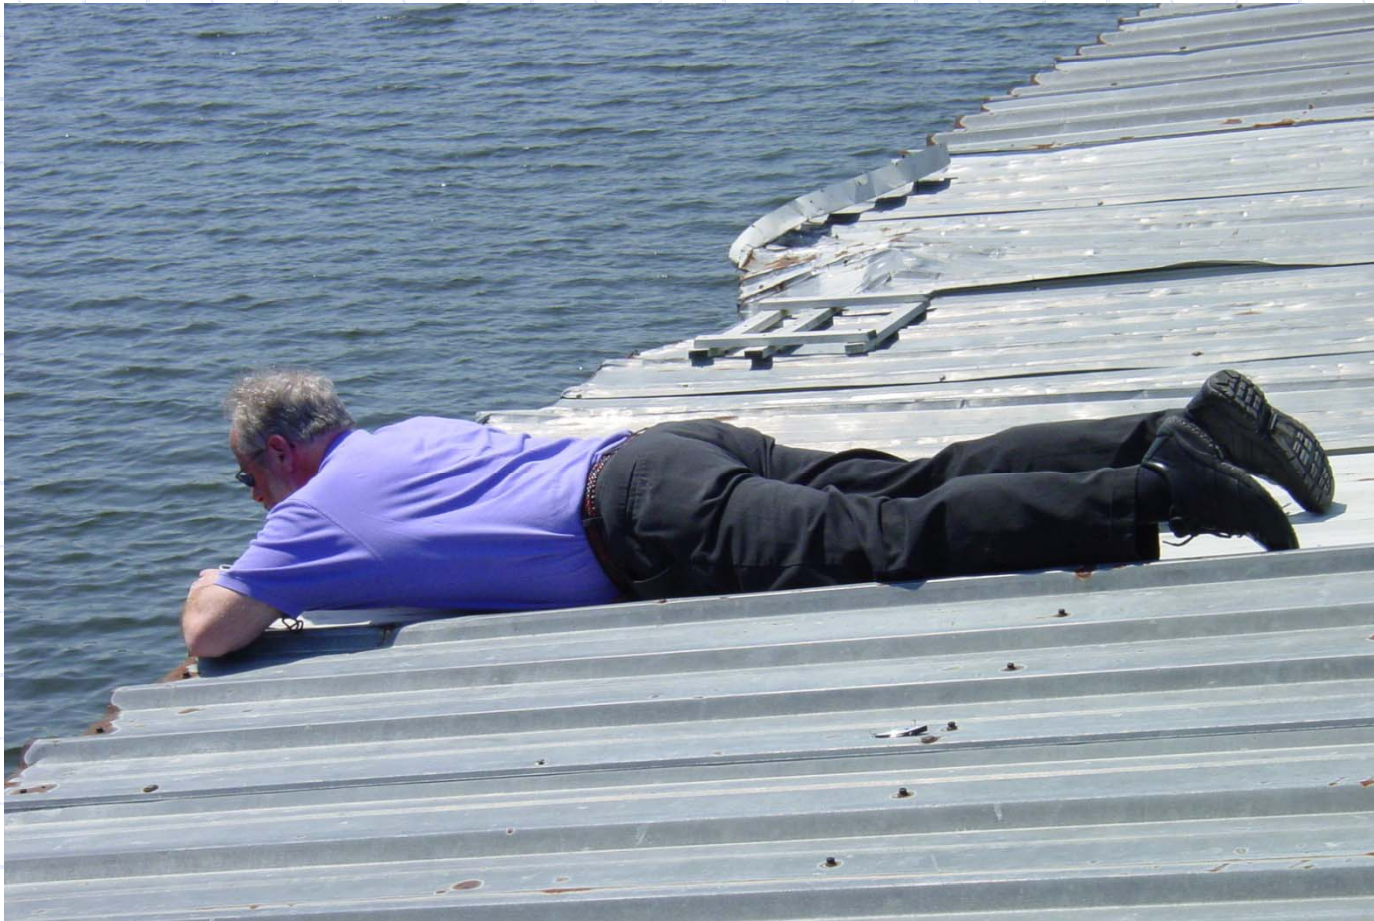
Issues with roof: framing and covering

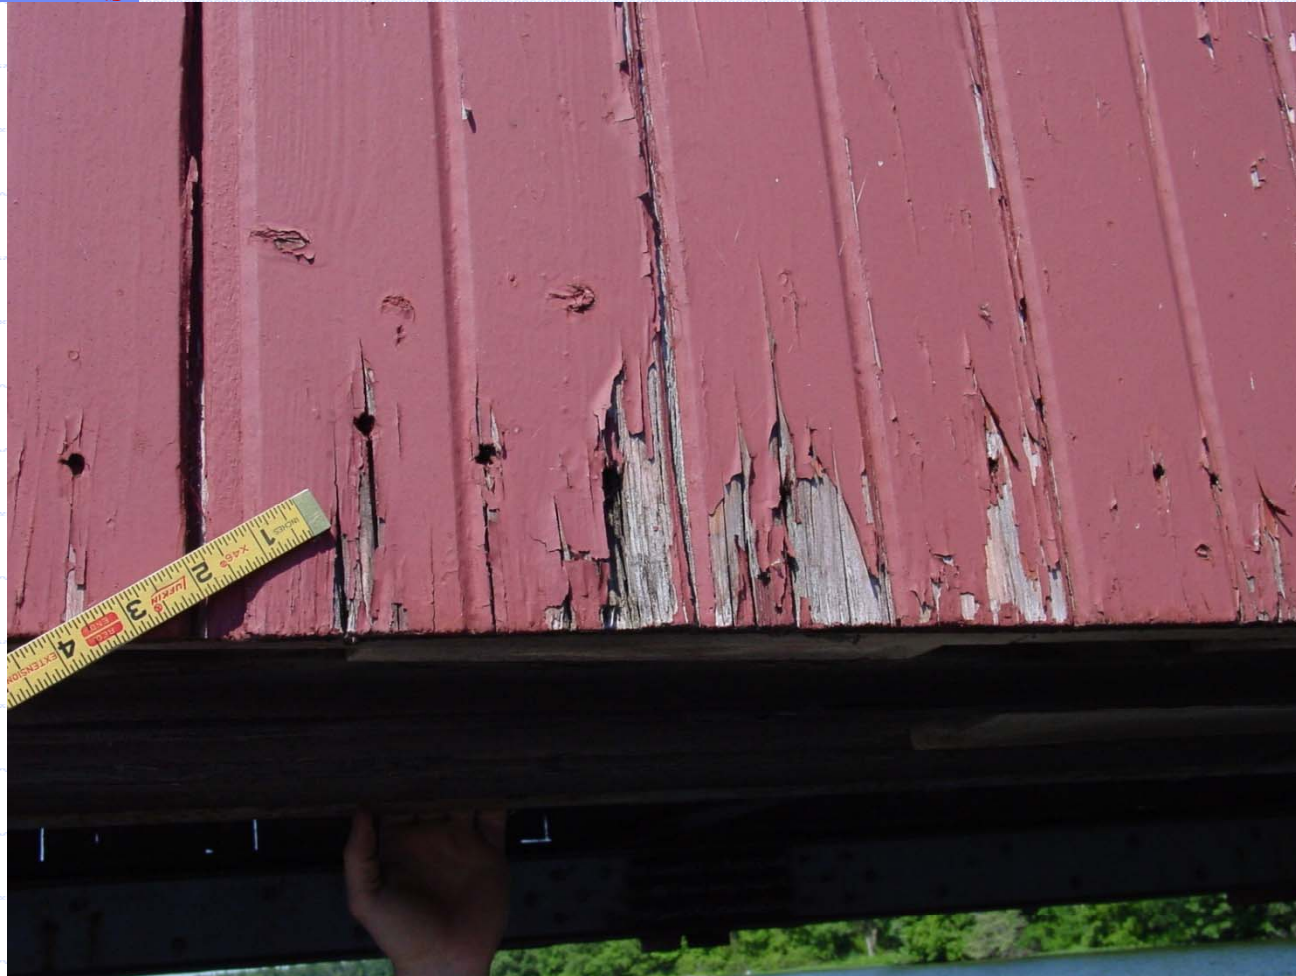
Issues with siding: rot, lead paint peeling into the river

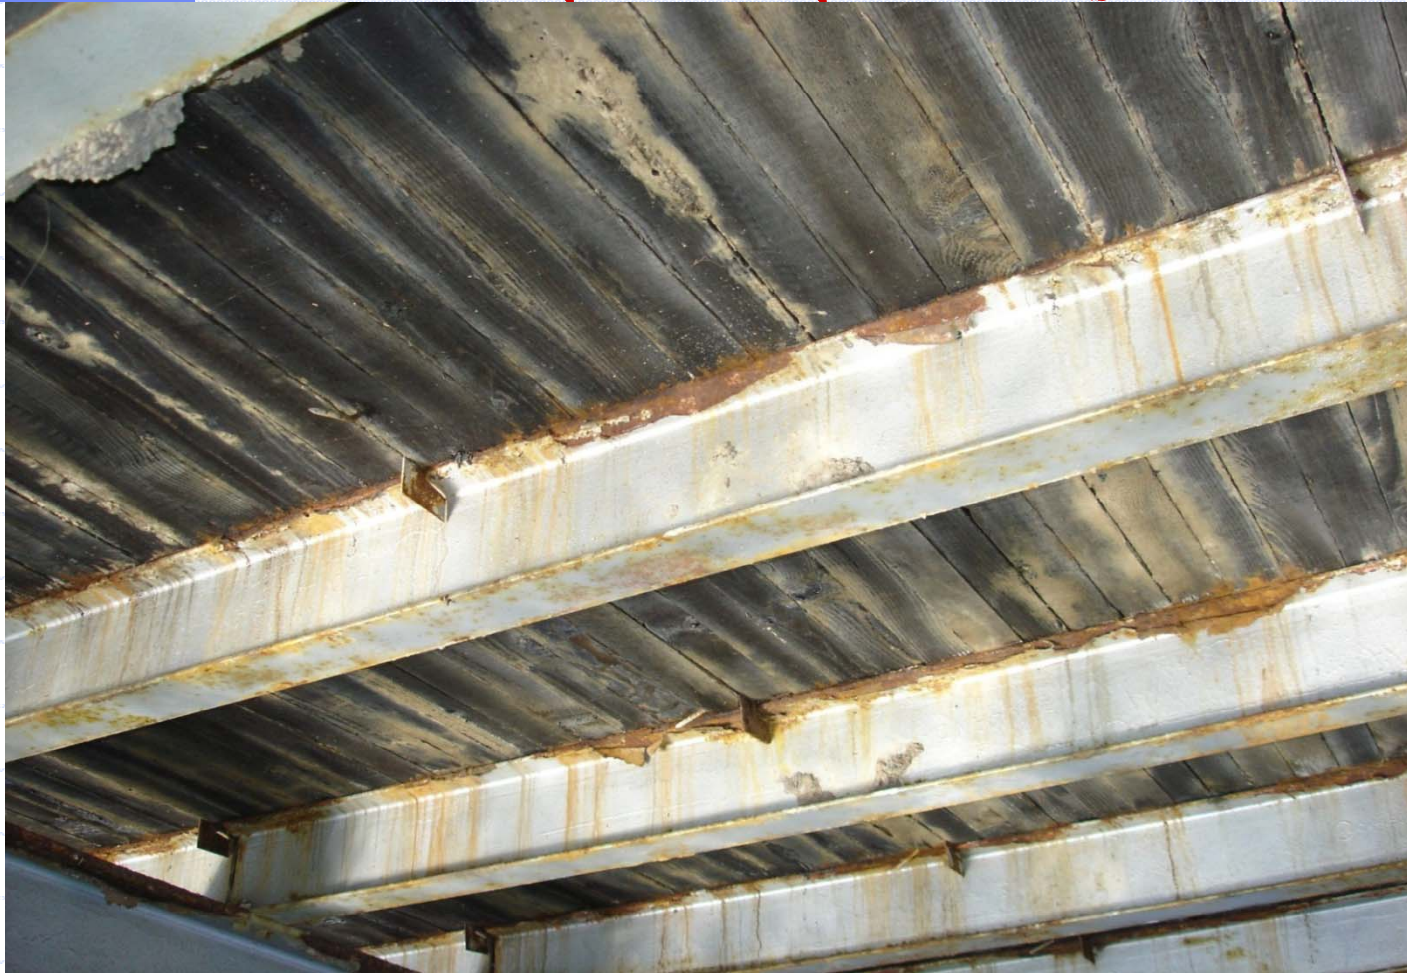
1950s steel deck framing,
corroded, lead paint peeling

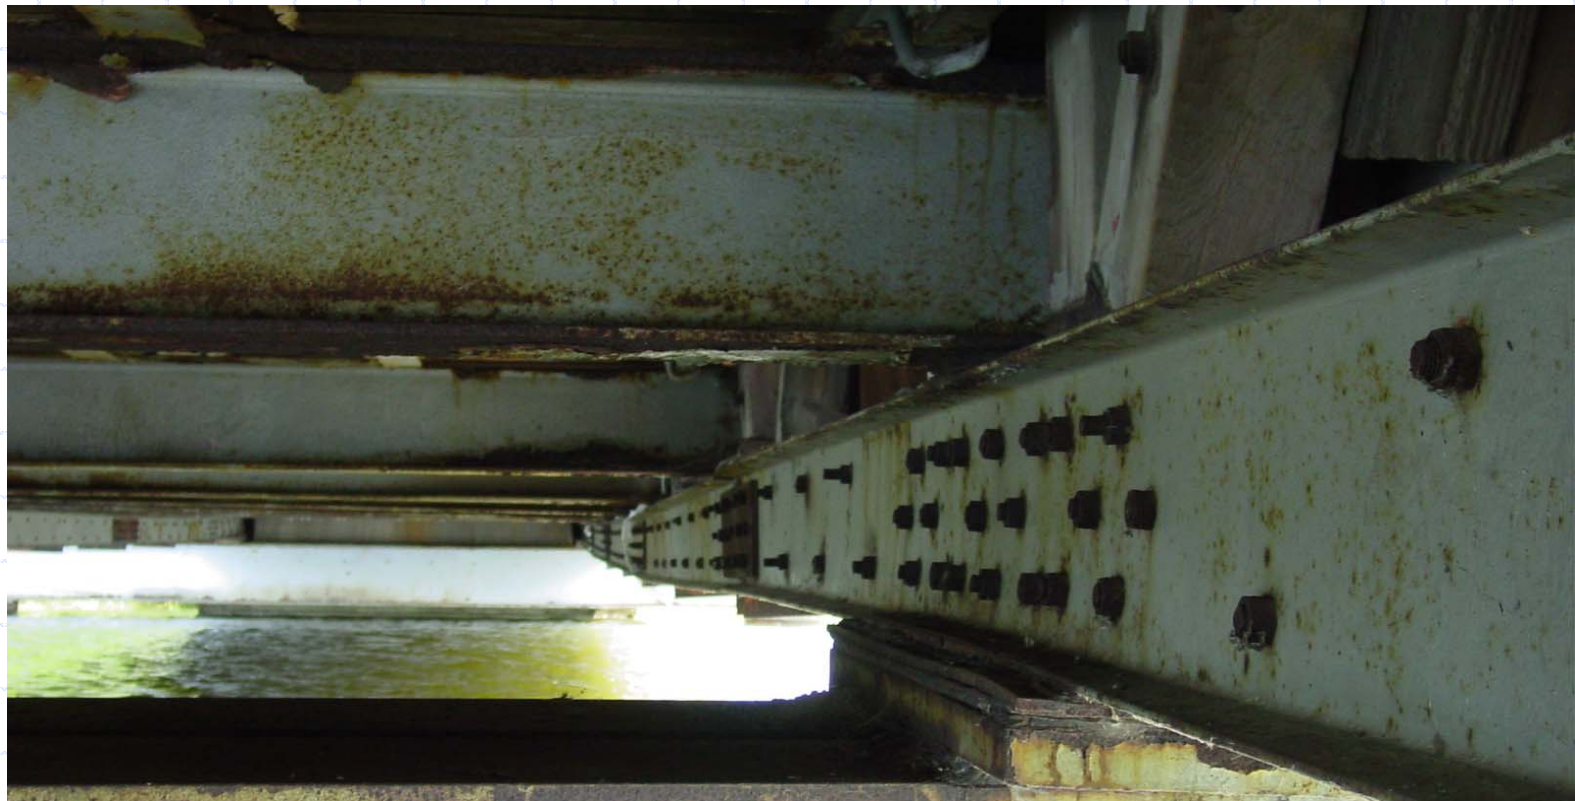
Truss bottom chord reinforcing corroded, south span sagging

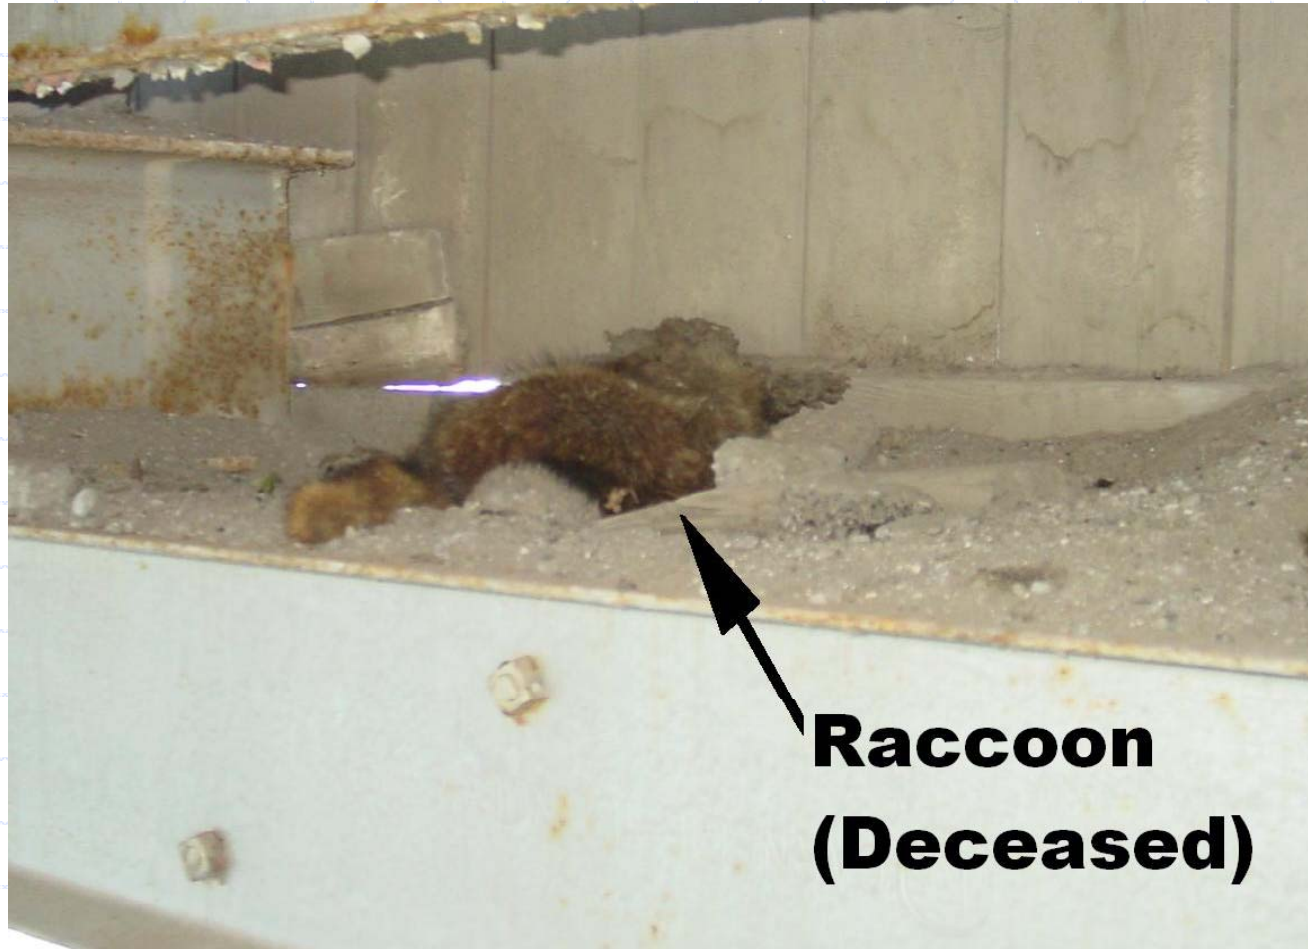
Rotting of bottom chord

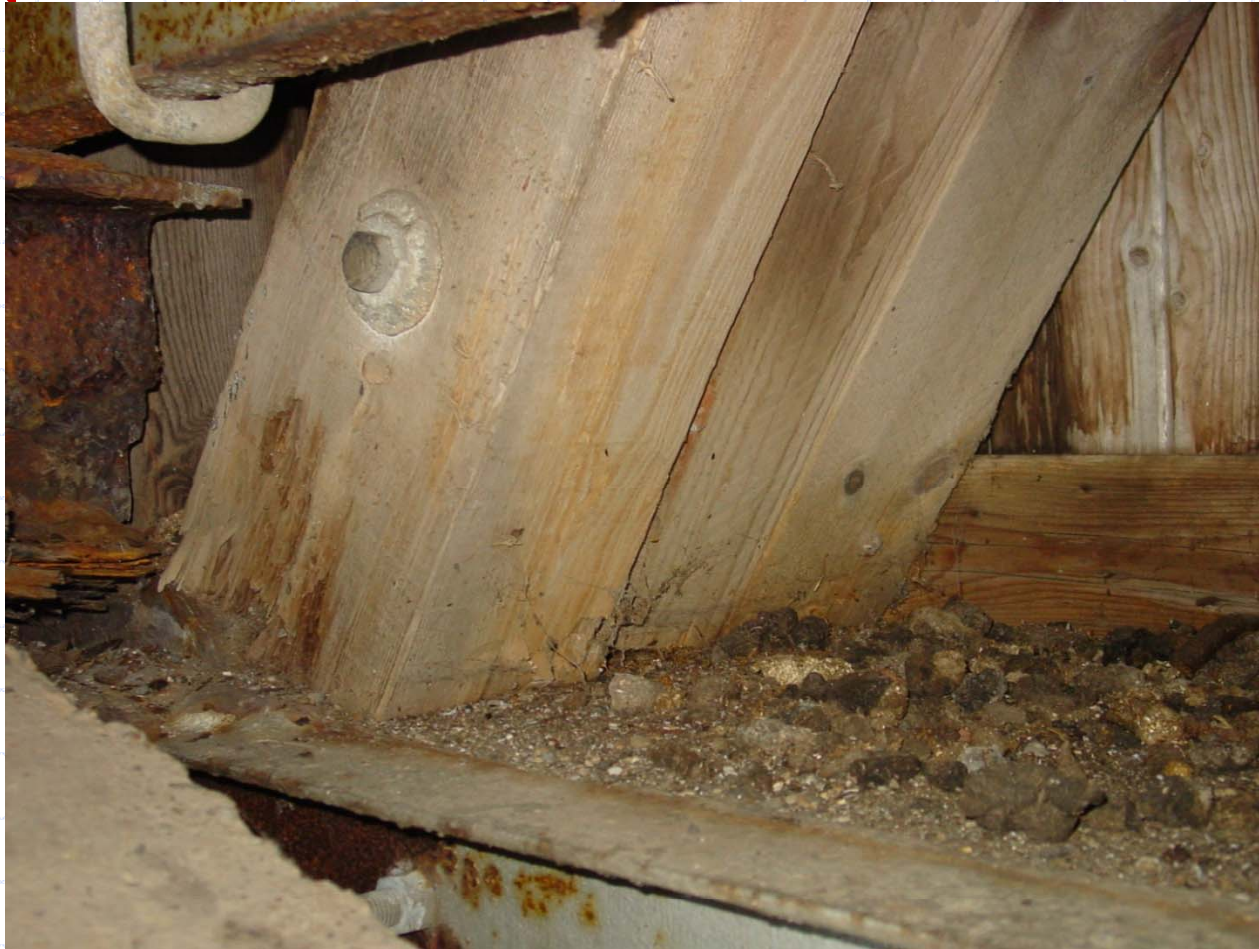
Rotting and crushing of compression diagonals

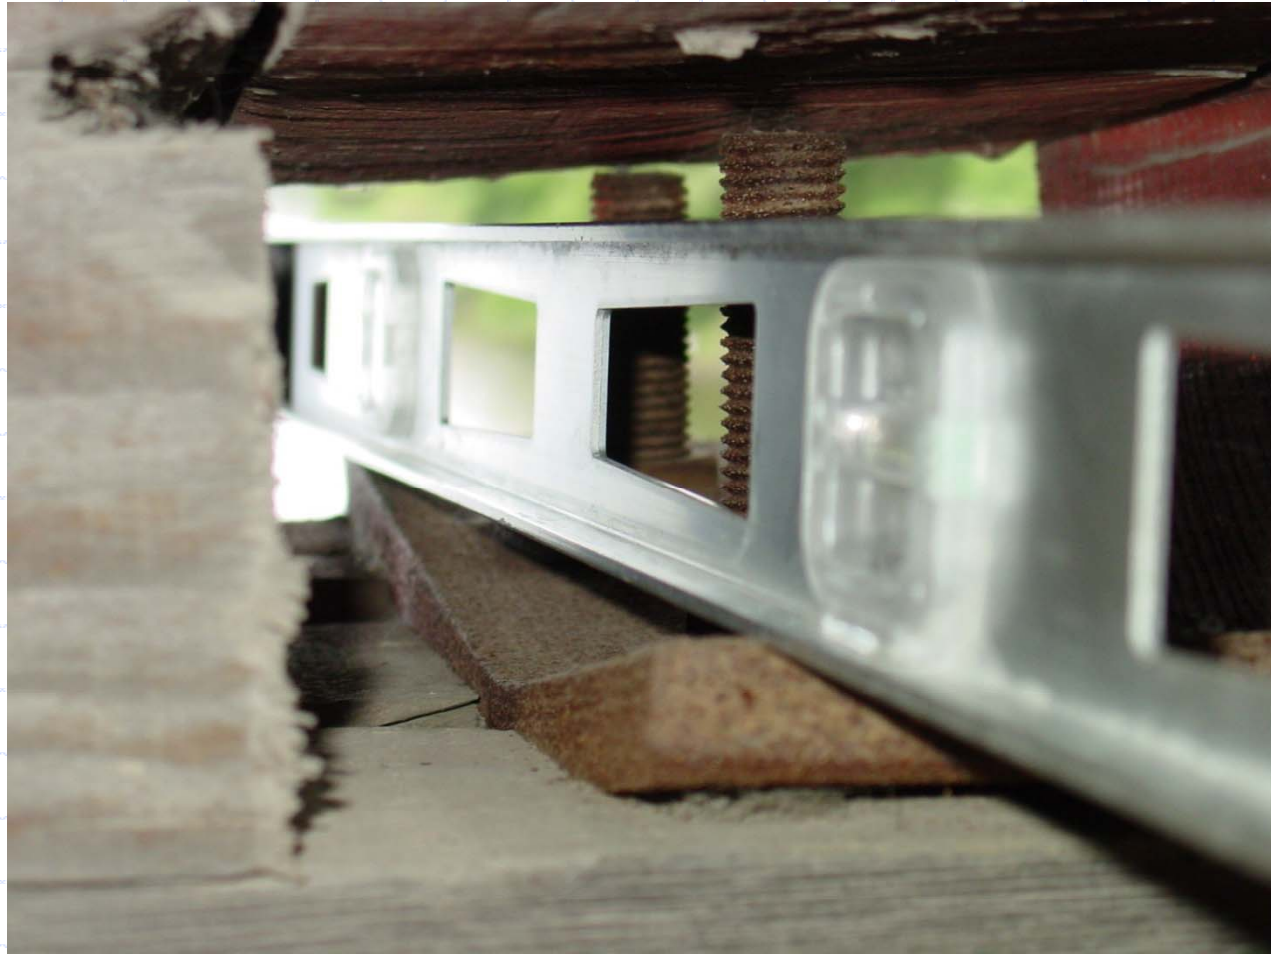
Crushing of tension rod bearings, at top chord...

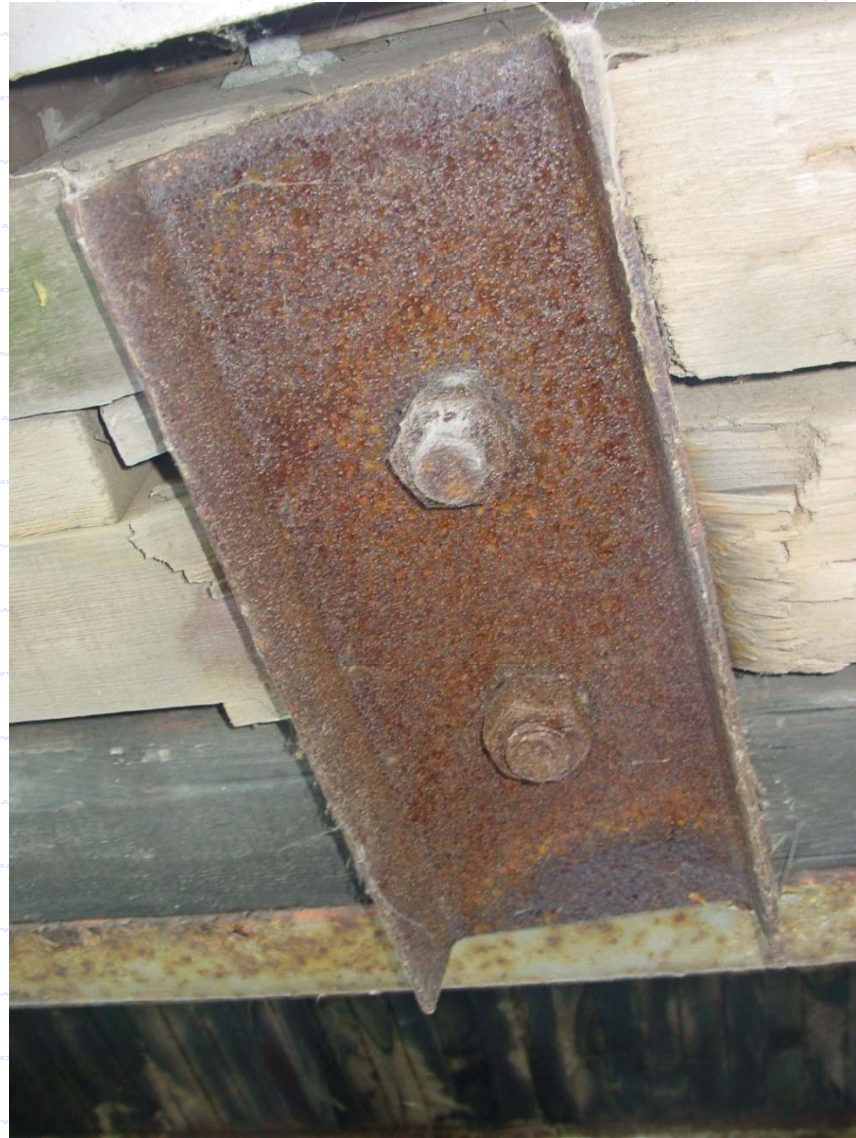
And bottom

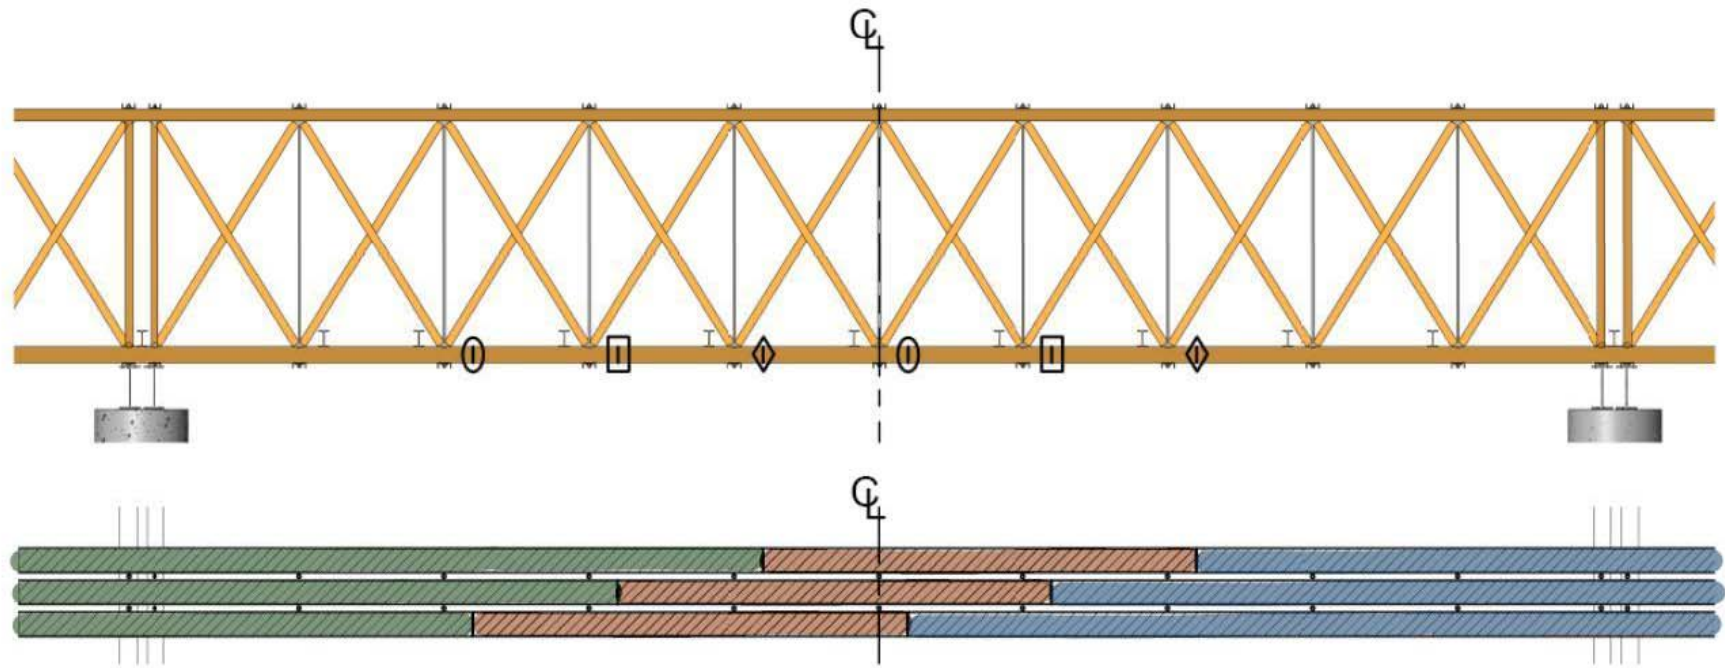
Bottom chord splice locations

- ◆ Max bottom chord tension on gross area of timbers appeared acceptable
- ◆ But tension chord members were spliced in original construction

- ◆ Evaluate tension on net area and shear parallel to grain in the timbers and fishplates, and compression on the bearing surfaces
- ◆ To support wagon loads, need 13,000# of load transfer through each fishplate if we rely on them alone to do the job

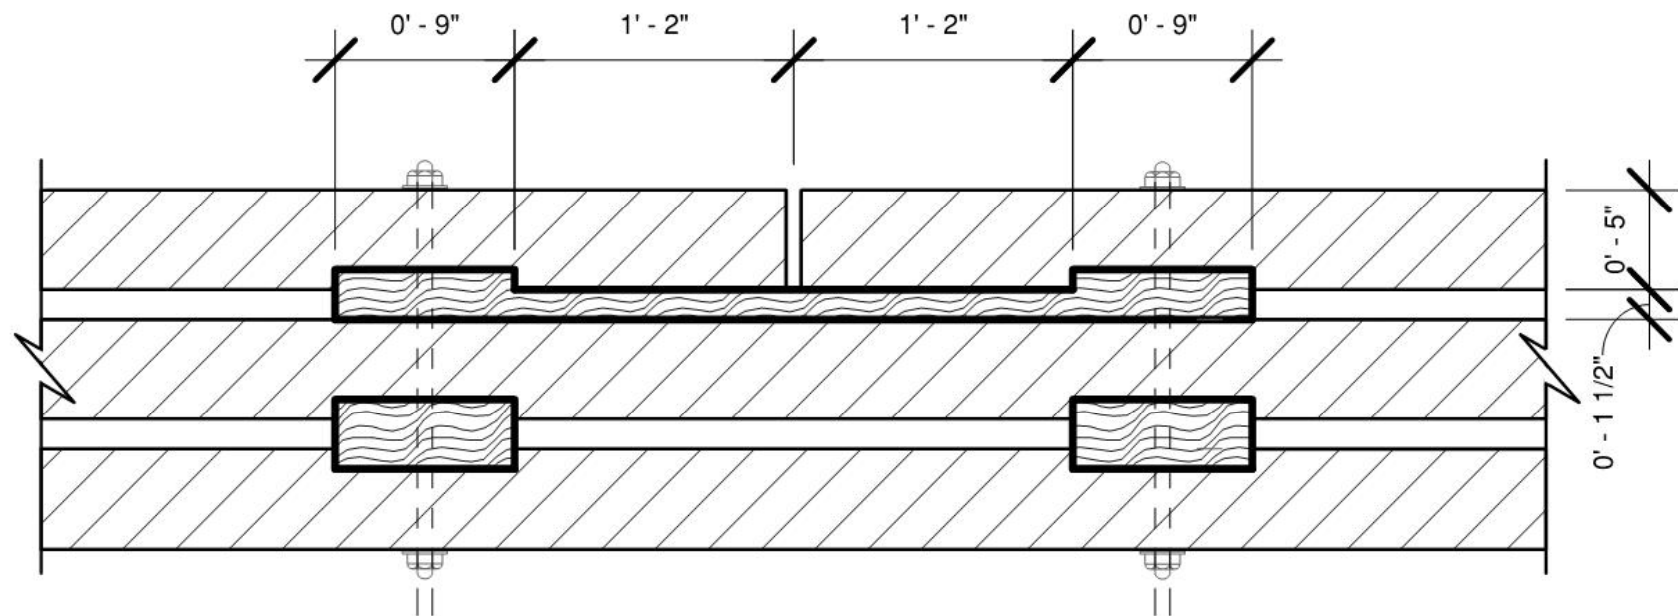
Fishplate detail

- ◆ Per current code limits on bearing stress, bottom chord fishplate capacity is 5,200#, not adequate even to carry self weight of bridge
- ◆ Might then assume all tension carried by remaining two laminations (ref S. Patrick Sparks, APT Journal 2005), but they too are spliced
- ◆ Need to consider development of tension capacity of bottom chord as a whole, all three laminations

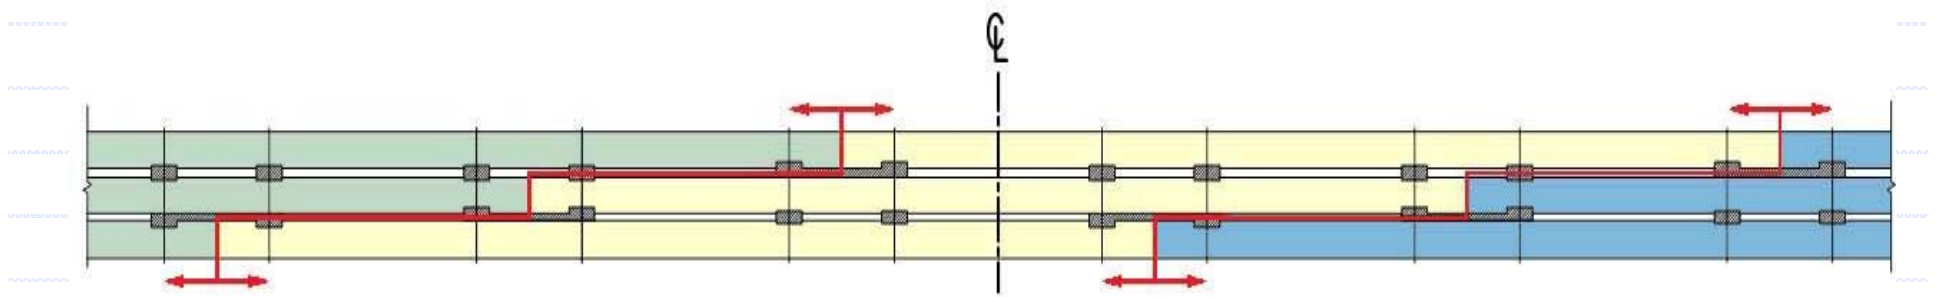
The weak links

- ◆ Four bearing surfaces and one or two bolts in single shear at critical path
- ◆ Total capacity = 26,000 # per current NDS, including C_d and $0.75 F'_c$ limit
- ◆ (or 33,000# per pre-2001 NDS)
- ◆ Acceptable for wagon loads, not H15 on trusses with deteriorated and cobbled chords

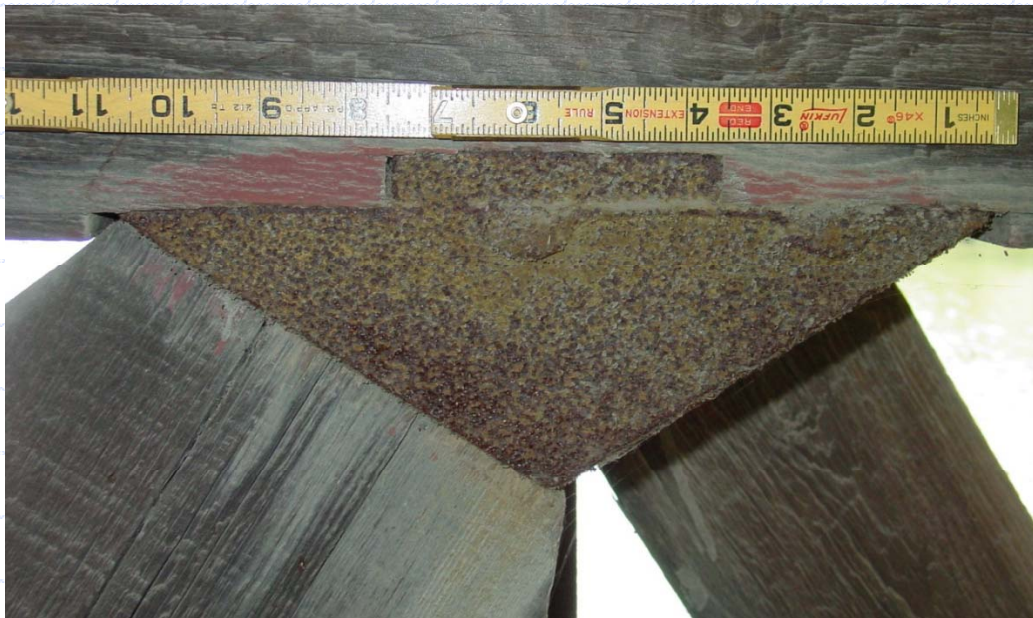
Load paths at castings

- ◆ Max vertical = 31 k, $f_c = 200$ psi (wagons)
- ◆ Max horizontal component = 18 k
- ◆ $f_{c//}$ on lug bearing surface = 1950 psi! but $F'_{c//}$ for EWP SSP&T = 834 psi

- ◆ In recent times, max horizontal load carried may have been = 28k, so $f_{c//} = 3000$ psi
- ◆ Tension rods don't bear on wood, no dowel bearing to help out
- ◆ Friction?
- ◆ Is C_D of 1.15 too conservative?
- ◆ Confined $f'_{c//} = 3000$ psi, » 800 psi?

No action taken

- ◆ Had supported higher loads in the past without damage
- ◆ Ductile failure mode

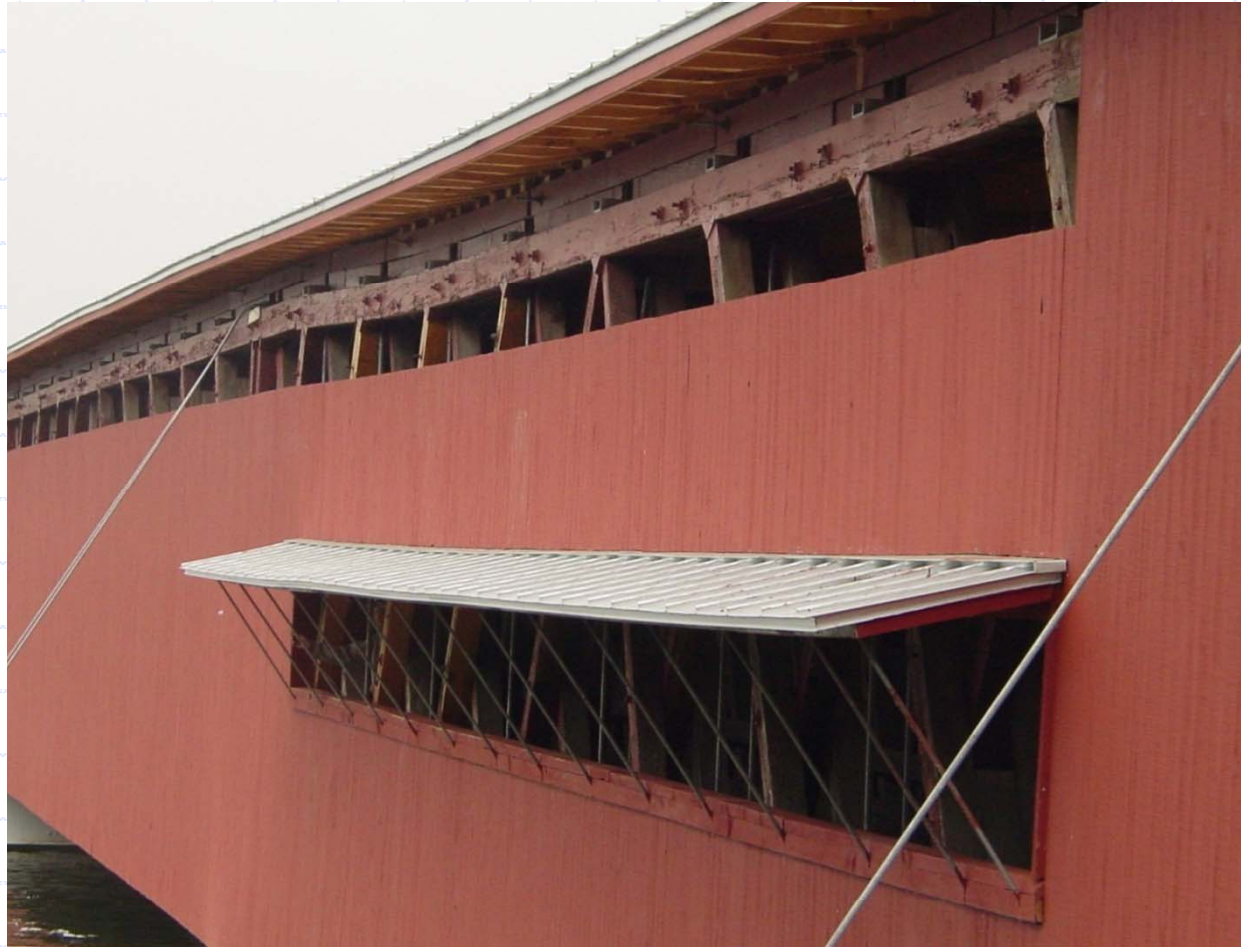
Sag didn't get removed

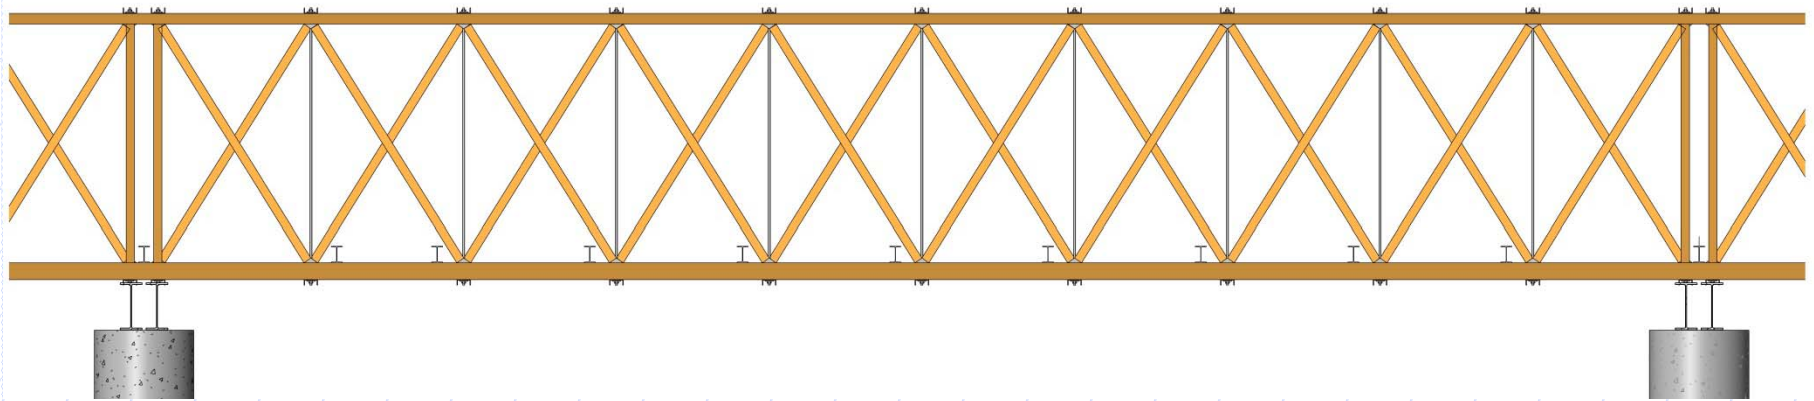
- ◆ Was prestressing the original concept? Can it practically be maintained?
- ◆ We found almost all to be loose; they don't brace the compression diagonals out of plane
- ◆ Assembly requirement only?
