PCC Rehabilitation US 30 in Denison

Shane Tymkowicz

November 28, 2018

Municipal Streets Seminar

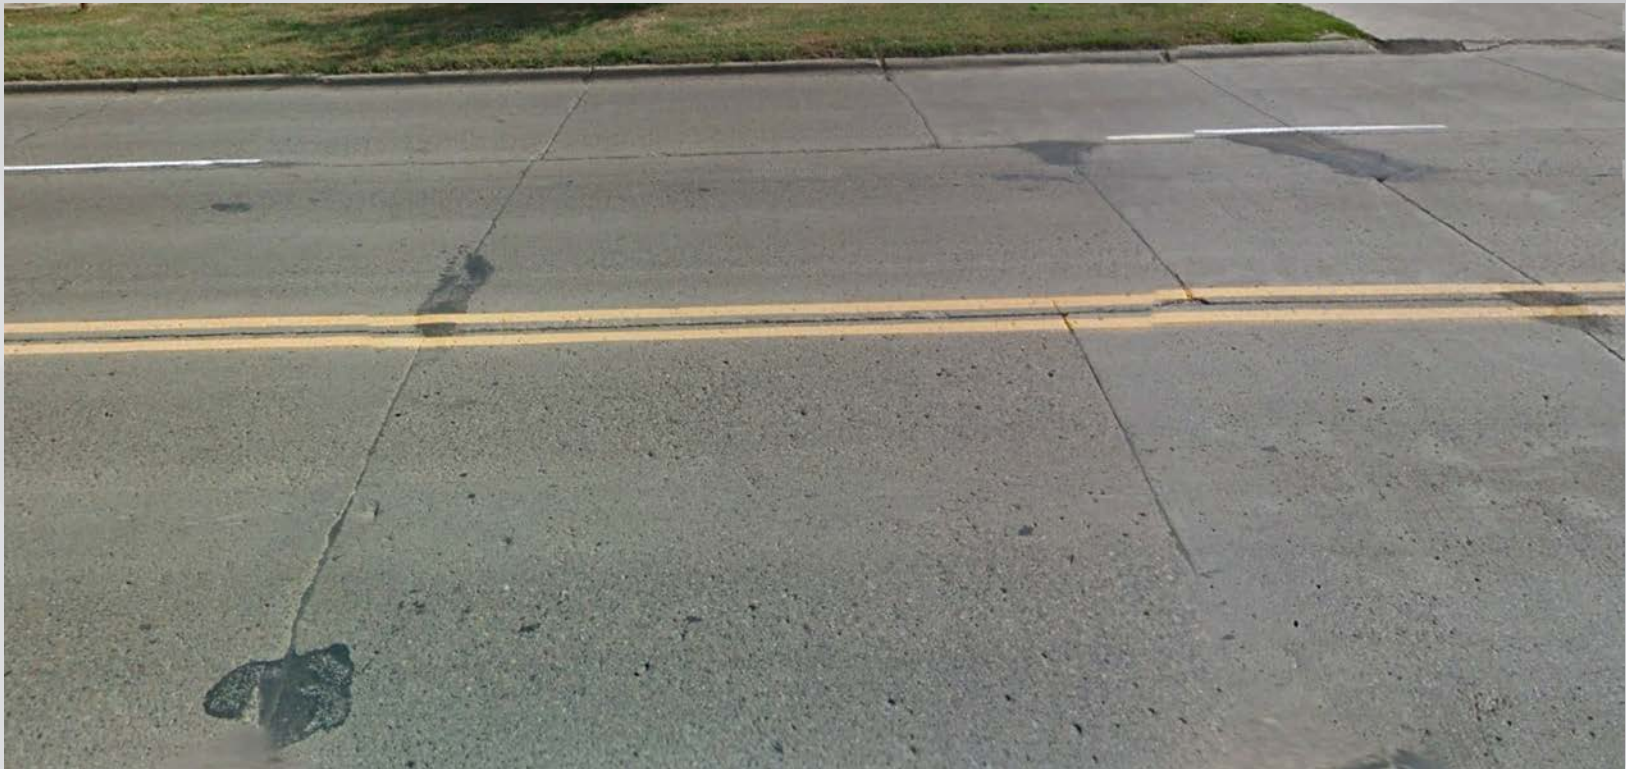
Pavement Condition

- Joint Spalling
- Corner Cracks
- Low Friction
- Lots of Good Slab
- Durable Aggregate
- Past Patching

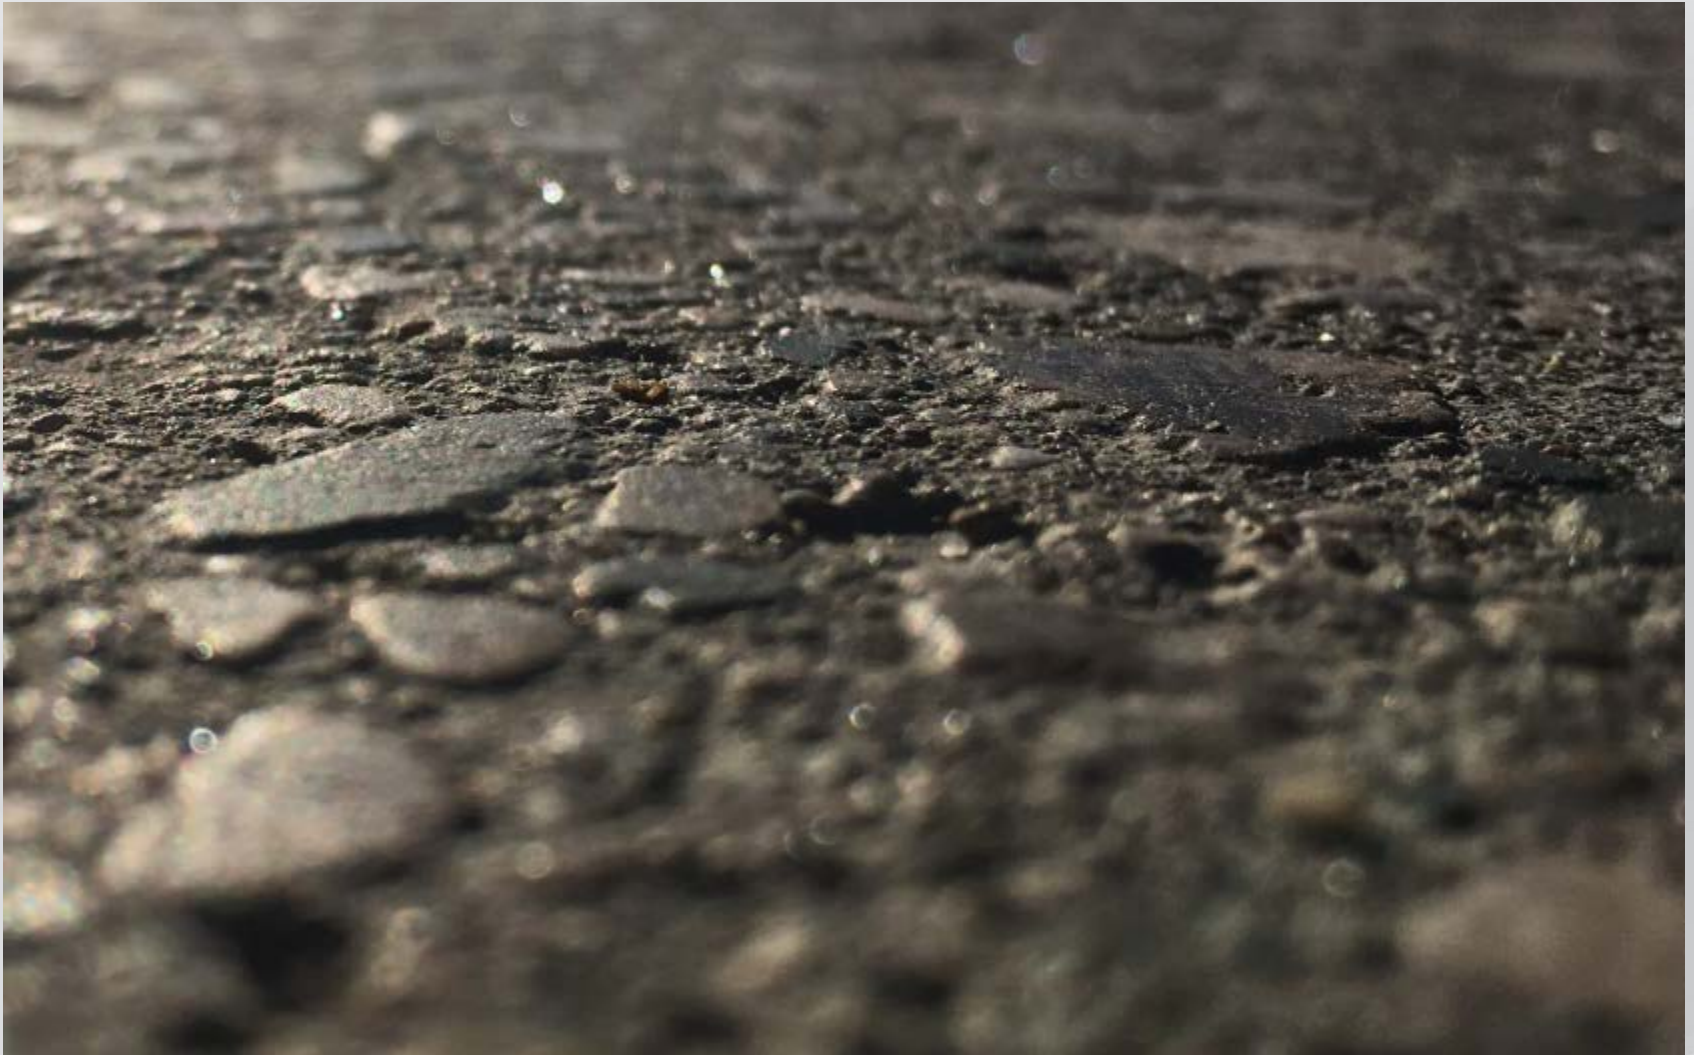
Low Friction/ Polished Aggregate

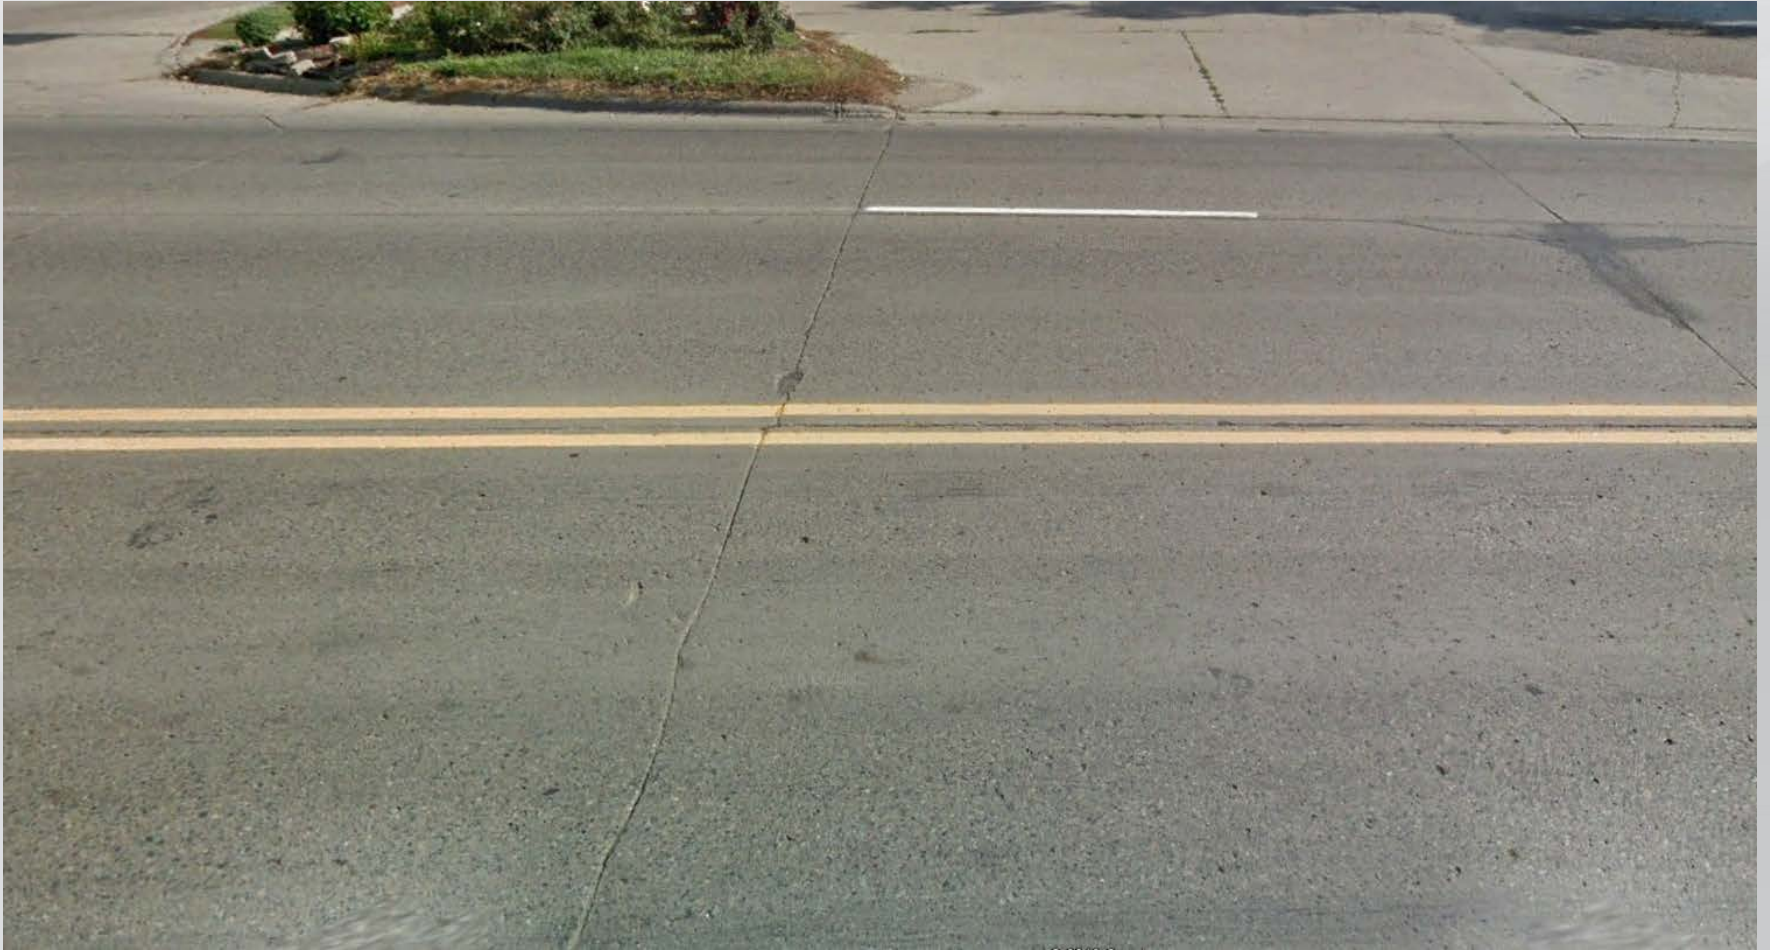
Pavement Condition

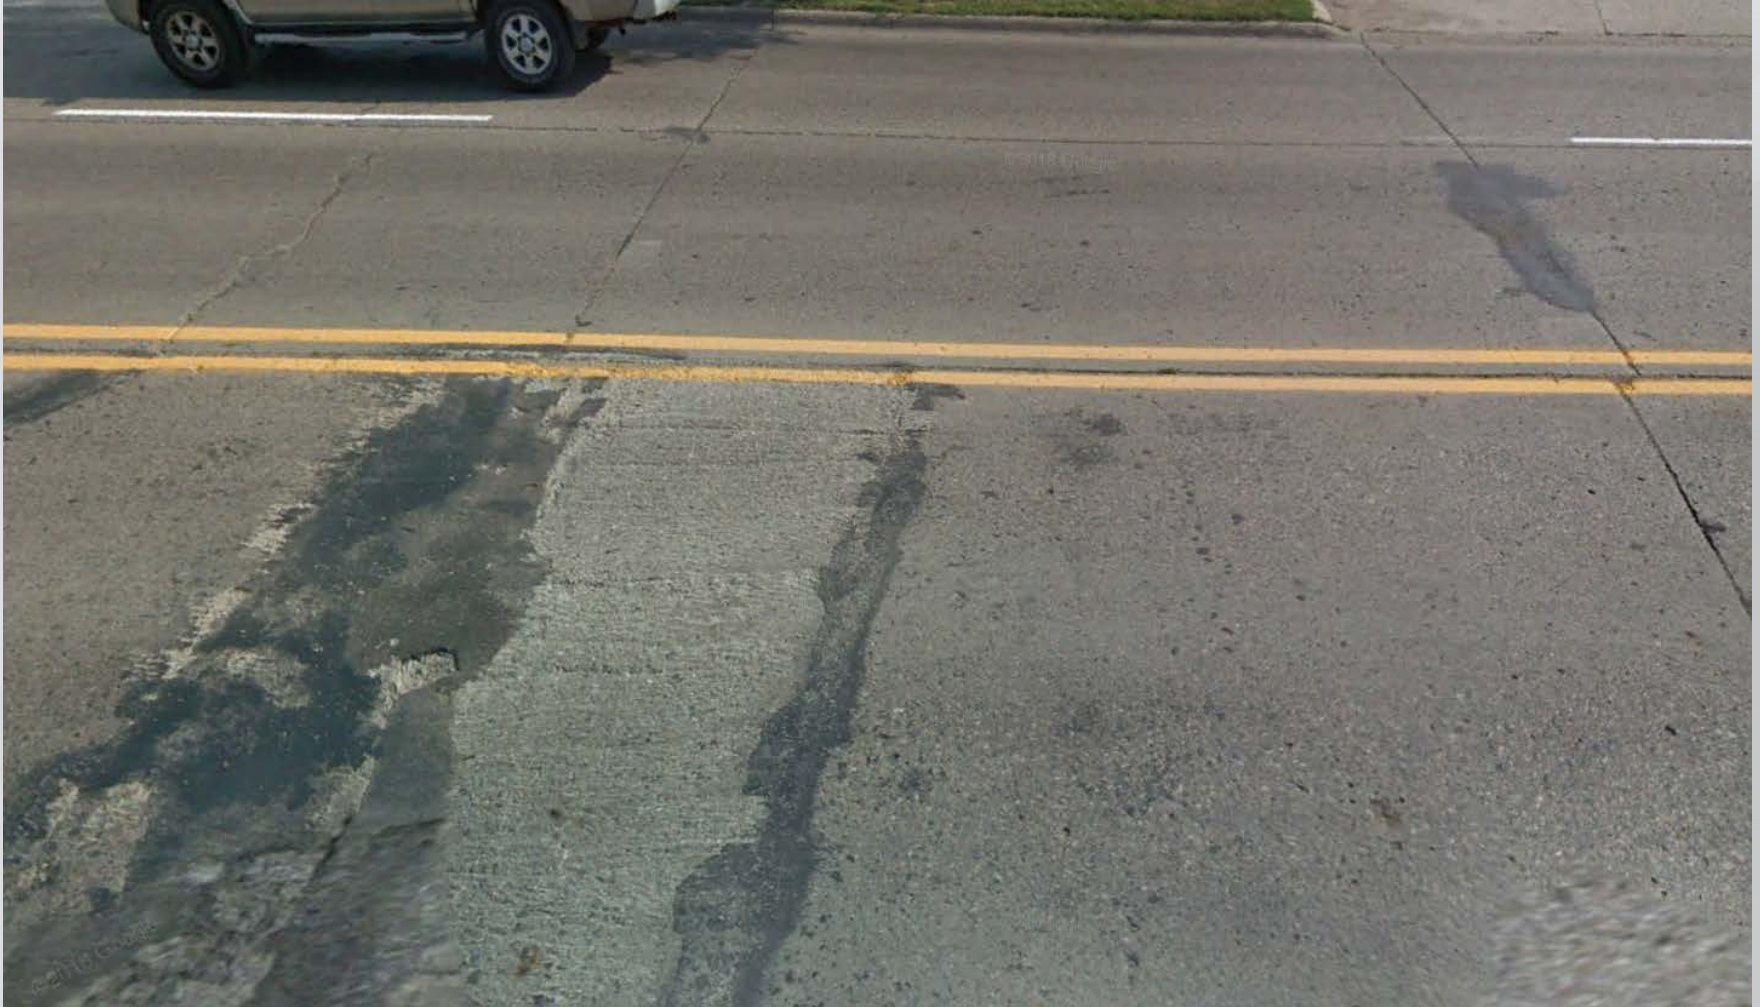
Pavement Condition

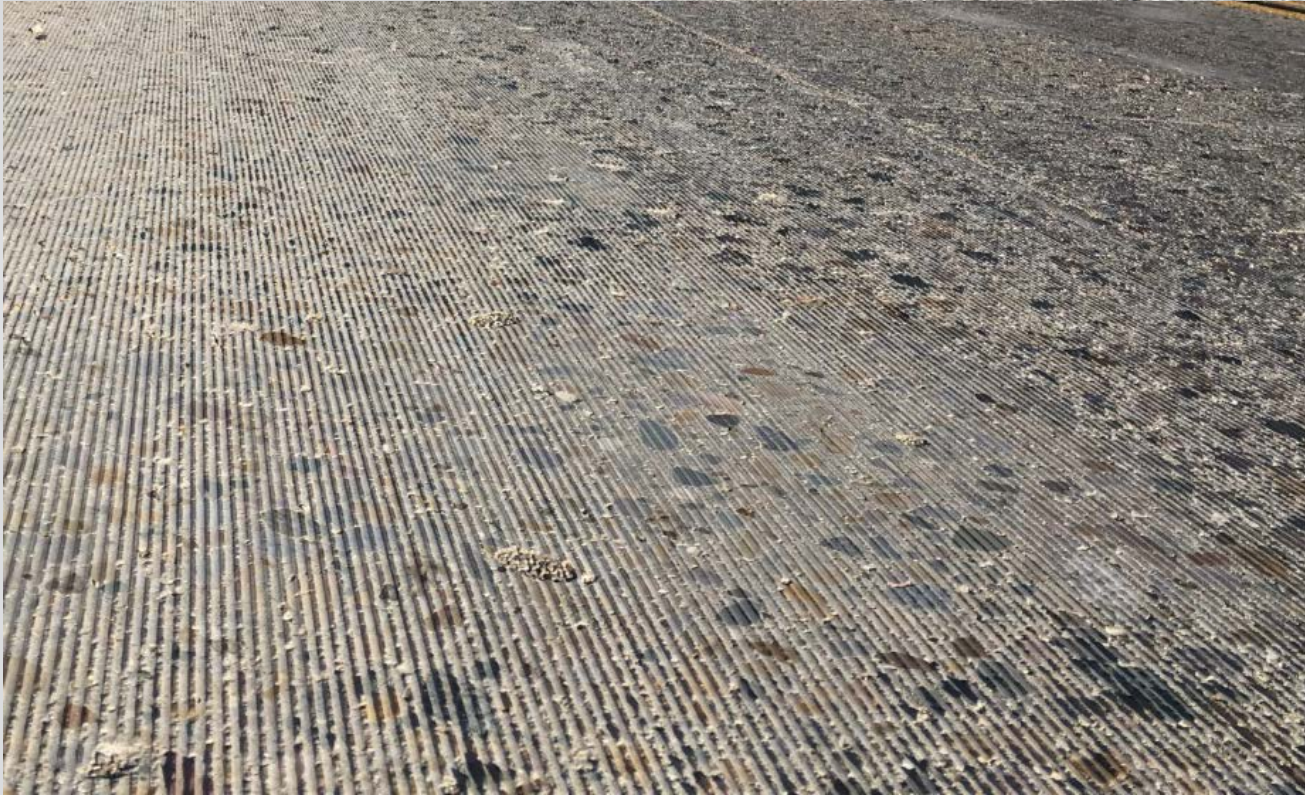
Pavement After Grinding

- IRI Before – 294.8 inches/mile
 - Note 2017 Data was 277 inches/mile
- IRI After – 116.7 (115 < 45mph)
 - Intersections & Drainage
- PCI Before – 18 (Very Poor)
- PCI After* - 87 (Good)
