Road Safety Assessment for the Intersection of Olentangy River Road and Linworth Road in Franklin County, Ohio

Final Report November 2009

This road safety assessment was conducted and supported by the Office of Safety, Federal Highway Administration through the Road Safety Audit Peer-to-Peer Program

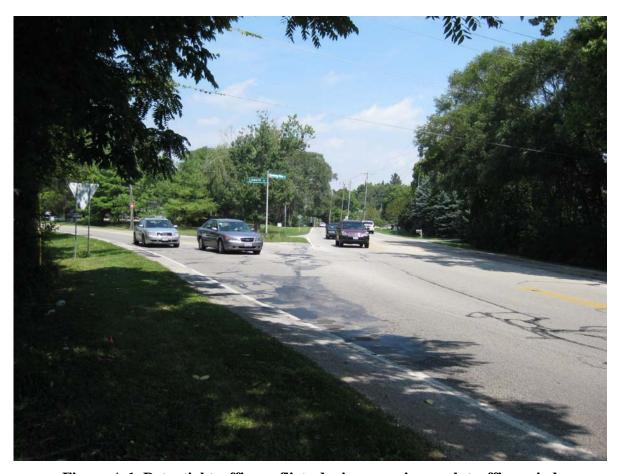
Figure A.1. Potential traffic conflicts during morning peak traffic period

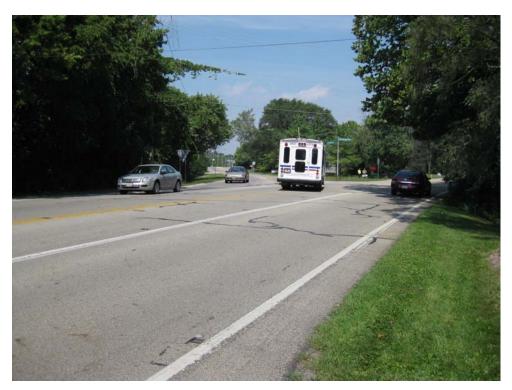
Figure A.2. Transit vehicle in intersection

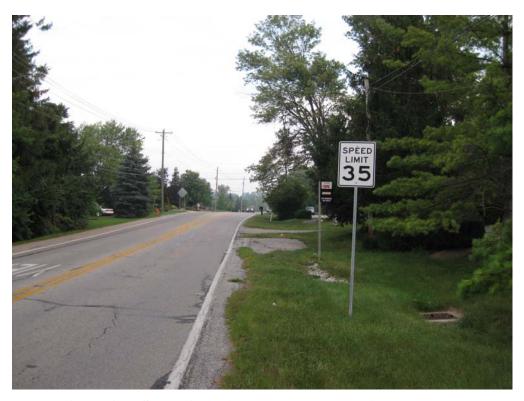
Figure A.3. Speed limit sign on northbound Linworth Road

- Check the location of posted speed limit signs and reposition as needed to better meet driver needs and expectations. Consider additional speed limit signing along southbound Olentangy River Road approaching the intersection.

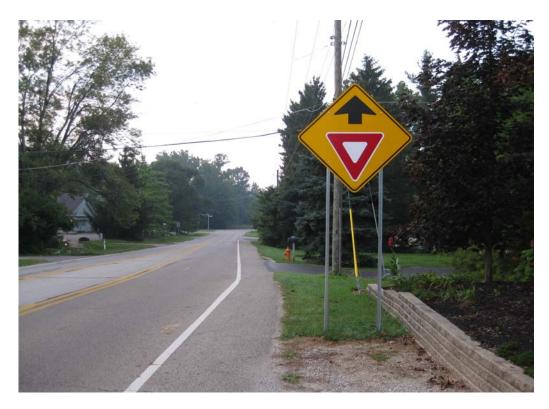
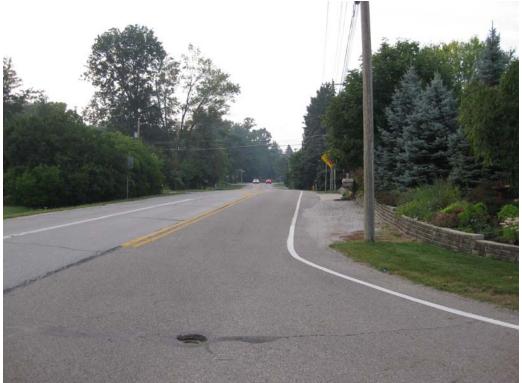
Figure A.4. Advance YIELD sign on southbound Linworth Road, hampered by vegetation

- Upgrade existing signing and pavement markings and trim vegetation to improve visibility. The assessment team concluded this is a viable option for consideration, and more extensive low-cost improvements will be discussed below.

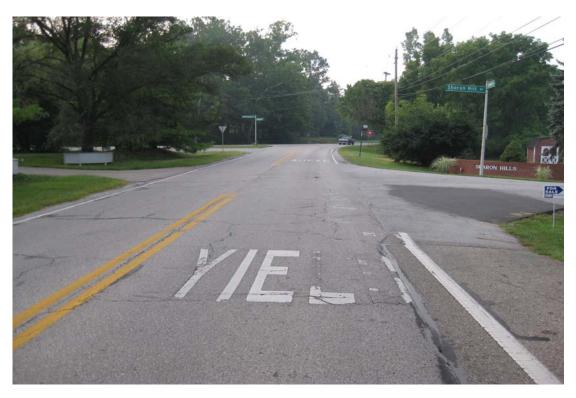
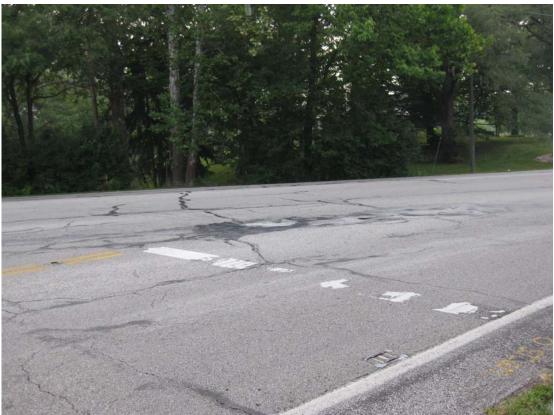
Figure A.5. Pavement markings on southbound Linworth Road

- Install stop bars and YIELD symbol pavement markings at all appropriate existing traffic control device locations in the intersection. Mill markings into the pavement surface to extend longevity.

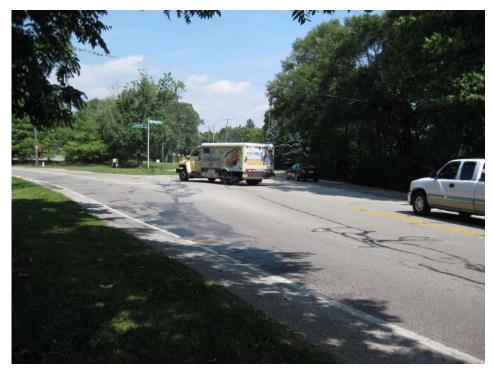
Figure A.6. Use of left-turn storage lane from northbound Olentangy River Road

- Upgrade all pavement markings and install arrows and/or ONLY symbols in the left-turn lane for northbound Olentangy River Road.
- Install a dotted pavement edge line through the intersection for southbound Olentangy River Road.

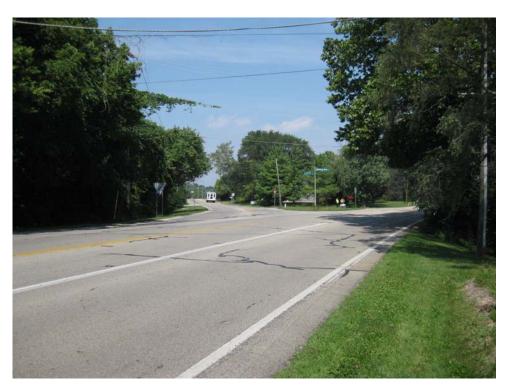
Figure A.7. View of intersection from southerly approach on Olentangy River Road with left-turn storage lane

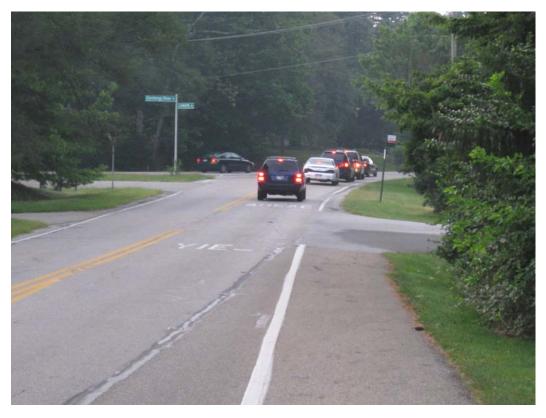
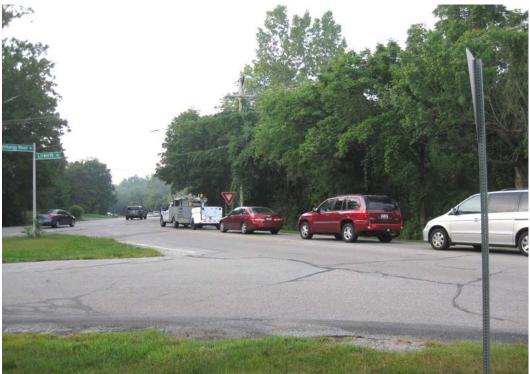
- Replace YIELD sign on southbound Linworth Road with a STOP sign. The team would not recommend this option because driver performance most likely would not improve perceptibly and a STOP sign would result in queue build-up during morning rush hour on southbound Linworth Road, as observed by the team.

Figure A.8. Queue build-up on southbound Linworth Road during morning peak period traffic

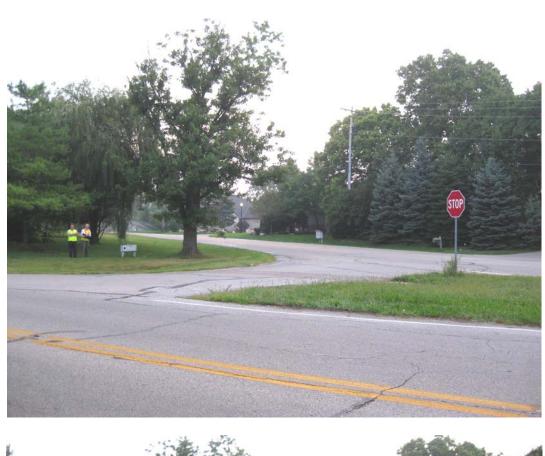
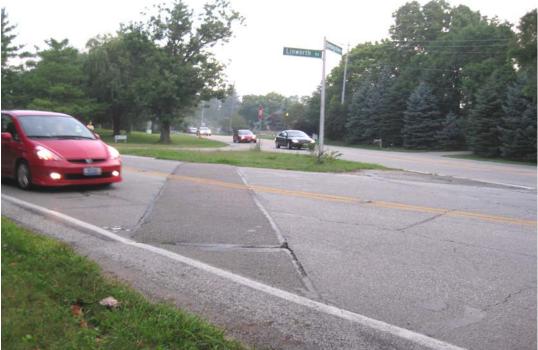
Figure A.9. View of southbound Olentangy River Road from southbound Linworth Road, hampered by trees

- Remove the existing large maple tree on the north side of the intersection that hampers driver sight distance from the YIELD sign on southbound Linworth Road.

- Negotiate with the property owner for trimming or removal of other trees that hamper visibility on the property just northerly from the intersection, including a weeping willow, a Siberian elm, and pine trees.

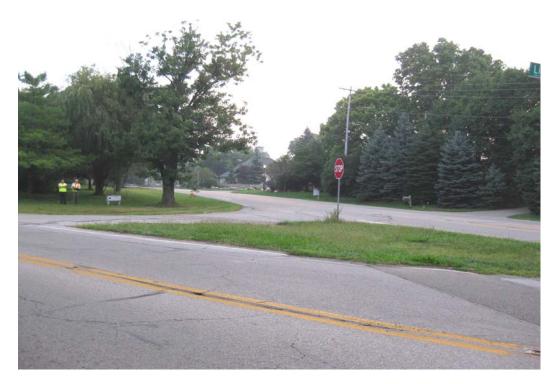
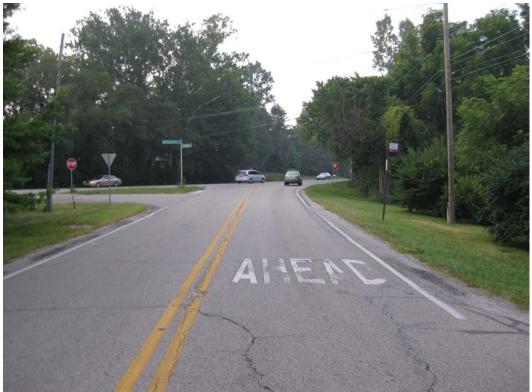
Figure A.10. View of intersection from SB Linworth Road

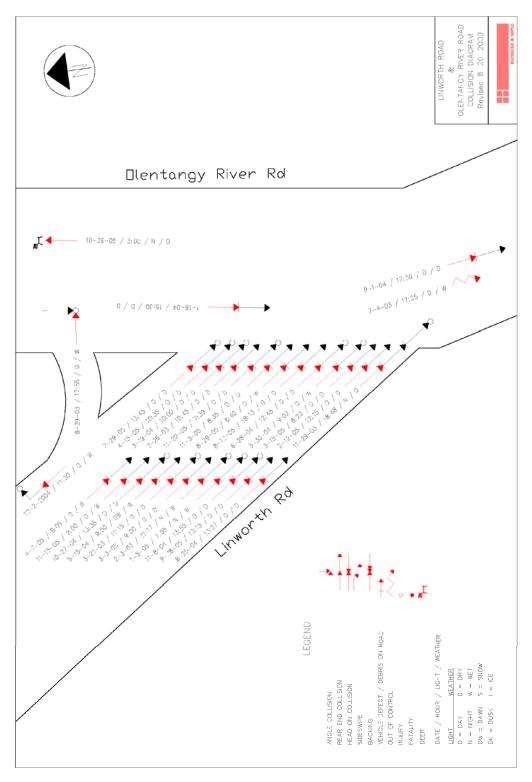
In the period of 2003 through 2005, 30 crashes were reported at the intersection, 24 of which (80%) were rear-end collisions near the YIELD sign on southbound Linworth Road. For the period of 2006 through 2008, 19 crashes were recorded, 16 (67%) of which were rear-end at the YIELD sign. Most crashes were property damage only (PDO), but 14 injuries were recorded in the 2003–2005 period, and 5 were noted in 2006–2008. No fatalities were recorded at the intersection in either of these periods. Almost all crashes occurred in daylight conditions, and a fairly consistent pattern was noted for day of week, although no crashes were recorded on Sunday. Dry pavement conditions were noted for most crashes, although some occurred with a wet pavement surface. In terms of time of day for crashes, a peak occurred during morning rush hour, and again a slight peak occurred over the lunch hour. This would be consistent with observations of traffic patterns and driver performance made by the assessment team.

Figure B.1. Collision diagram, 2003–2005

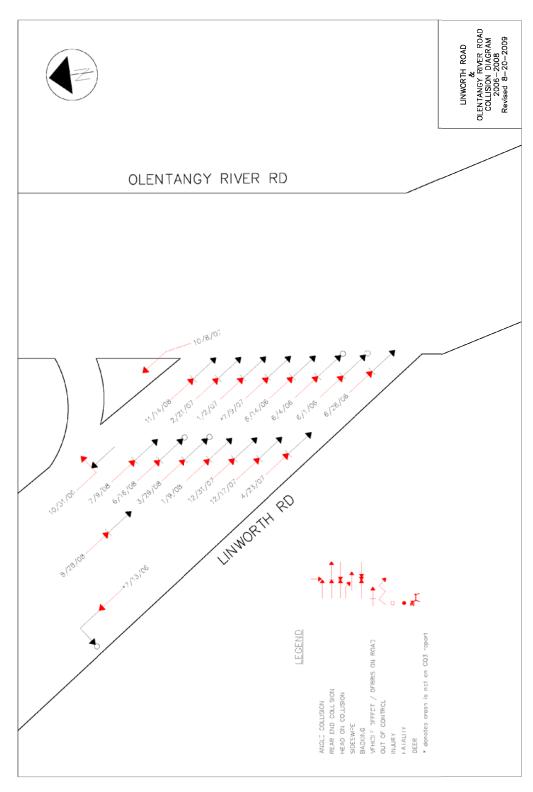
Figure B.2. Collision diagram, 2006–2008
