# Road Safety Audit for the US 61/ Harrison Street and West Locust Street Intersection in Davenport- Scott County, Iowa

**Final Report**  
**October 2008**

**Sponsored by**  
the Iowa Department of Transportation

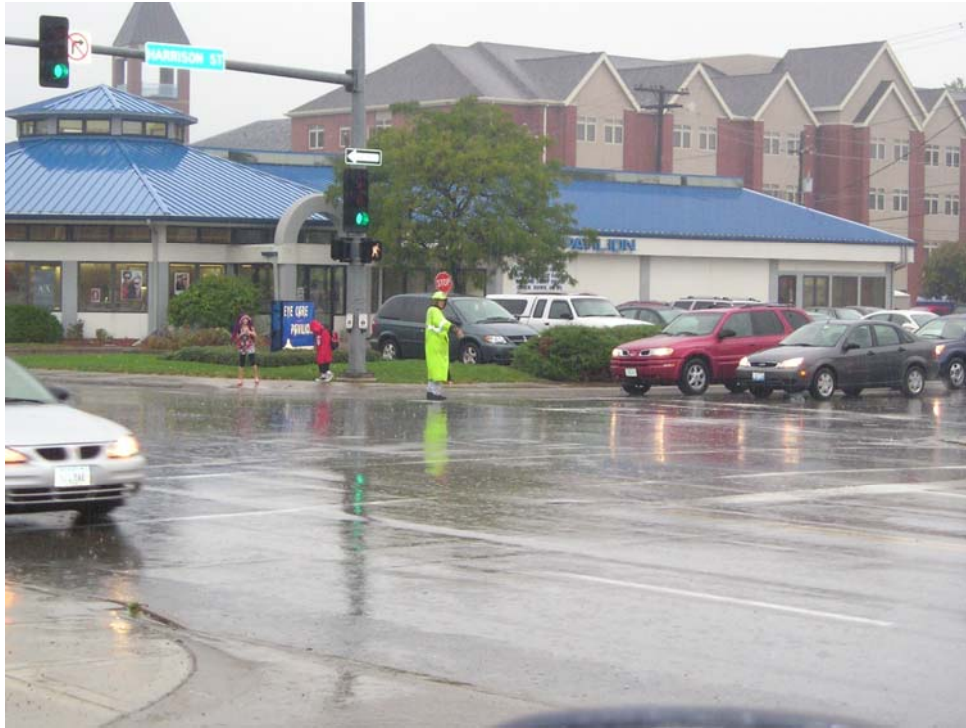
**Figure A.1. Crossing guard with school children**

At the next scheduled crossing guard meeting, consider discussing MUTCD Part 7 guidance and recommendations, especially regarding STOP paddle requirements and apparel, and consider discussing the crossing habits of junior high students.

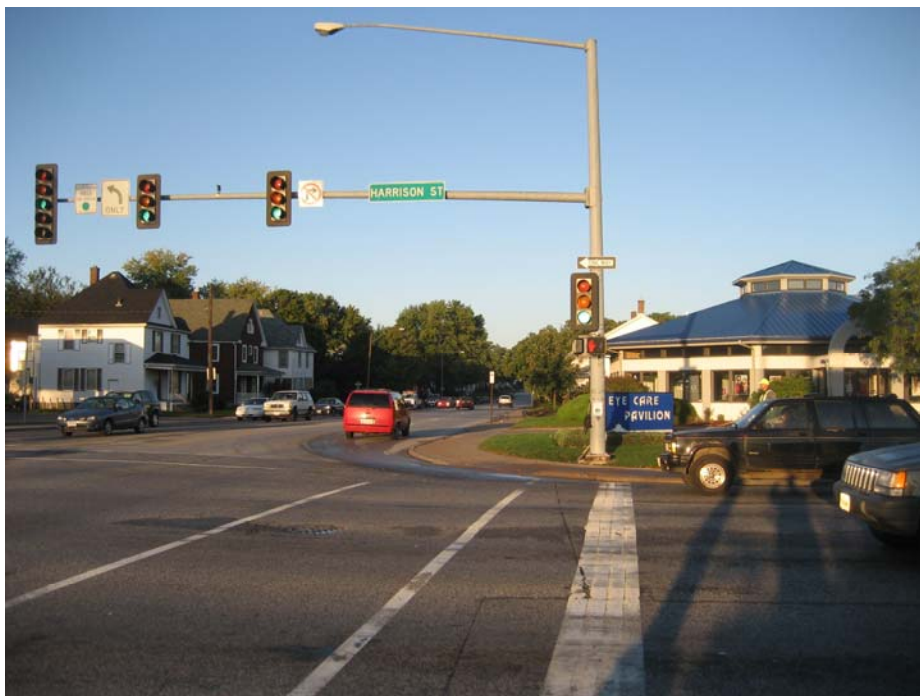
**Figure A.2. Pedestrian crossing pavement markings**

Replace existing pedestrian crossing markings, using milled-in installation to prolong service life. Additionally, install a “No Right Turn When Pedestrians Are Present” sign or similar restrictive signing for southbound Harrison Street to westbound Locust Street traffic. Consider installing count-down signals for pedestrian use.

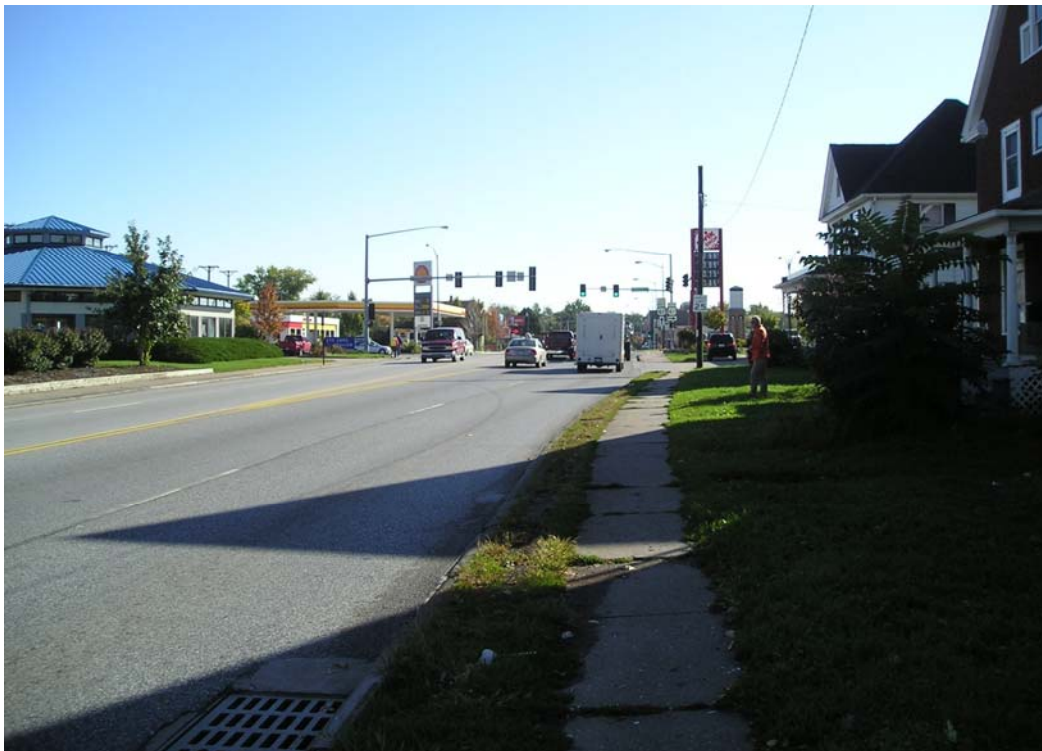
**Figure A.4. Eastbound Locust Street**

If a sufficient area can be found, consider placing a radar speed trailer on eastbound Locust Street to alert drivers and monitor the speeds of approaching traffic west of the intersection.

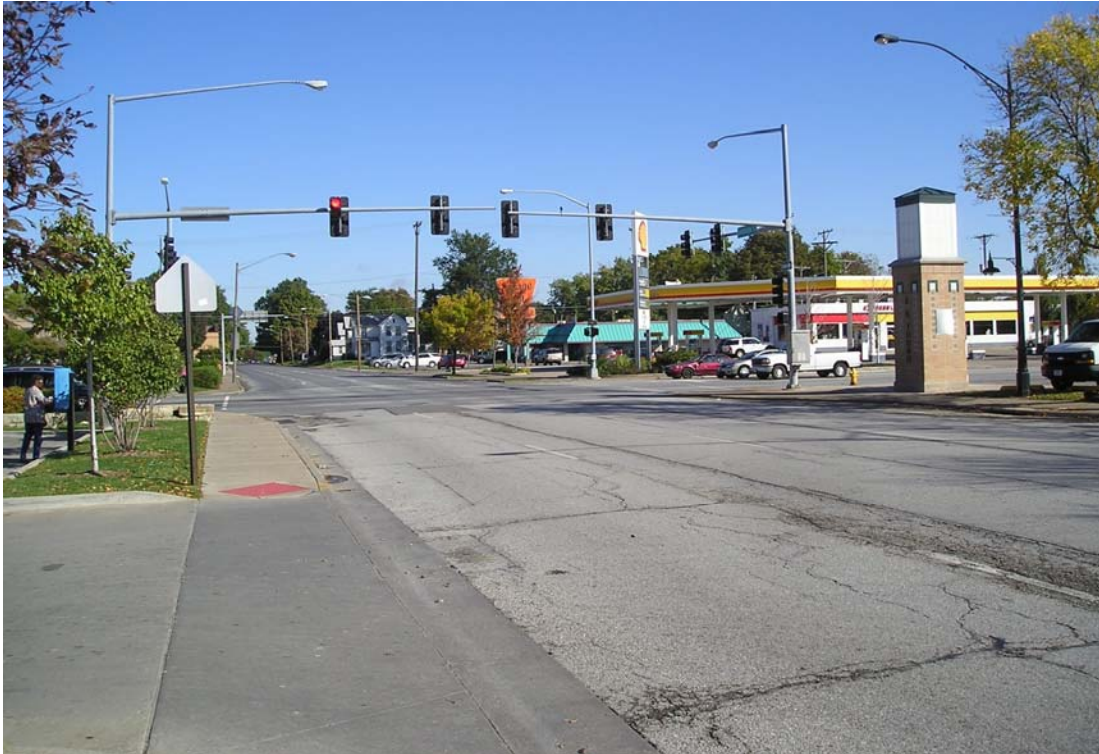
The southbound traffic signal assembly features a “tattle-tail signal” facing south to advise law enforcement officers if a signal violation has occurred. This can be effective, but it is less efficient than automated enforcement because it requires the presence of an officer to observe violations and issue citations.

**Figure A.7. Tattle-tail signal for southbound Harrison Street traffic**

When the city's automated enforcement program is recommenced, consider relocating cameras to this intersection to address red light running. Meanwhile, continue using the "tattle-tail" signal on southbound Harrison Street to mitigate signal violations for that movement.

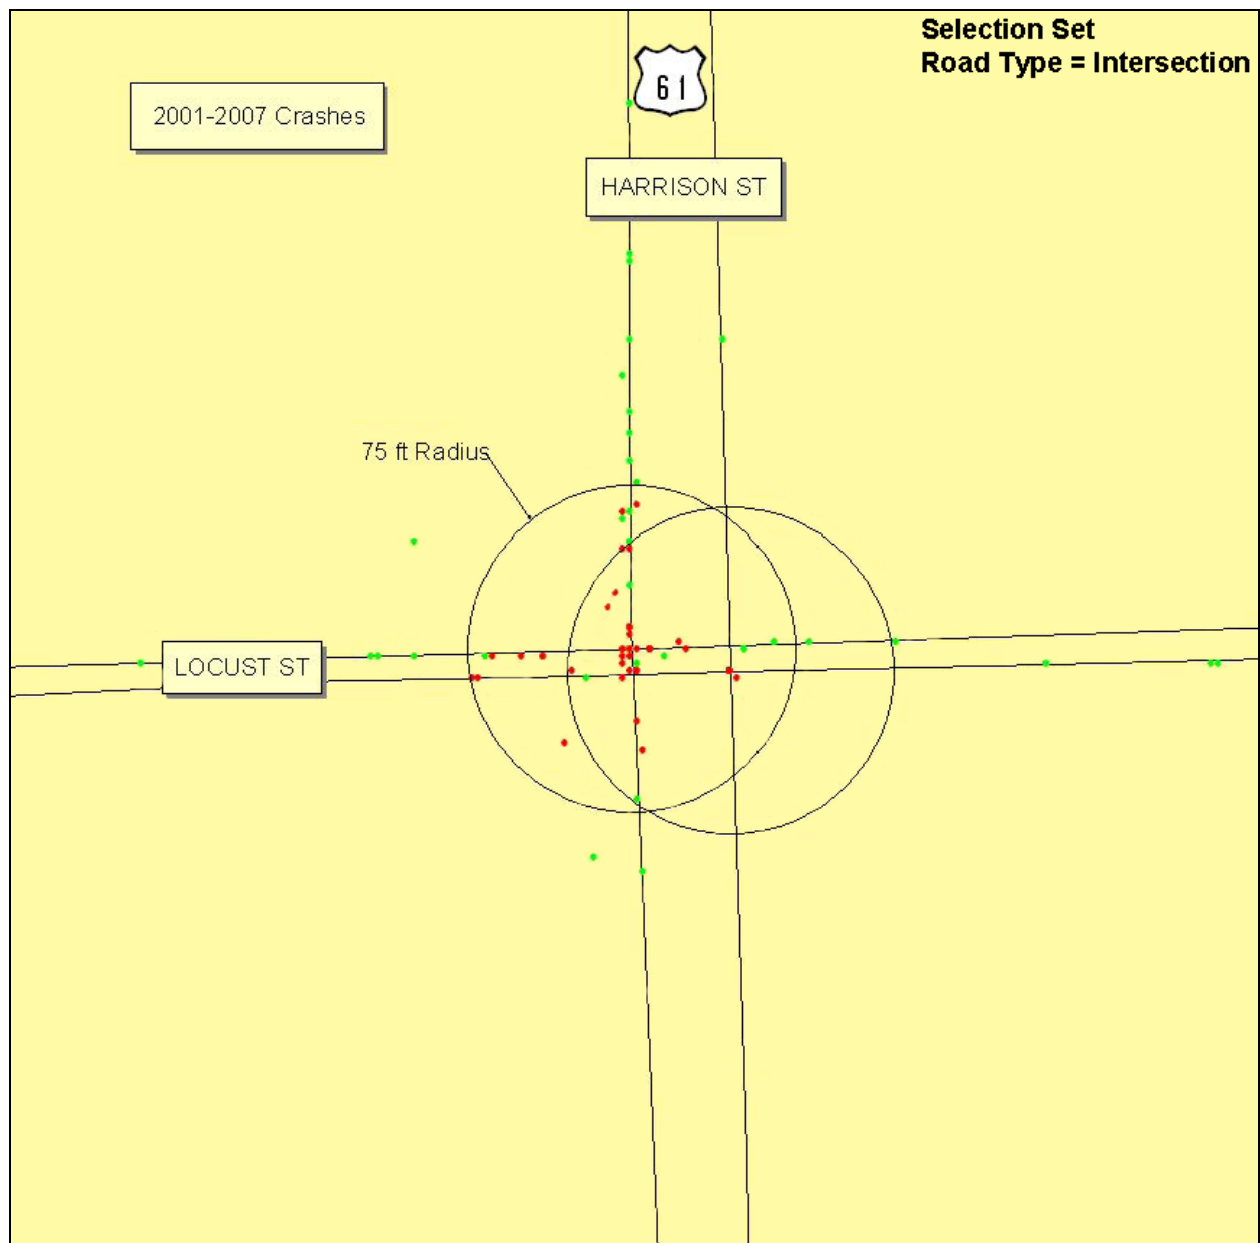
**Figure B.1. Crash locations for the intersection, 2001–2007**

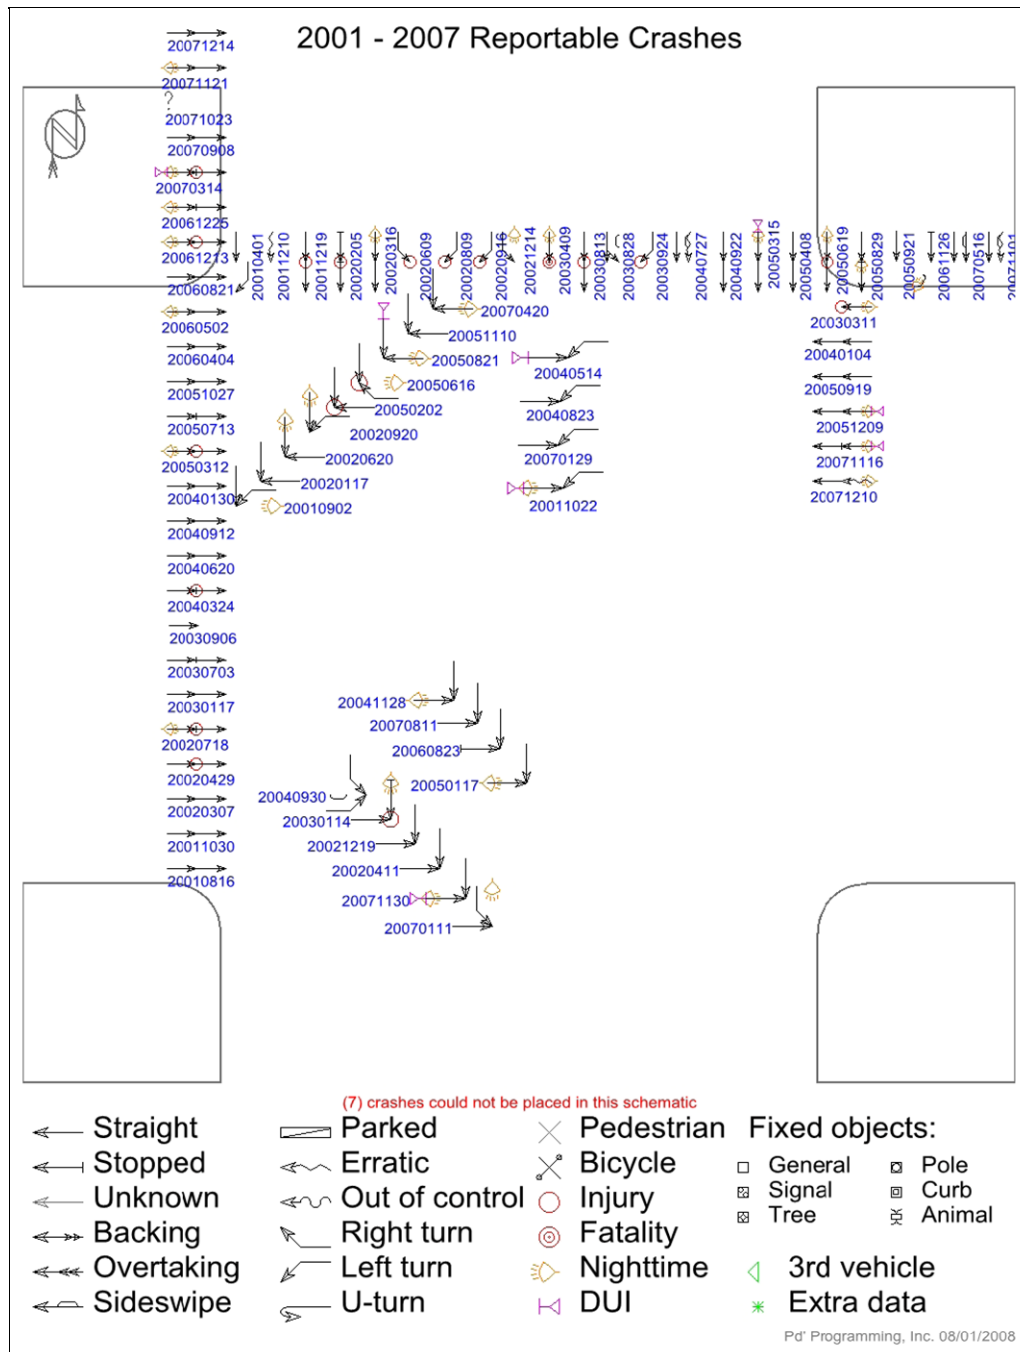
**Figure B.2. Diagram of crashes for the intersection, 2001–2007**
