MAIN BLACK BRIDGE, MONTMORENCY COUNTY, MI

Main Black Bridge

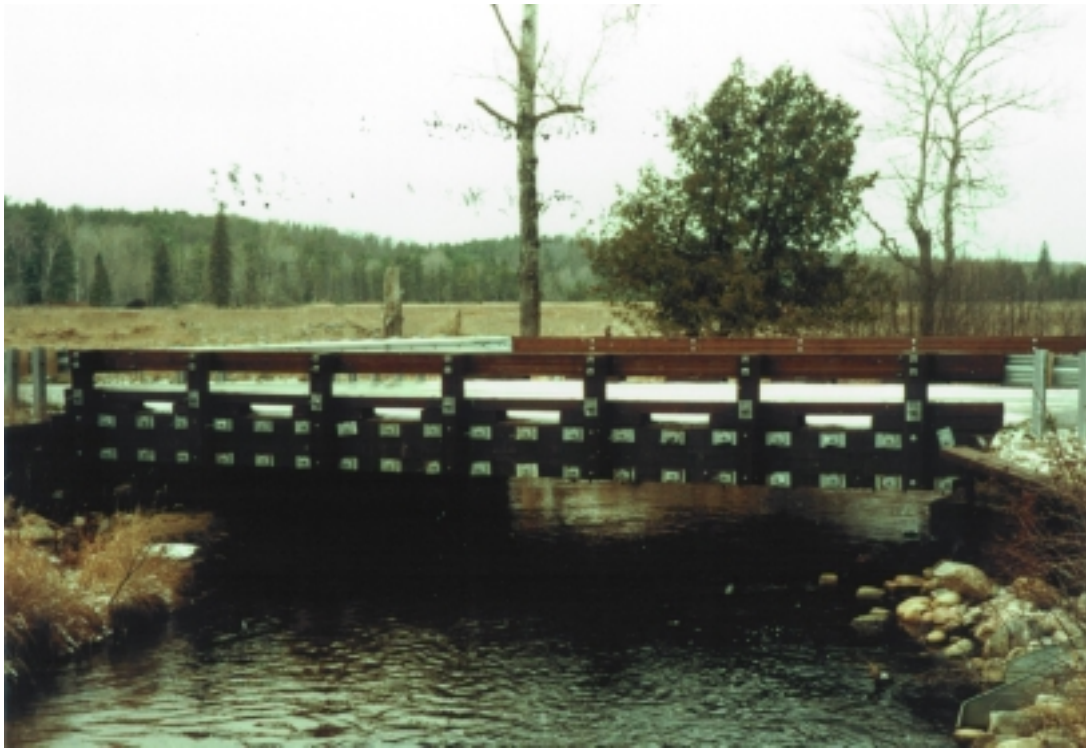
Latest visual examination of the bridge by the road commission manager indicated no apparent structural problems with the bridge or sub-structure. Early after construction, it was noted that the stressing rods were loose and were re-stressed. There have been complaints from local citizens about creosote dripping into the stream.

This bridge was fabricated by a contractor into panels. As noted, the bridge rods were loose after construction and later it was determined that the bridge was overstressed, thus causing the nuts to slip in the rods. It was also found out that some of the nuts were defective and replaced.
