University of Idaho

CONCRETE PERFORMANCE IN AGGRESSIVE SALT ENVIRONMENT.

Olaniyi Arowojolu,
Graduate Student, University of Idaho

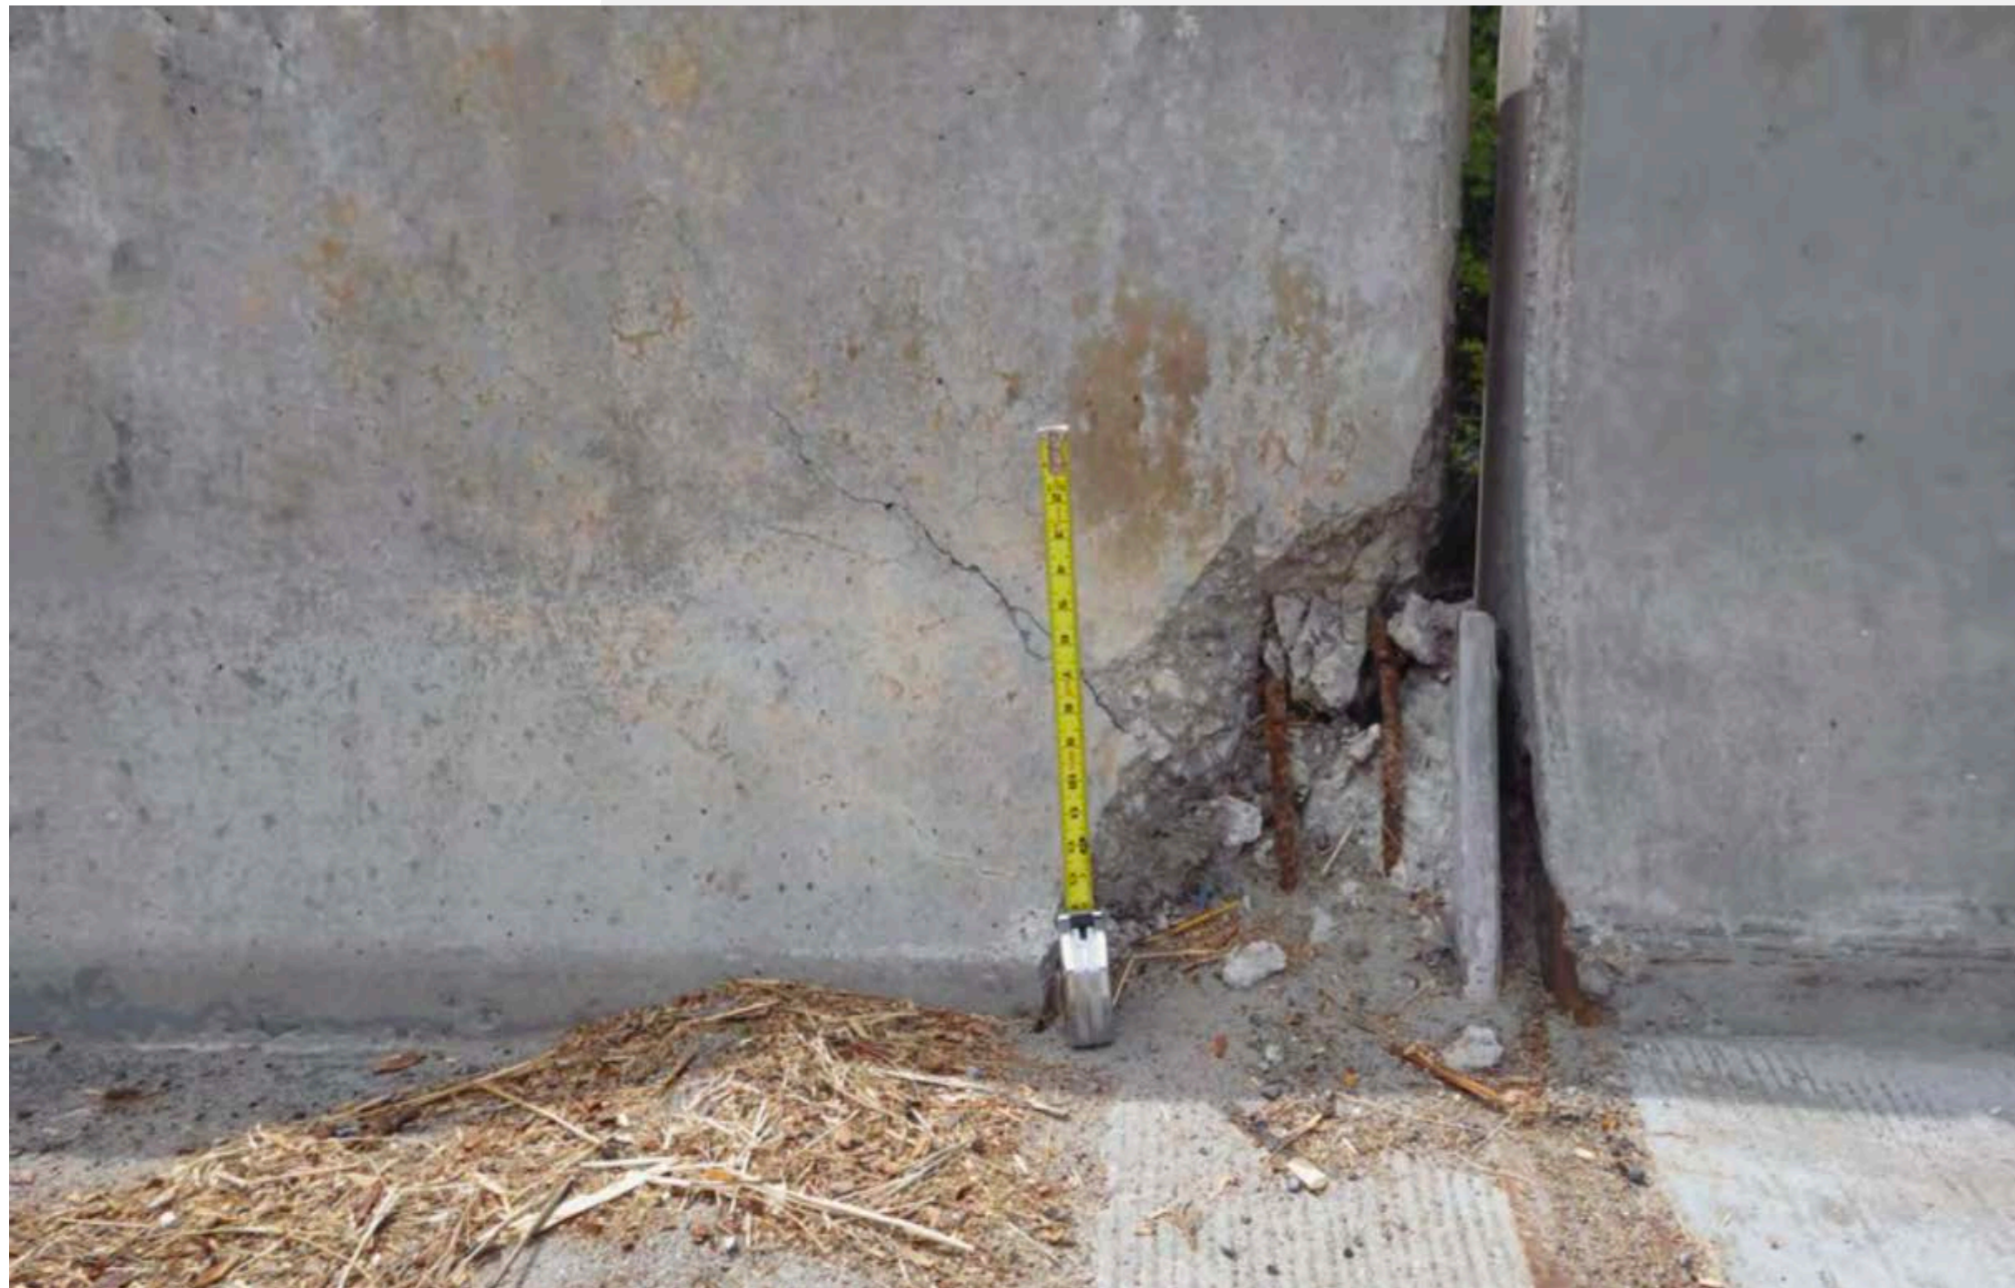
Spall in approach rail at SW. (ITD 2012)

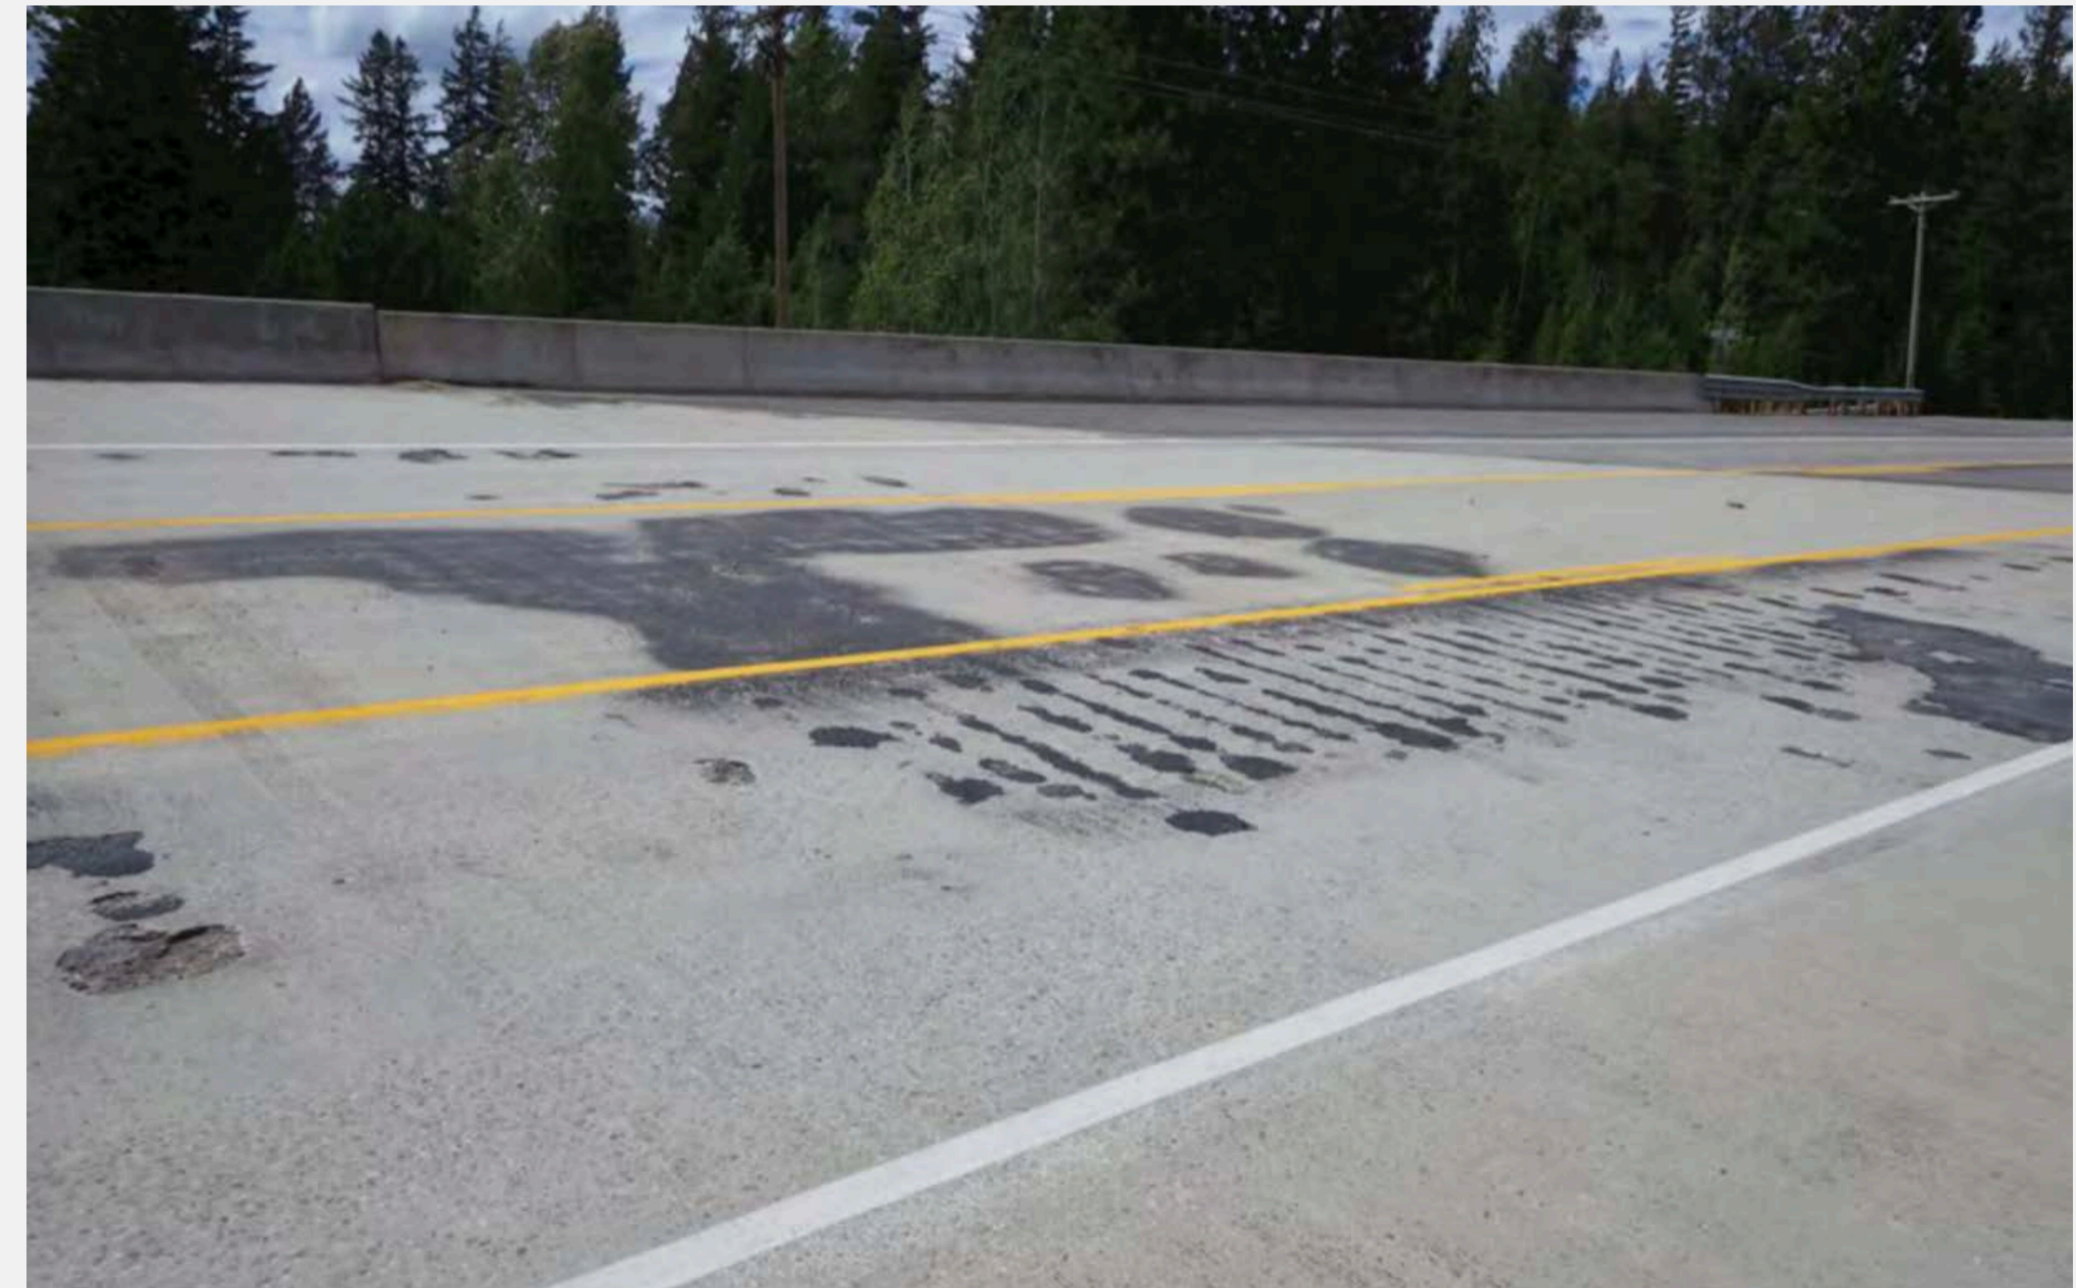
Large area of patched spalls, spalls with rebar exposed and delamination at mid-span of deck.

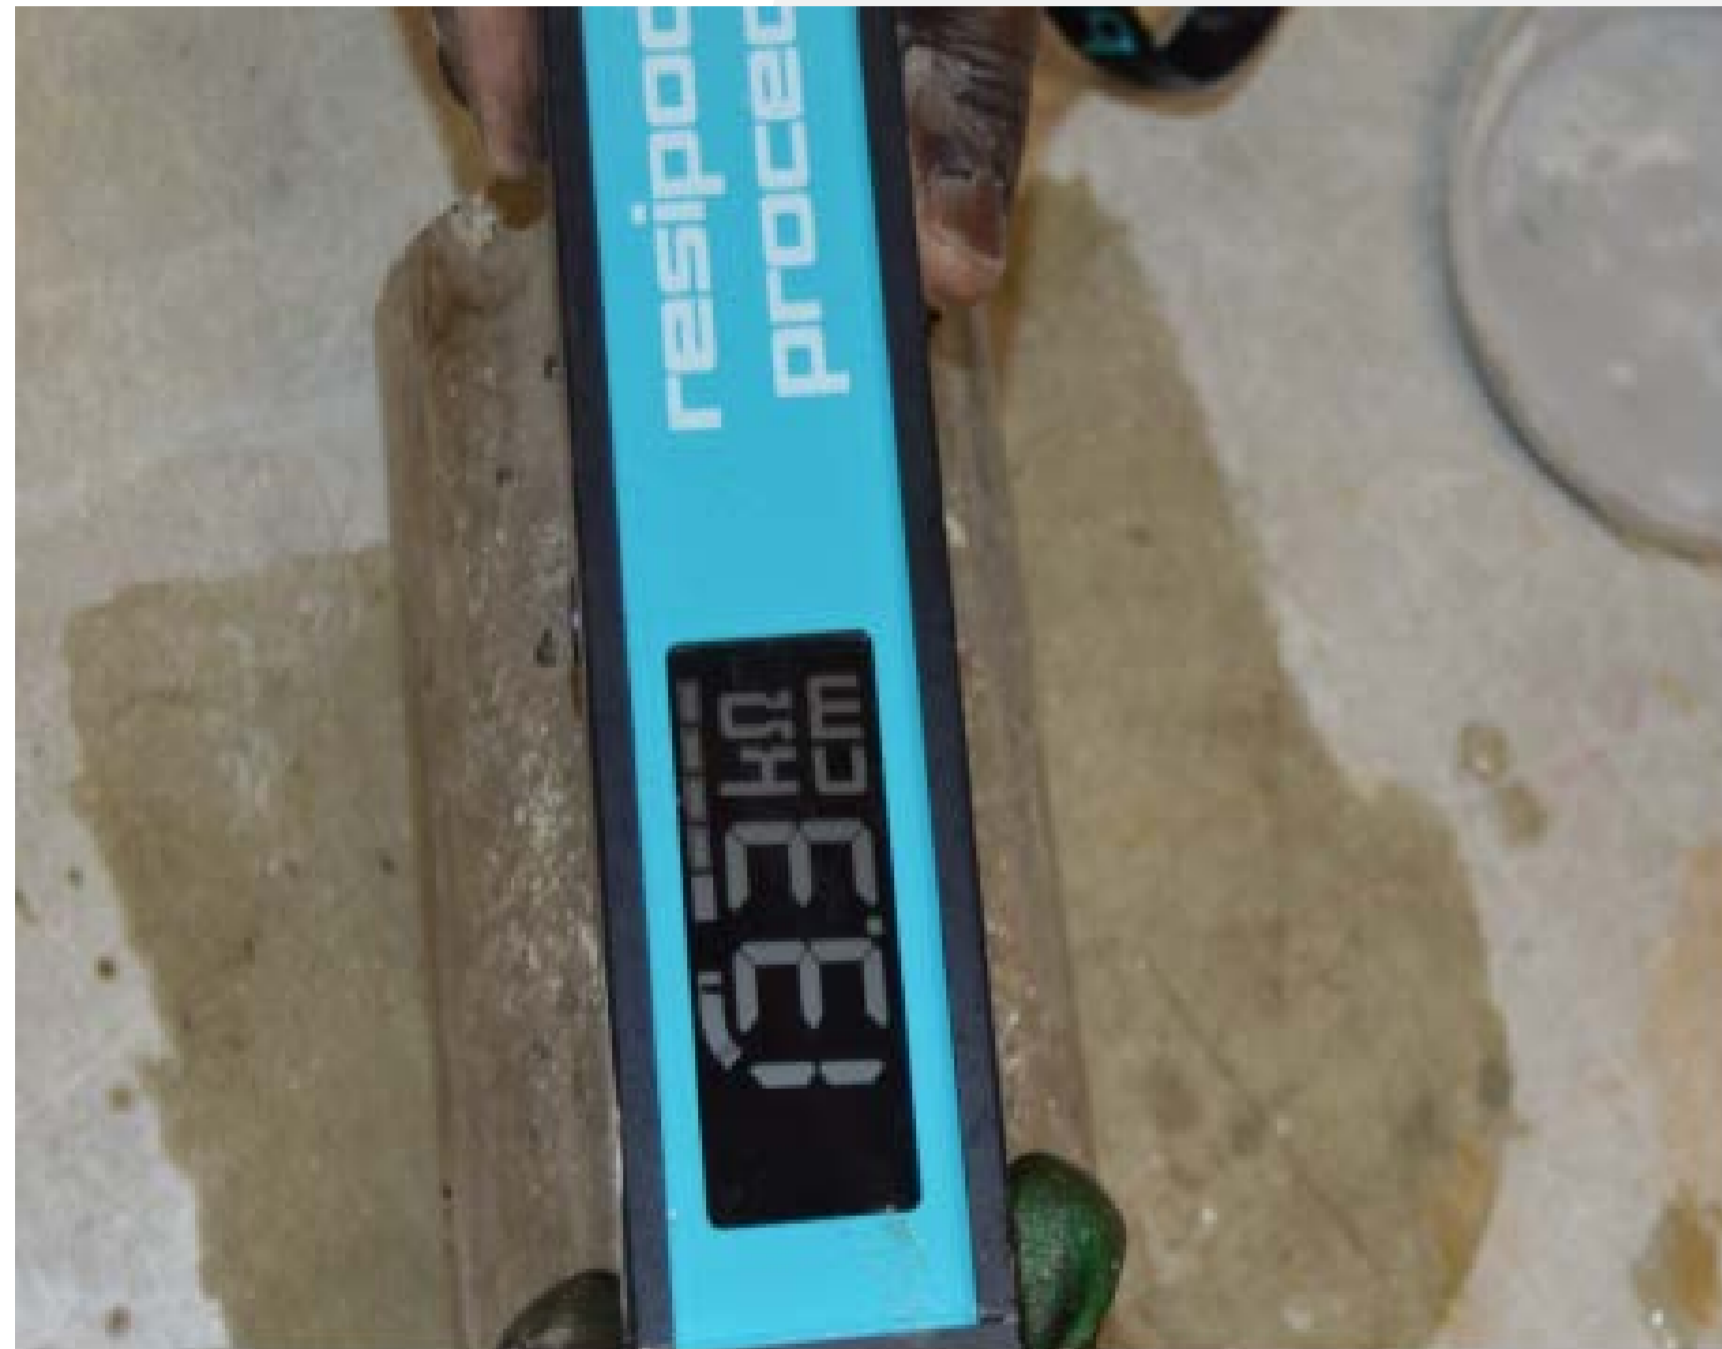
Figure 1- Surface resistivity testing.

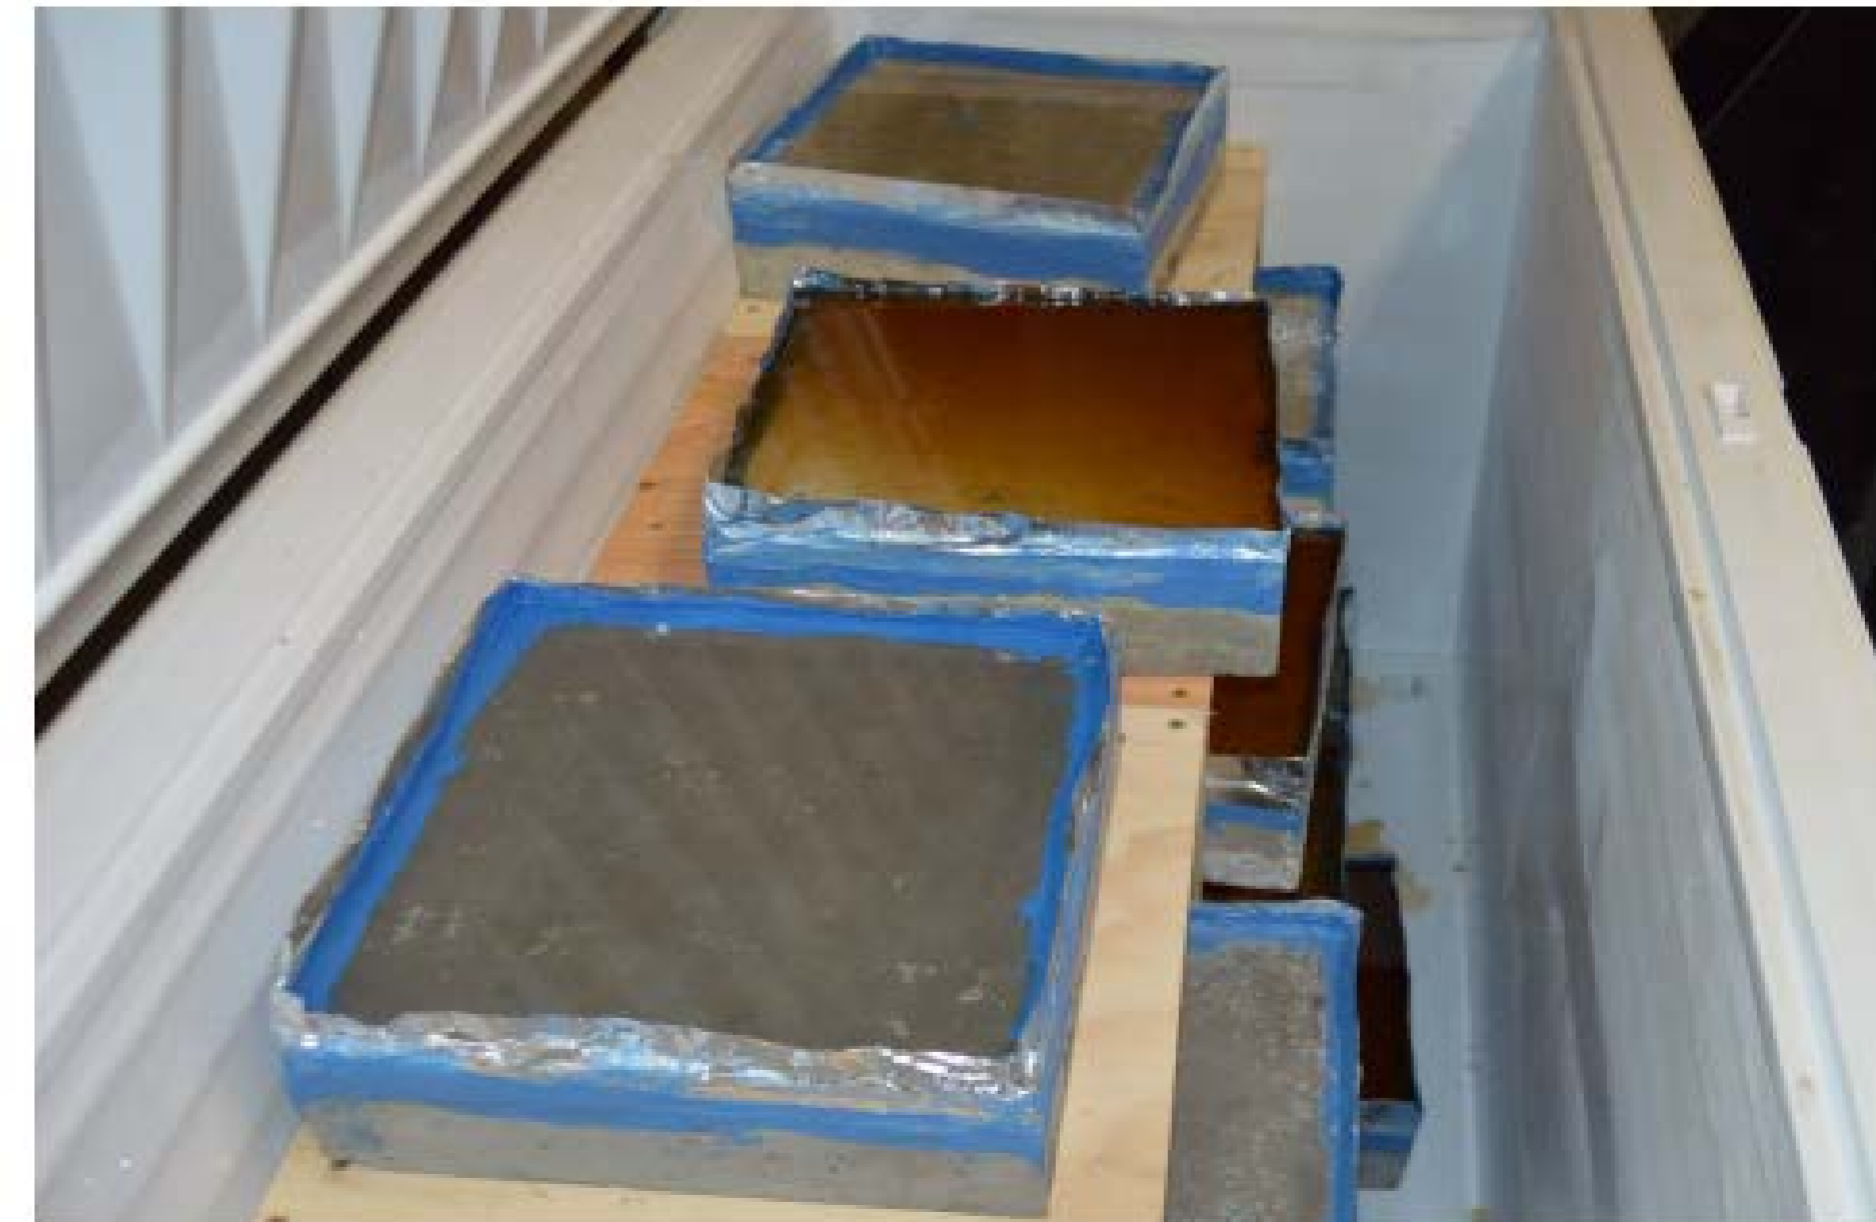
Figure 3: Slabs exposed to freezing environment during deicing scaling test.

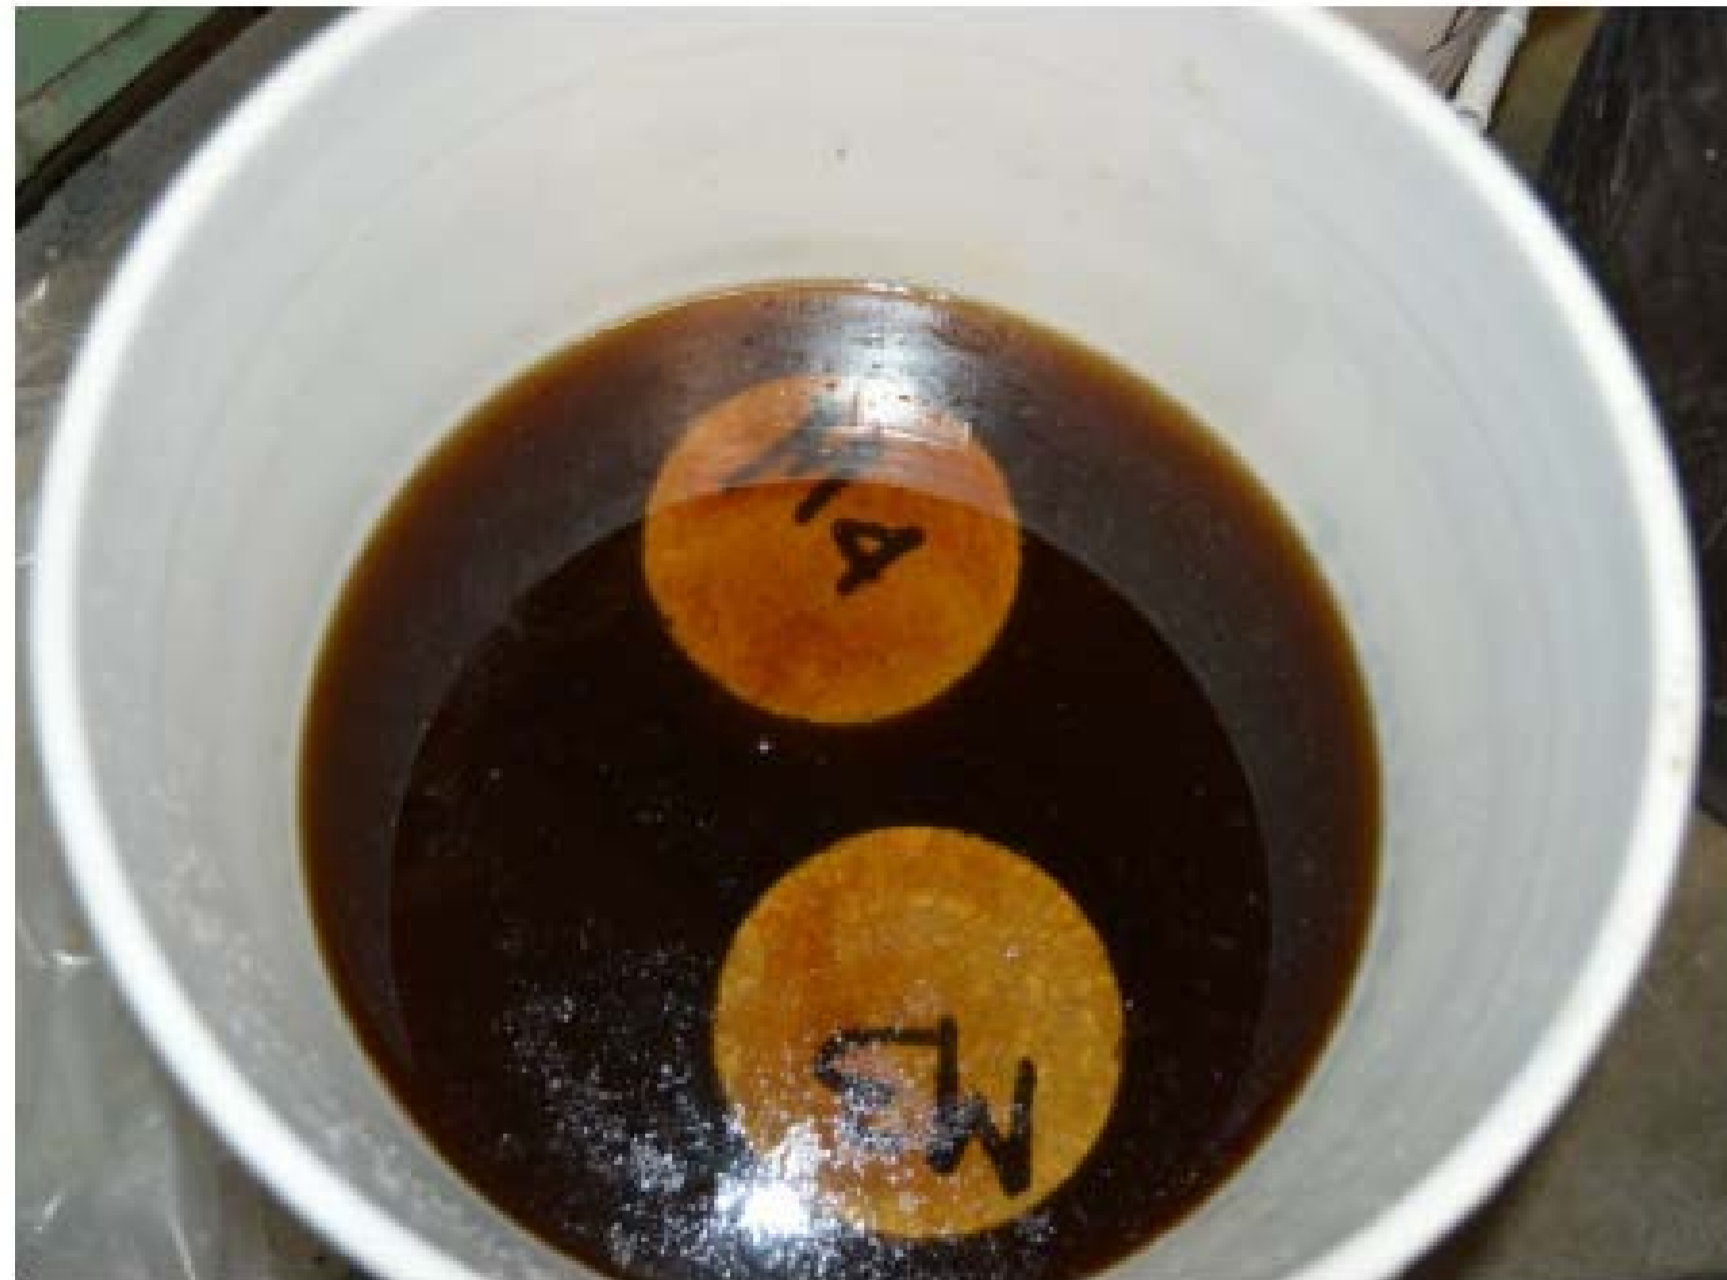
Figure 4- Specimens under continuous soaking.

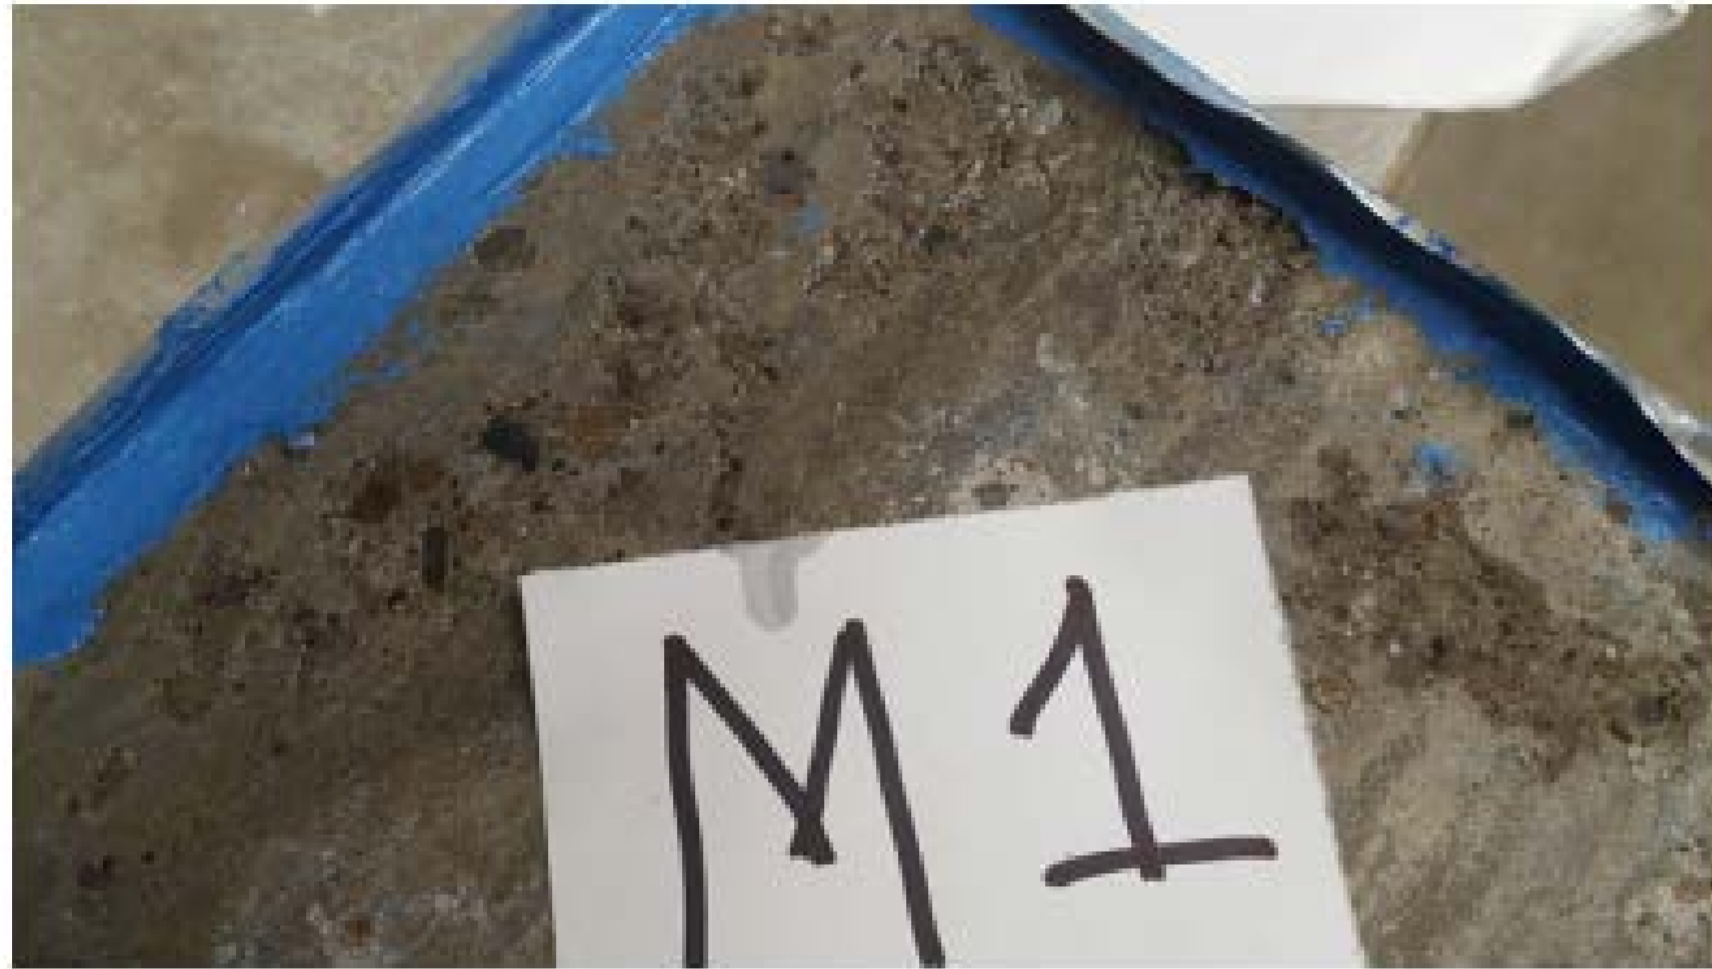
Figure 7: District 1 SH 5 Crossing mixture after deicing scaling test

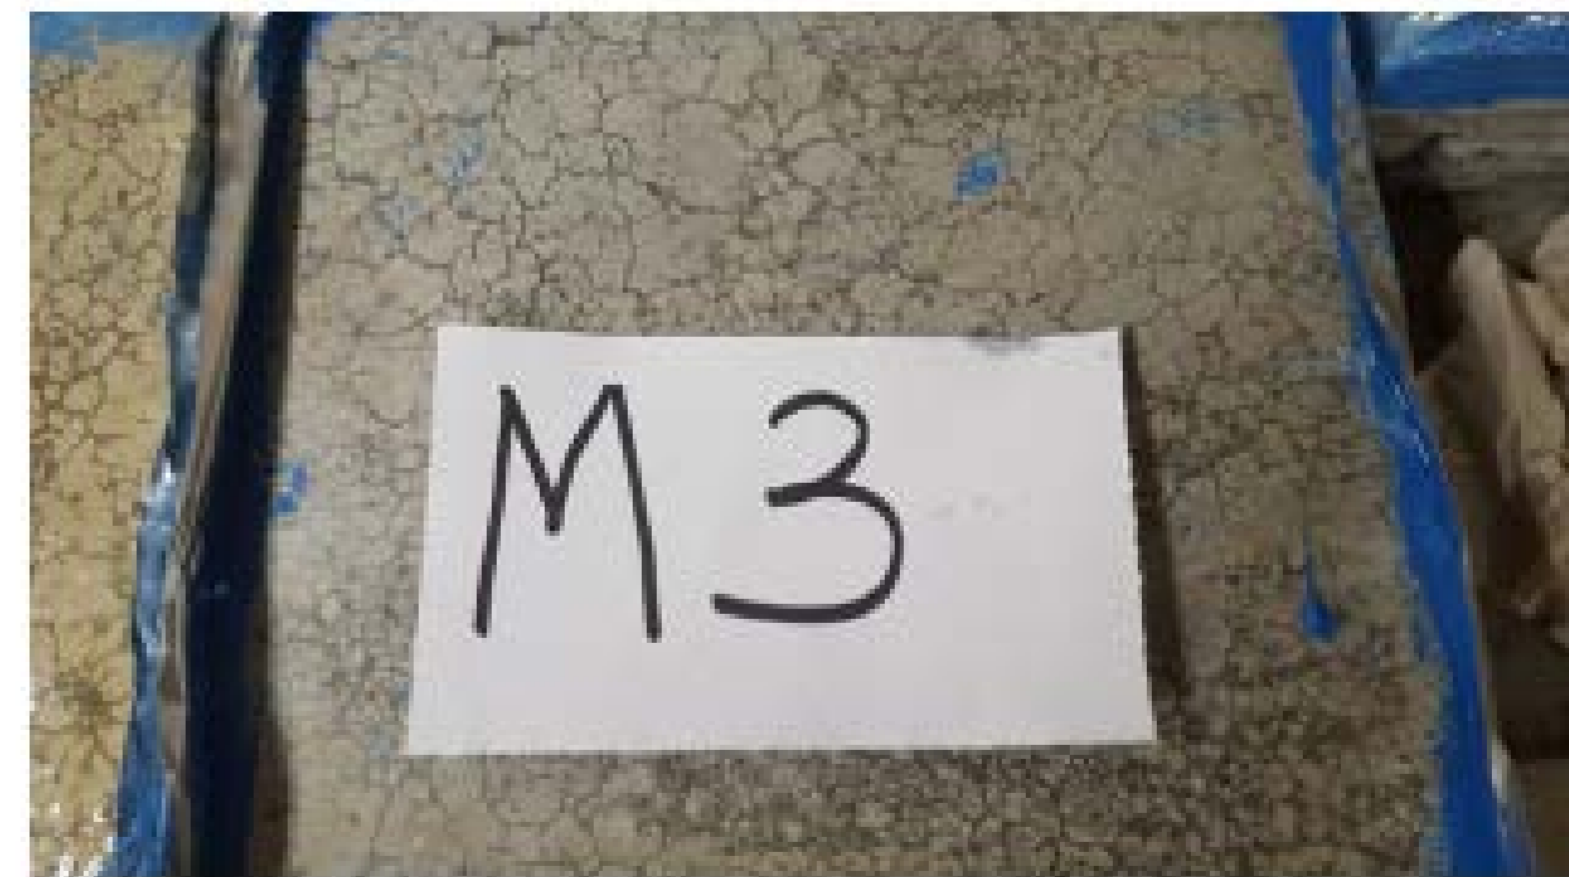
Figure 10: Thain road paving Lewiston mixture after deicing scaling test

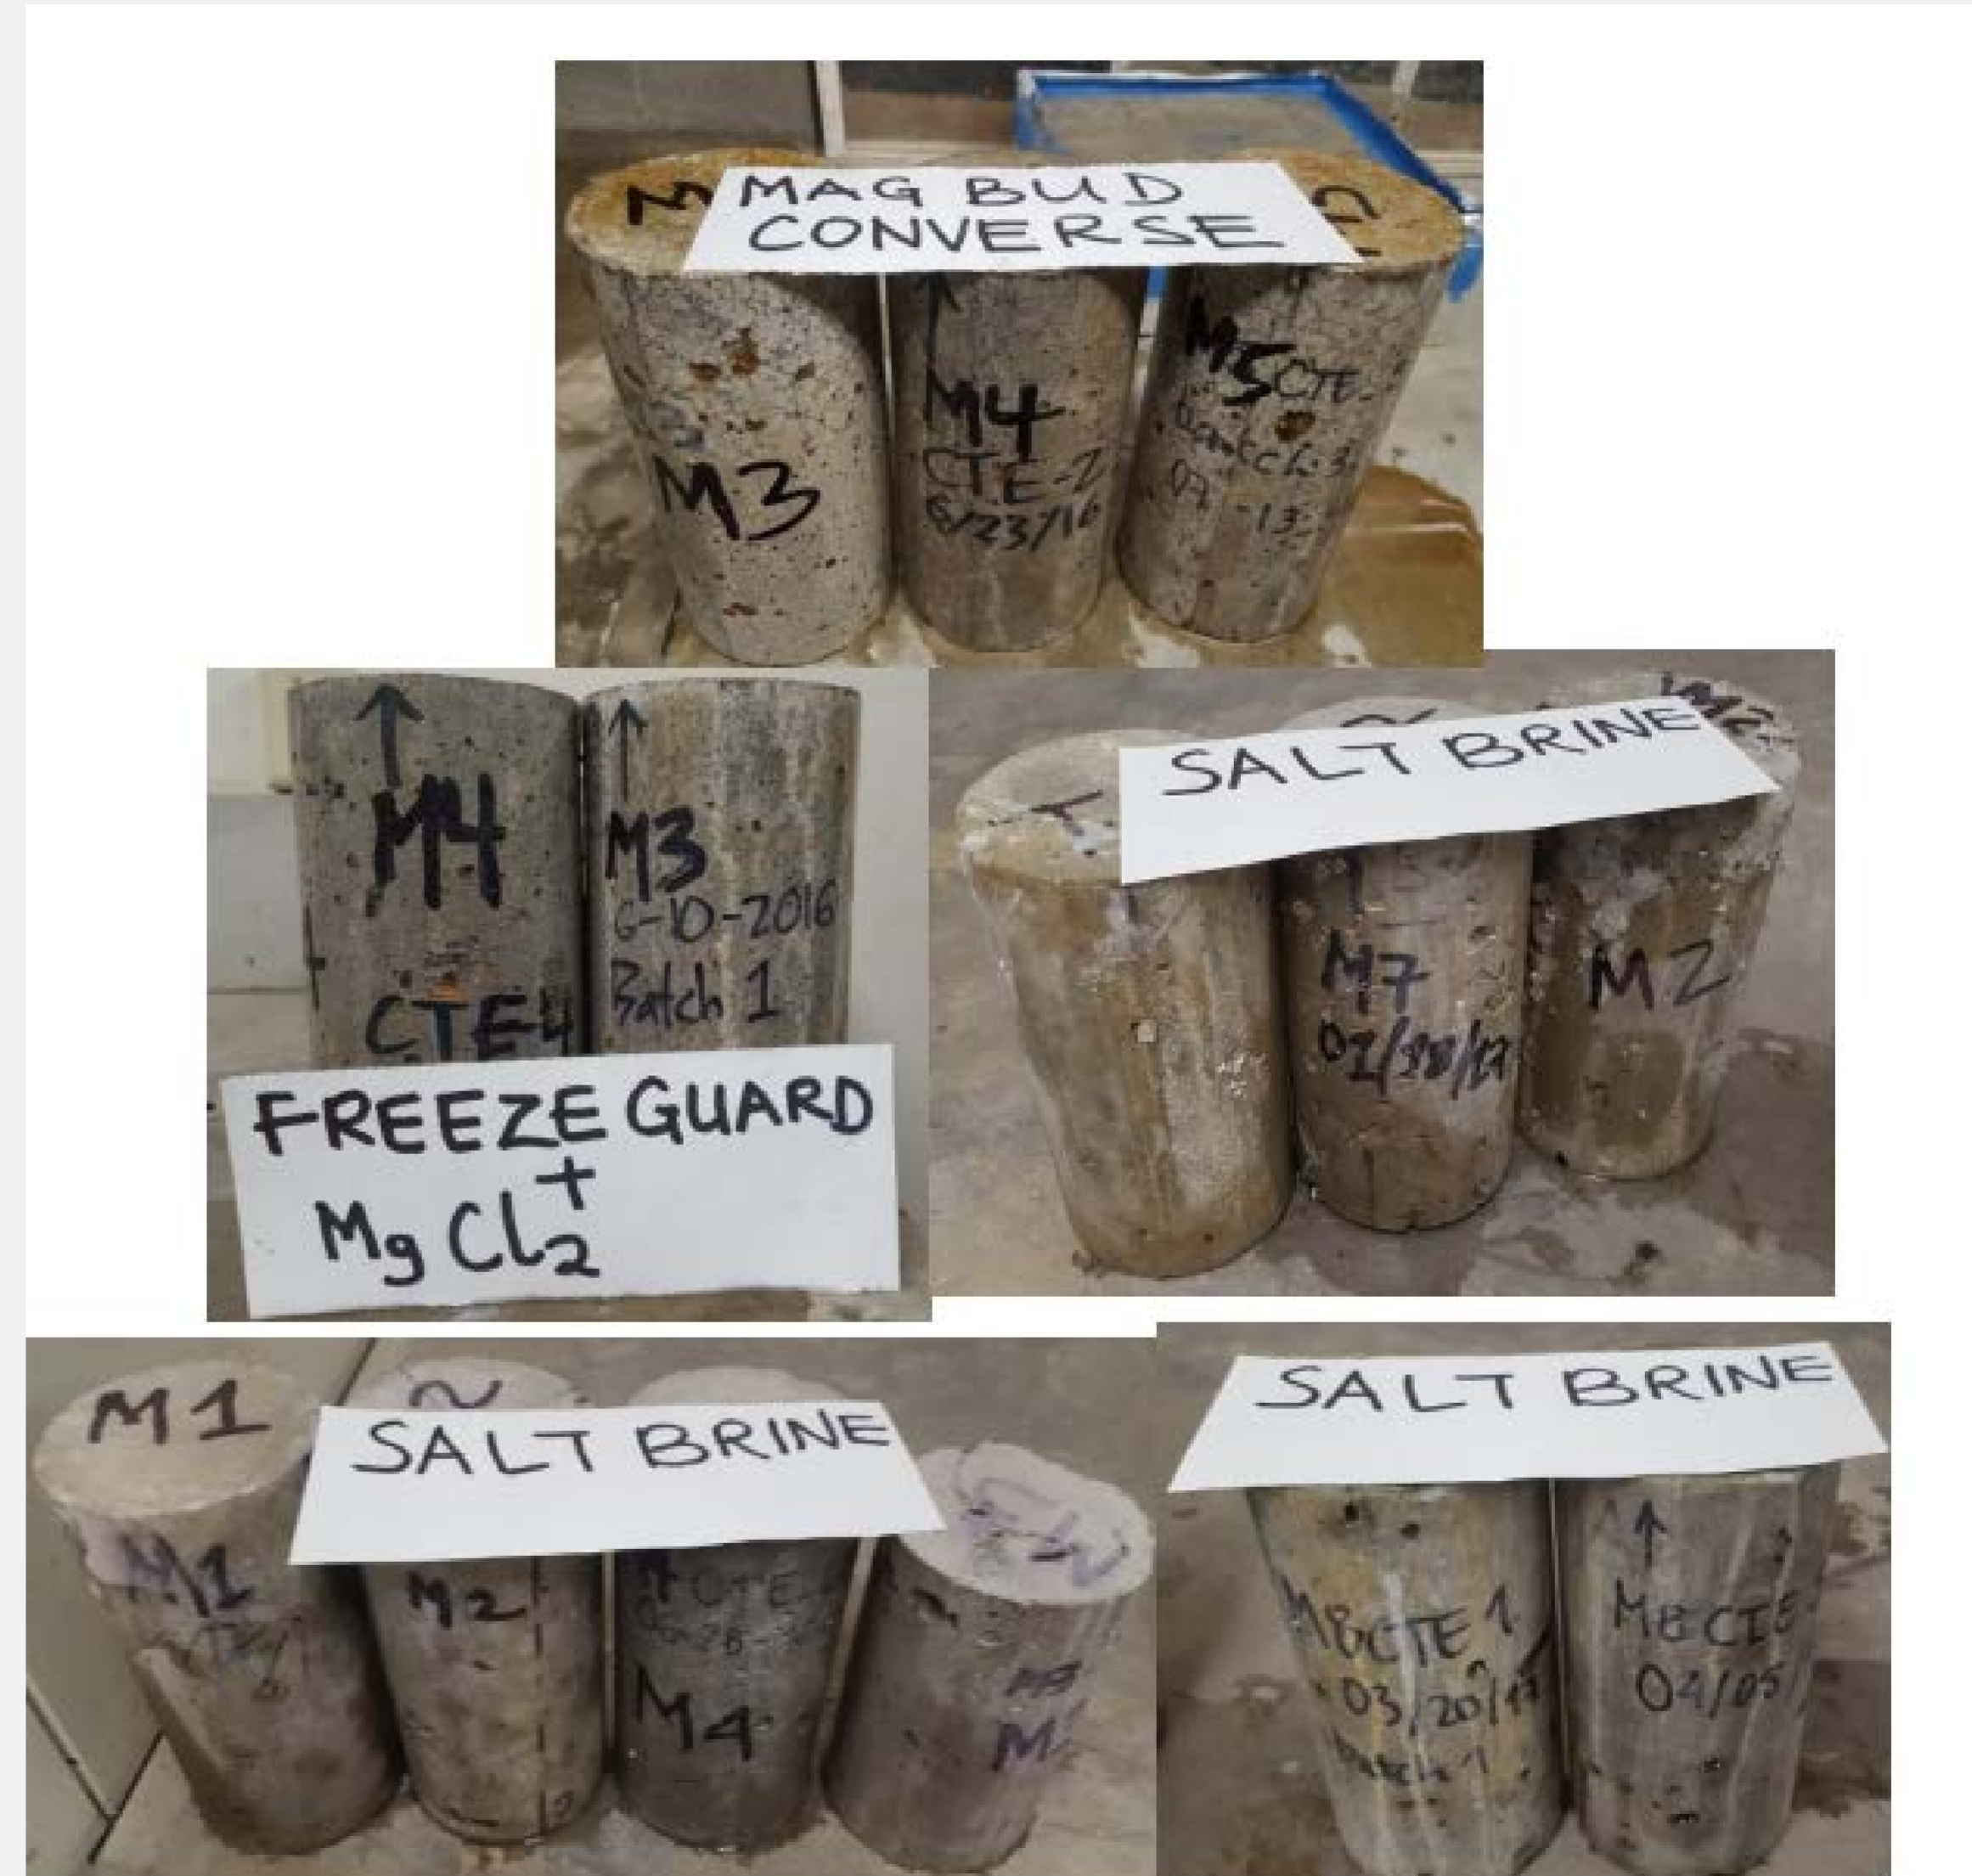
Figure 15: Concrete specimens after 90-days continuous soaking in deicing salt.

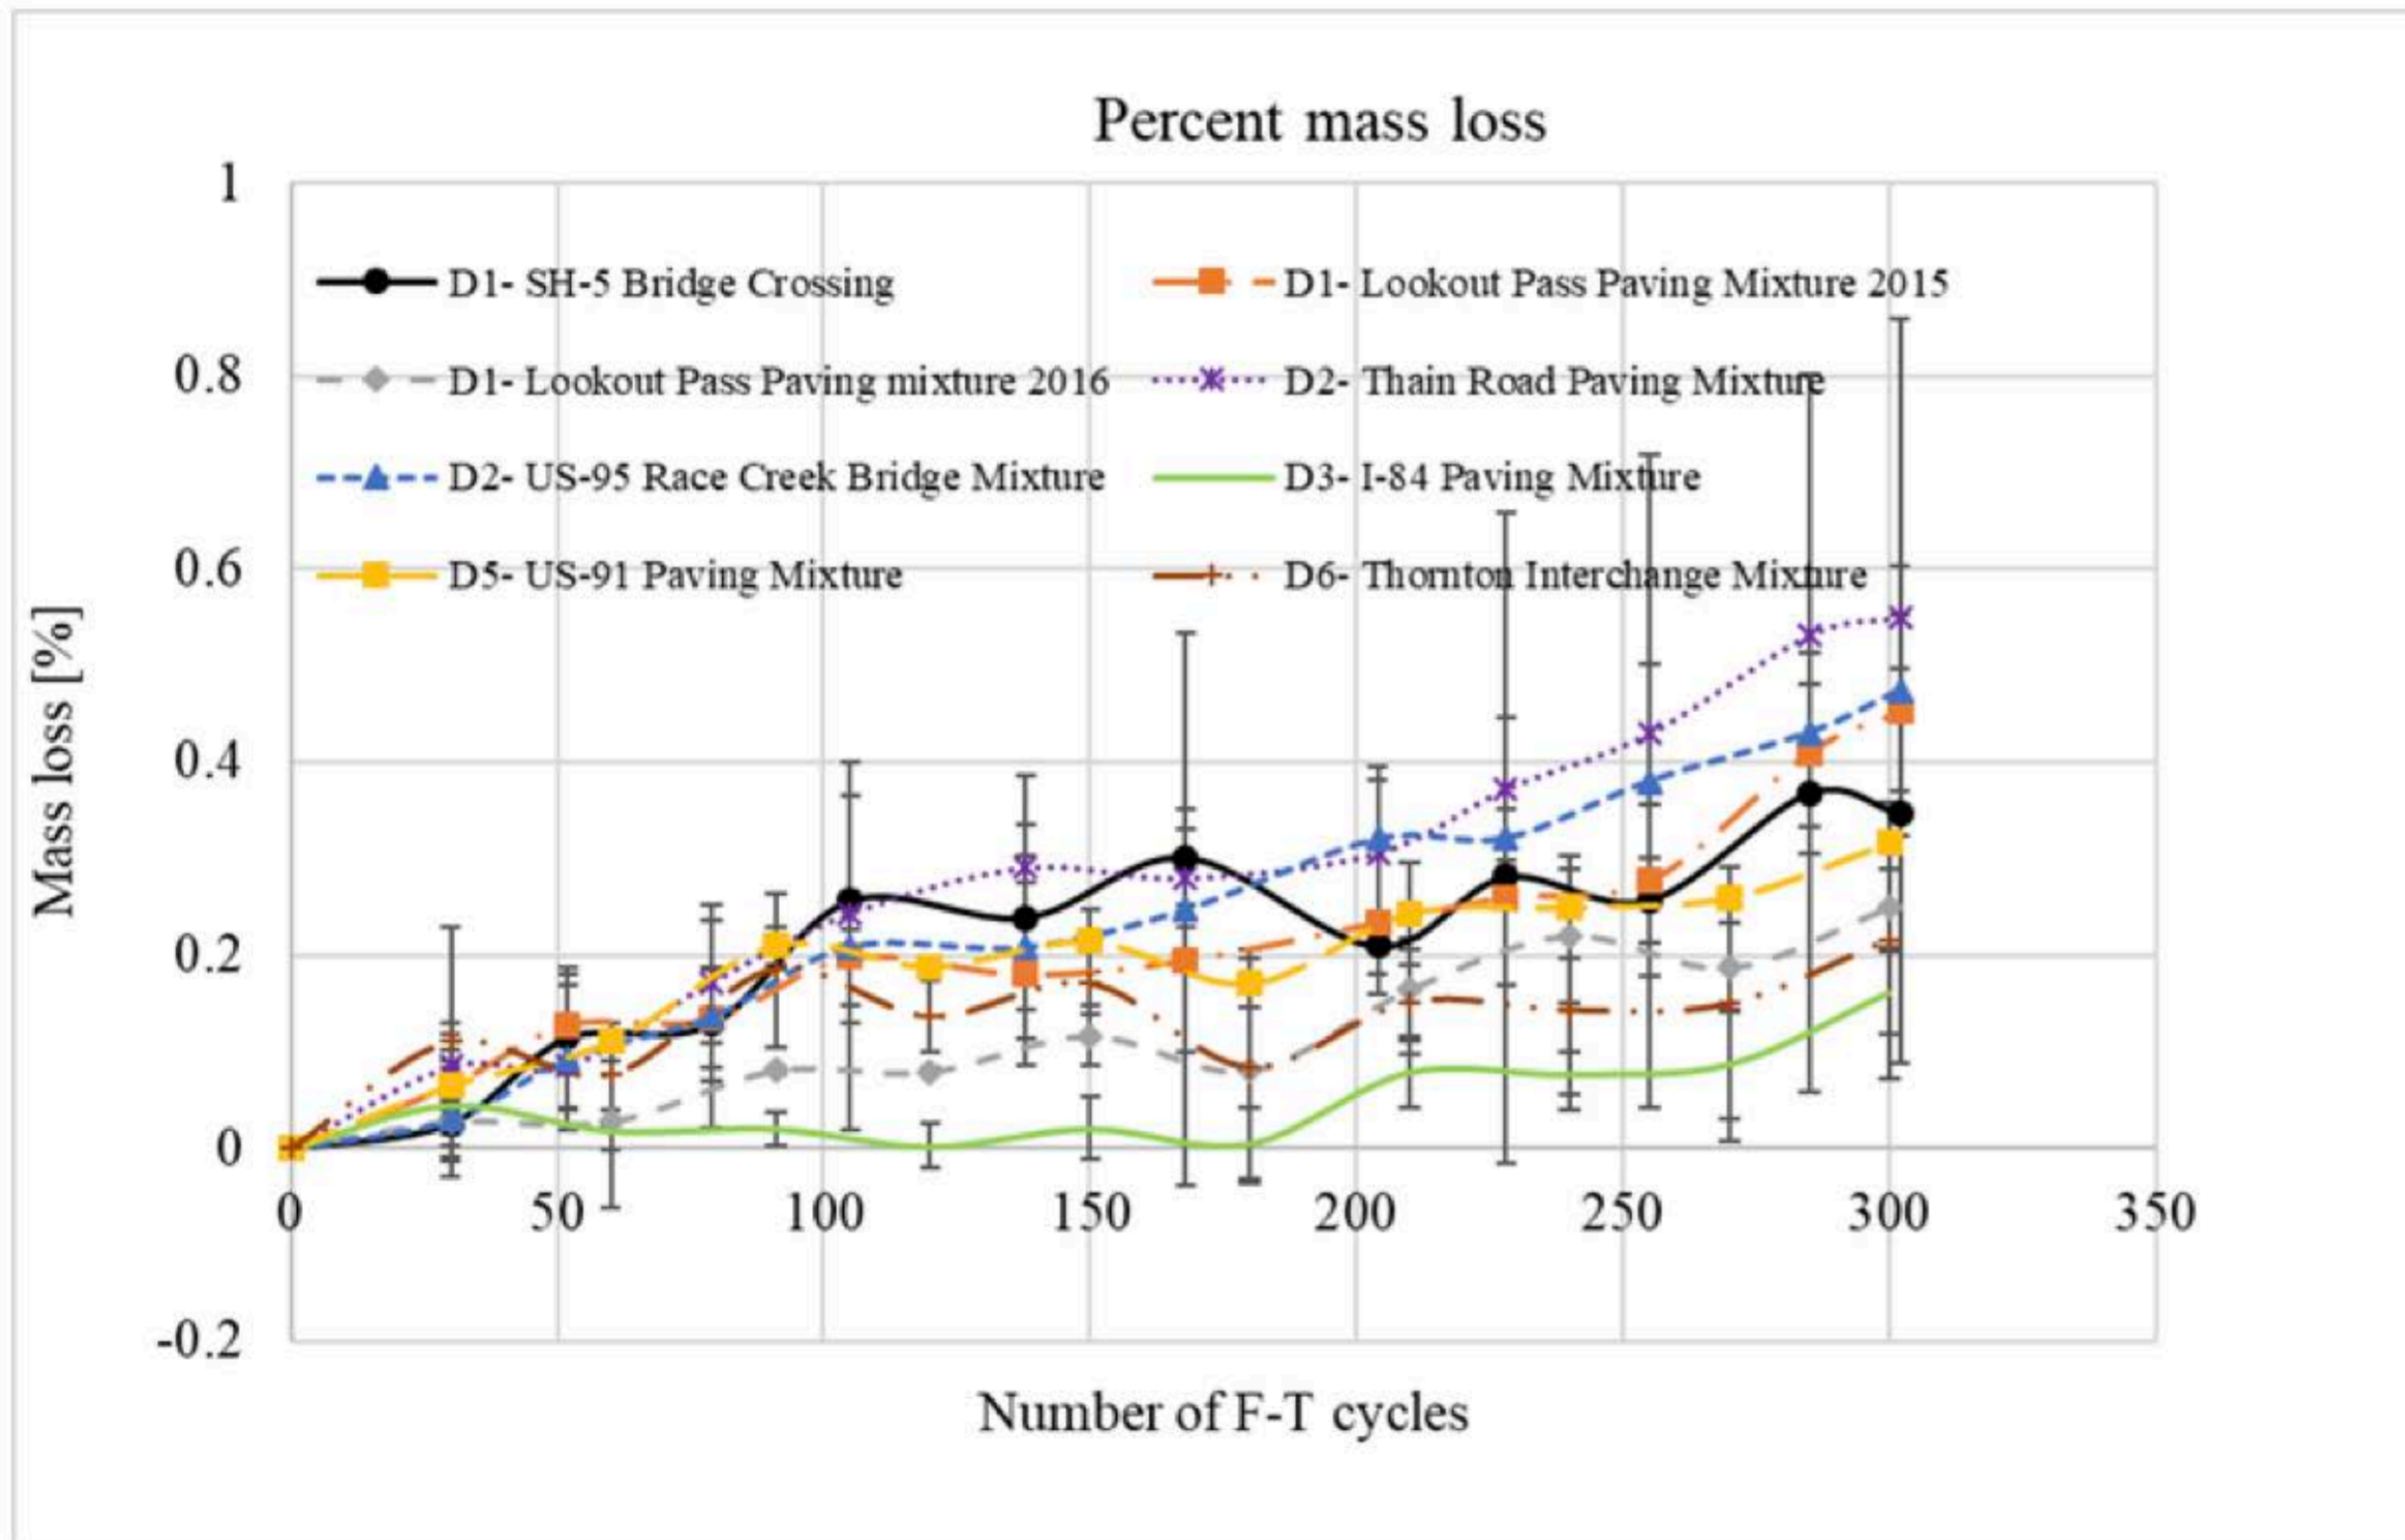
Specimen mass loss in F-T tests

- The mixtures currently used by ITD perform satisfactorily under F-T cycle, as evidenced by relatively high percentage retained elastic modulus and relatively low mass losses after being subjected to a total of 300 F-T cycles.
- The structural mixture (SH-5 Bridge crossing, Plummer) suffered a severe scaling, while other mixtures showed mild to moderate scaling. The reason for the severe scaling in Mix M1, could be because of the absence of supplementary cementitious materials- Fly Ash that inhibits the formation of calcium oxychloride (CAOXY) as observed by different authors.
