University of Idaho

CONCRETE PERFORMANCE IN AGGRESSIVE SALT ENVIRONMENT.

Olaniyi Arowojolu,
Graduate Student, University of Idaho

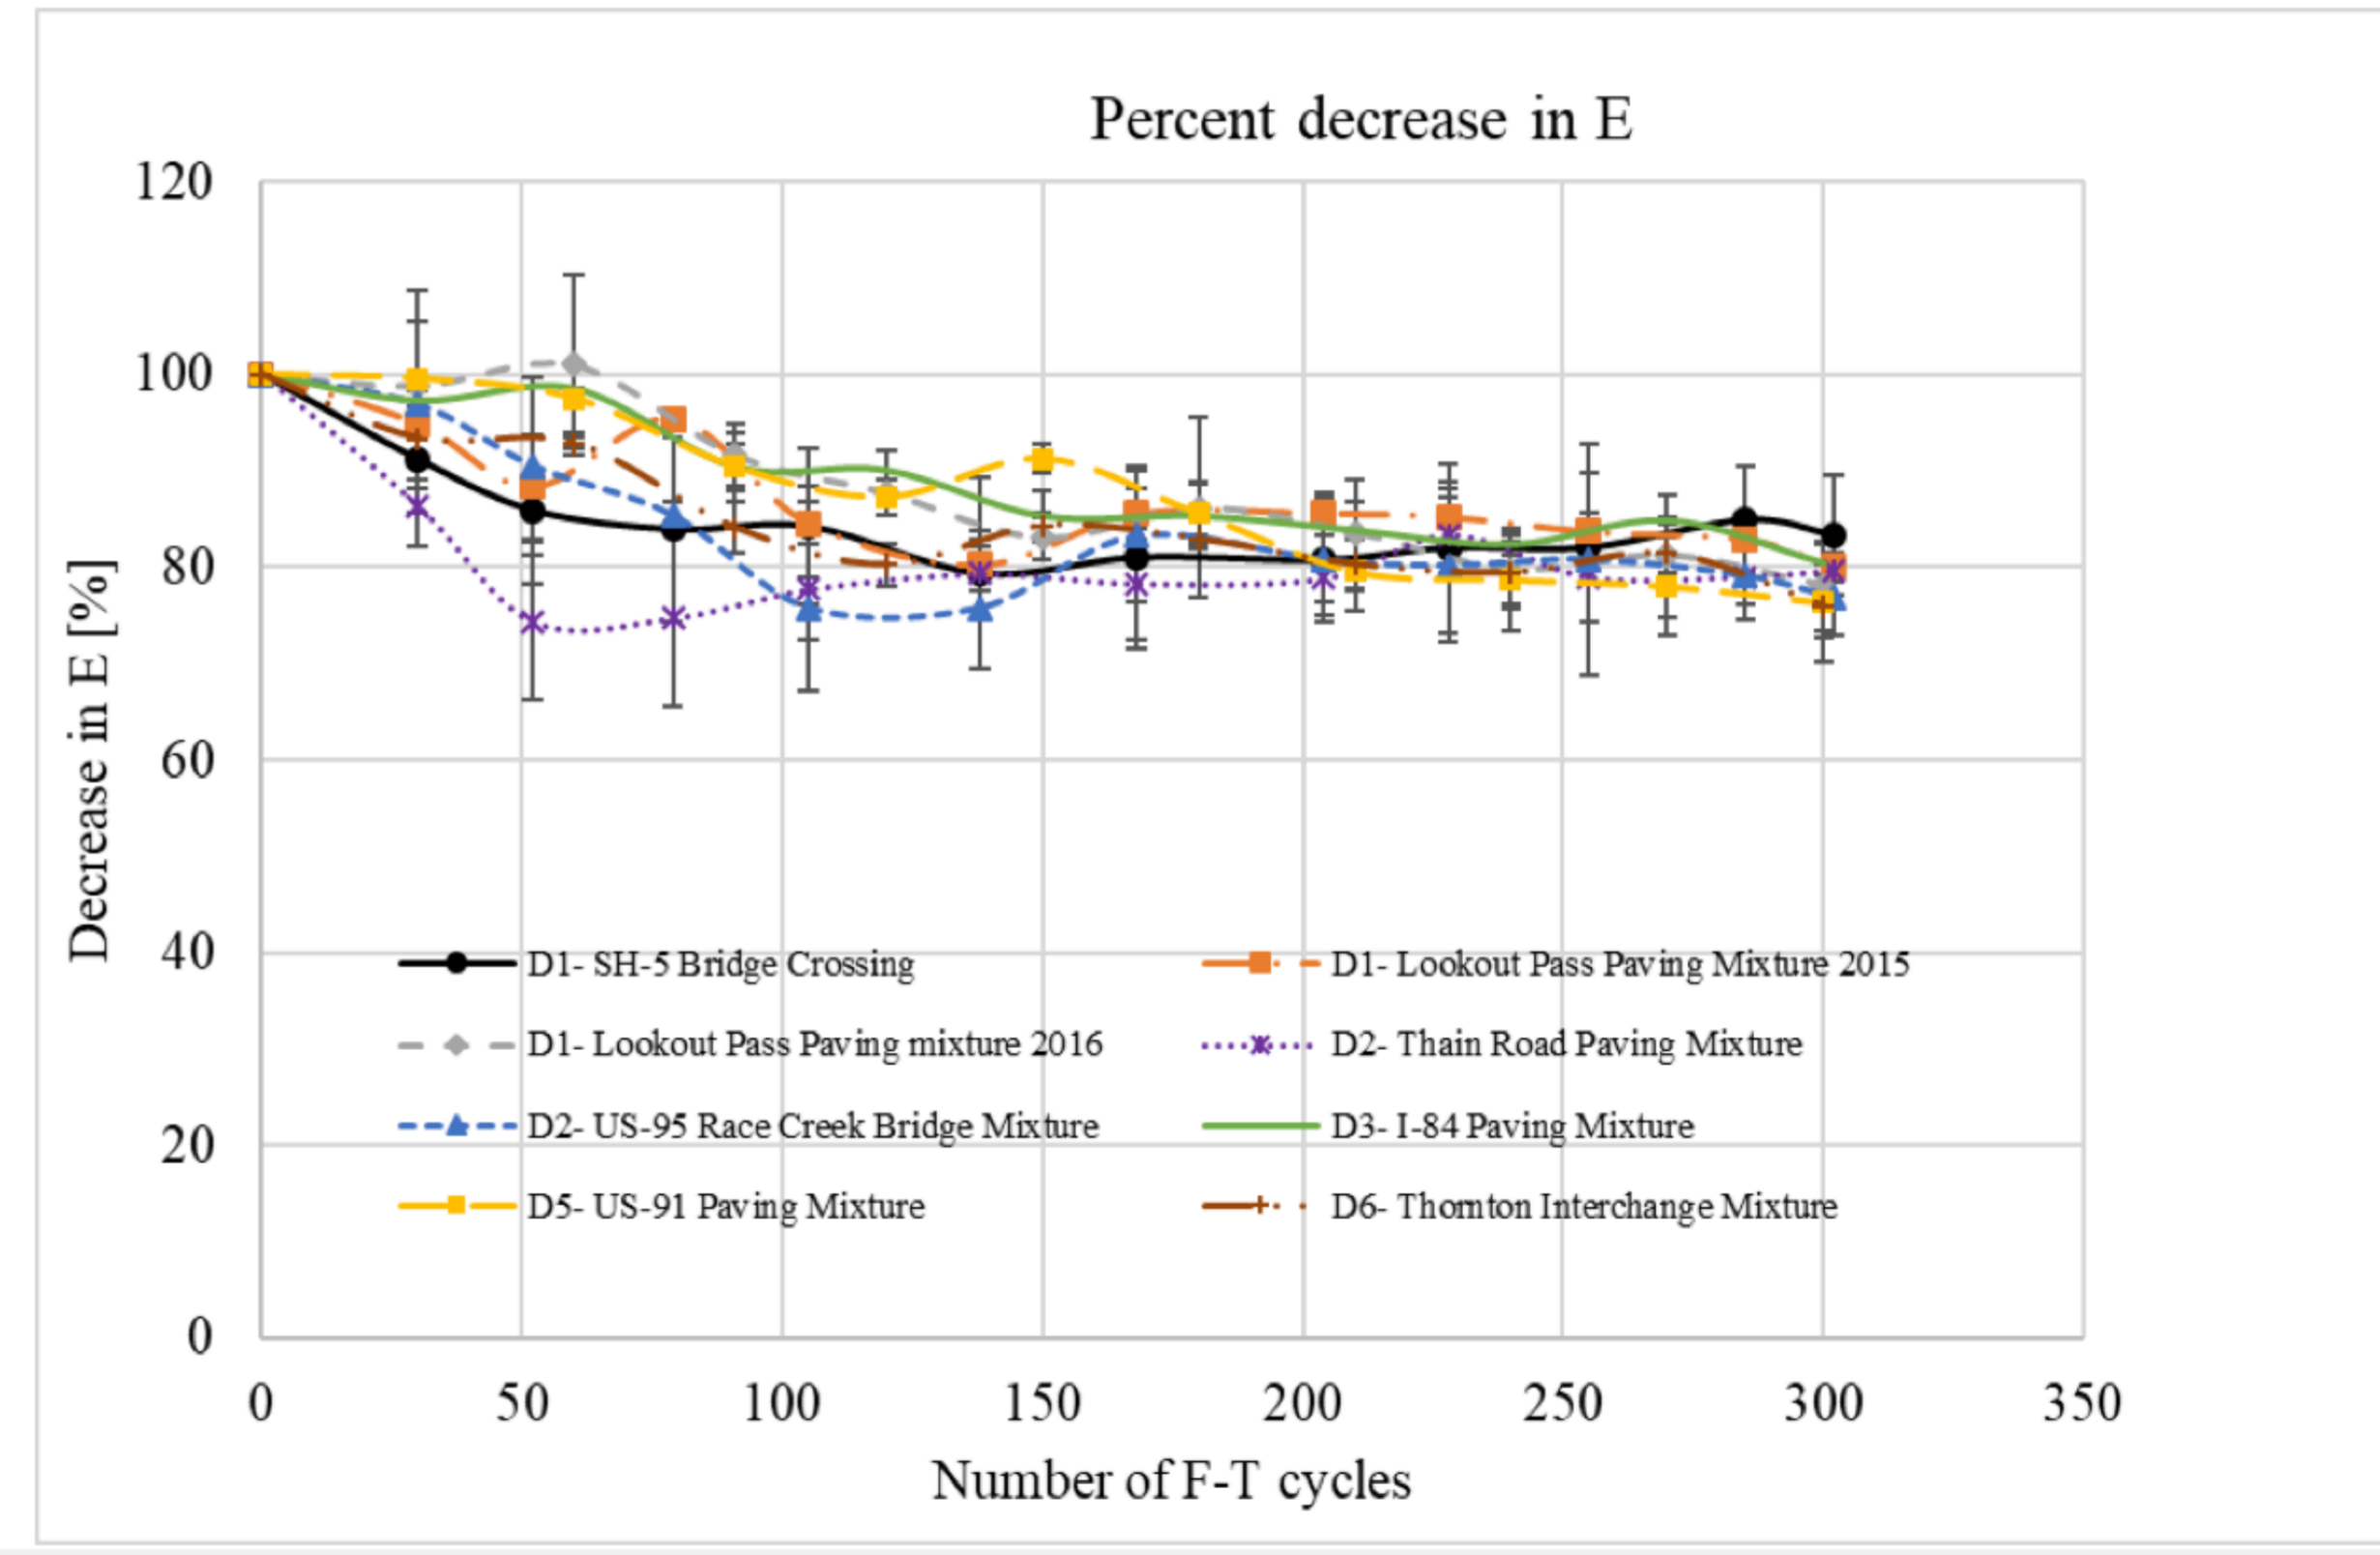
Variation in elastic modulus in F-T tests

- The mixtures currently used by ITD perform satisfactorily under F-T cycle, as evidenced by relatively high percentage retained elastic modulus and relatively low mass losses after being subjected to a total of 300 F-T cycles.
- The structural mixture (SH-5 Bridge crossing, Plummer) suffered a severe scaling, while other mixtures showed mild to moderate scaling. The reason for the severe scaling in Mix M1, could be because of the absence of supplementary cementitious materials- Fly Ash that inhibits the formation of calcium oxychloride (CAOXY) as observed by different authors.

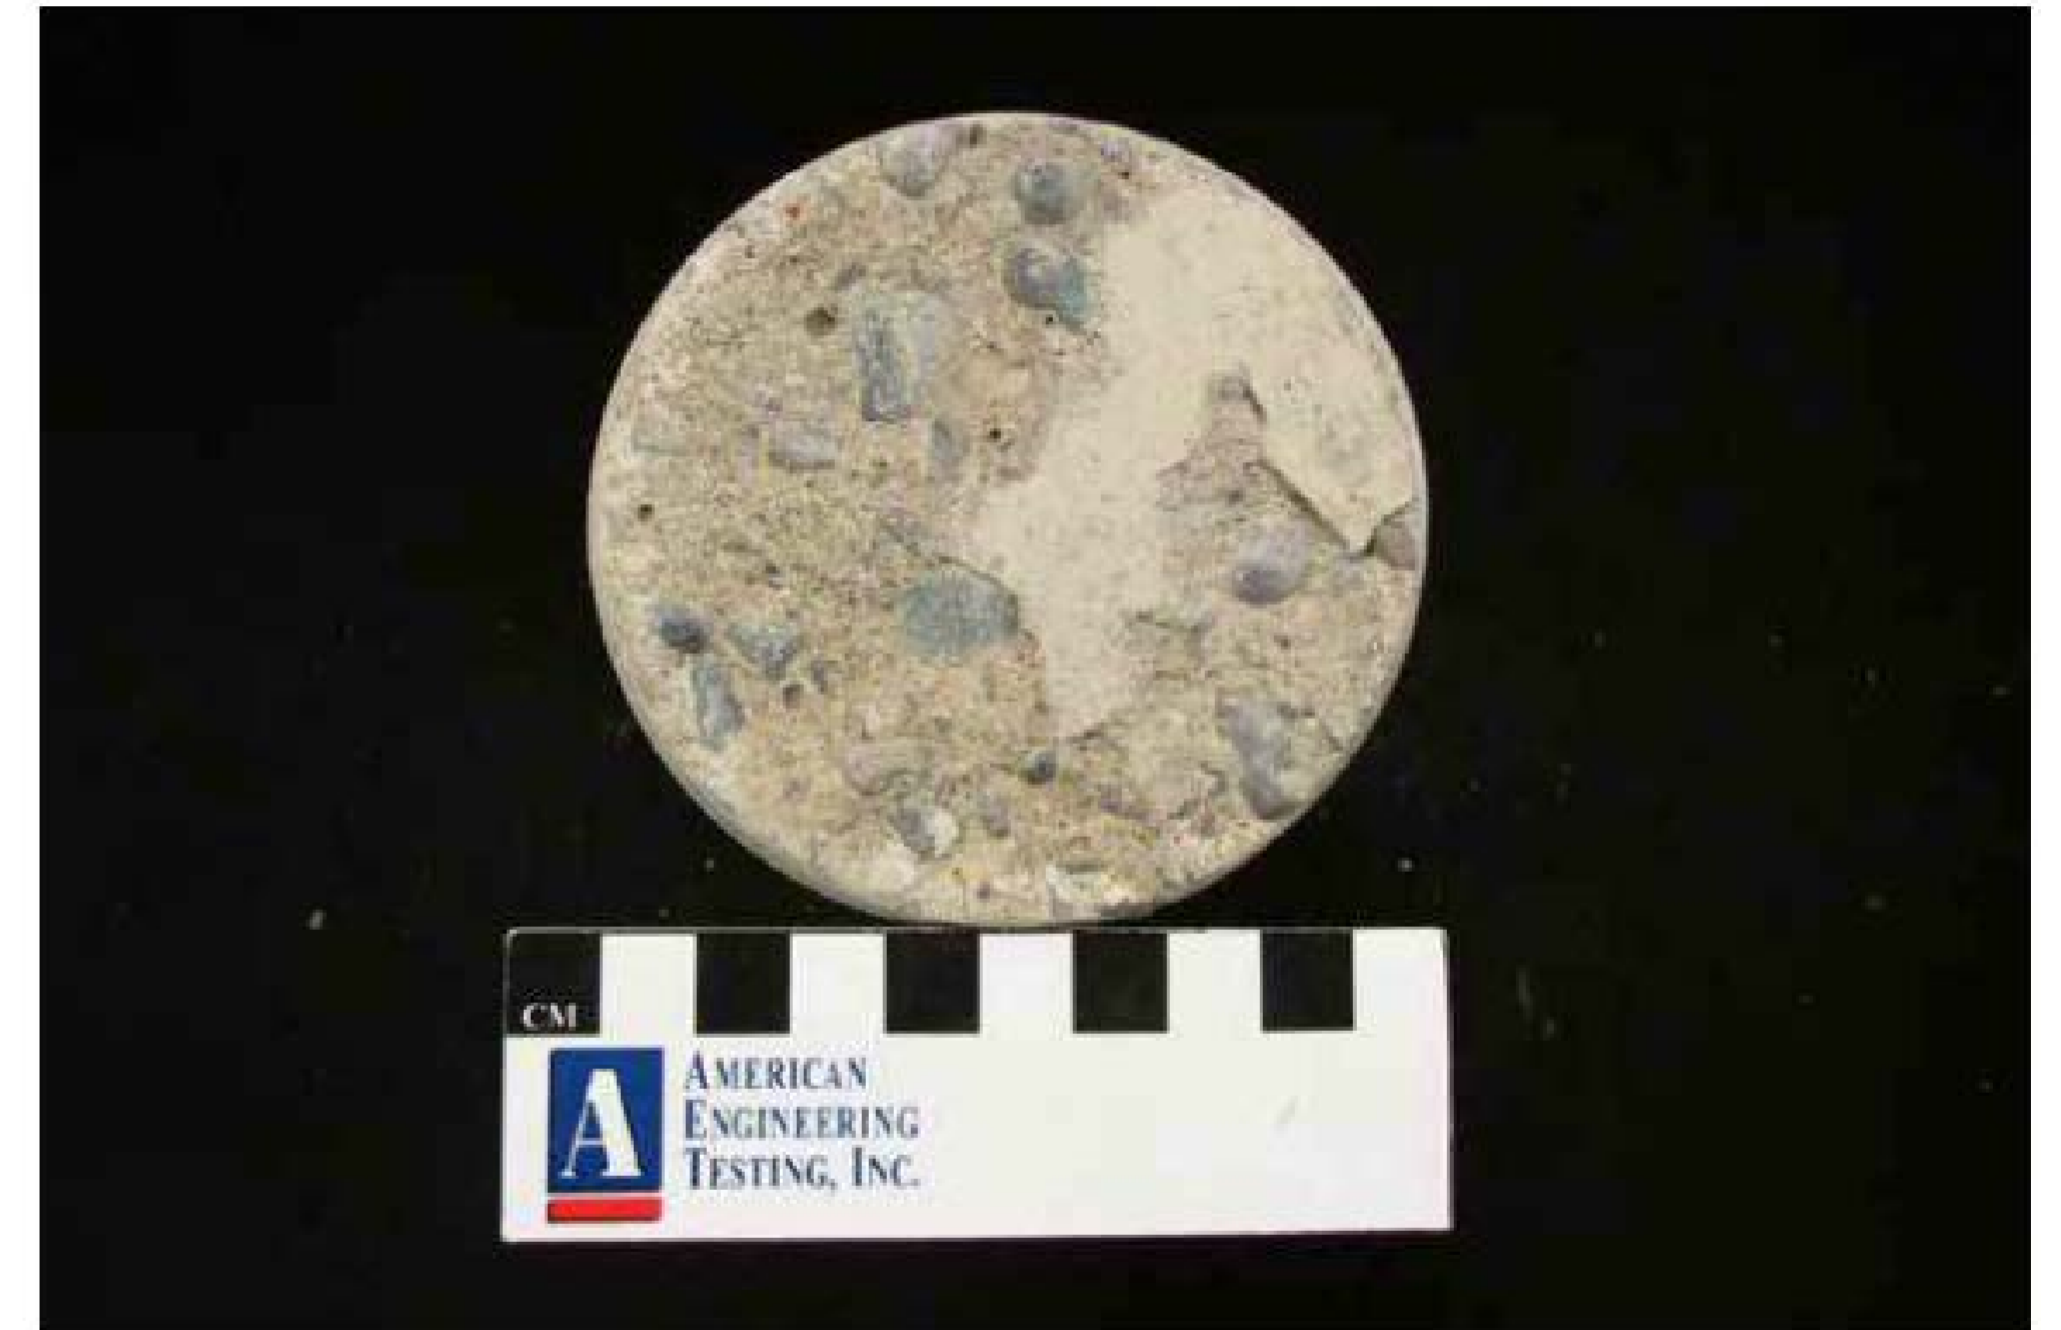
S-10 DESCRIPTION: Mostly scaled front surface of the core sample as received.

District 1 SH5, mostly scaled front surface of the core sample received.
