# IOWA STATE UNIVERSITY

Center for Earthworks Engineering Research

## Improving the Foundation Layers for Concrete Pavements TPF-5(183)

### David J. White, Ph.D., P.E.

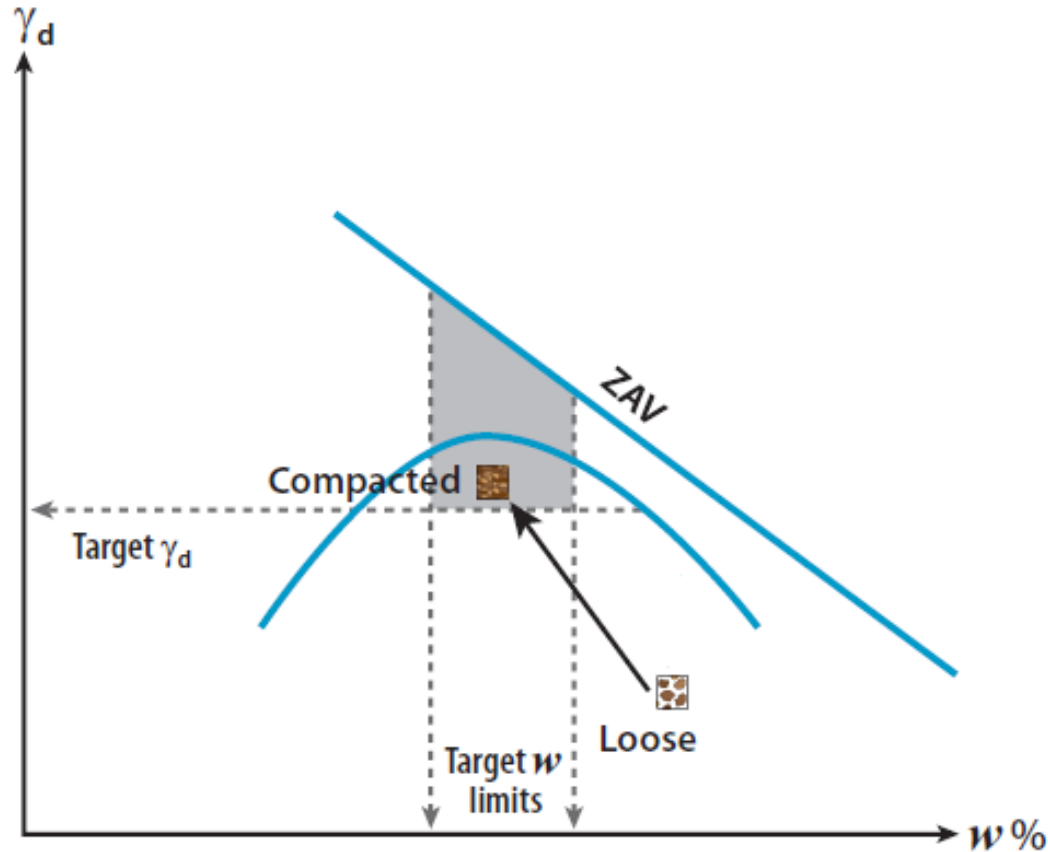
Relationship between moisture content and density of geomaterial  
(from White et al. 2010)

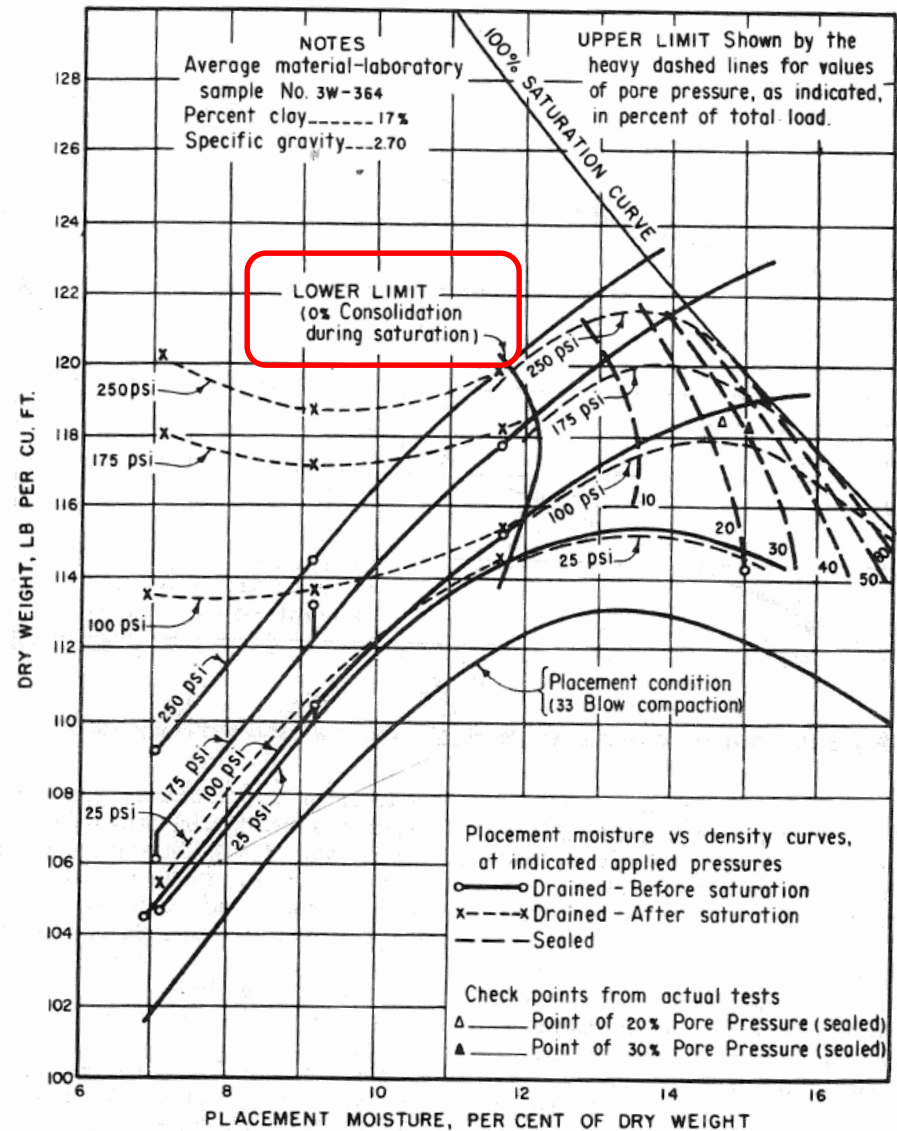
Moisture control limits can be set based on desired volume change characteristics as a function of overburden stresses.

Fig. 8.16 Placement moisture control. (After Holtz, 1948.)

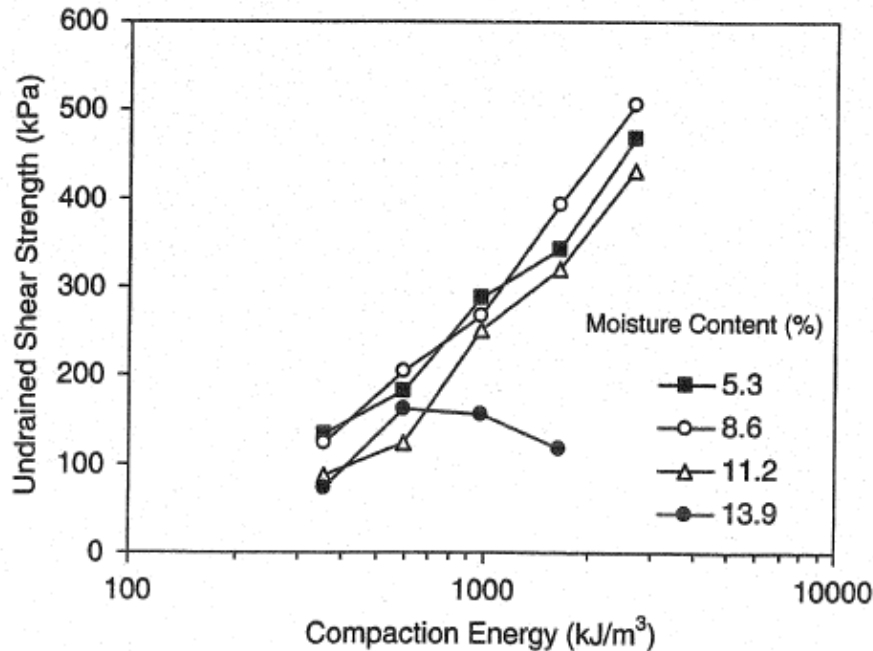
Compaction energy and moisture content change density about 10% and strength/stiffness 500%.

FIGURE 6 Semilogarithmic relationship between undrained shear strength and compaction energy as a function of water content.

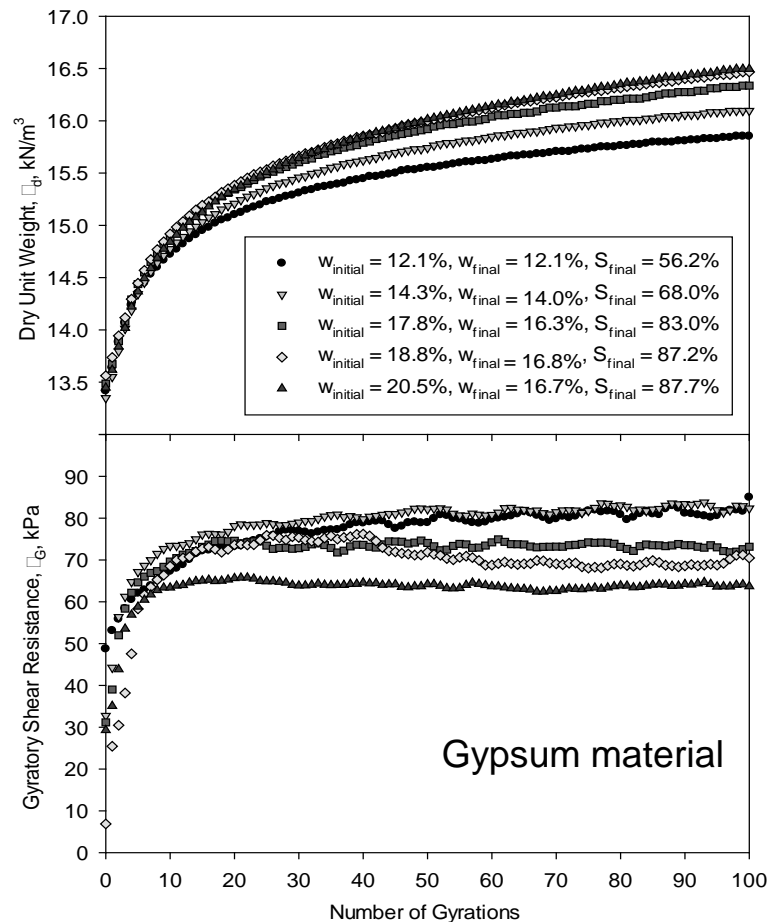
# Laboratory gyratory compaction tests can provide moisture-density-shear strength-energy relationships.

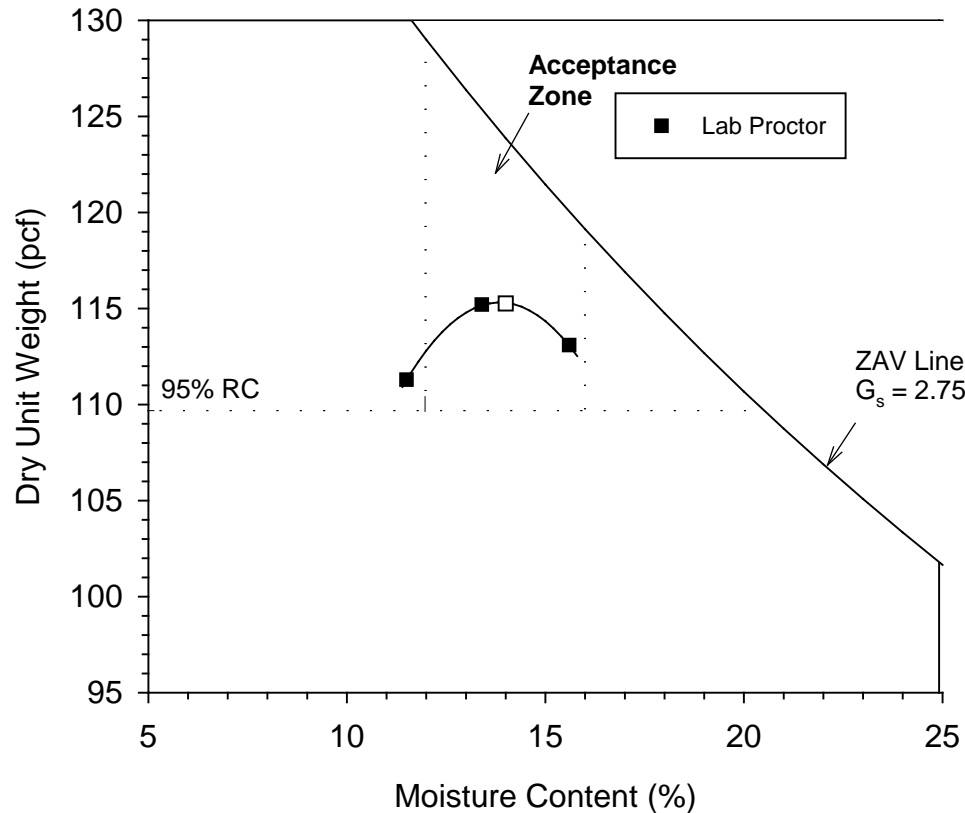
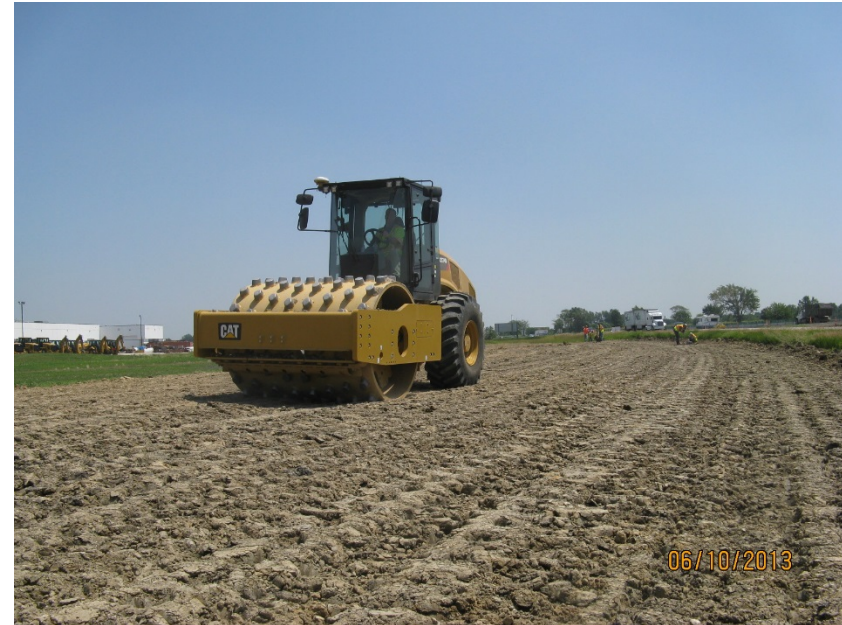
# Traditional density based specifications indicate bias during QC testing.

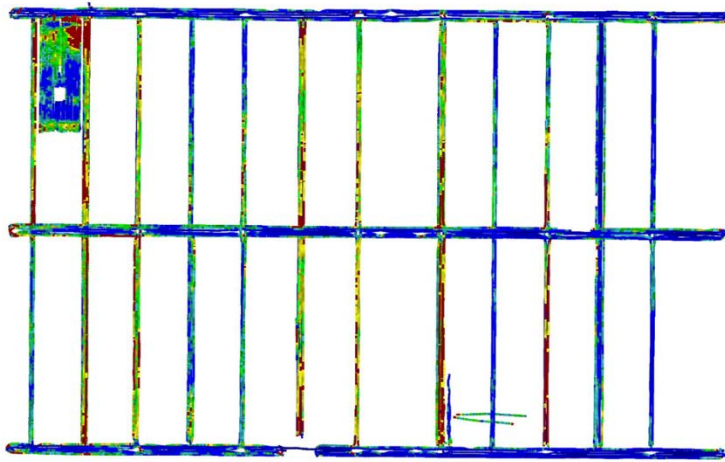
# QC/QA nuclear testing showed lack of reproducibility and did not capture the wide range in stiffness values measured.

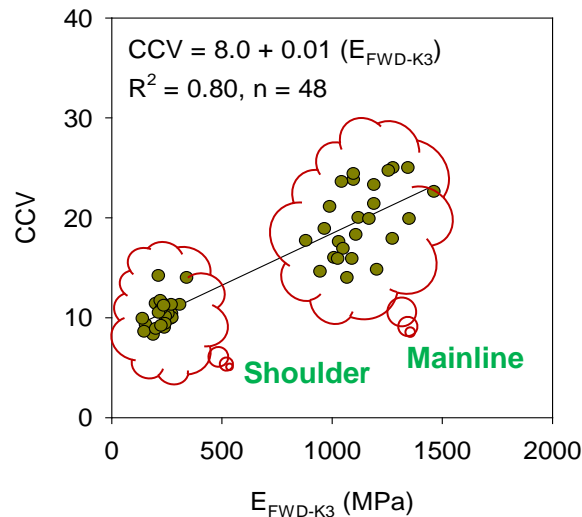
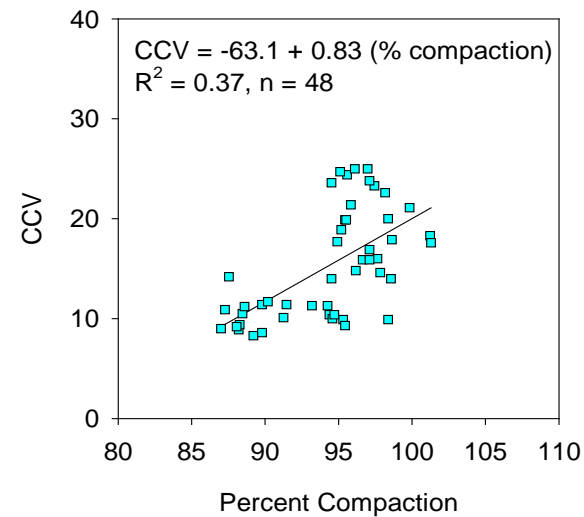
# IC measurements on HMA also correlated better with FWD modulus values than with density

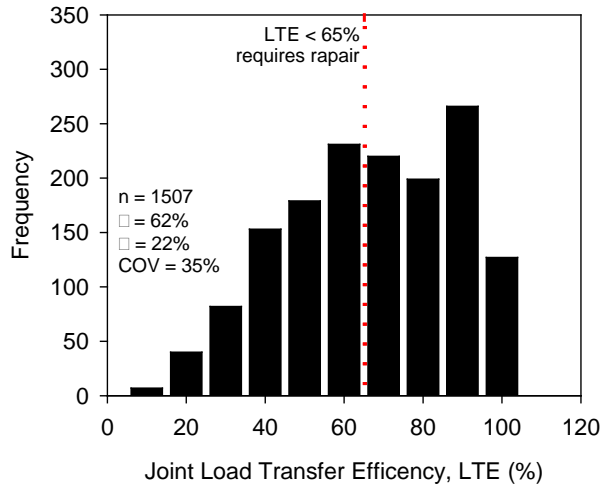
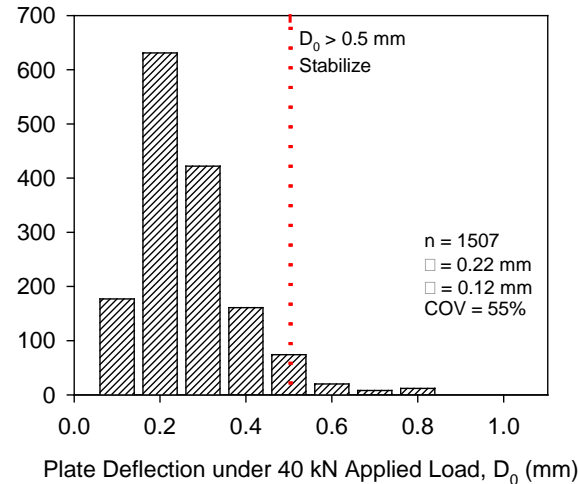
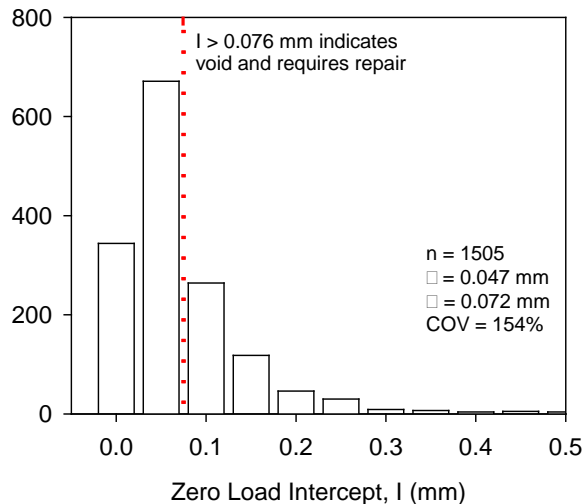
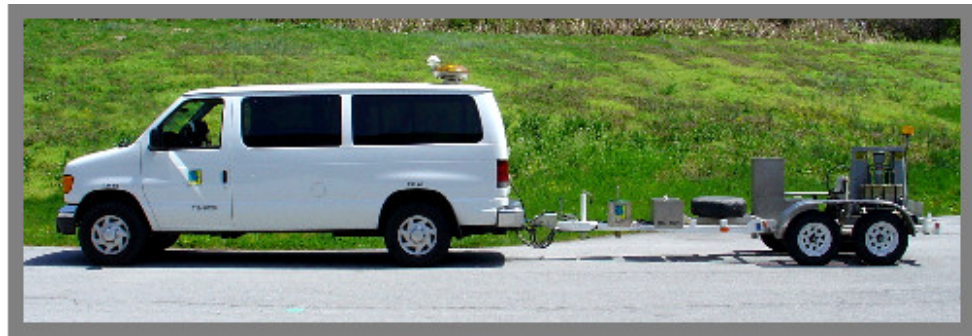
# Penn DOT used FWD testing to determine locations for foam stabilization

Joints with  $LTE < 65\%$ ,  $D_0 > 0.5$  mm, and  $I > 0.076$  mm require joint patching and stabilization, and all joints with  $I > 0.076$  mm require stabilization only

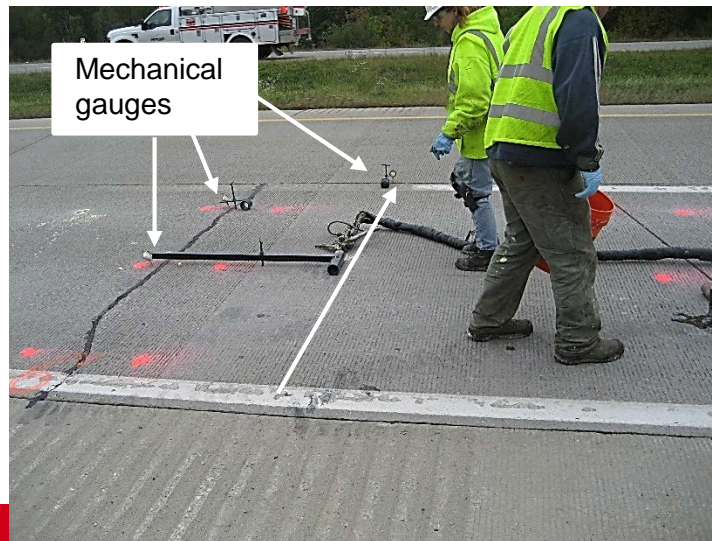
Foam was injected under pressure and pavement lifting was monitored to reduce faulting at cracks

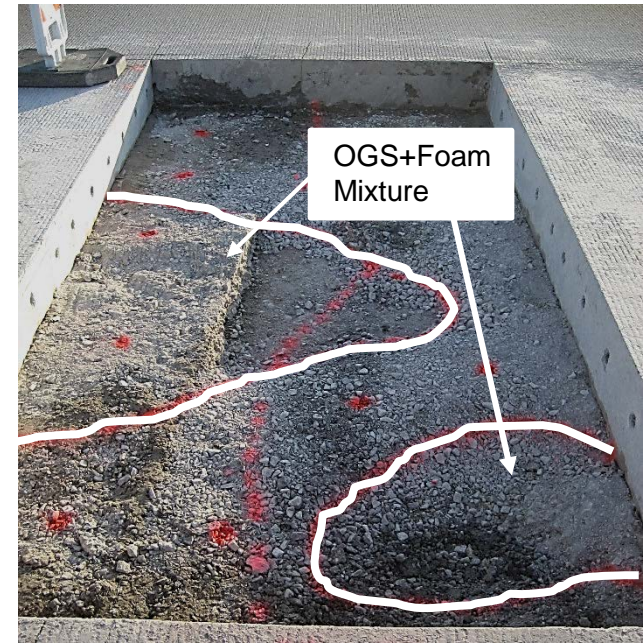
# Testing in patching areas showed variable stiffness conditions due to non-uniform foam penetration

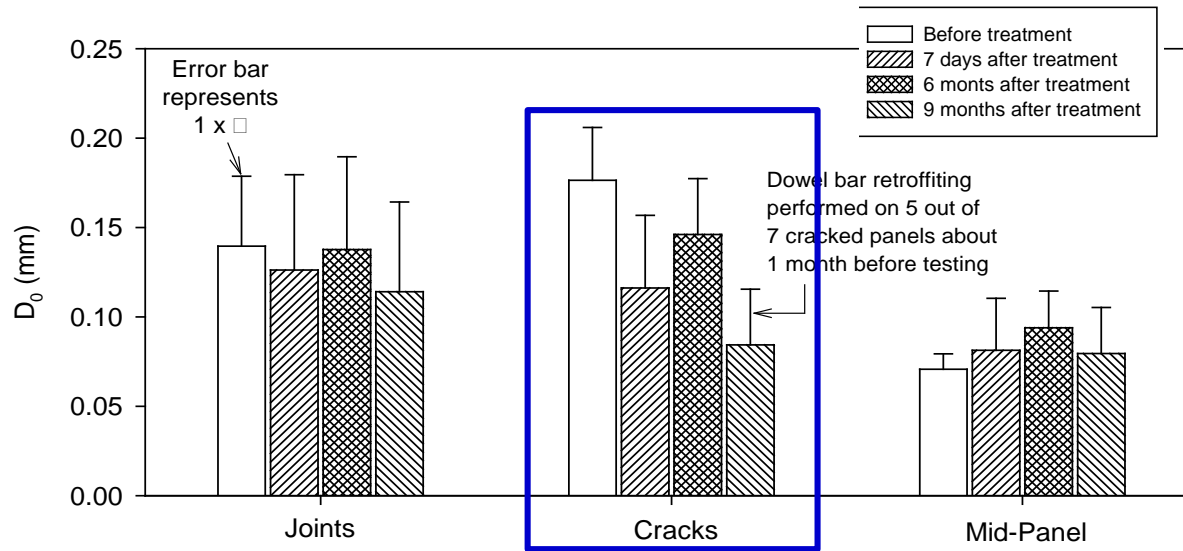
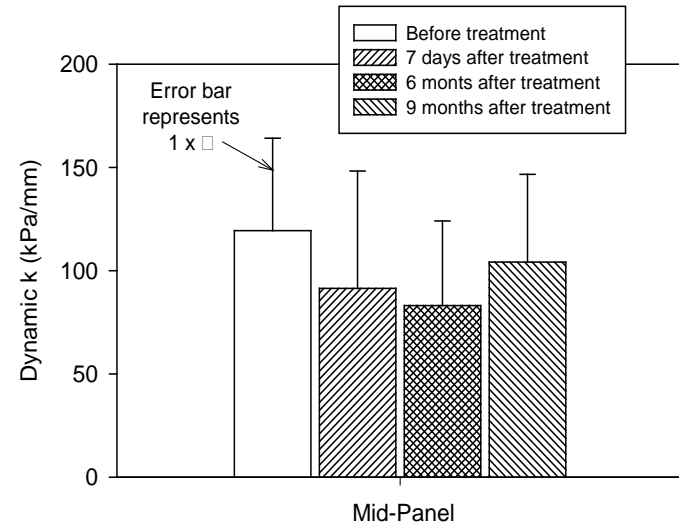
# FWD testing after treatment showed statistically significant improvement near cracks, but not at joints or mid-panel

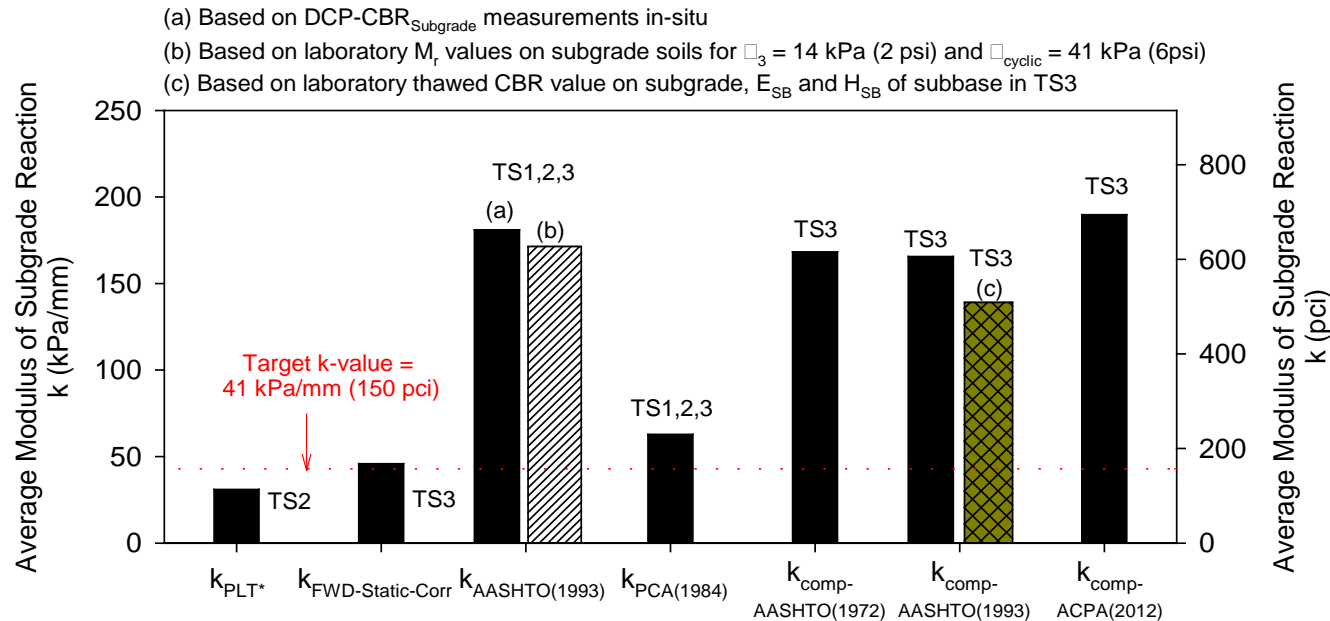
# Comparison between $k$ determined from PLT, FWD, DCP, and lab $M_r$ testing revealed significant variability

**NOTE:**  $k_{comp}$  values are determined by accounting for subbase layer thickness and moduli values following ACPA and AASHTO design guide procedures

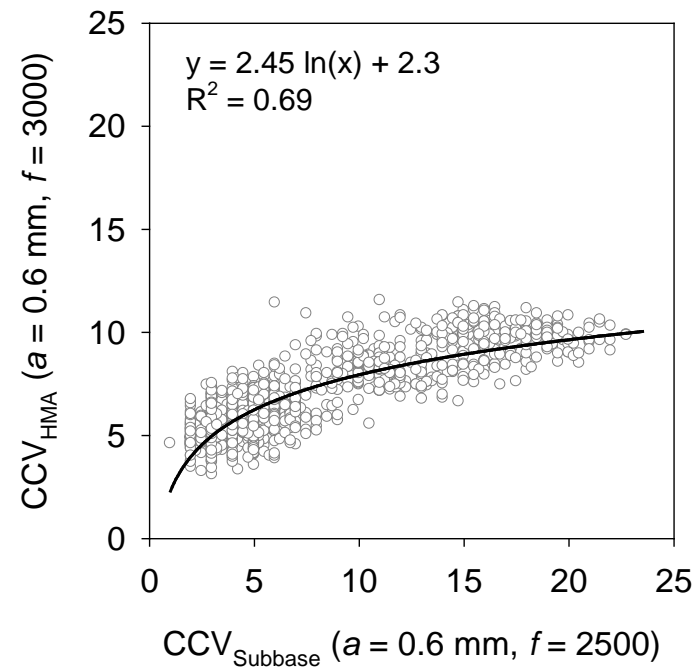
# Foundation layer stiffness has a large influence on stiffness measurements over asphalt layer.

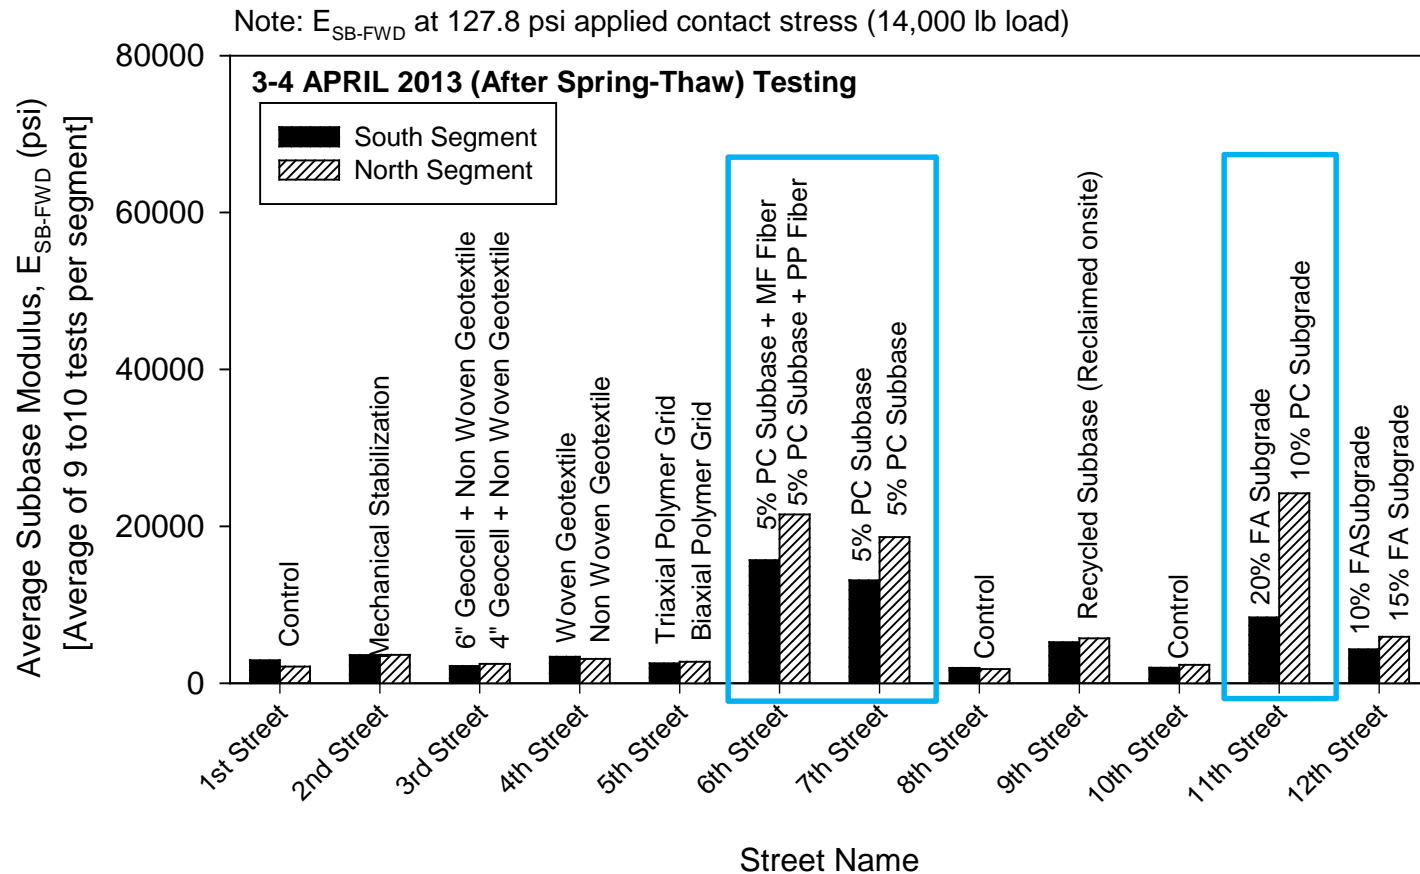
FWD testing showed 5 to 20 times higher moduli on *cement stabilized sections* during spring-thaw

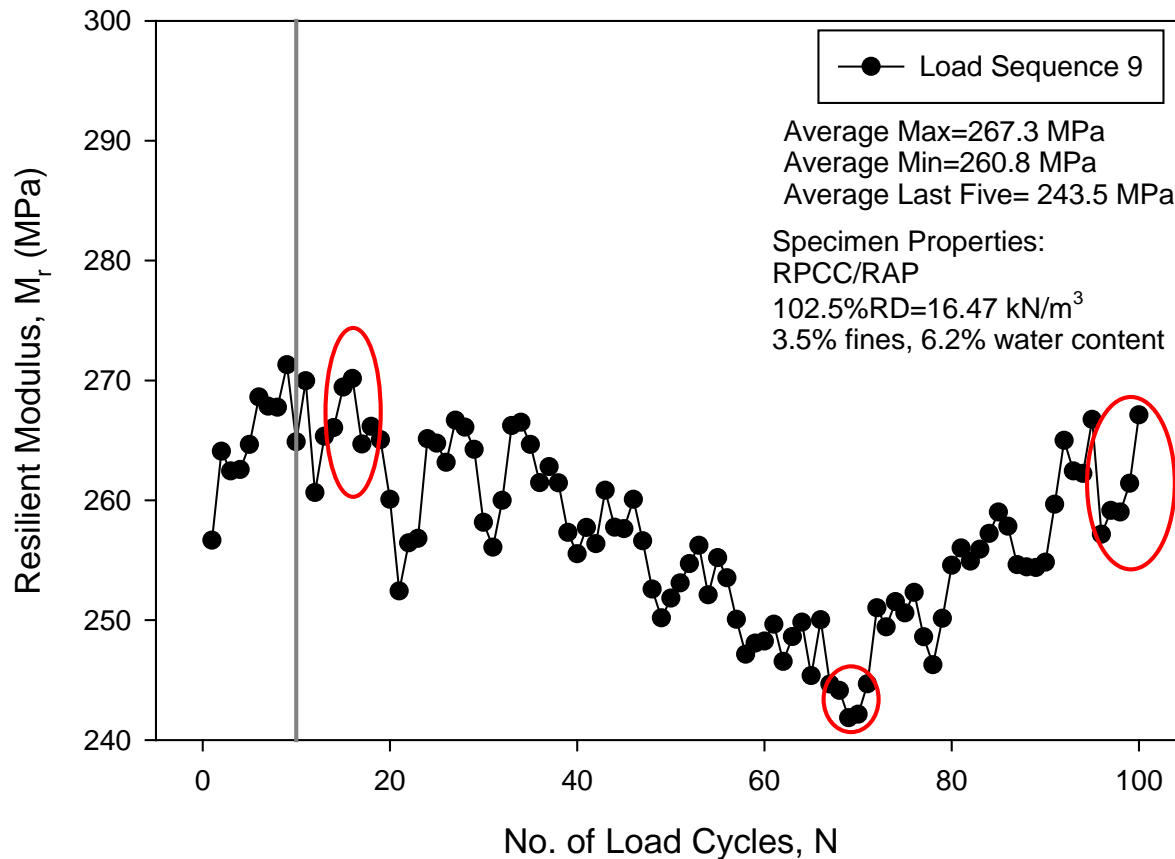
Lab  $M_r$  testing standards require averaging last five cycles which may not be always representative

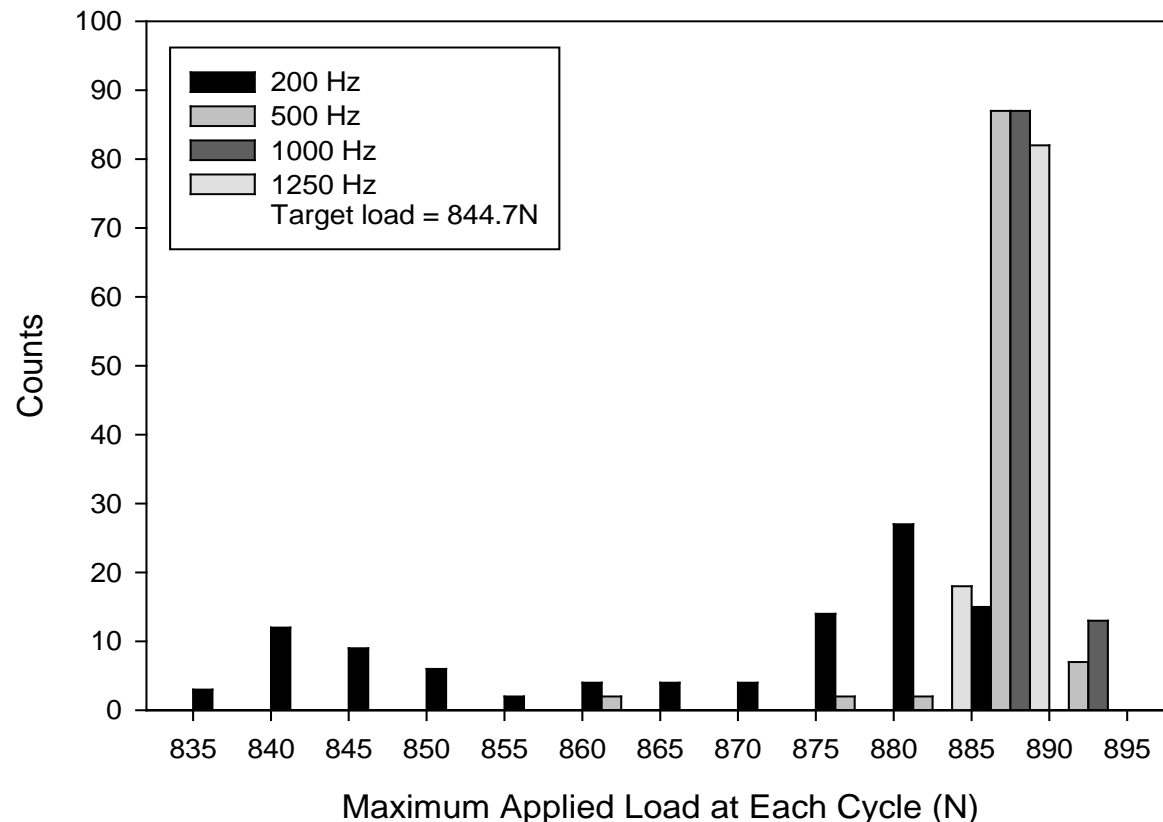
AASHTO T307 protocol recommends sampling @ 200Hz which does not adequately capture the peak stresses – 500 Hz or greater is recommended.

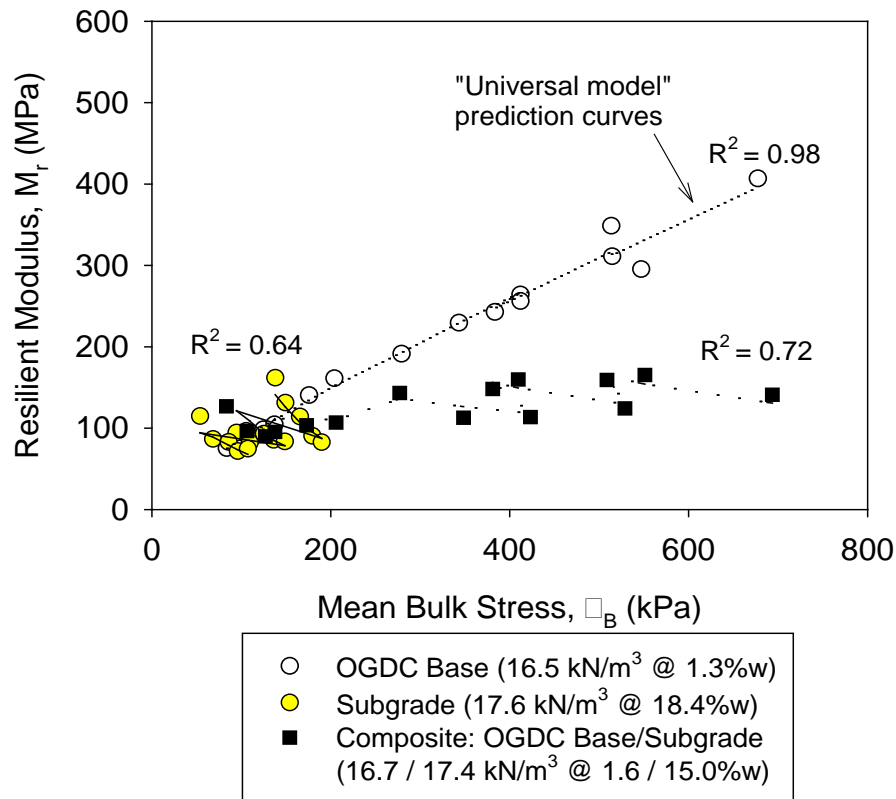
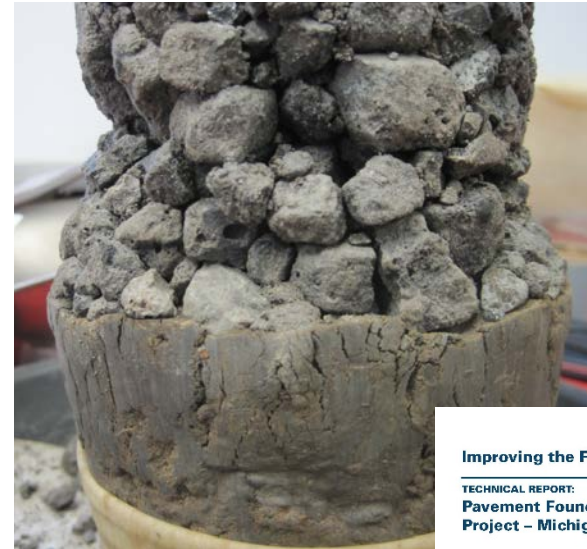
$M_r$  testing on composite samples showed that the “weak” subgrade layer governs the composite sample modulus

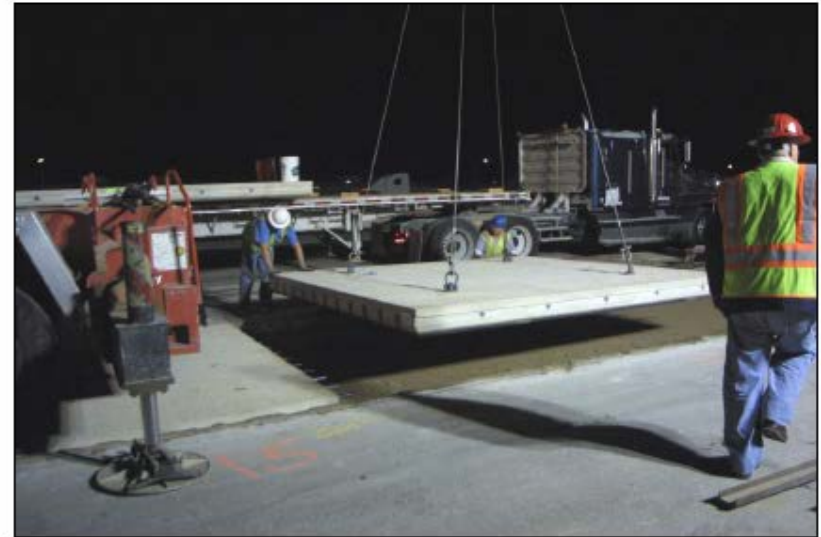
FWD testing on precast panels showed improvements in terms of FWD deflection and LTE

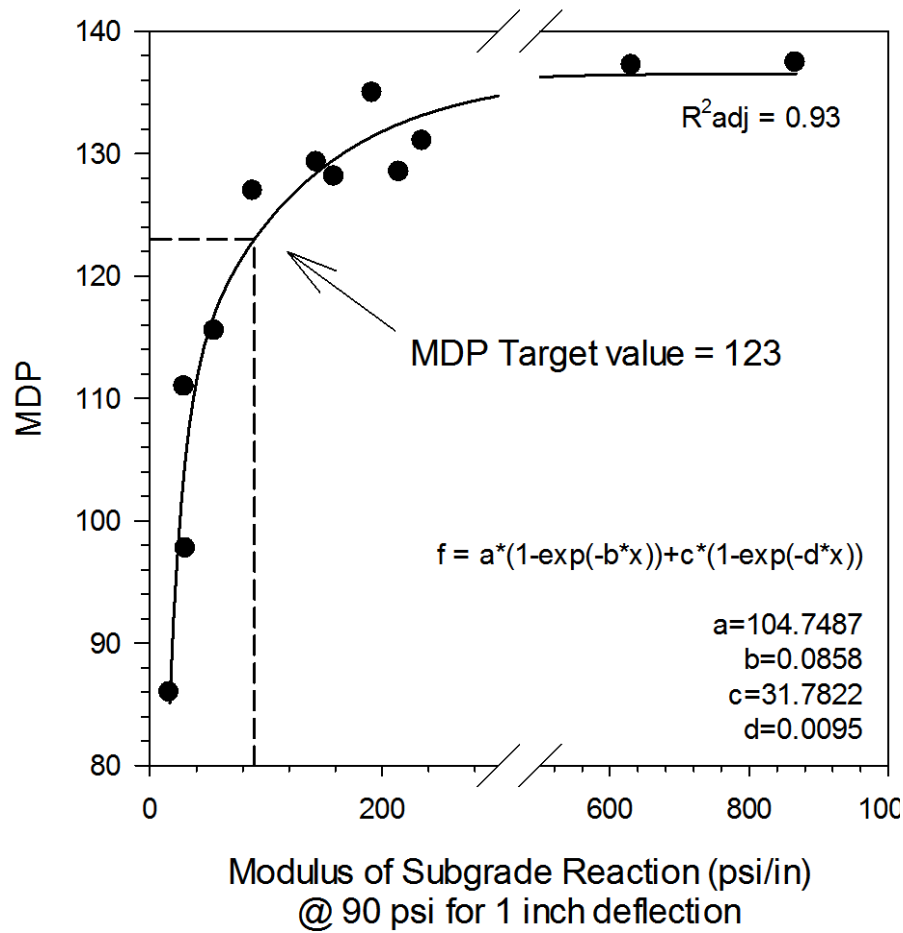
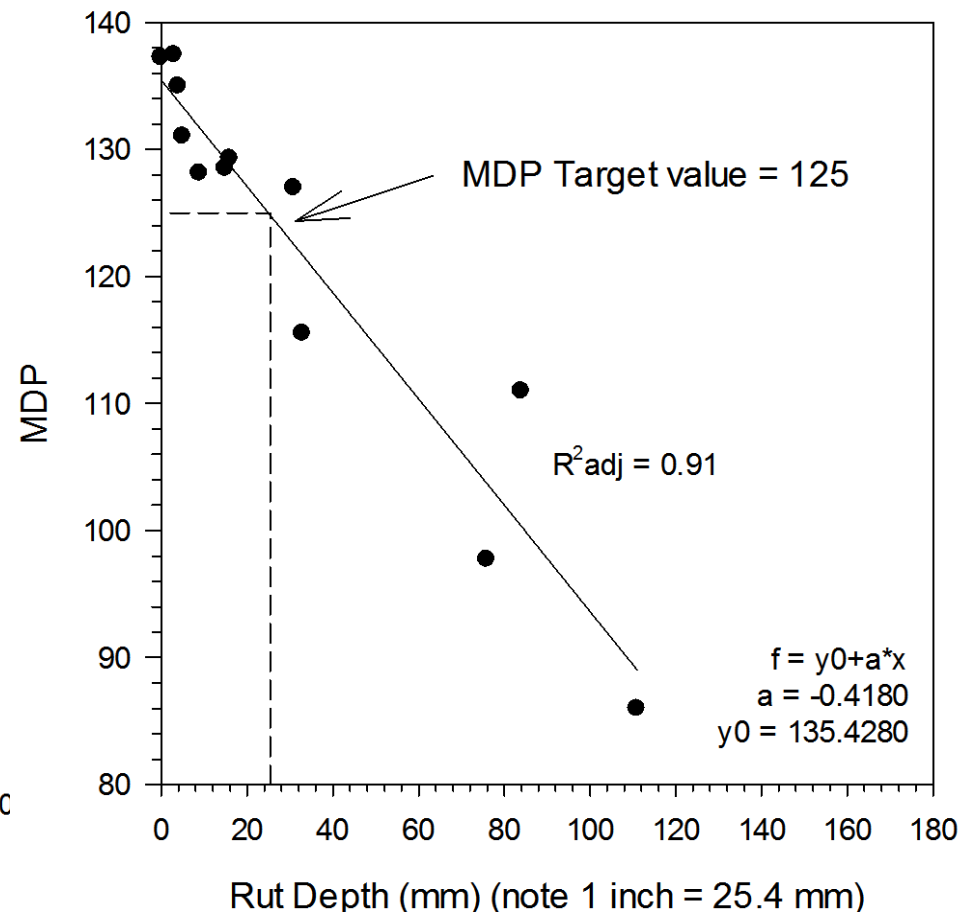
# Proof rolling can be substituted with stiffness-based assessment.

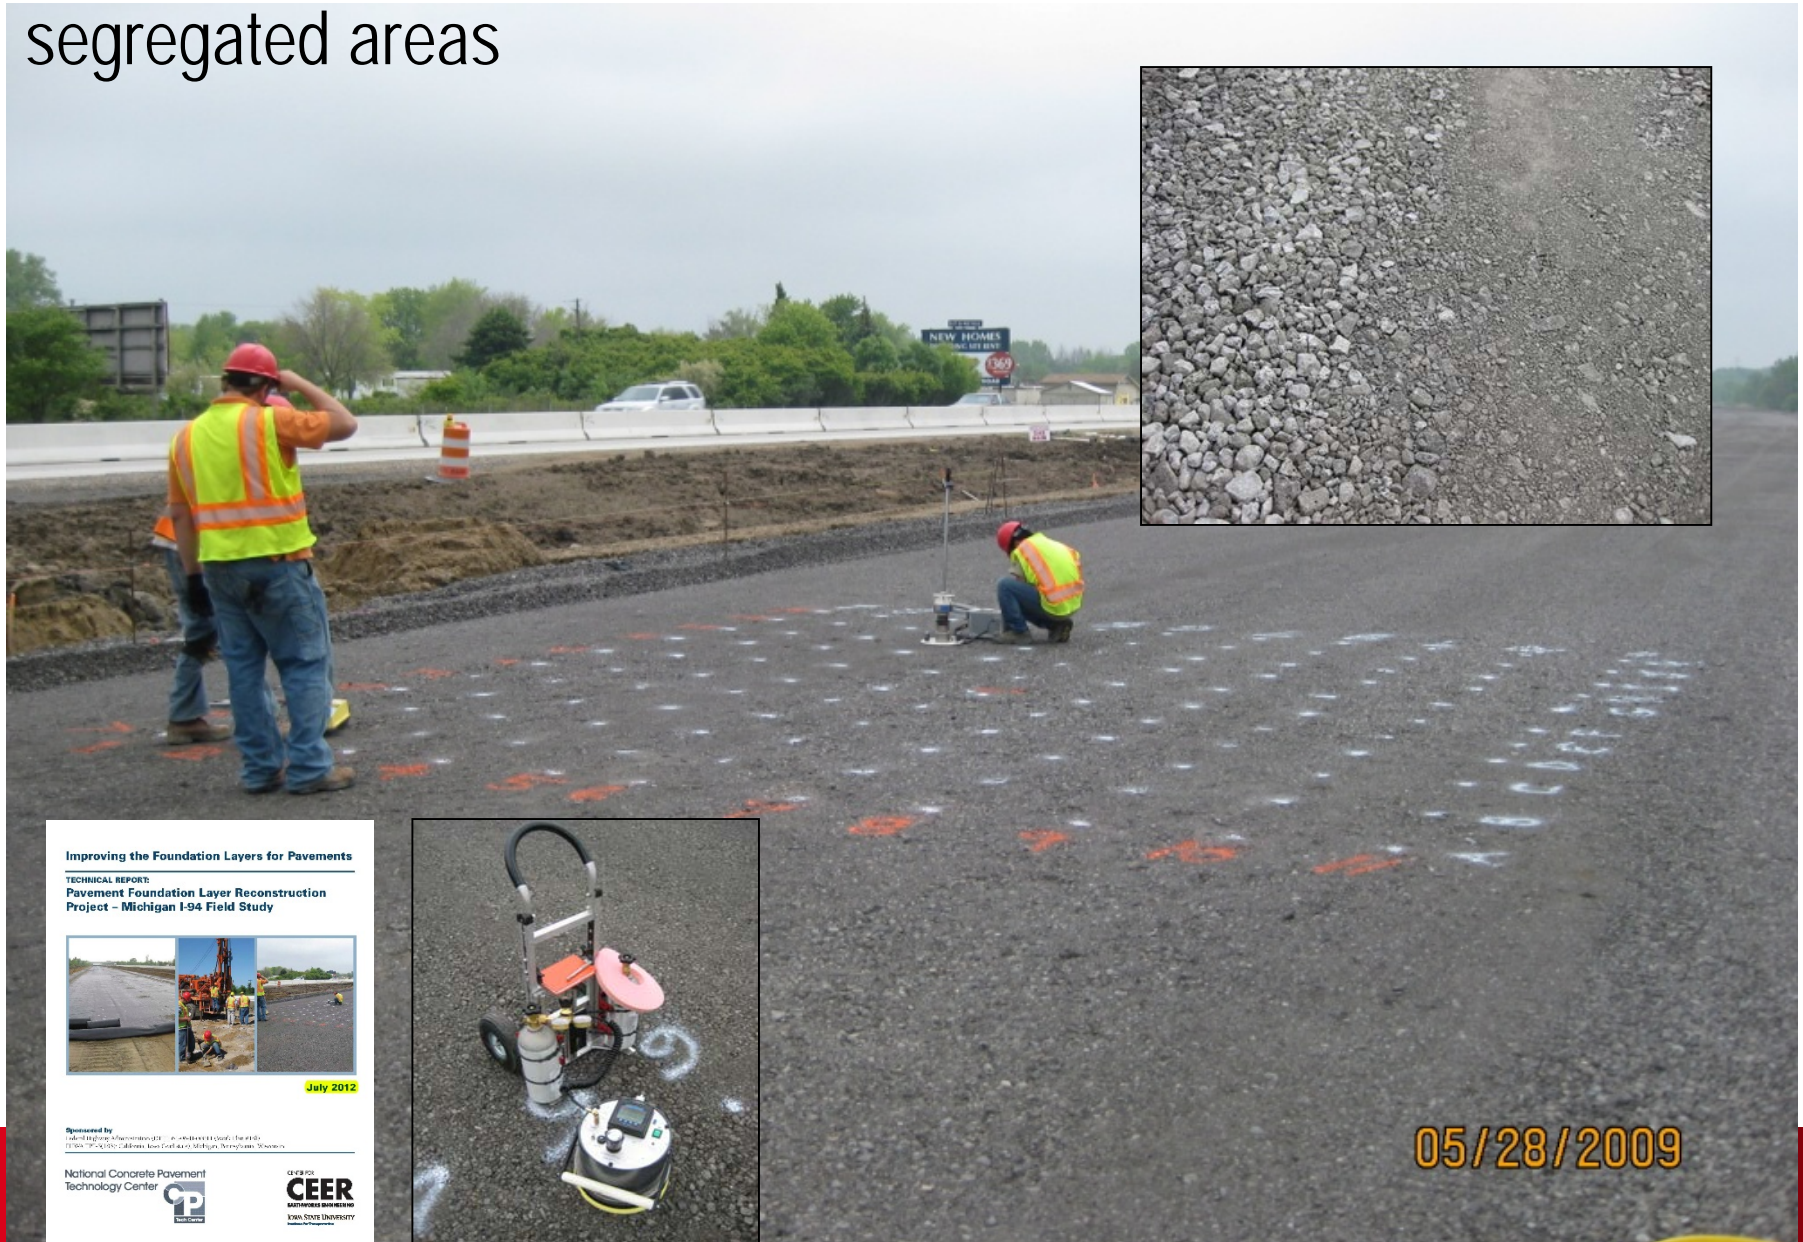
# APT testing was performed in dense-grid pattern to identify segregated areas

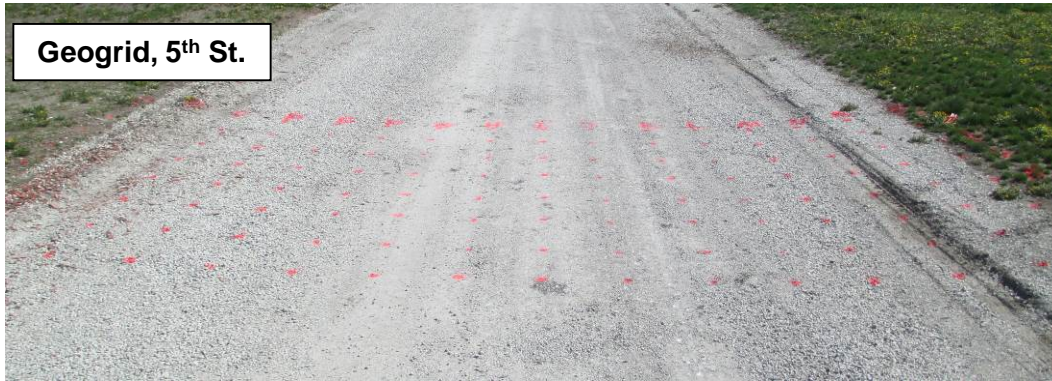
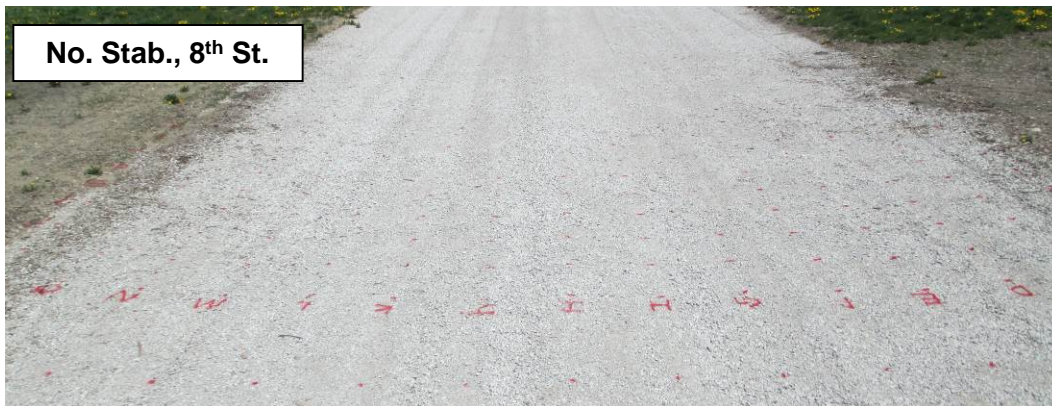
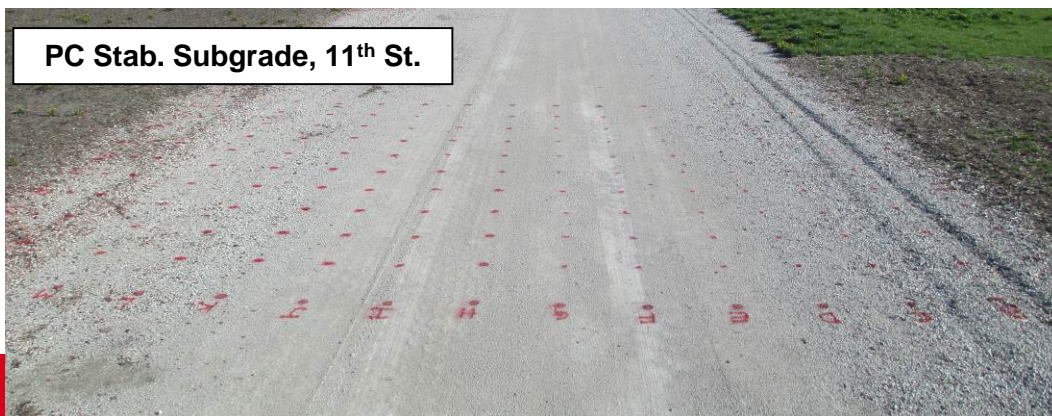
# Subgrade support conditions and trafficking affect particle breakdown

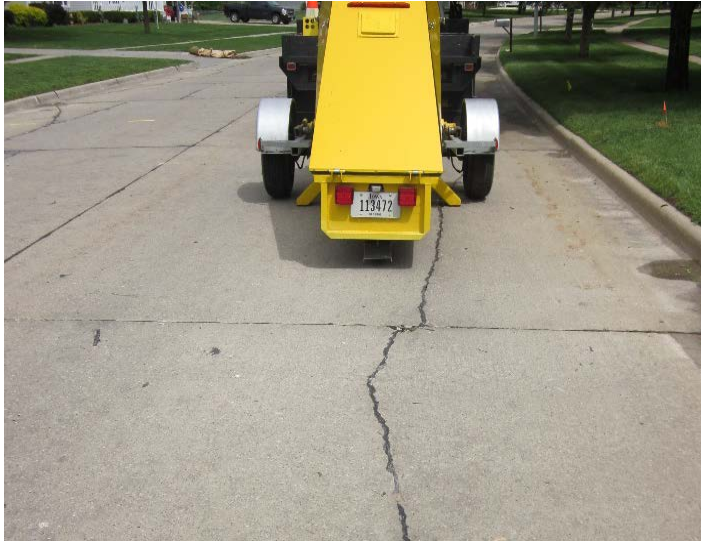
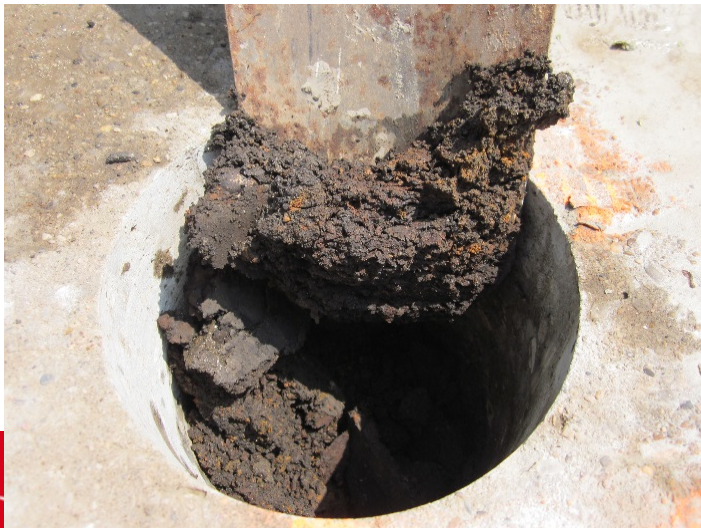
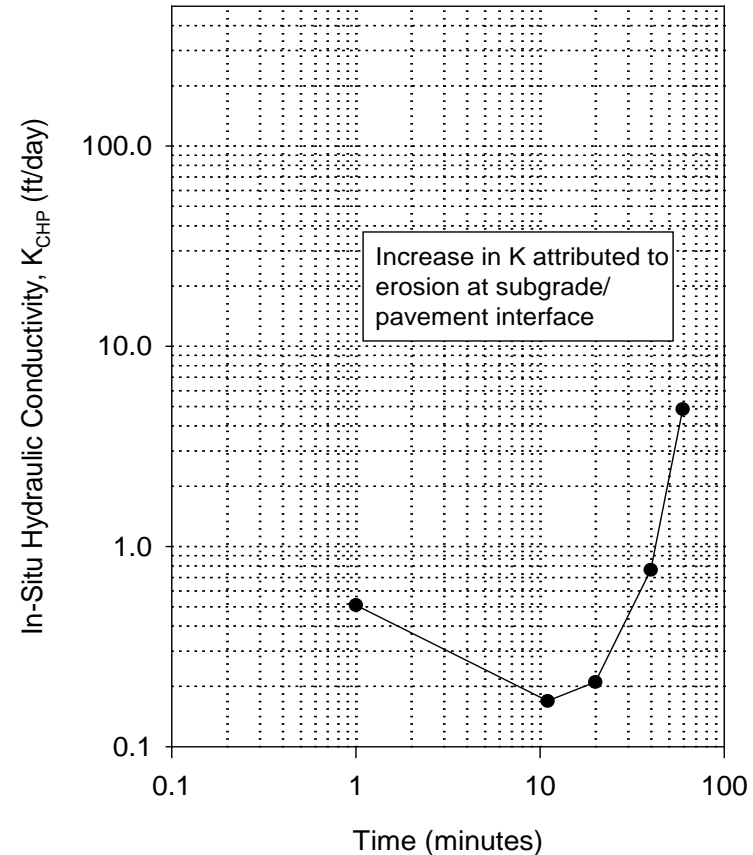
# CHP Tests under existing pavements showed evidence of erosion at the interface

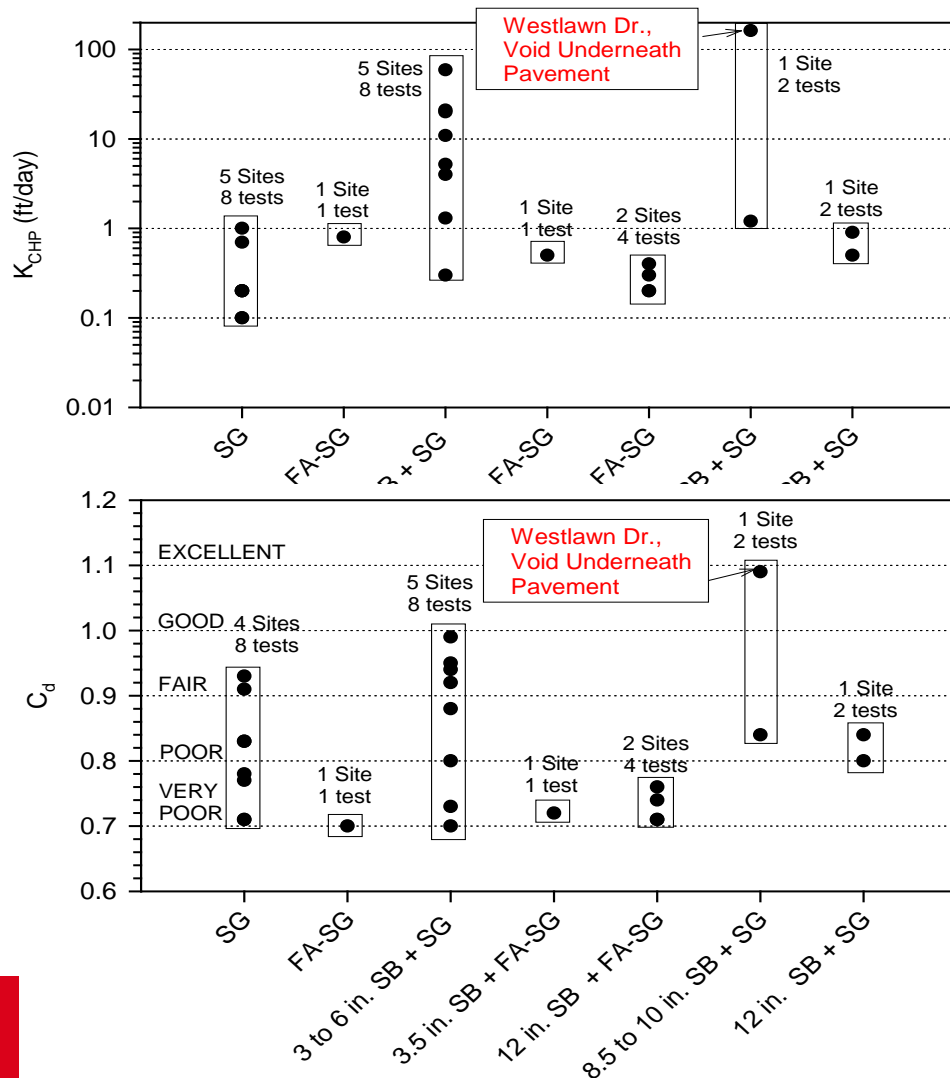
# CHP tests results on a wide range of support conditions (Low Volume Pavements)

Tests conducted at 16 Sites (28 tests)

*Increasing subbase layer thickness did not necessarily improve  $C_d$  or  $K$  value*
