# IOWA STATE UNIVERSITY

Center for Earthworks Engineering Research

## Improving the Foundation Layers for Concrete Pavements TPF-5(183)

### David J. White, Ph.D., P.E.

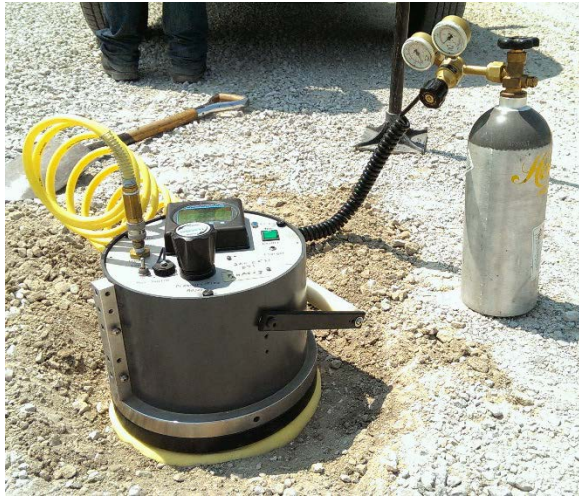
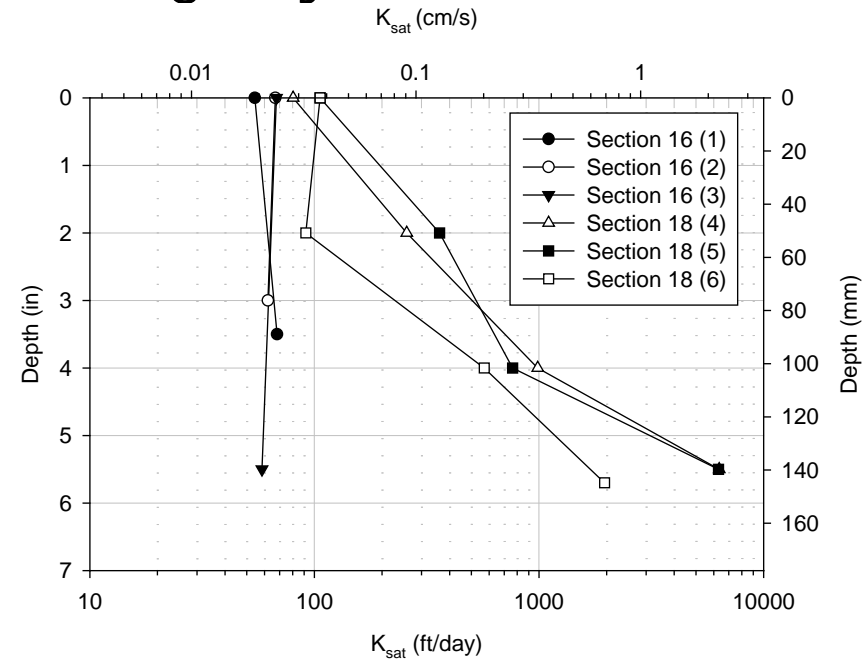
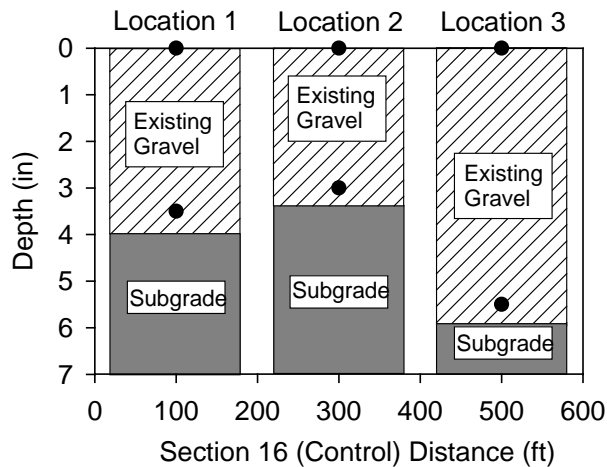
# Use of geocomposite active drainage systems can improve subsurface drainage

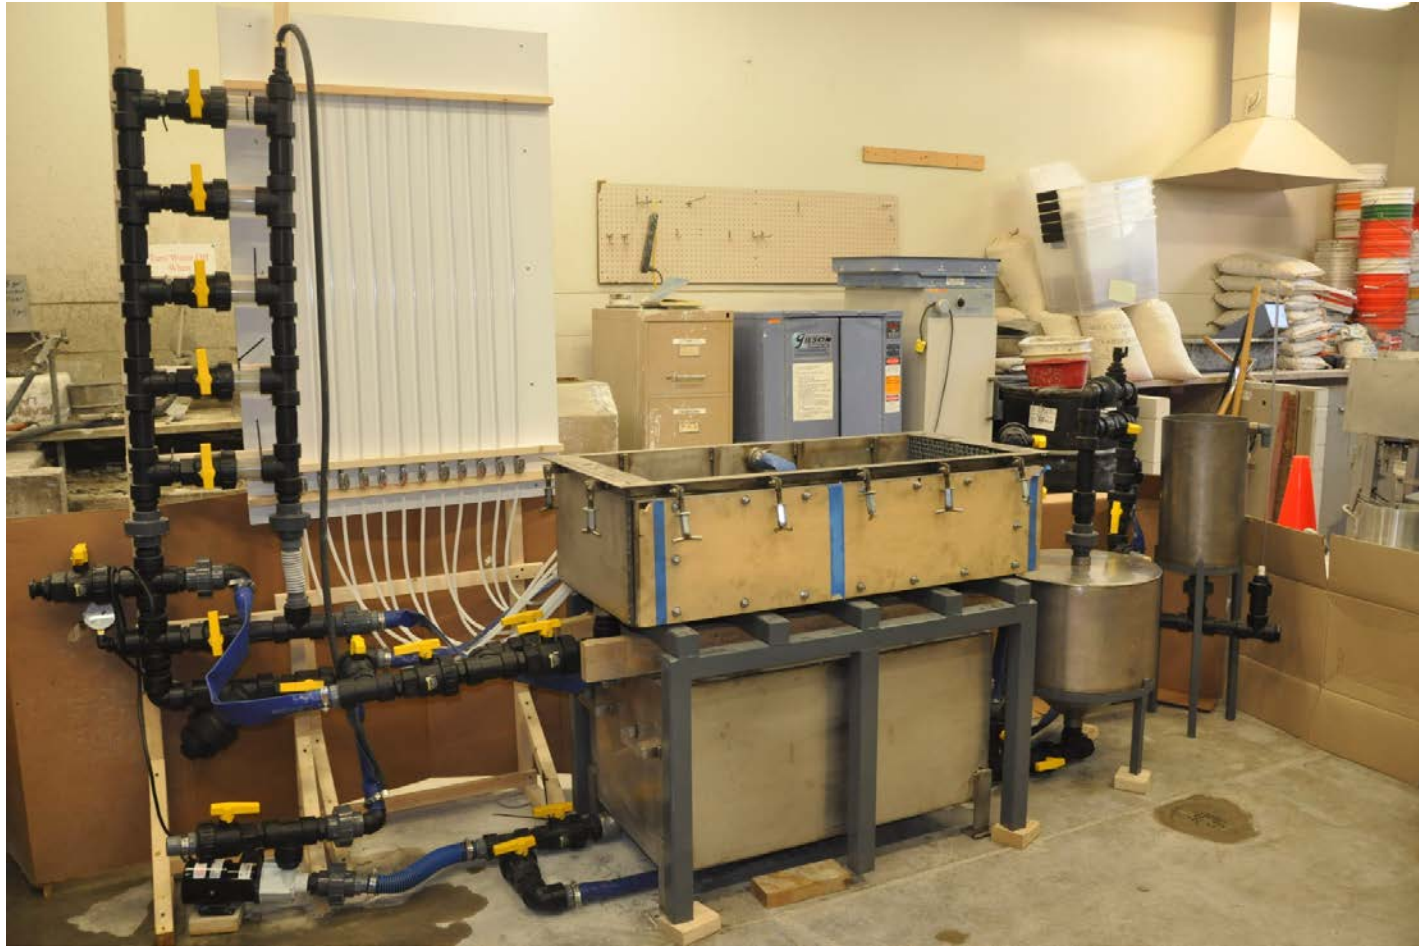
Laboratory horizontal permeability test device was fabricated at ISU to simulate field drainage conditions

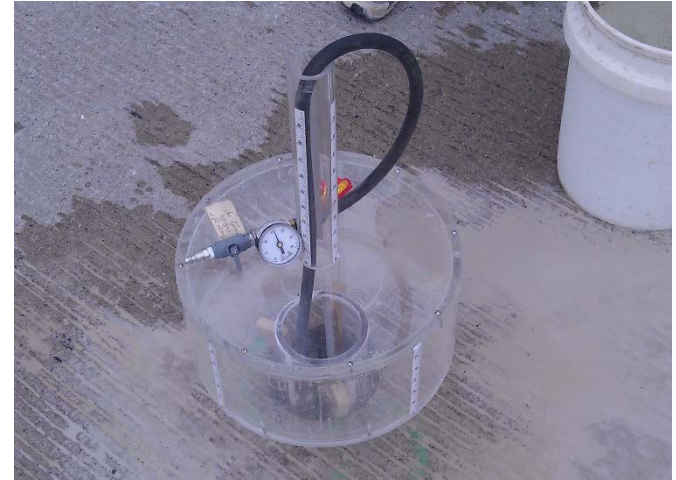
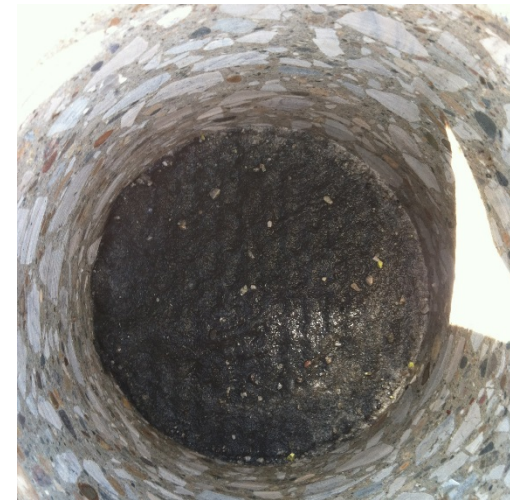
2 to 4 orders of magnitude higher  $K_{\text{sat}}$  can be achieved with geocomposite without reducing stiffness

6 in. PCC	6 in. PCC
6 in. Crushed Limestone Subbase	6 in. Crushed Limestone Subbase
PC + MF-PP Fiber Reinf. Subbase	PC + PP Fiber Reinf. Subbase
Subgrade

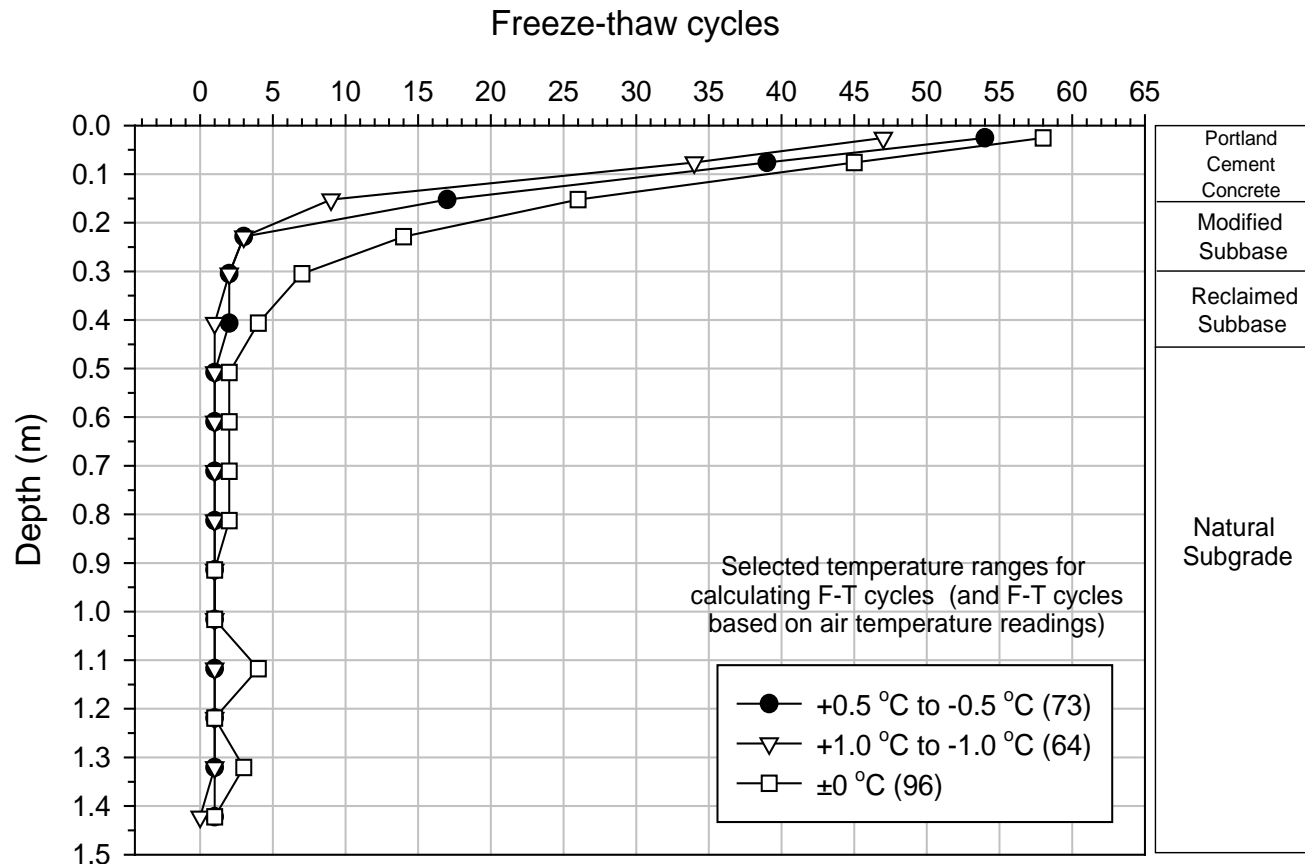
# Pavement and foundation layers are subjected to significant number of freeze-thaw cycles

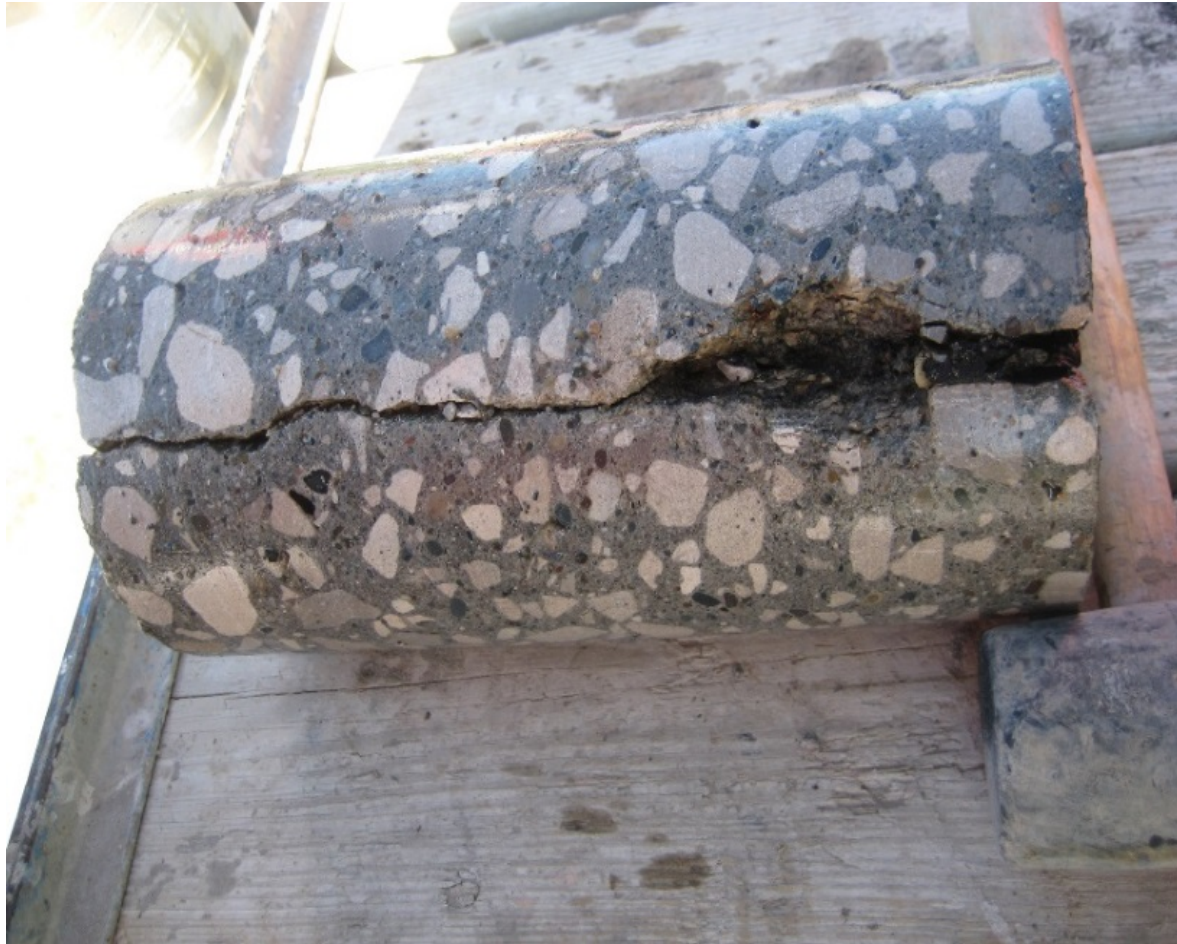
# Poor drainage beneath pavement causes joint deterioration due to trapped water

$$K_{\text{SAT}} < 1 \text{ ft/day}$$

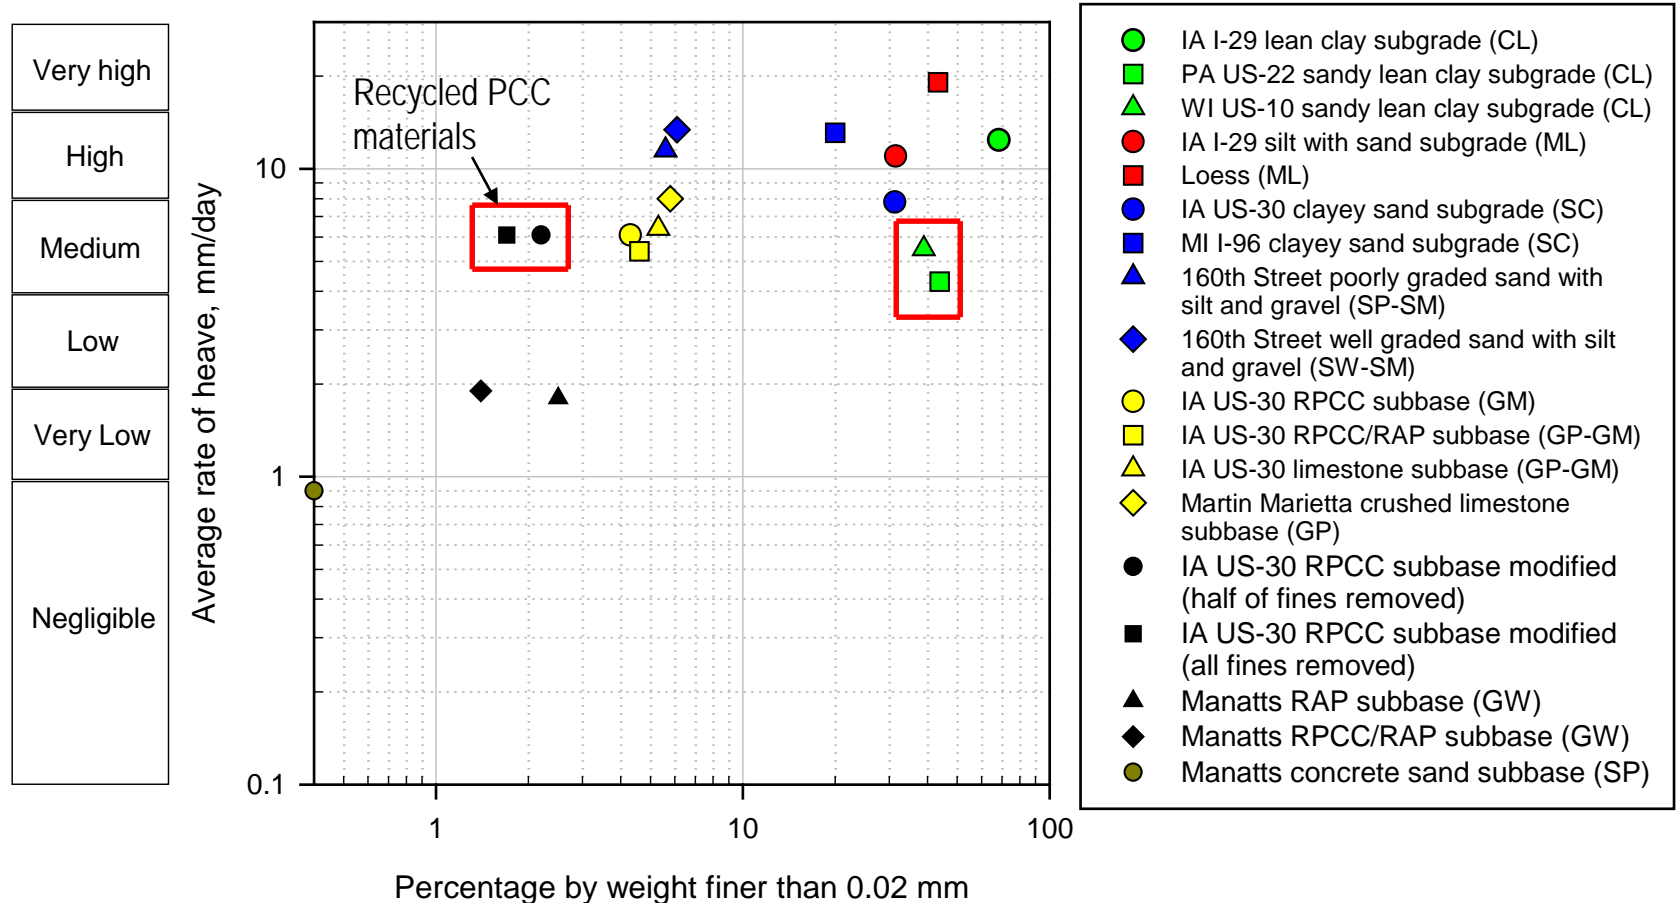
# The frost-heave rate of recycled PCC granular material showed as much heave rate as cohesive materials.

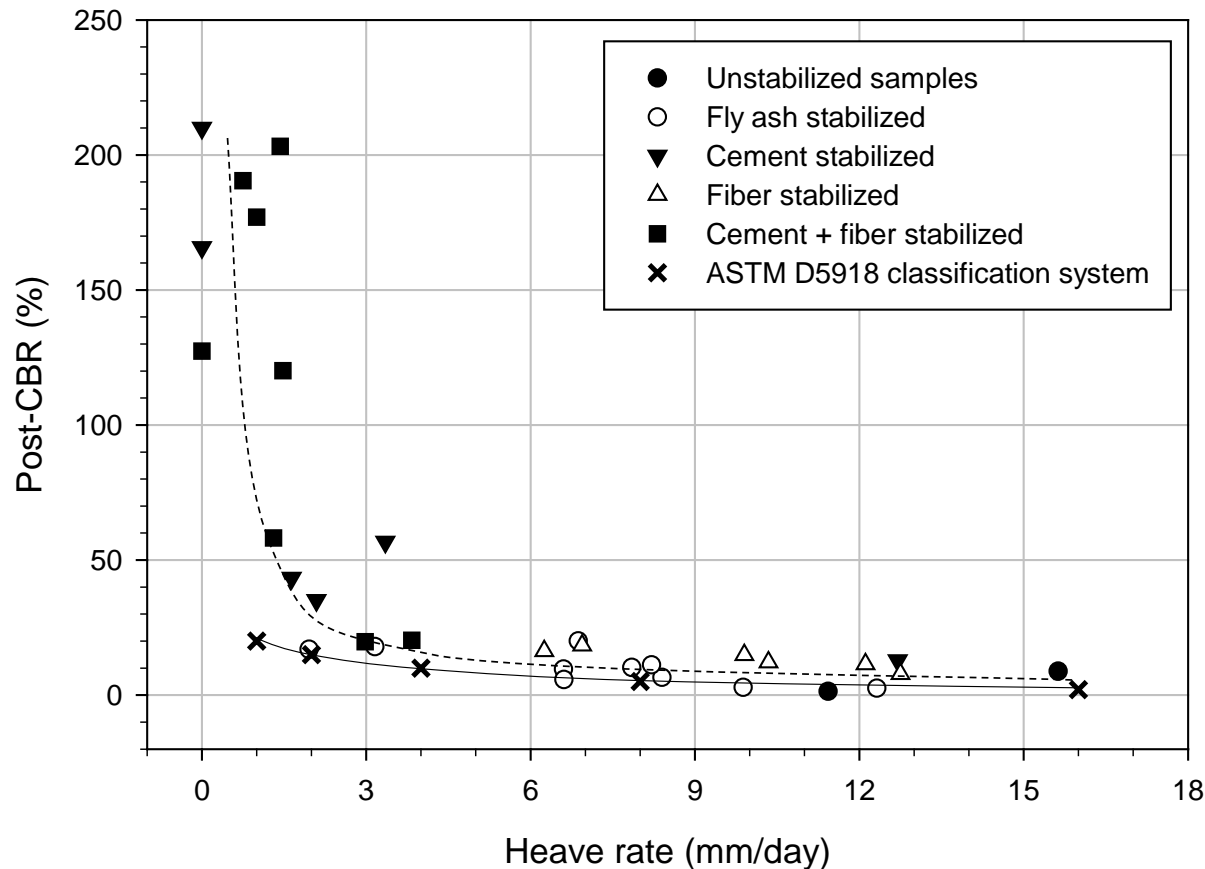
# After thaw CBR decreases as heave rate increases

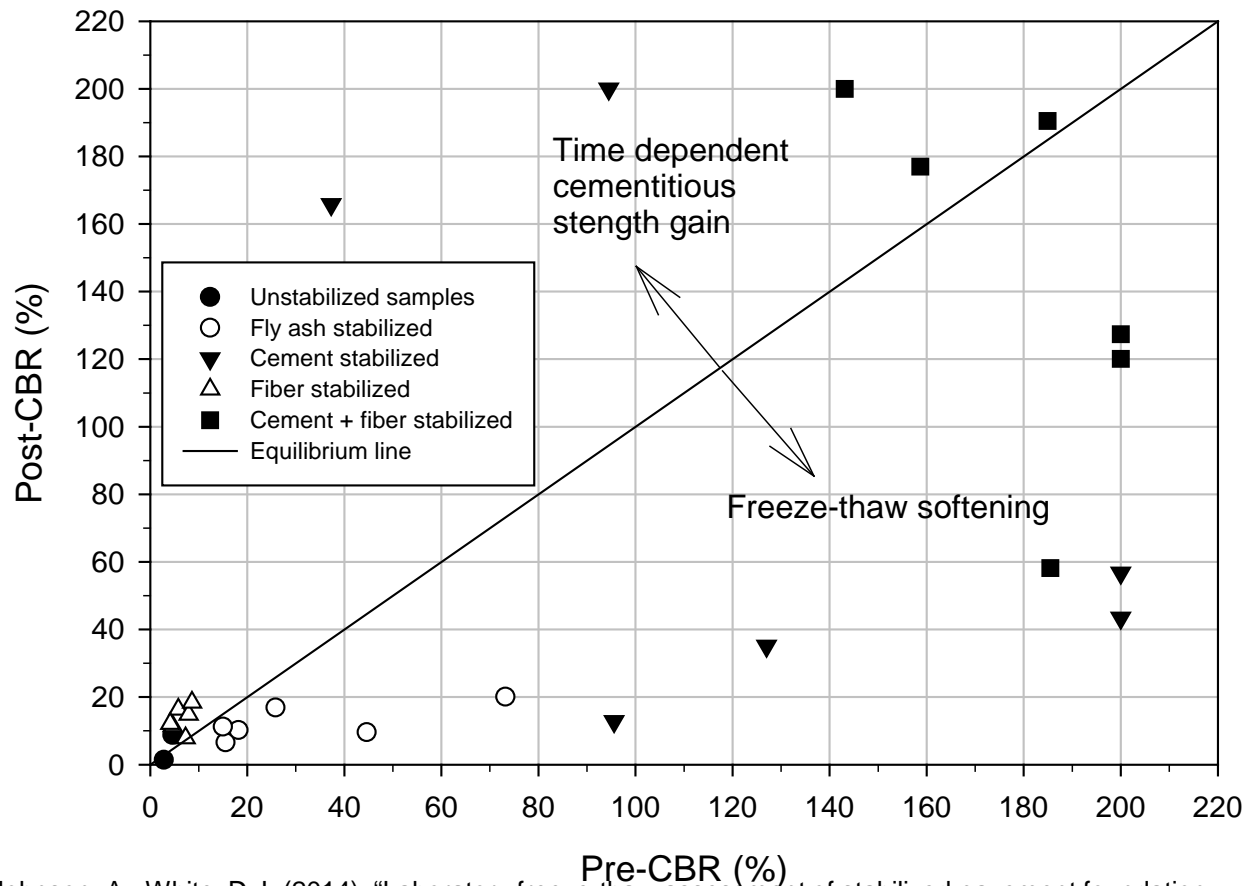
# CBR values comparison before and after thawing
