# ASR Research in Texas

Brian D. Merrill, P.E.  
State Bridge Construction &  
Maintenance Engineer

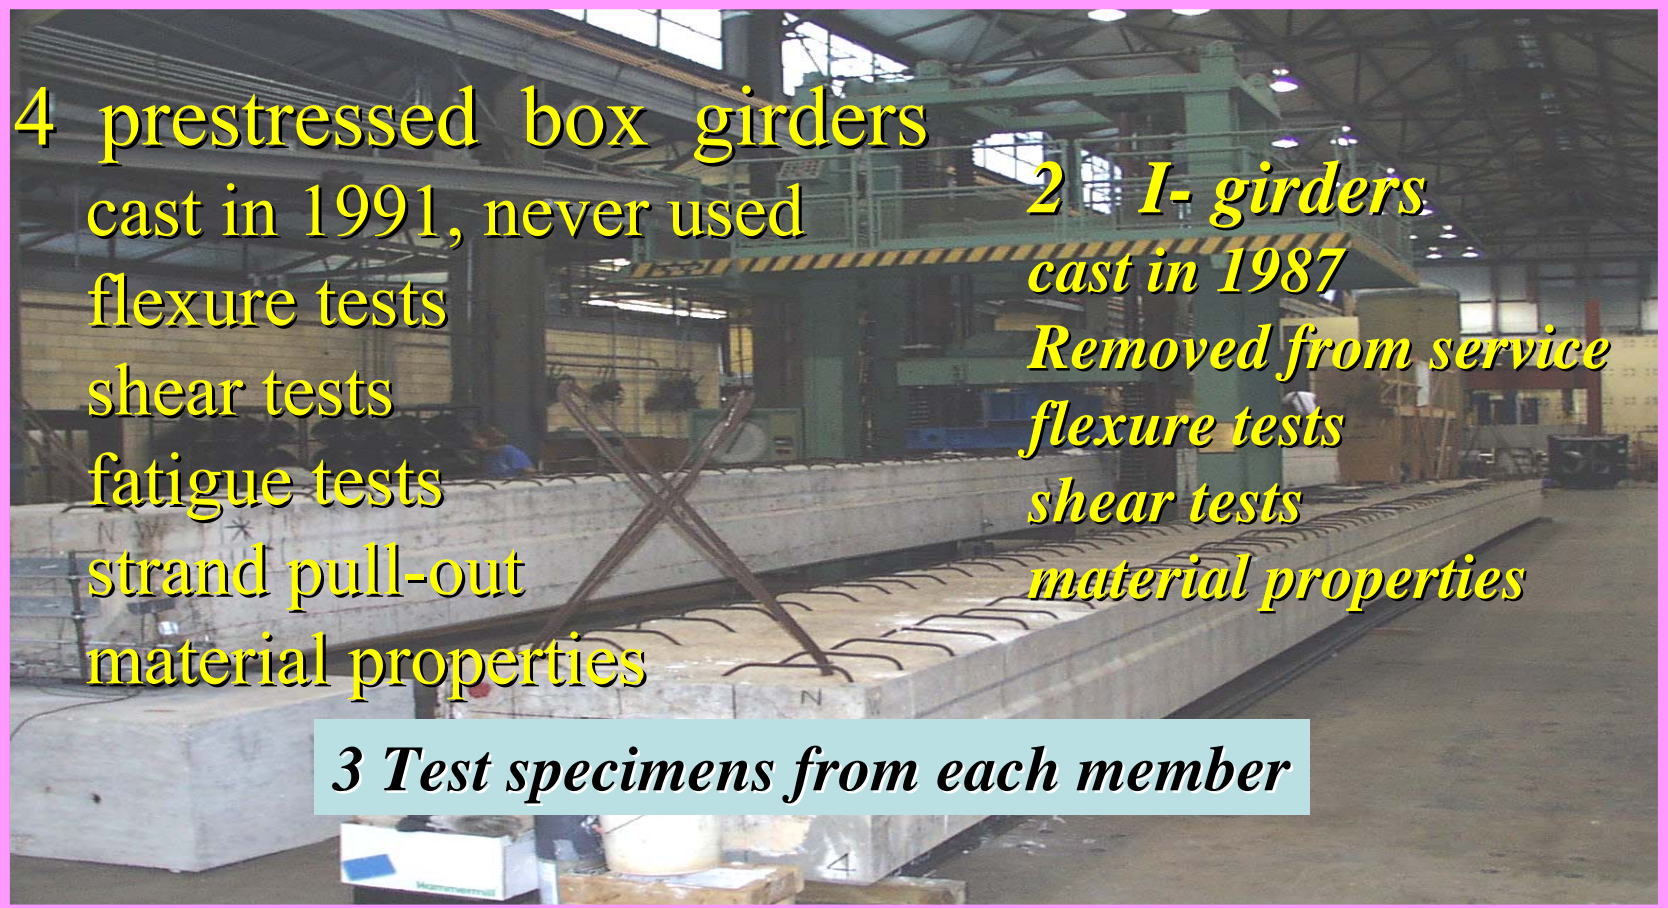
4 prestressed box girders  
cast in 1991, never used  
flexure tests  
shear tests  
fatigue tests  
strand pull-out  
material properties

2 *I-girders*  
*cast in 1987*  
*Removed from service*  
*flexure tests*  
*shear tests*  
*material properties*

**3 Test specimens from each member**

- Flexure: Damage did not affect flexural strength, ultimate deflection, or strand slip
- Shear: Damage caused a loss of shear strength, increase in ultimate deflection, and more strand slip
- Fatigue: Reliable performance under large overload
  - 28,000 cycles to failure at 0.75  $V_n$
  - > 3 million cycles to failure at 0.50  $V_n$
- Deterioration can be monitored using crack index:  
 $\Sigma l w^2$  in a defined area

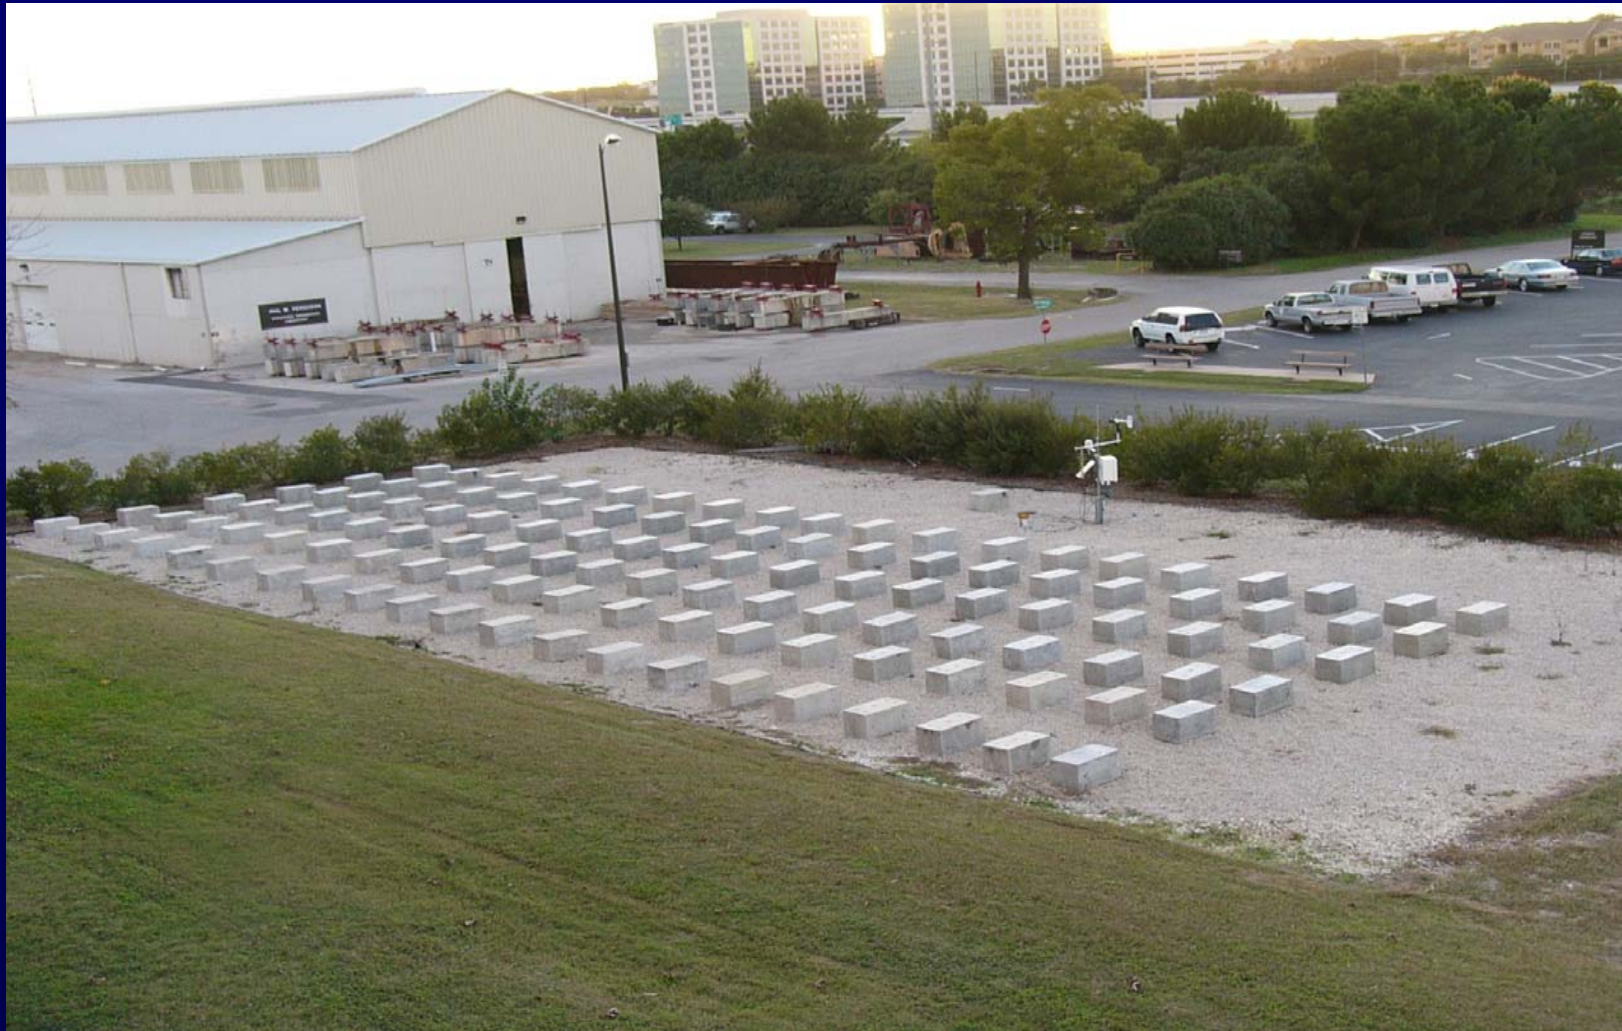
# Concrete “Graveyard”

- Understand relationship between ASR & DEF
- Evaluated existing testing protocols
- Developed guidelines for new specifications
- ID'd and tested mitigation strategies using SCM's (graveyard)
- Evaluate potential for further ASR/DEF
- Done at UT by Folliard w/ Thomas & Fournier,.....

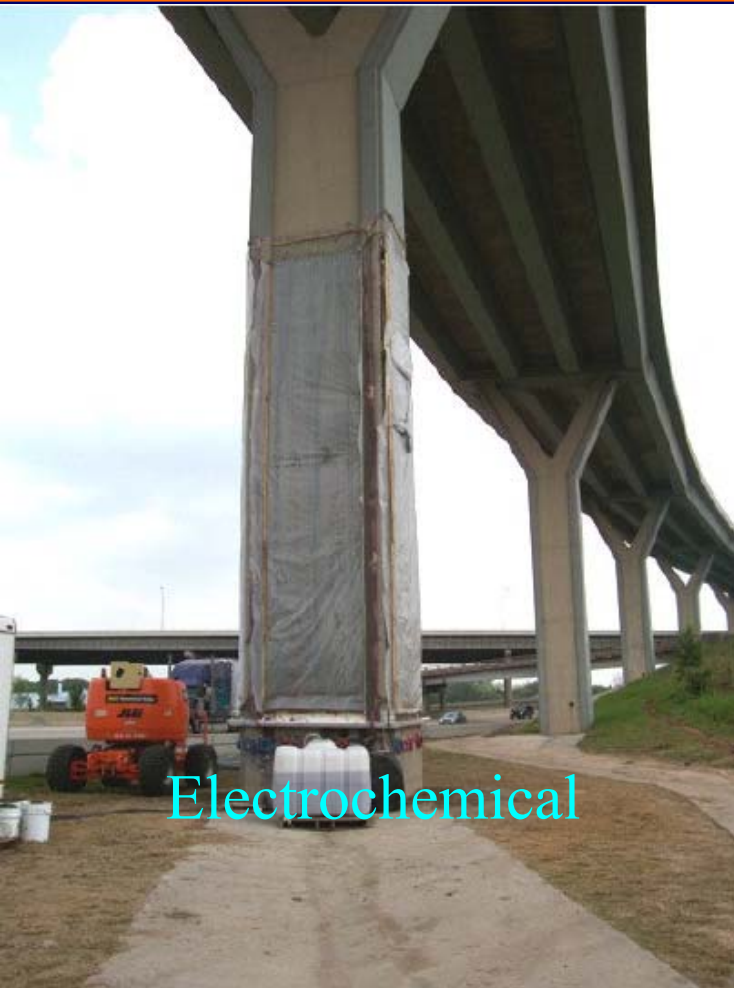
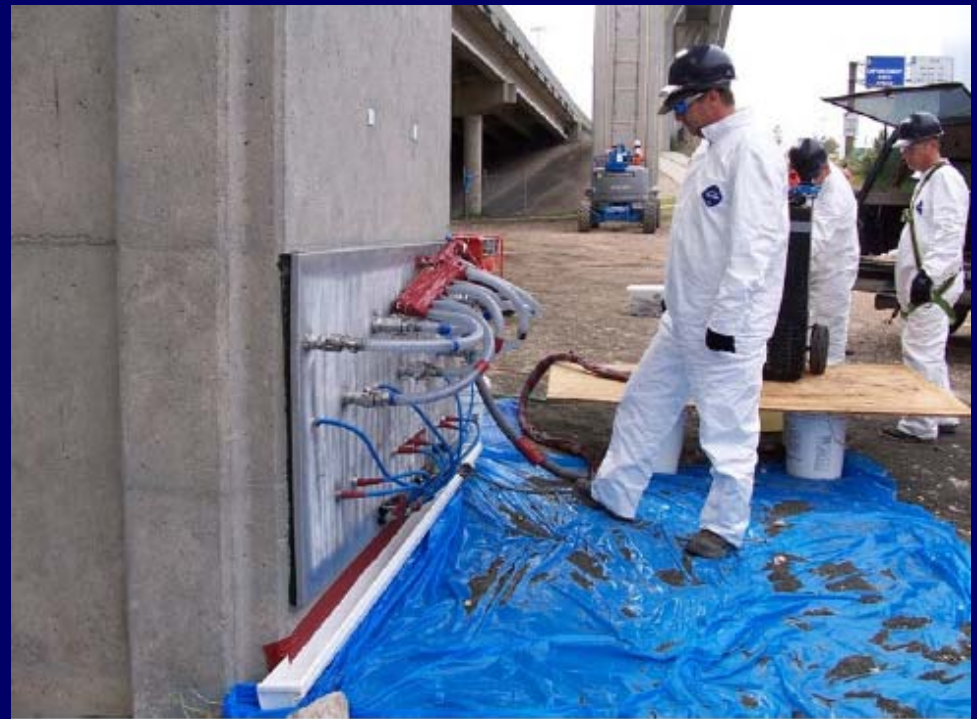
Electrochemical

Vacuum

Only limited penetration of lithium penetration beyond 1/2" to 1"

- Most important product from this project will be Materials Protocol – already being used in TX and in other states.
- Progress made on evaluating stresses due to DEF – confinement of 600 psi or less seems to be efficient in suppressing DEF.
- $\text{LiNO}_3$  did not penetrate well into concrete

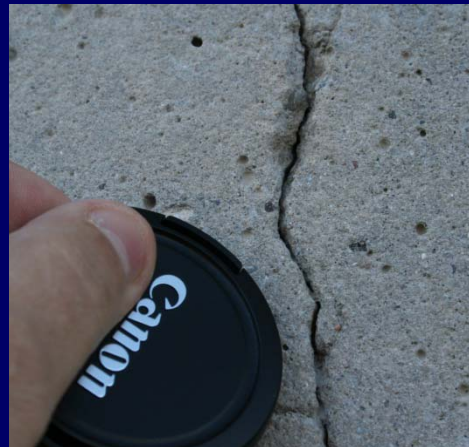
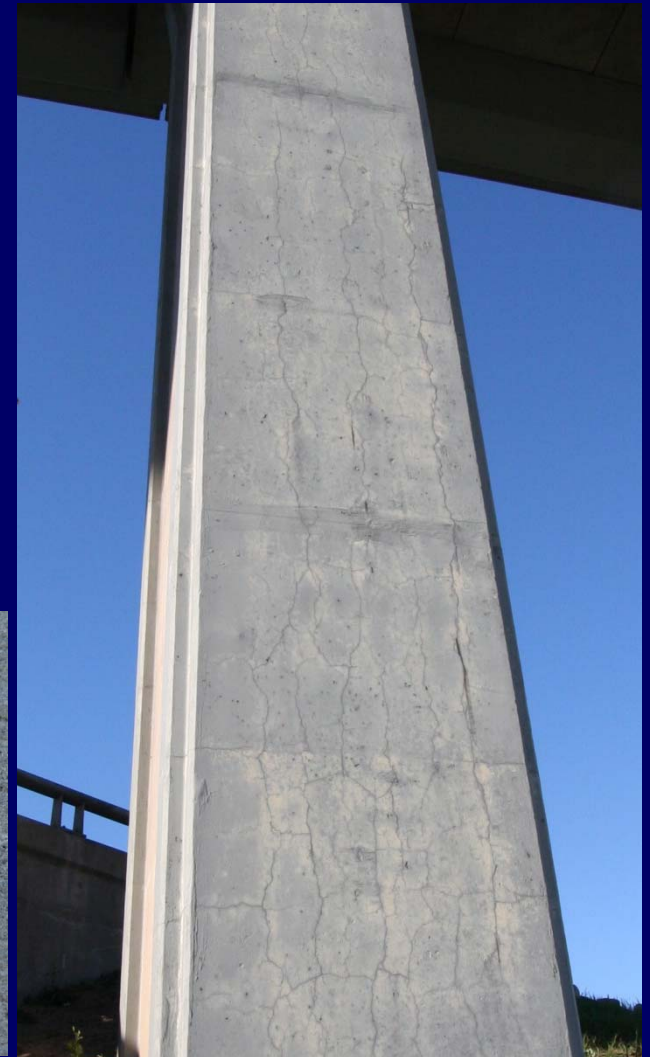
- ▶ Determine the performance of critical lap splices in bridge columns with varying degrees of cracking due to ASR/DEF
- ▶ Determine the need and effectiveness of rehabilitation techniques for damaged lap splice regions

- ▶ Casted 16 column specimens
  - ▶ 2 control specimens
  - ▶ 14 specimens for field exposure and ASR/DEF degradation mechanisms
- ▶ Provoke ASR/DEF
  - ▶ DEF
    - ▶ Control concrete temperature to above 160° F for first 2 days of curing by electrical heating elements
  - ▶ ASR
    - ▶ High Alkali - Type III Cement
    - ▶ Reactive Siliceous Aggregates
    - ▶ Sodium Hydroxide Supplement

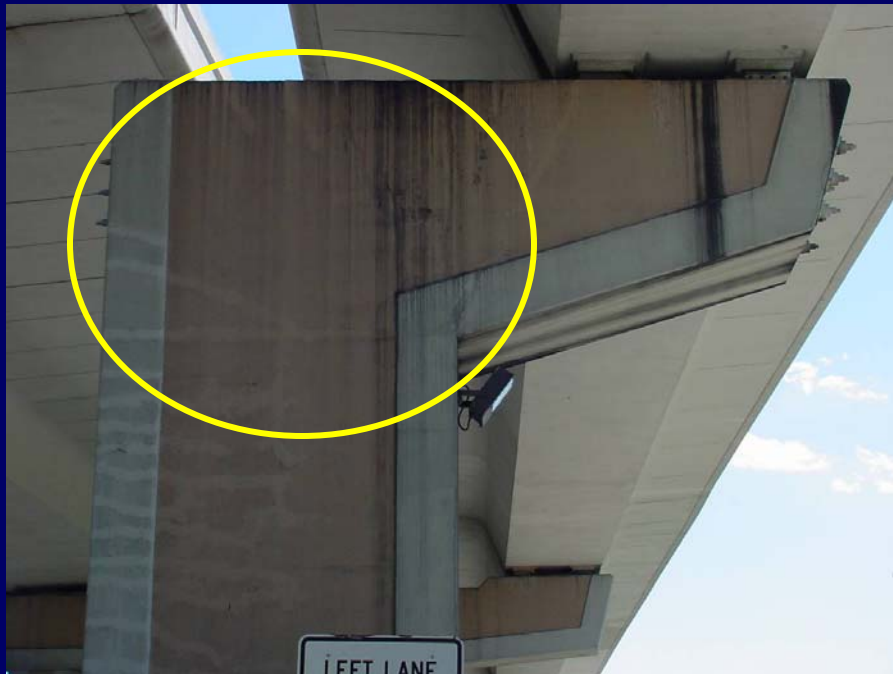
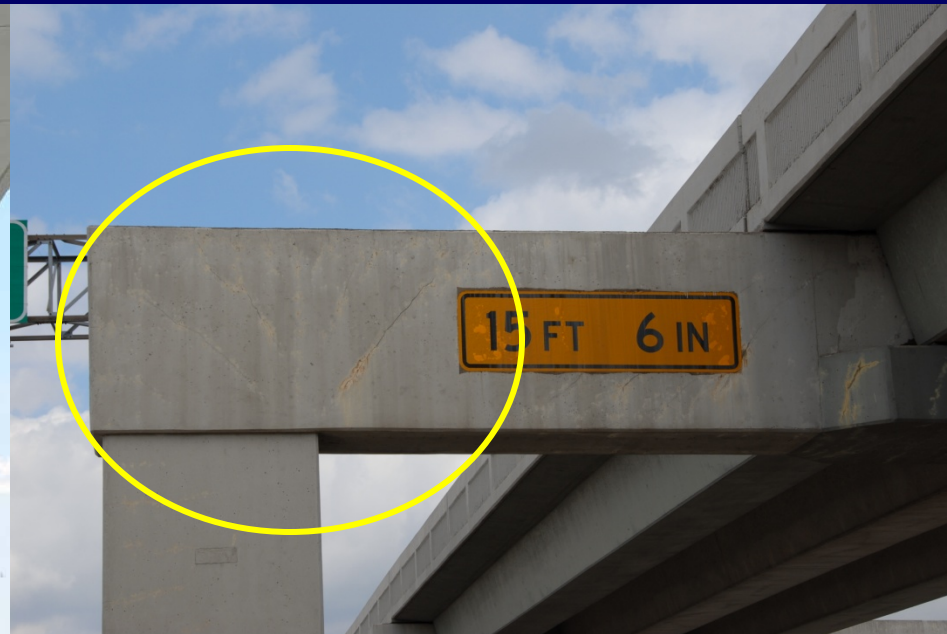
- ▶ There is a significant portion of the TxDOT infrastructure that has experienced premature concrete deterioration due to ASR and/or DEF. This research project is to determine the performance of critical D-regions with varying degrees of cracking due to ASR/DEF using large-scale specimens and analytical methods.

- ▶ 4 C-shaped beam-column specimens (2 D-regions)
  - ▶ 1 control specimen (casted)
  - ▶ 3 specimens for field exposure and ASR/DEF degradation mechanisms (cast in Jan-Feb 09)
- ▶ Provoke ASR/DEF
  - ▶ DEF
    - ▶ Control concrete temperature to above 160° F for the first 2 days of curing by electrical heating elements
  - ▶ ASR
    - ▶ High Alkali - Type III Cement
    - ▶ Reactive Siliceous Aggregates
    - ▶ Sodium Hydroxide Supplement

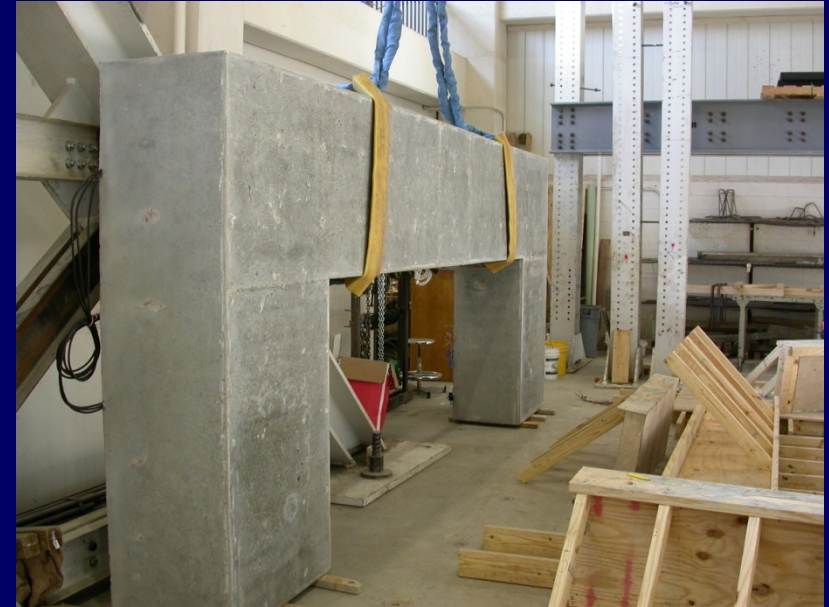
- ▶ 1 control specimen
  - ▶ Testing in late winter/early spring 2009
- ▶ 3 deteriorated specimens subjected to wet/dry cycles
  - ▶ Testing at phase I cracking (~fall 2009)
  - ▶ Testing at phase II cracking (~fall 2010)
  - ▶ Testing at phase III cracking (~summer 2011)
- ▶ Specimens are ideal candidates for NDT and NDE studies

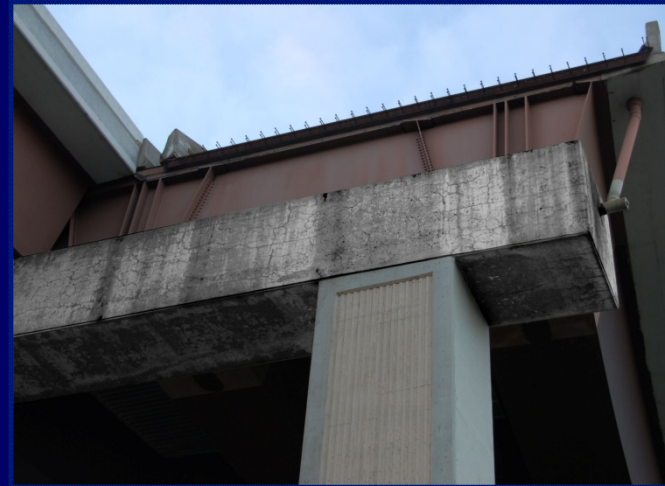
US 59 & I-10 Interchange

Signs of premature concrete deterioration due to alkali-silica reaction and/or delayed ettringite formation identified on several bridge bent caps in Houston, Texas.

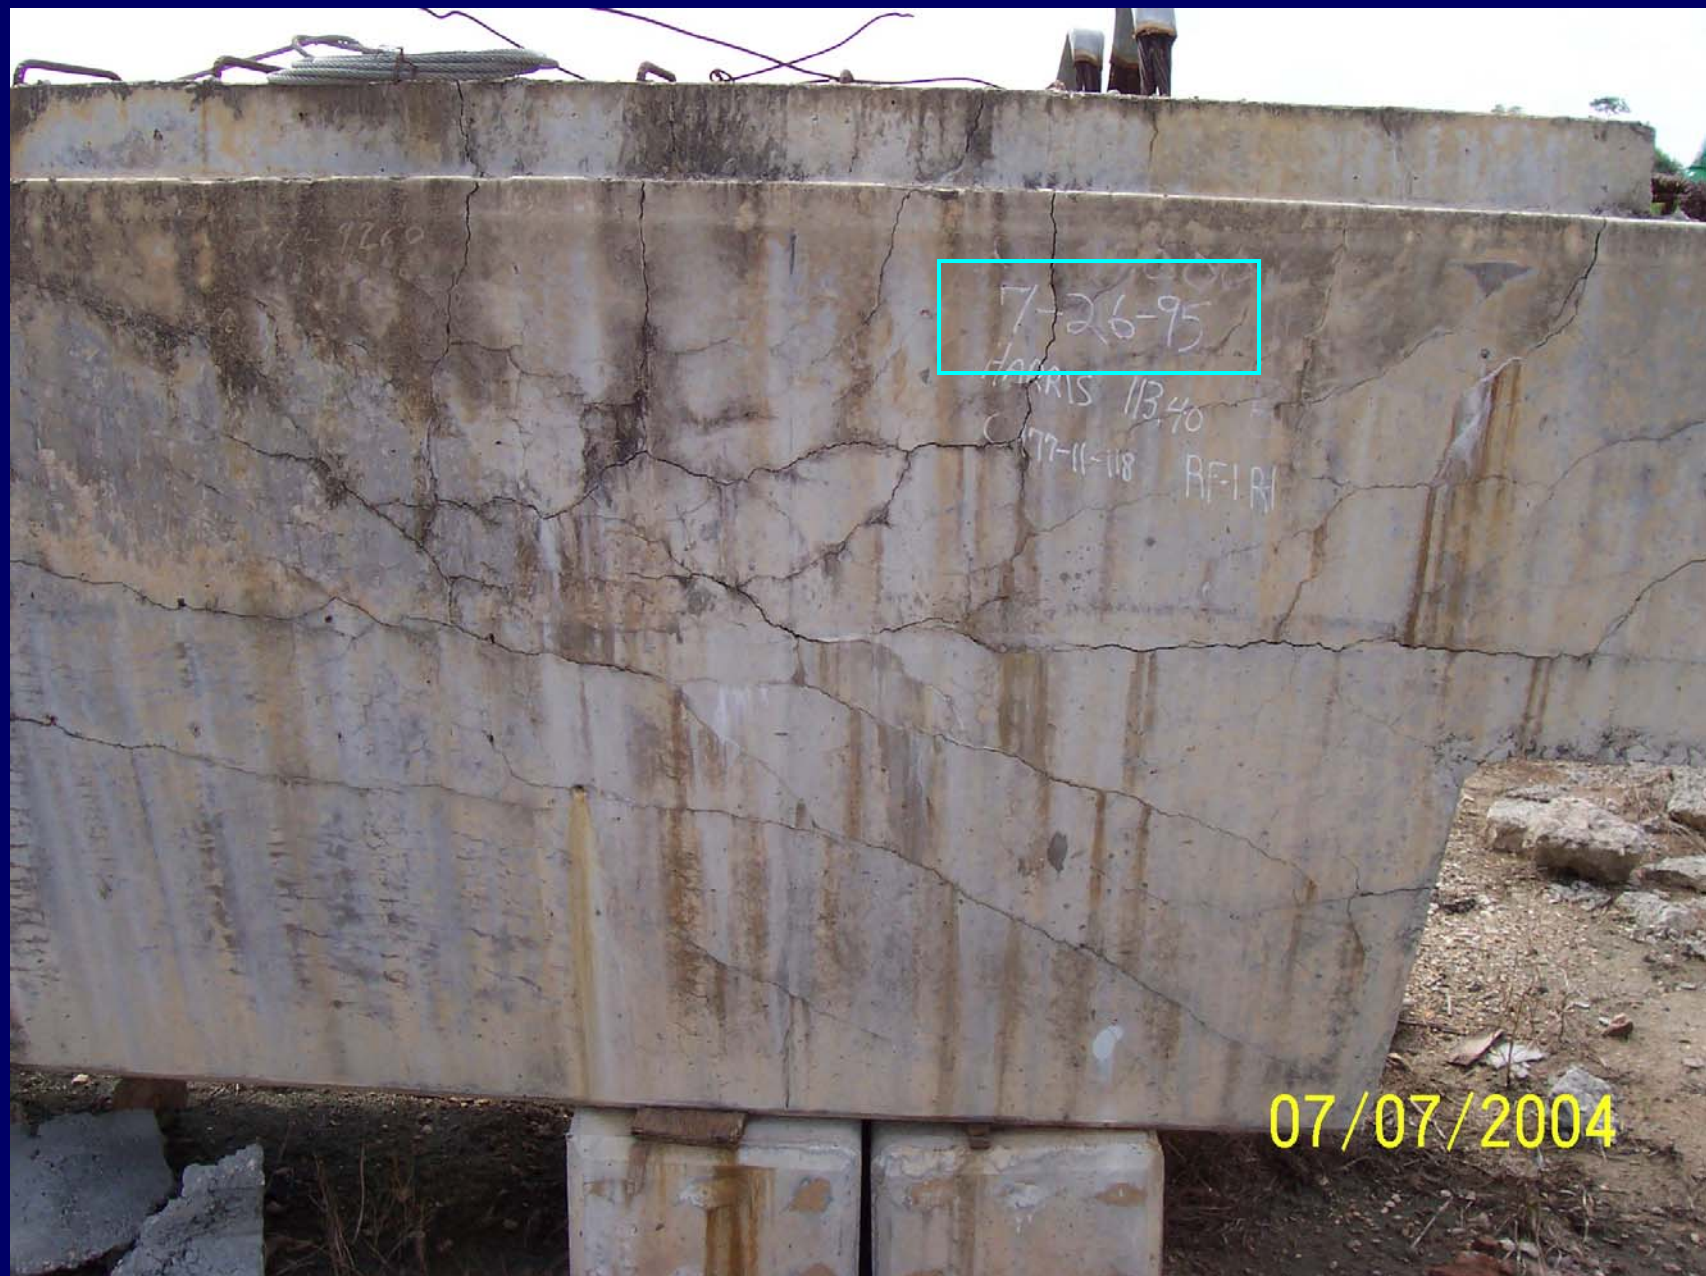
- Cast in 1995 at Contractor's casting yard
- A few were rejected (several 100's put into service)
- Possible ASR throughout girders
- DEF in end regions

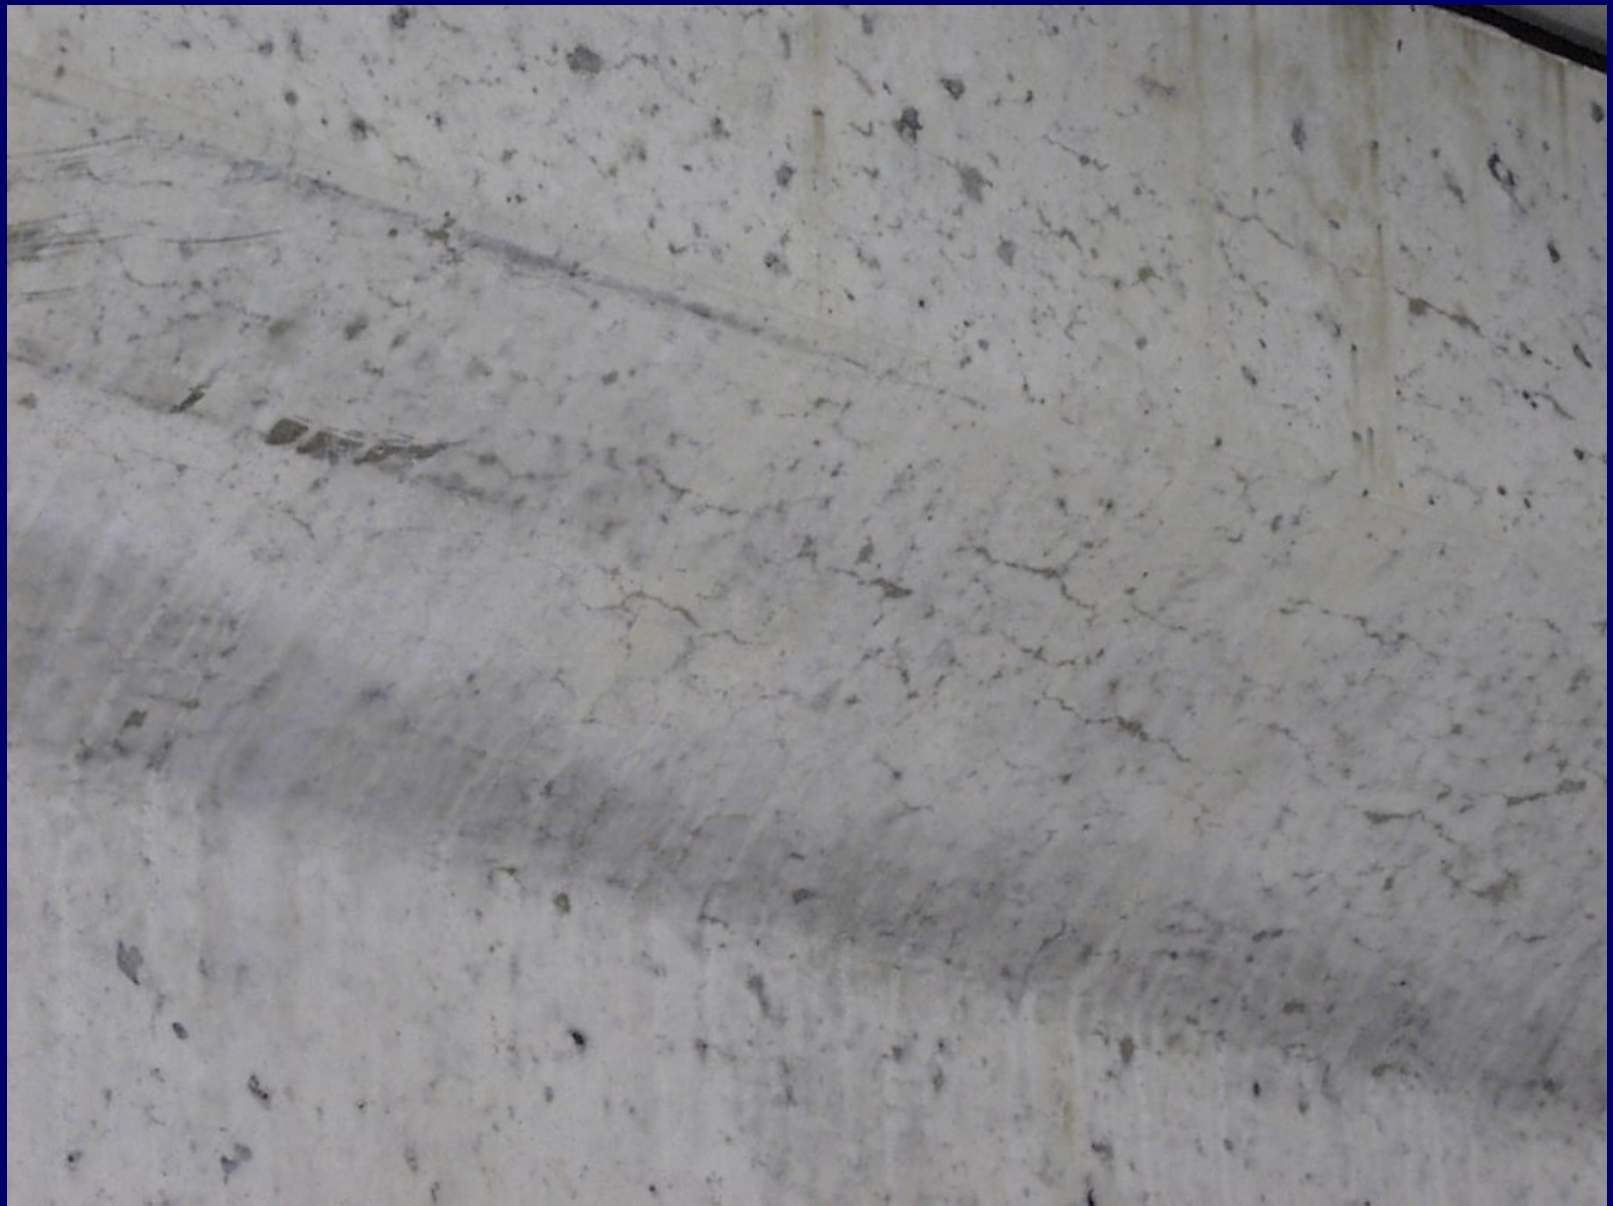
- Early 2008 TxDOT inspectors noted cracking of new prestressed concrete girders that were still in storage.
- These girders were fabricated 2002-2006 for various projects and all used similar concrete mix designs
- The mix designs met the ASR specs

- Evidence of ASR gel was confirmed in the girders.
- Alkali content appears to be below 4.0 pcy in two cases.
- 20% Class F Fly Ash may not always provide enough mitigation.

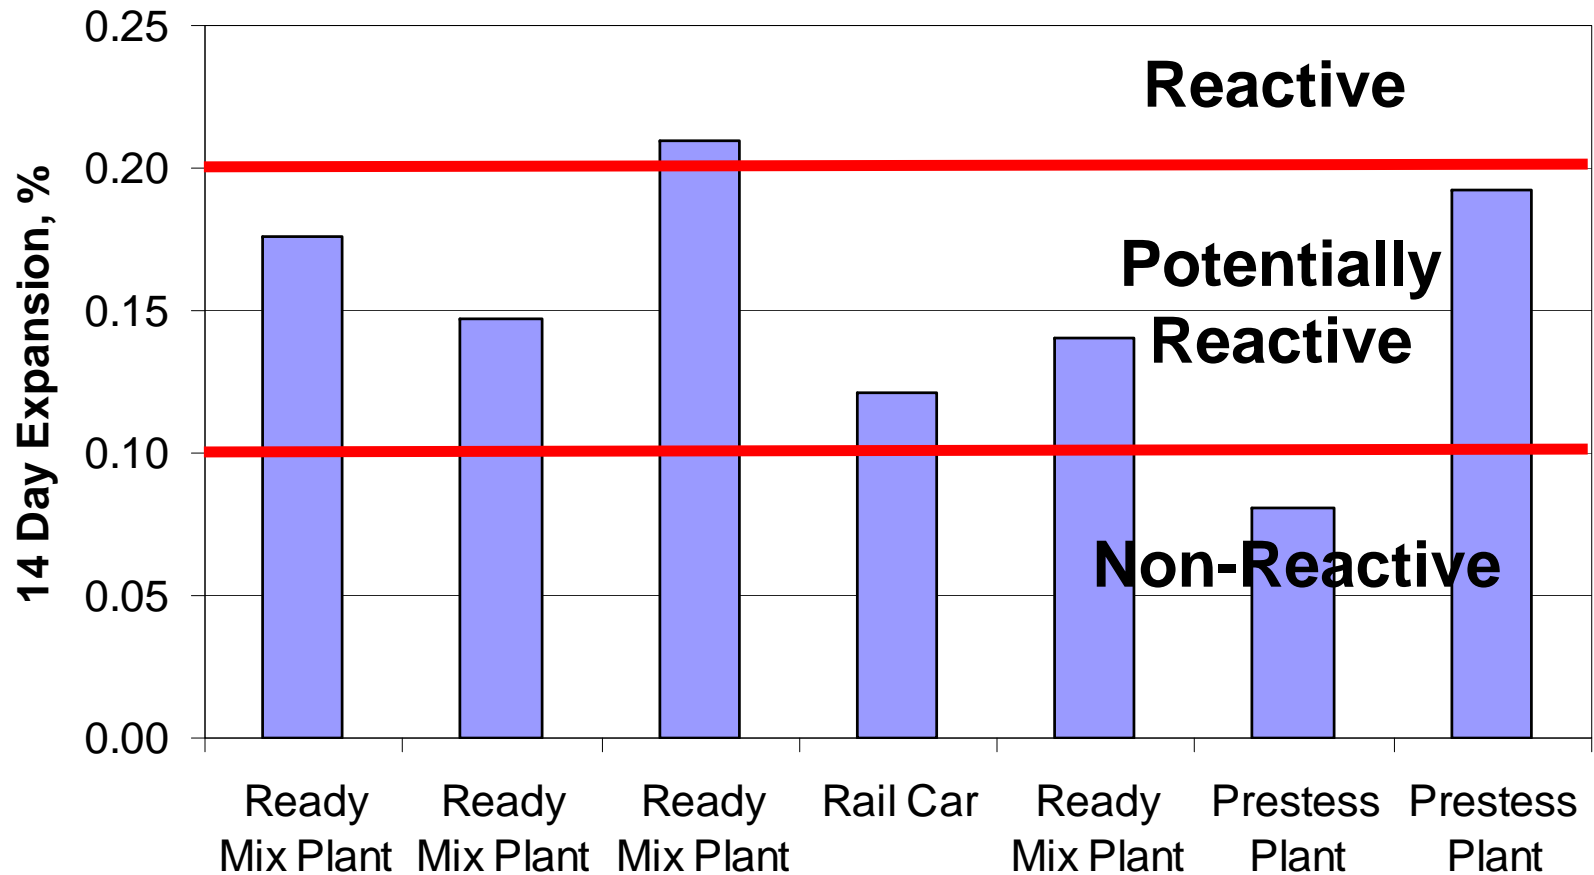
# ASTM C 1260 Testing

## Limestone Coarse Aggregate

Varibility of Reactivity in Coarse Aggregate

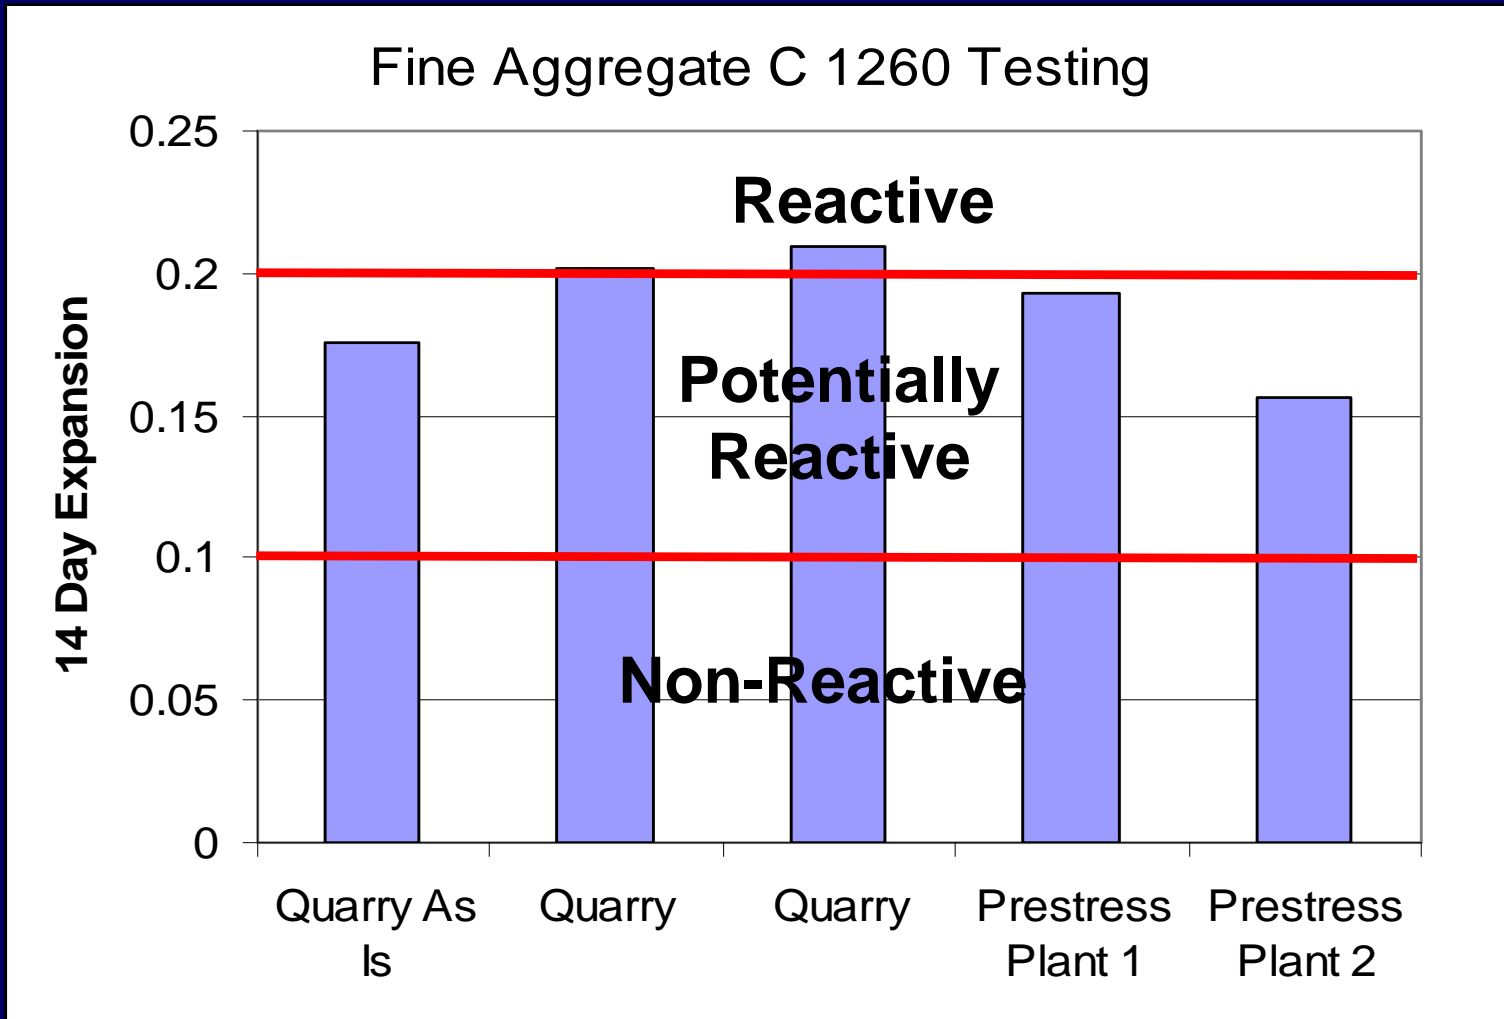
# ASTM C 1260 Testing

## Fine Aggregate
