Designing Pavements for Long Term Stability in Expansive Clays

Jeff Dean
Oklahoma DOT

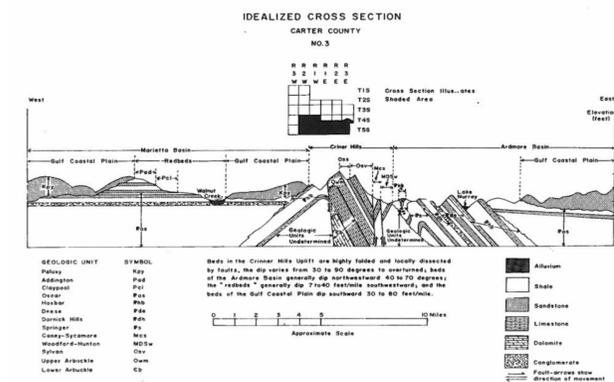
FIGURE 1 - Geologic Cross Section of Southern Carter County

The project lies within the Ardmore Basin which extends from a mile south of the Carter-Love county line through Ardmore to the south edge of the Arbuckle Mountains. Geologically, the rock units in this area are tilted (dip) at angles approaching vertical, with dip angles of 70 to 80 degrees being common. (Figure 1) The Springer and Goddard shale formations present here are thousands of feet thick and due to their tilted nature, have weathered much more deeply than the more typical flat-lying rock formations present in most of Oklahoma. These formations produce the highly weathered, highly plastic clay soils, that reach depths of 18 feet, along this portion of the I-35 alignment.

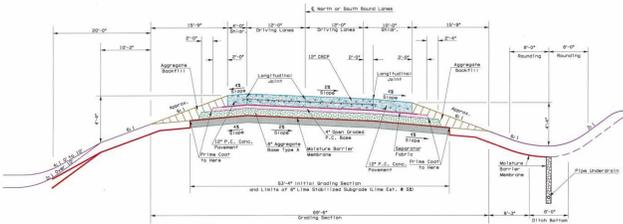
Figure 2 – Typical Section of the Reconstructed Pavement

This section of I-35 carries an ADT of 40,000 vehicles with 30% trucks. It is part of a major trucking corridor for the southern United States. Given the high volume of trucks and the problem subgrade soils, continuously reinforced concrete was chosen as the new pavement. CRCP was chosen because it is widely regarded as having the best performance on heavy clay soils. The CRCP would be 12 inches thick with a steel content of 0.73%. The mix design required a minimum cement content of 564 lb/CY and a minimum 28 day compressive strength of 3000 psi. It would be placed on a 4 inch thick drainage layer of open graded Portland cement concrete and have a base course of 8 inches of crushed stone. The moisture barrier would be placed on top of lime stabilized subgrade beneath the layer of crushed stone.

The barrier material would need to have a high tear and puncture resistance to withstand the placement and compaction of the crushed aggregate base layer. A thorough search located a material that met the requirements. It was a coated, reinforced geomembrane, made from a HDPE (High Density Polyethylene) reinforcement geotextile that is coated on both sides with a LDPE (Low Density Polyethylene). It is typically used as a water storage liner. Field tests confirmed that the material had the puncture and tear resistance required to withstand the construction traffic loads. The design required the membrane to extend across the entire 70 ft. grading section plus an additional 20 feet beyond each side making a total width of 110 feet. In the project extents requiring pipe underdrain to intercept groundwater seepage, the membrane was extended to the bottom of the pipe underdrain trench. Our belief was that in placing the membrane an additional 20 feet beyond each side of the grading section, it would achieve the same effectiveness as the deep vertical moisture barrier placed along the pavement shoulder (Figure 2).

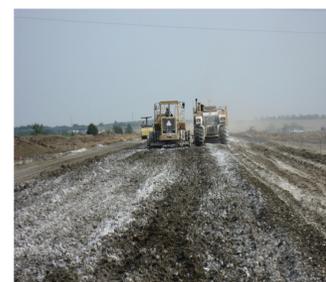
Figure 4 - Lime Stabilization operations

The design was finalized and the project was let out for bid. The project was awarded in August 2006 and completed in 2008. Figures 3 through 9 show the sequence of removing the old pavement and reconstruction of the new section.

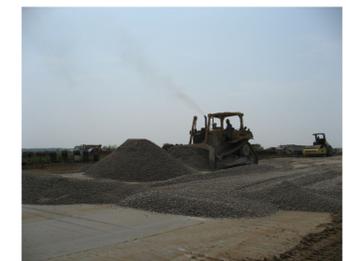
Figure 6 – Spreading the crushed aggregate across the membrane

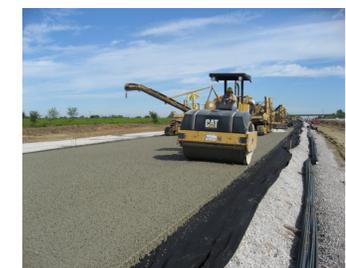
Figure 7 – Compacting the open graded base layer

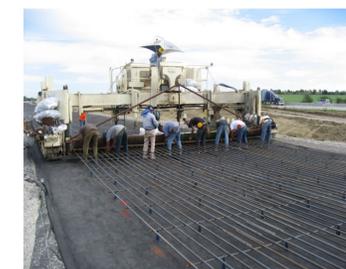
Figure 8 – Tying the steel reinforcement

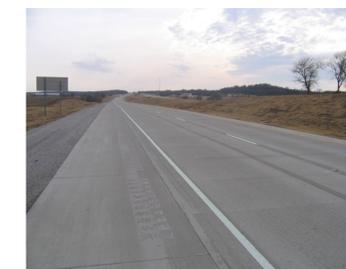
Figure 9 – The completed project.
