Update on Kansas Research

Heather McLeod, Ph.D., P.E.
Concrete Research Engineer
Kansas Dept of Transportation

National Concrete Consortium
April 22-24, 2014
Jacksonville, FL

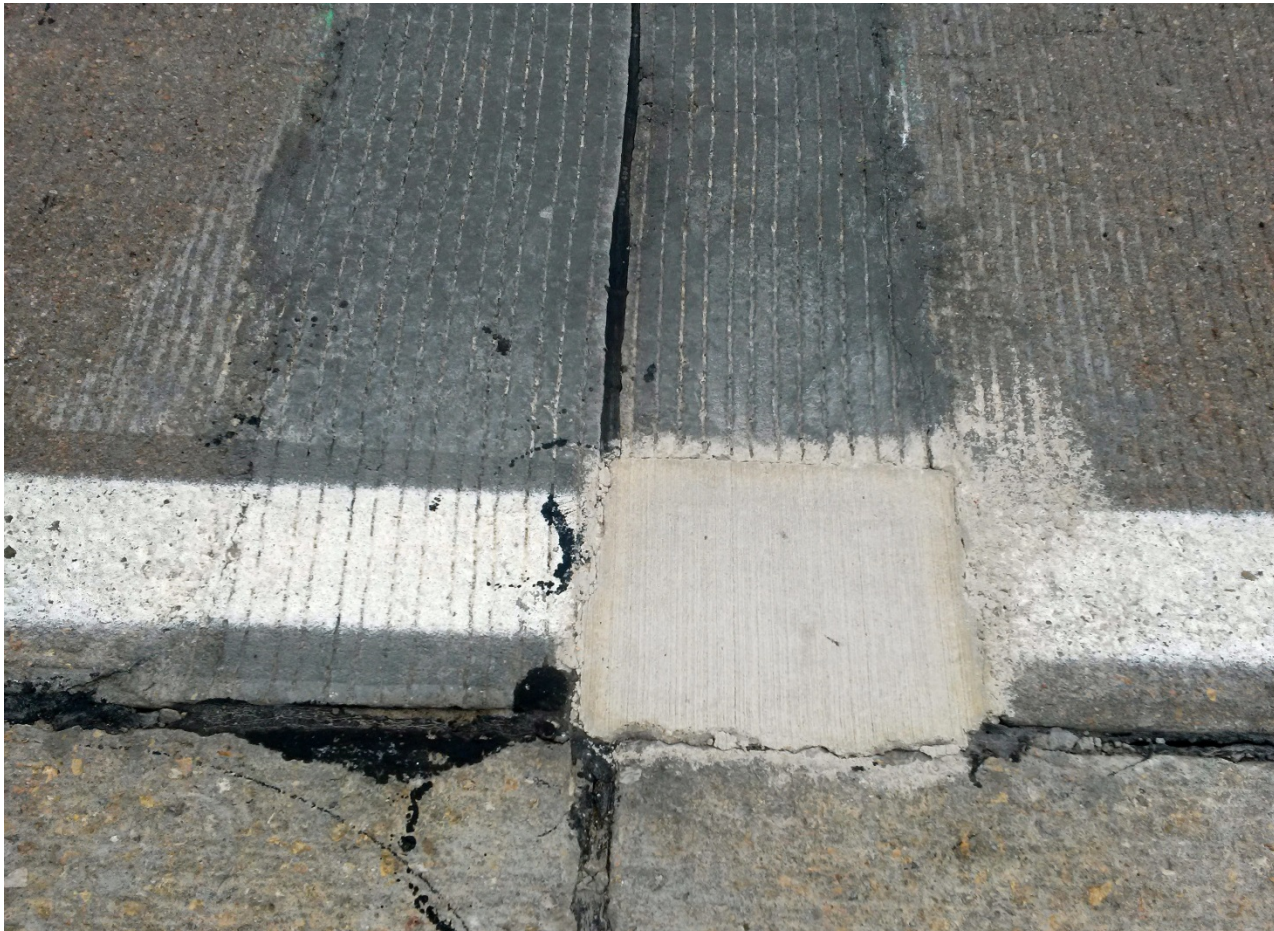
ASTM C457 Hardened Air

- Patching vs. No Patching

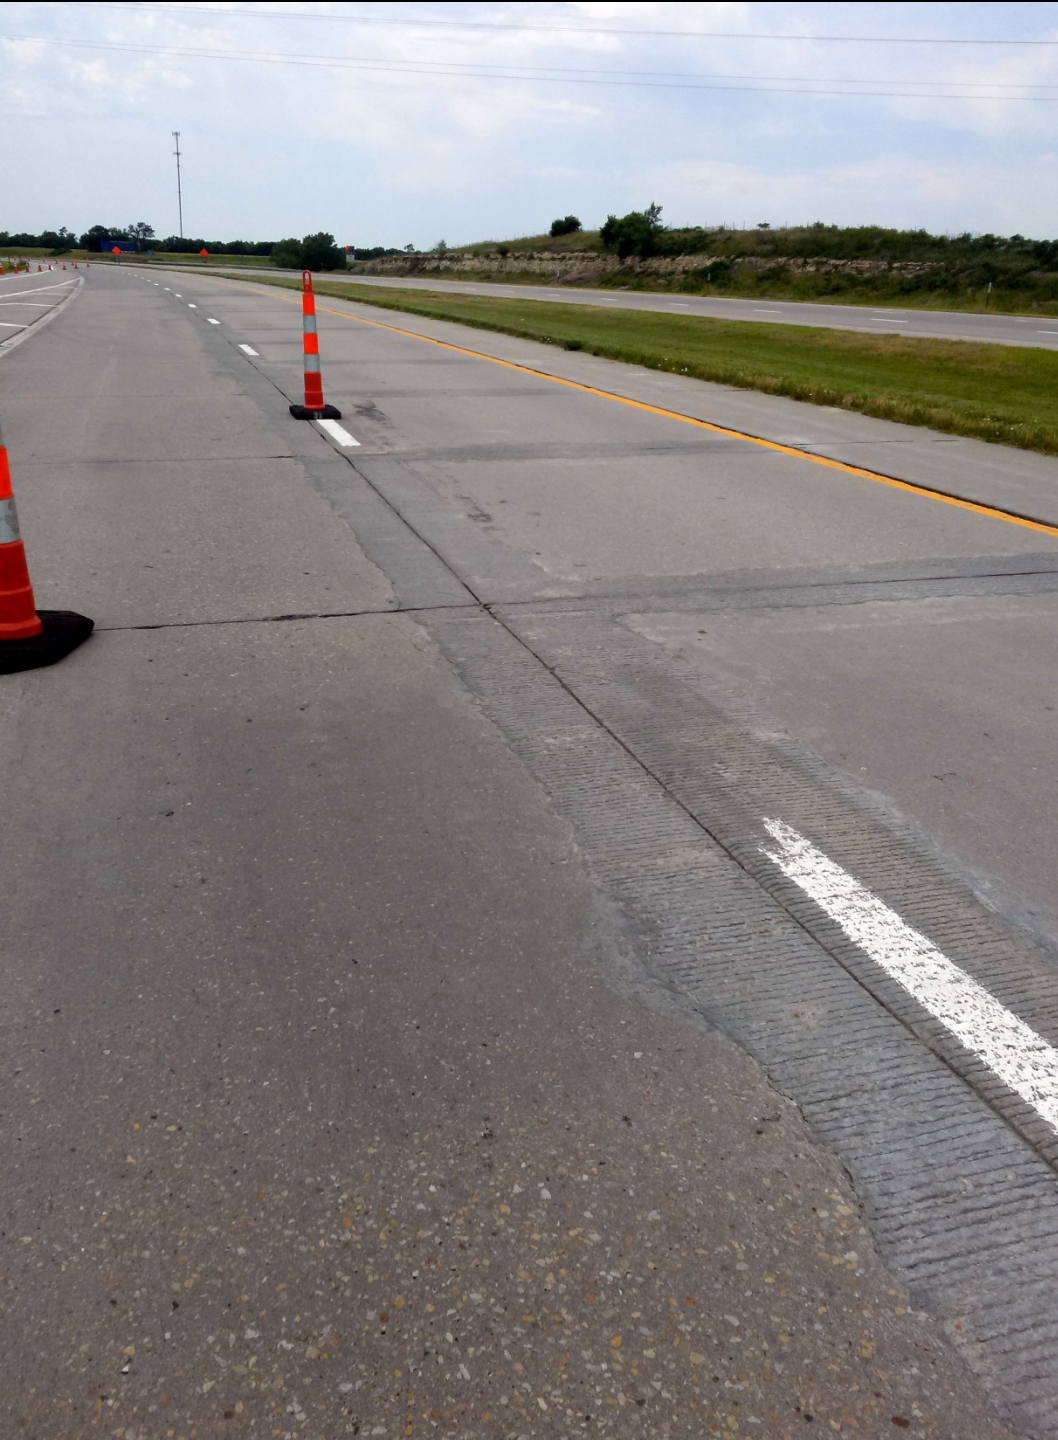
1993 EB Lanes

- Significant paste-related freeze/thaw deterioration
- Longitudinal and transverse joints

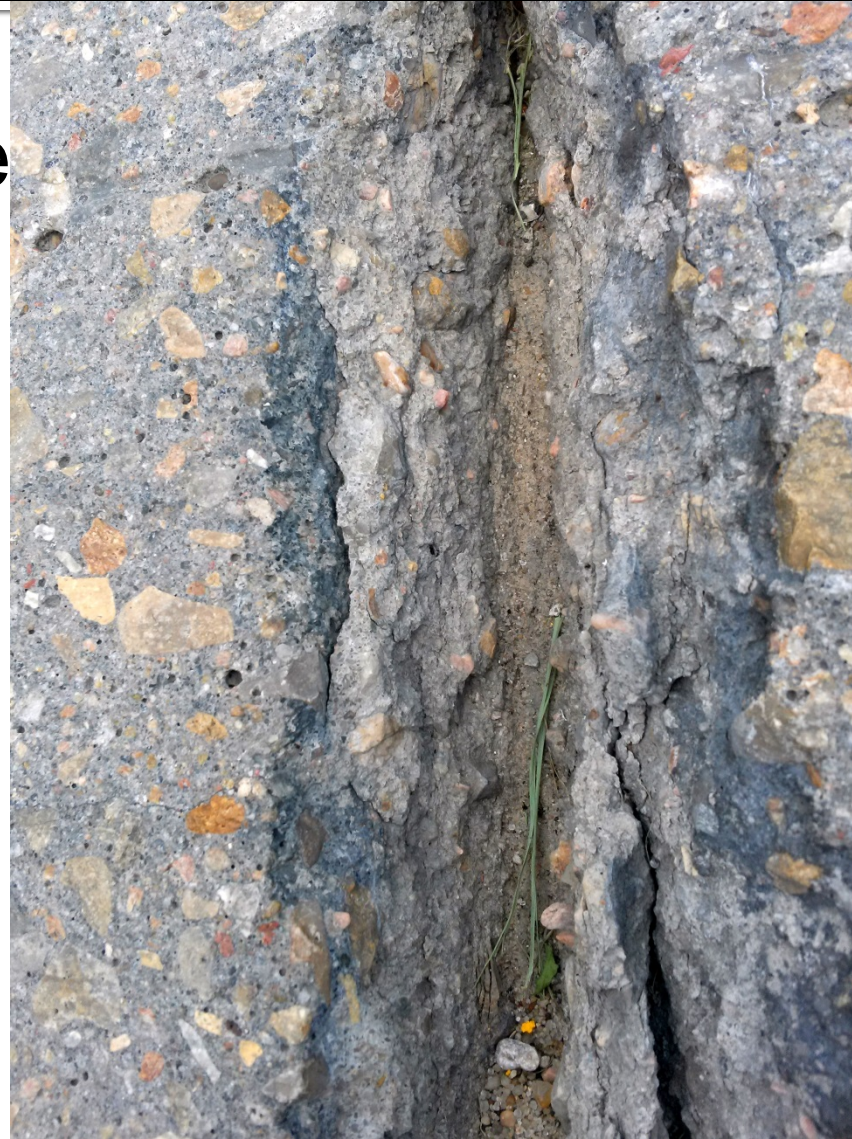
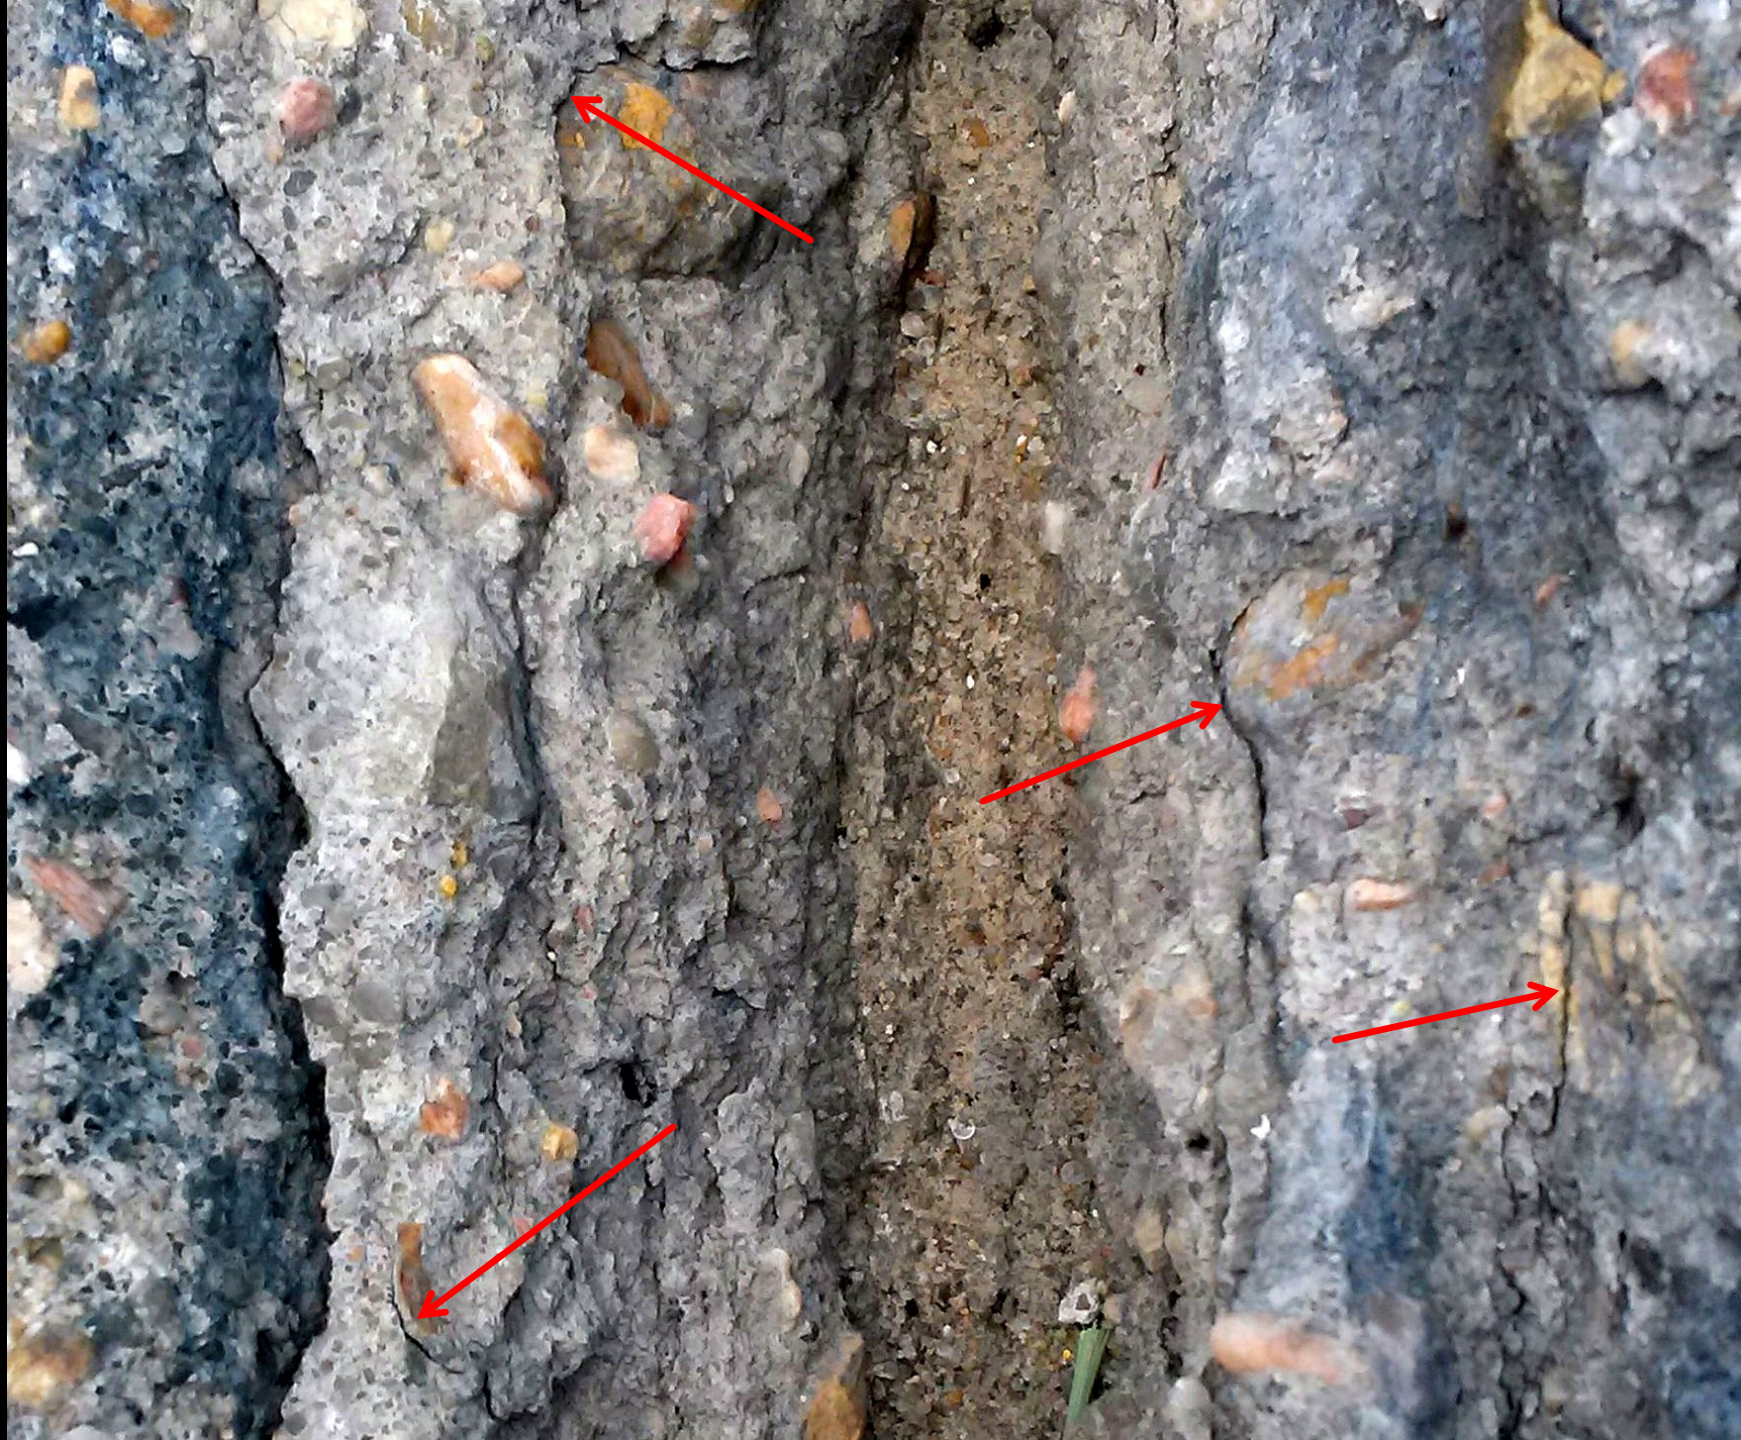
1993 Construction of EB

- Vertical planes of failure
- Close to joint

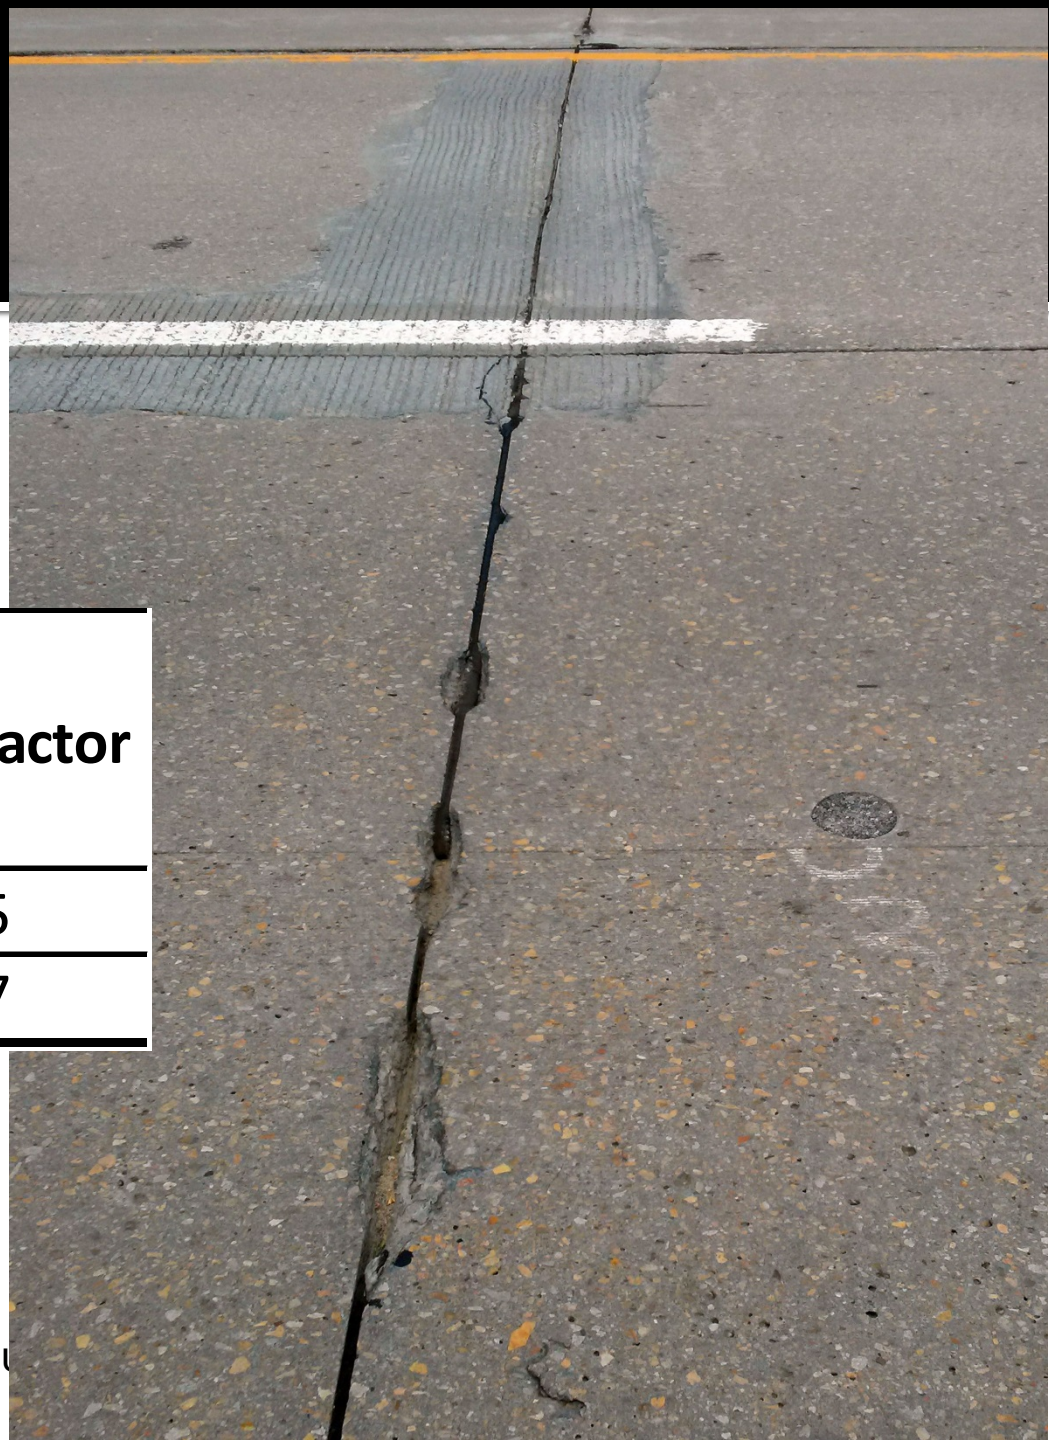
1993 EB Lanes

- ASTM C-457¹

Sample	Total Air %	Spacing Factor mm
Core 3	4.9	0.285
Core 4	4.8	0.187

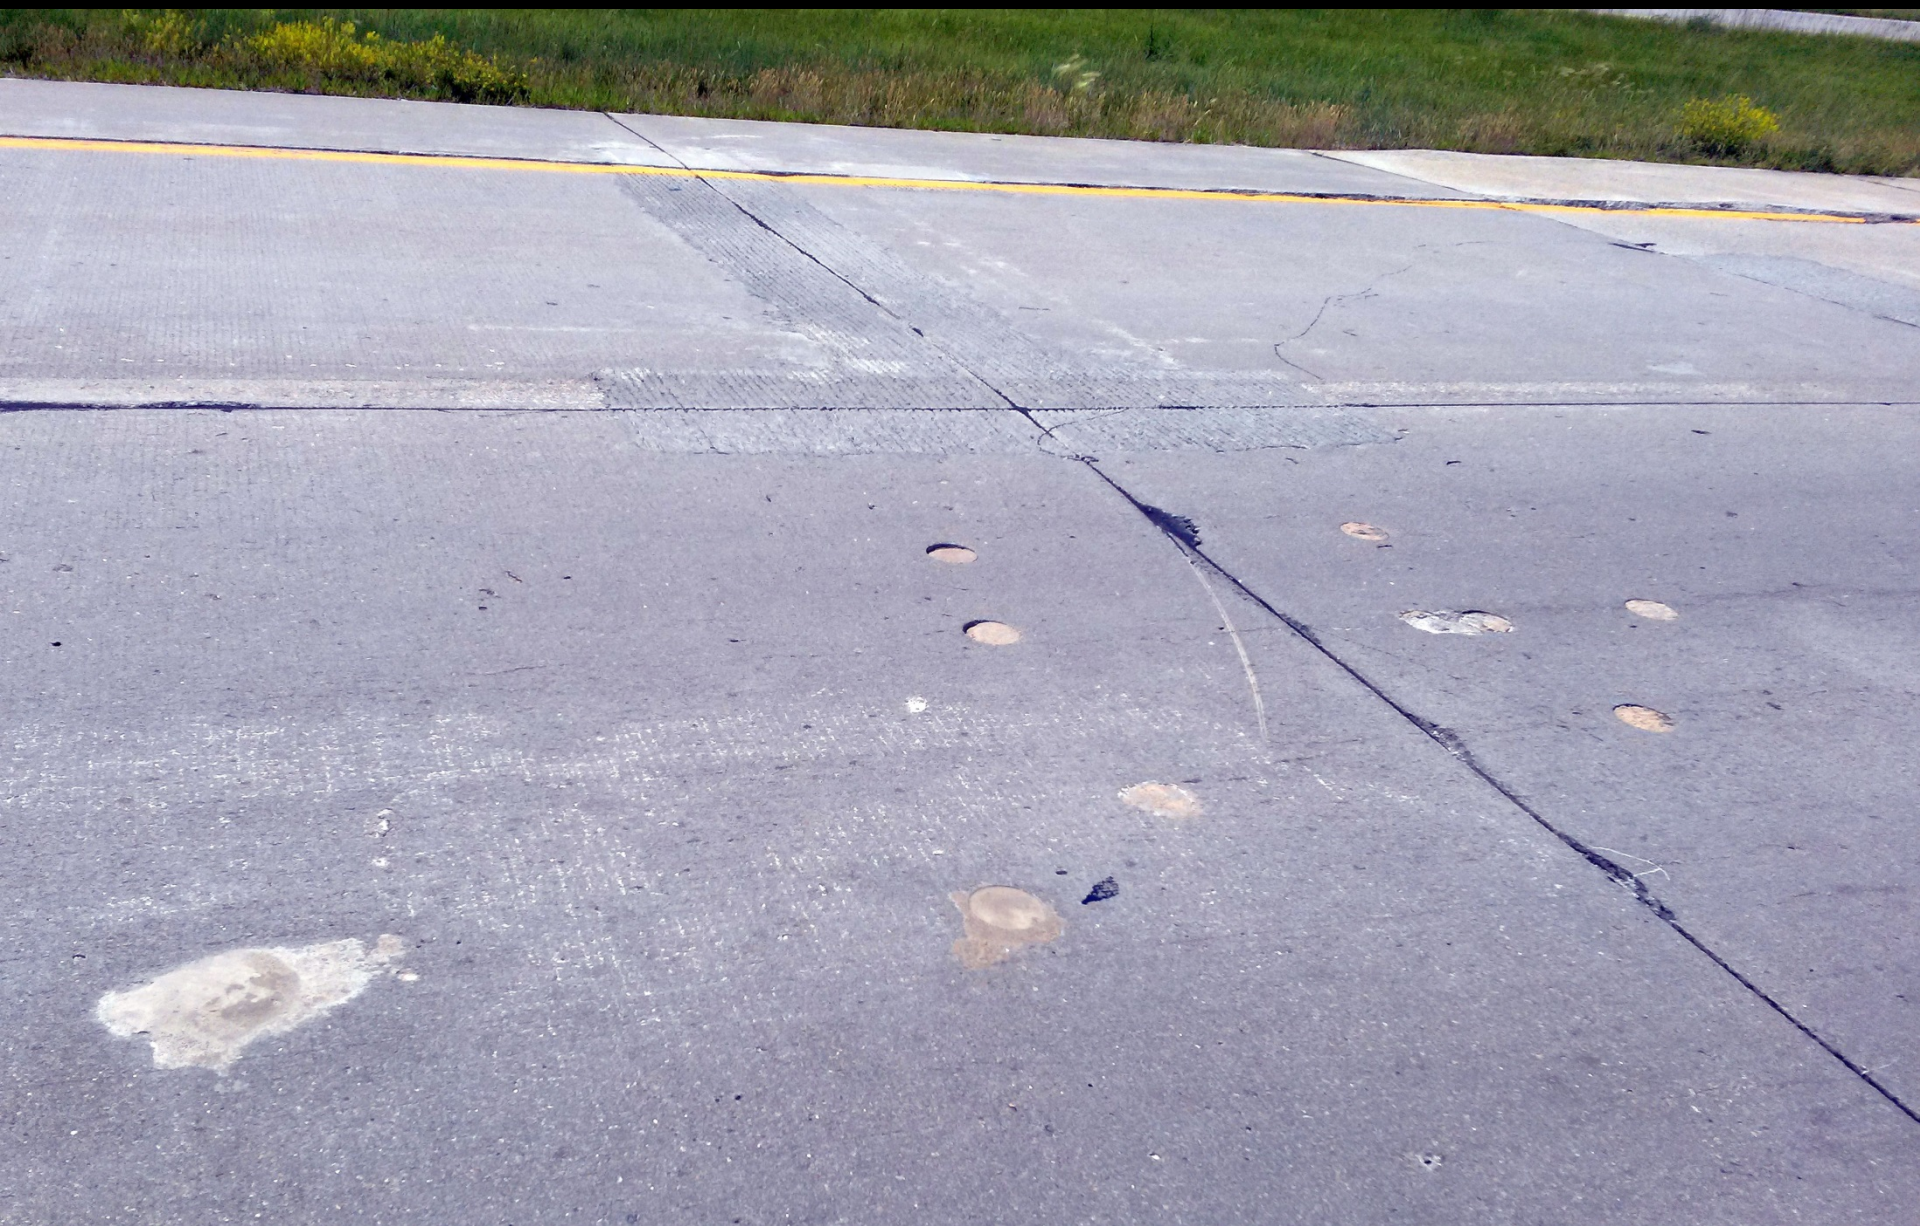
Core location – patching
Section – no patching

Core location – no map cracking
Section – map cracking starting
panels 3-4

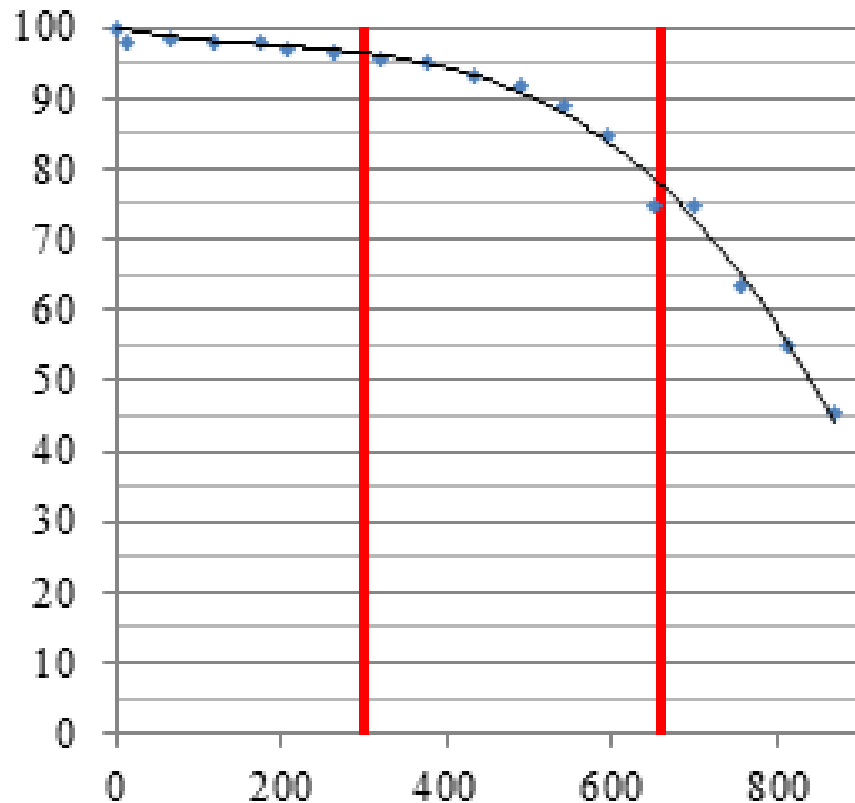
RDME

F/T Testing of Limestone with Poor Service History

- Material Source appears to be the major factor in Kansas D-Cracking
- D-cracking can be top-down
- ASTM C666 can be reviewed for clarification
- DM and Exp results are usually in agreement
- Kansas is using extended F/T testing
