Laboratory Investigation of Concrete Beam-End Treatments

Iowa Department of Transportation  
(InTrans Project 12-442)

tech transfer summary

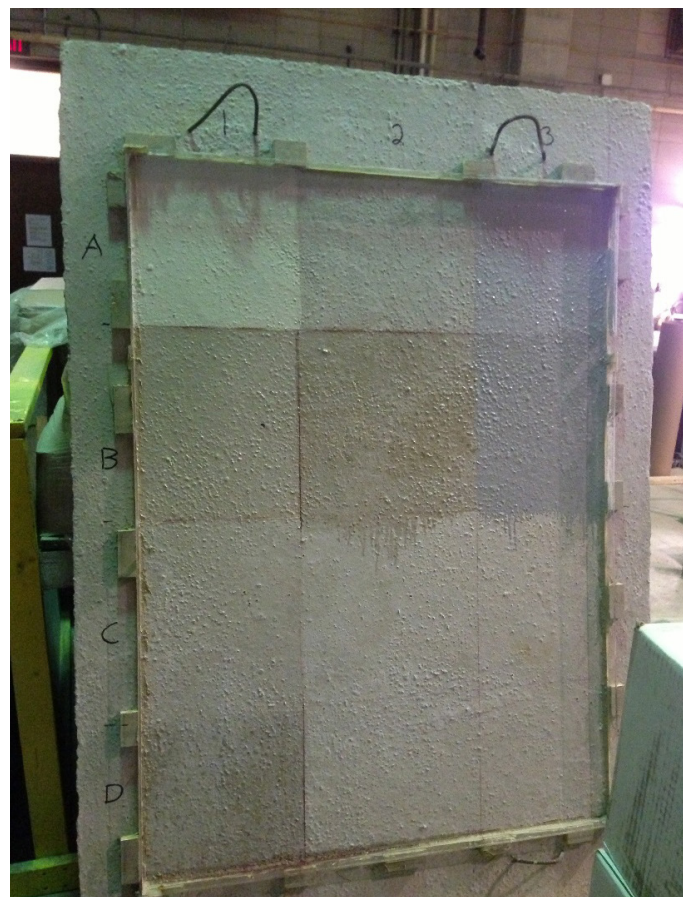
*Typical ponding slab with coating alternatives applied*

The selected products were tested in the laboratory according to AASHTO T259-80. Each product was applied to a designated square on each of three concrete ponding slabs, with each slab from a different precast facility in or near Iowa. In addition, two coats of Sikagard 62 were applied to one square, and two were left uncoated as controls.

The three slabs were submerged in a 3% chloride solution for 90 days, and samples were taken to be tested at the Iowa State University materials testing facilities. This procedure was repeated two more times.

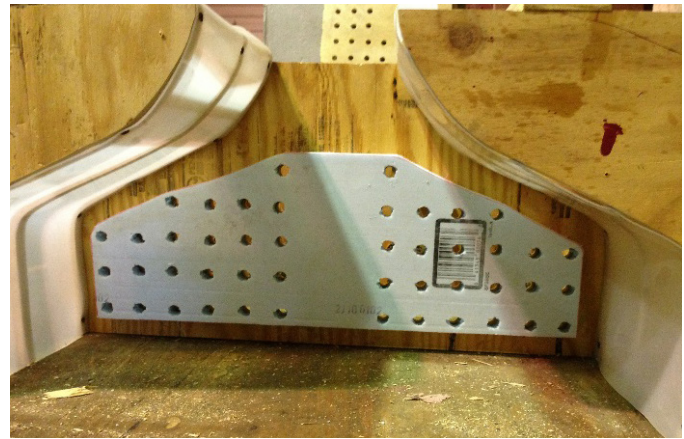
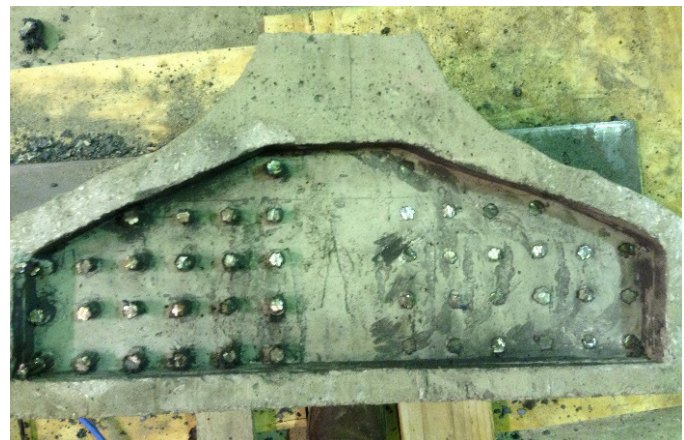
*Single blockout formed with 2 in. foam*

- Single beam-end blockout around the entire cluster of strands in the beam's bottom flange
- Double beam-end blockout around the two clusters of strands in the beam's bottom flange
- Individual blockout around each strand in the beam's bottom flange
- Drilling out the strands

All blockouts were filled with grout or similar material.

Single, double, or individual bar blockout are excellent options for separating the face of the beam end and the end of the prestressing strand. Viable alternative beam-end fabrication details include any of the blockout options: single, double, or individual strand.

Foam was found to be the best material for creating the voids. Further investigation is warranted into potential grout products, epoxy products, or both that can adequately fill voided areas without cracking.
