Laboratory Investigation of Bridge Strip Seal Joint Termination Details

tech transfer summary

February 2016

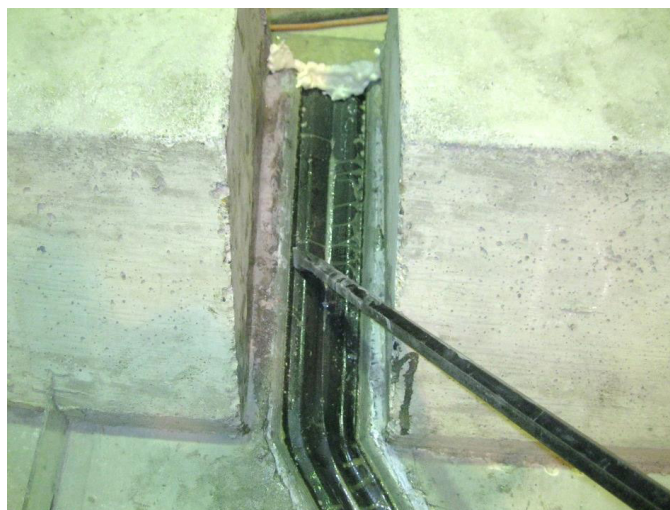
Use of a crowbar to install D.S. Brown gland

For the D.S. Brown strip seal, the gland installation between the barrier rails proved to be simple, taking a total of 10 minutes, and was achieved using a basic pry bar. Both the dogleg and straight-through of the D.S. Brown specimens passed all ponding tests.
