# Feasibility of Forming Transverse Joints with Joint Forming Devices

tech transfer summary

Evaluation of Transverse Joint Forming  
Methods for PCC Pavement

Iowa Highway Research Board (TR-532)

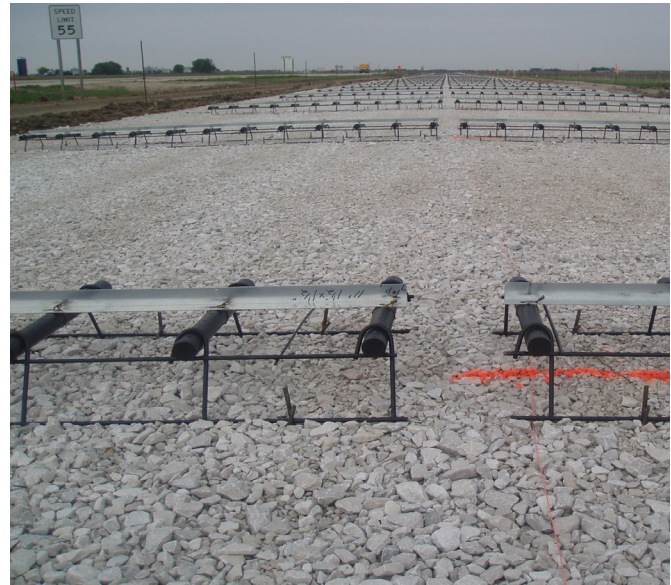
*Cross-section of joint-forming device on top of the dowels*

The joint-forming devices tested each consisted of a galvanized, L-shaped piece of metal placed in the area of the dowel basket to form the joint.

Six separate installations of six joints each (a total of 36 joint-forming devices) were made. The joint formers were placed either below the dowel baskets or on top of the dowels. The joint formers placed on the base were secured with dowel basket pins on approximately 610 mm centers along the joint formers. The pins were driven behind the L-shaped metal of the joint-forming devices (away from the paver) to prevent the metal from being overturned during paving. The joint formers above the dowels were secured with wire ties to the dowels themselves at 305 mm intervals to prevent rollovers.

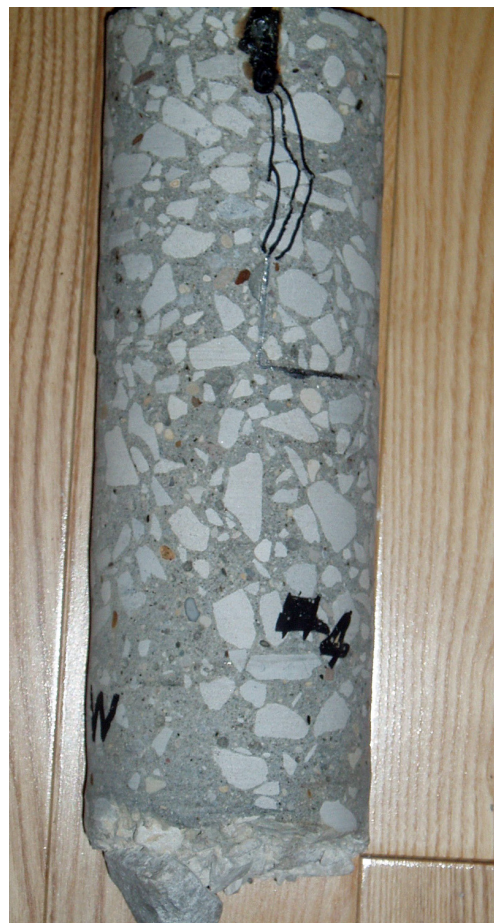
*Core sample showing a crack extending from the joint former*

- Most of the sawed joints around the test sites did not crack completely through the slab in the first 30 days after paving. In many cases, a crack only occurred late in the month on every sixth to eighth joint.
- Weather may have significantly influenced the results. The cool spring temperatures and small amounts of rain may have hindered the slab from curing and cracking.
- One core, taken from a section where the joint former is above the dowels, contains a crack that extends between the top of the joint former and bottom of the sawed joint. However, it is not possible to determine which way the crack initiated.
- In the cores taken across the test sections, the joint former is offset from the sawed joint by up to 25 mm. This process may have initiated a long-term spalling problem or an irregular surface crack, but to date no such activity has been noted.
