**Tools to Improve PCC Pavement Smoothness During Construction (R06E)**

# FIELD REPORT: ILLINOIS EQUIPMENT LOAN

This report summarizes the activities and findings of the equipment loan conducted in Illinois for the Illinois Tollway Authority.

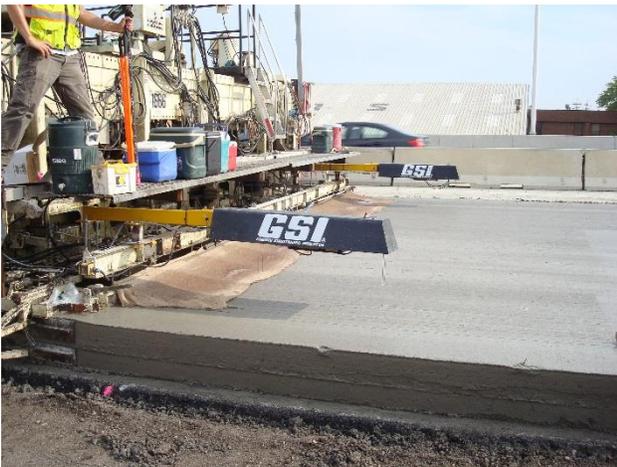
Figure 1. Gomaco GSI behind finish pan and burlap.

Figures 1 through 8 illustrate the installation of the GSI and different aspects of the paving equipment and processes used by K-Five.
