# Modal Testing for Nondestructive Evaluation of Bridges: Issues

AYMAN KHALIL, LOWELL GREIMANN, TERRY J. WIPF, AND DOUGLAS WOOD

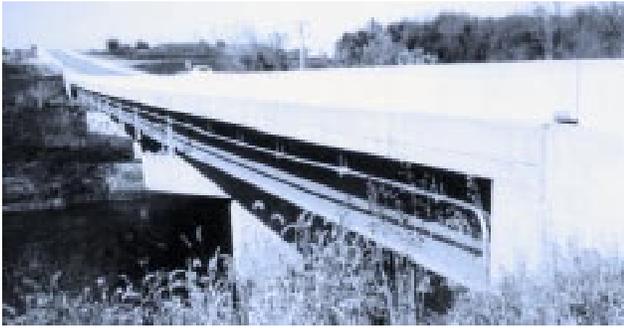
FIGURE 1 Boone River bridge on IA-17.

The bridge tested in this study is located approximately 2 km south of U.S. 20 on Iowa Highway 17 (IA-17). The bridge was constructed in 1972, and as shown in Figure 1, it is a three-span, steel welded plate girder bridge. A 200 mm thick reinforced concrete deck slab is supported on five plate girders of spans 29.70, 38.10, and 29.70 m, respectively. Composite action is provided between the deck slab and the steel girders using shear studs. At intermediate locations, X-type cross frame diaphragms brace girder webs at approximately 6.70 m intervals. Deck rehabilitation was conducted in the spring of 1997 during which 40 mm of concrete overlay was added to the existing deck.

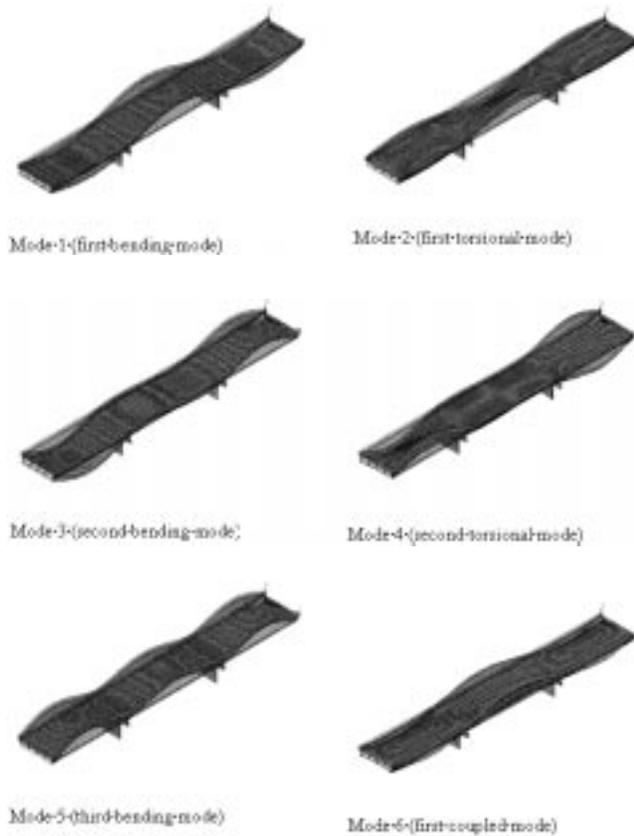
FIGURE 4 Description of the first six modes.

domain. The mode shapes are computed from the ratios of the peak amplitudes, taking into consideration the relative phase angle, at various points of the bridge. The method assumes that the modes are real and it provides good results if the modes are well separated. A fast Fourier transform (FFT), with a rectangular window, was applied to each acceleration time history to get the acceleration response in the frequency domain (the acceleration auto-spectrum or the acceleration spectrum). For example, in Figure 3, the acceleration spectrum that corresponds to the acceleration time history in Figure 2 is given. Natural frequencies appear as peaks in the response spectrum. It should be noted that not all peaks correspond to natural frequencies as some peaks in acceleration spectra simply corresponded to noise in the electrical measuring system. After preliminary investigations of all response spectra, it was possible to isolate ten modes of vibration and determine the corresponding natural frequencies. An interactive program written in C++ was used to extract the frequencies and mode shapes. Figure 4 illustrates the shape of the first six detected modes.
