# ***Access Management Guidebook for Major Arterial Intersections***

**July 2009**

## **ACCESS MANAGEMENT GUIDEBOOK FOR MAJOR ARTERIAL INTERSECTIONS**

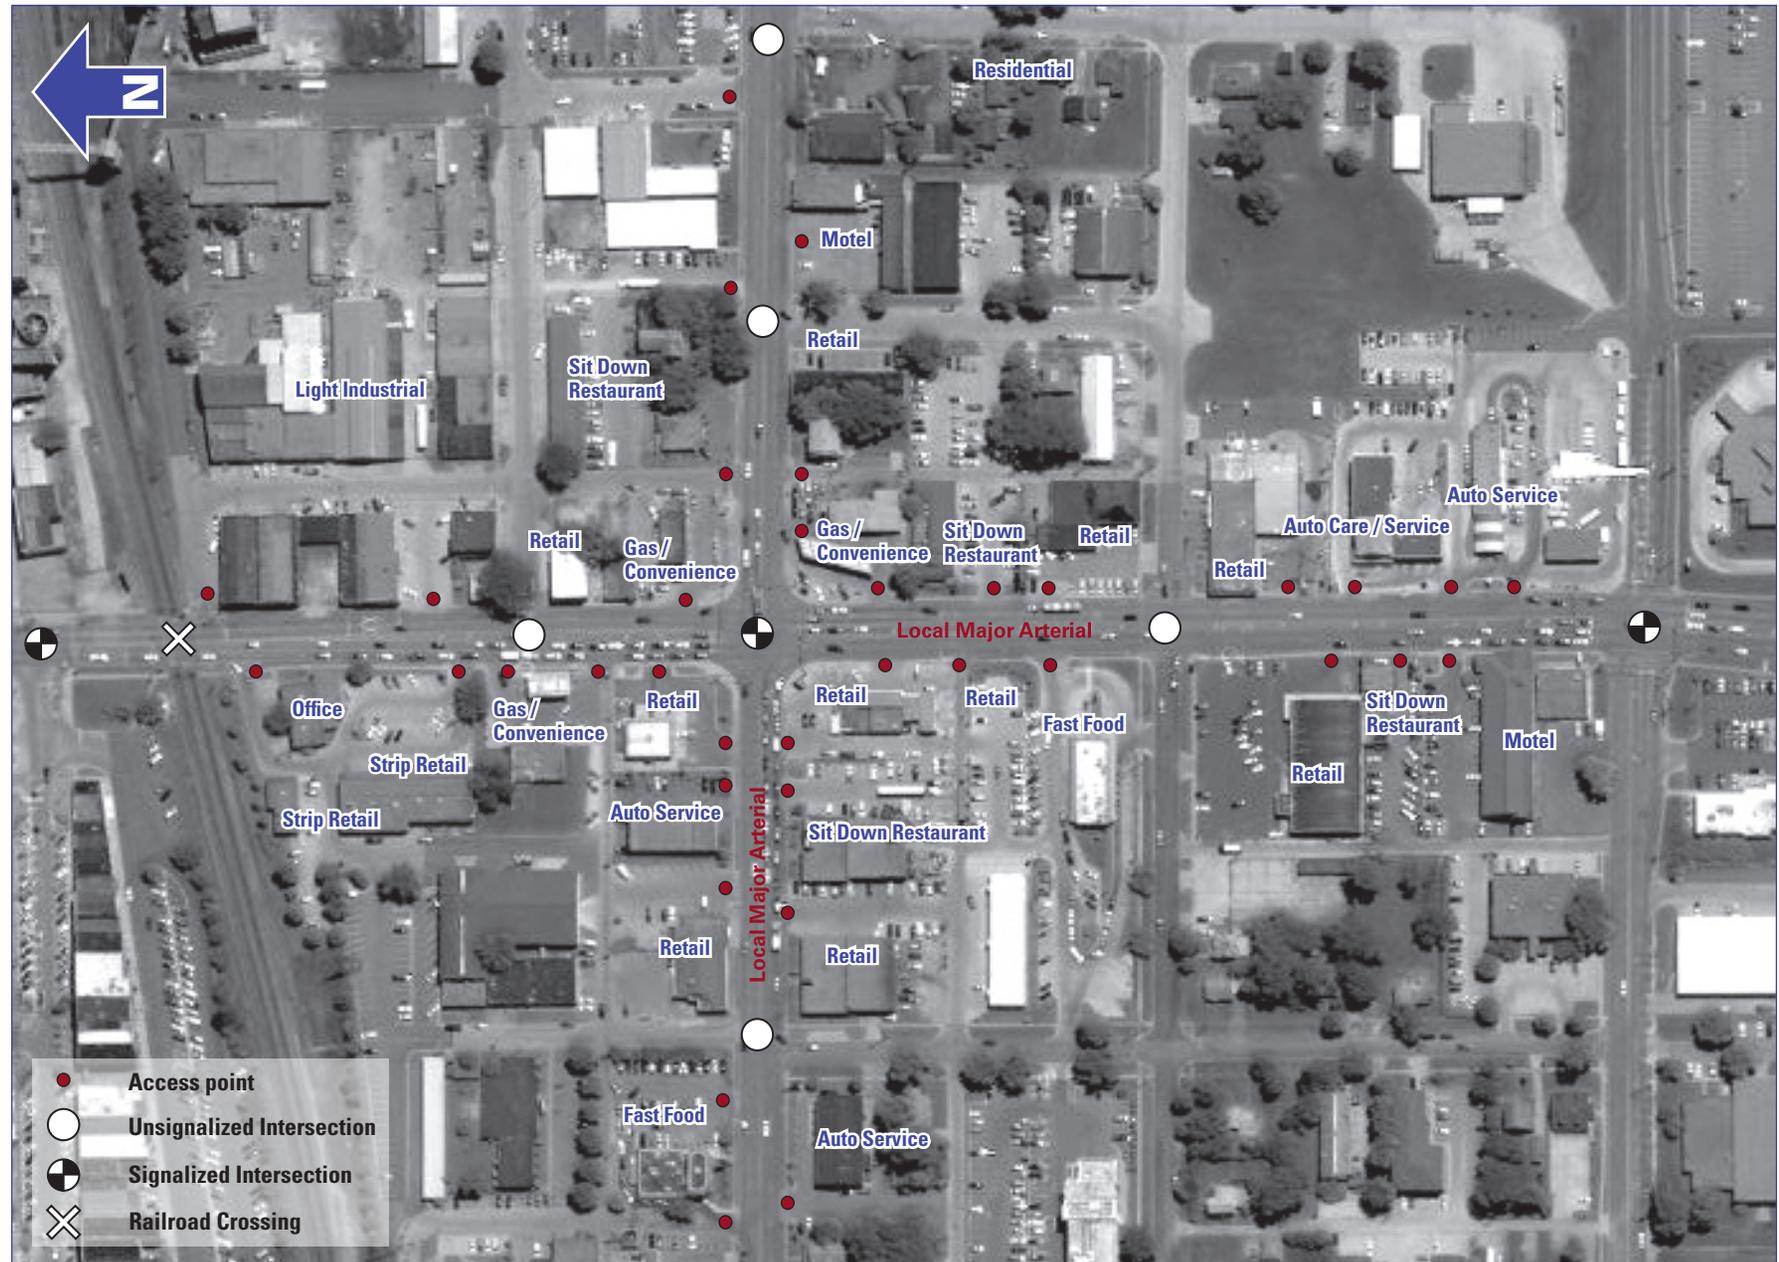
Figure 3. Case Study 3

Overall, access is very poorly managed at the third case study location. However, a couple positive applications of access management can be seen at this location:

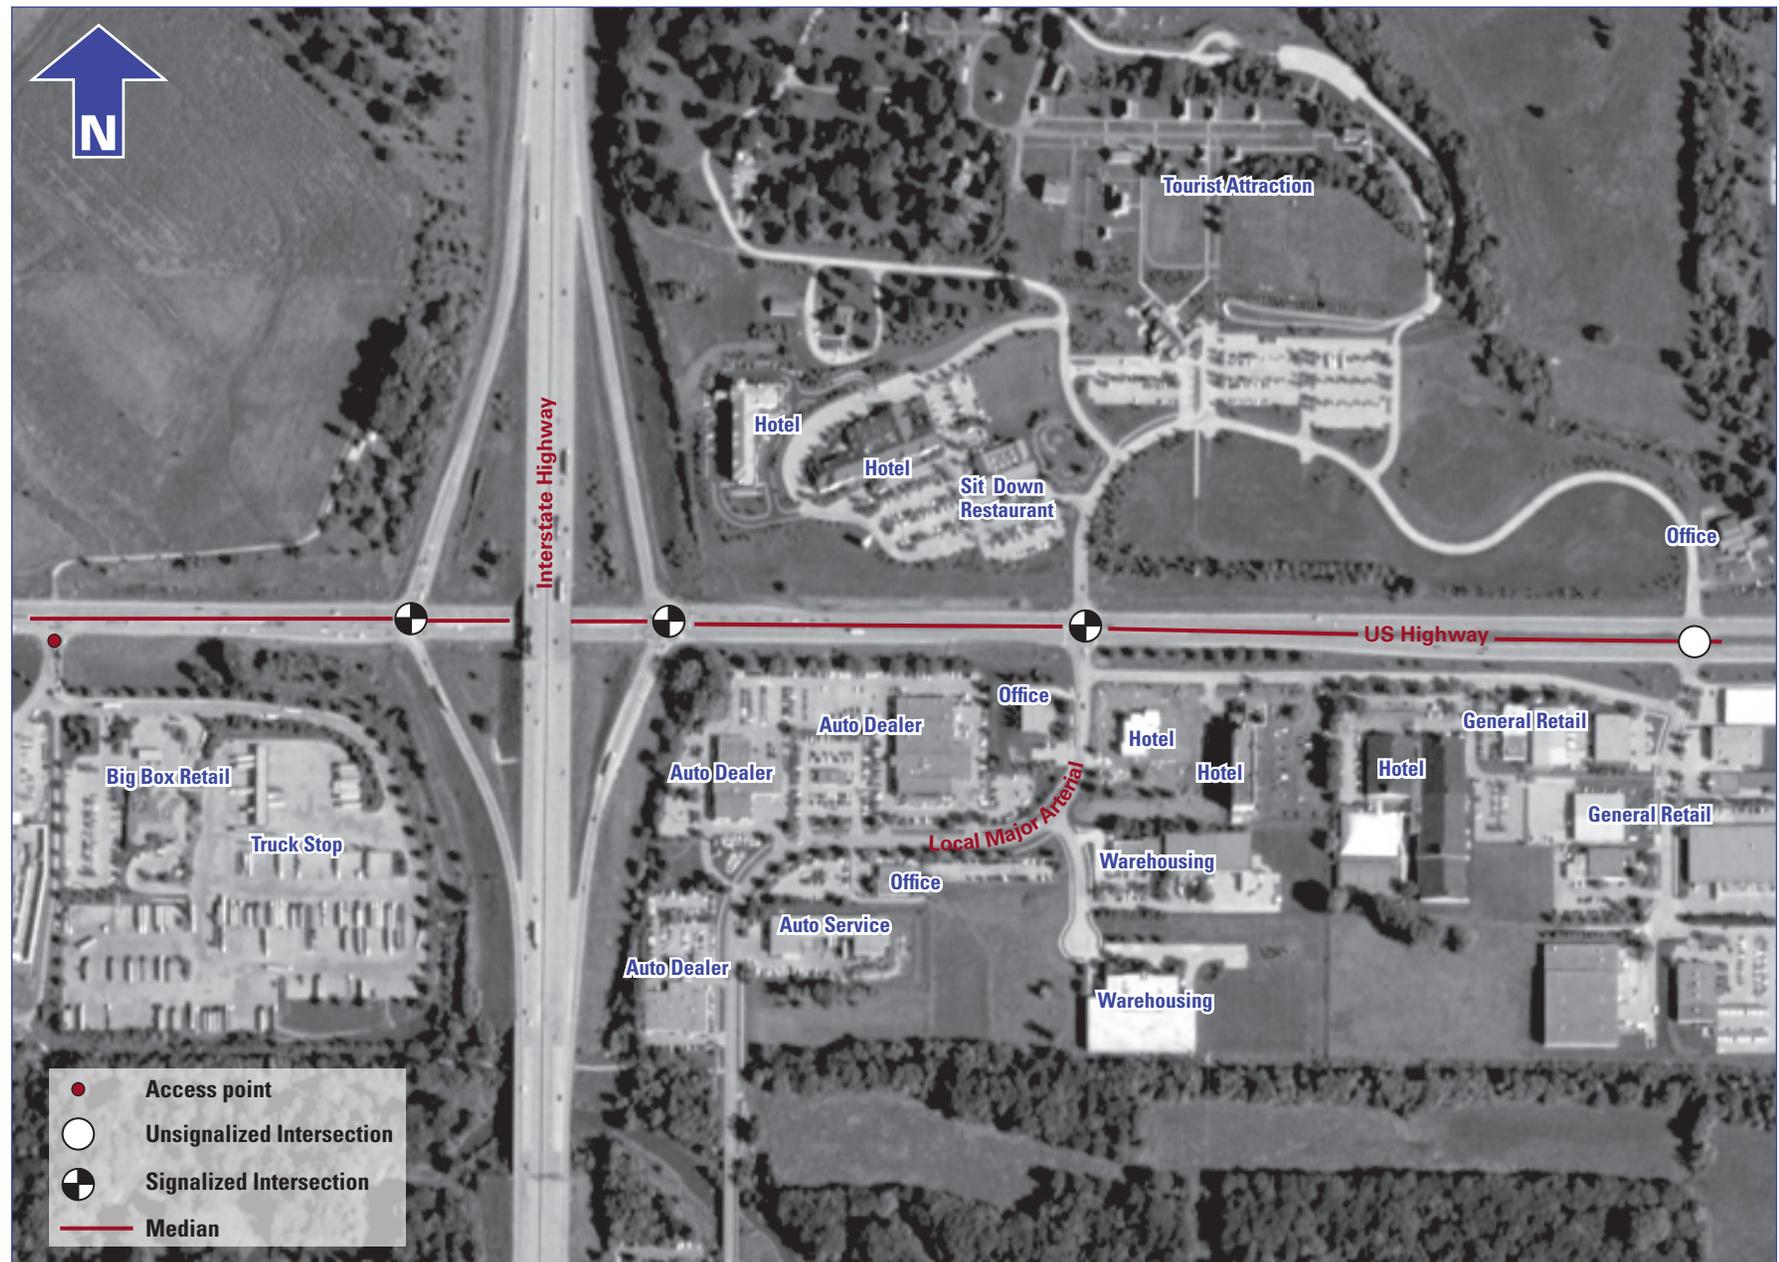
Figure 6. Case Study 6

As noted, access is largely well-managed at this case study location. Positive applications of access management here include

- Lack of connectivity between development on the northeast quadrant and development directly to the east—cross access could be provided, eliminating the need for traffic using the arterial to access between adjacent, similar developments;
- Lack of connectivity between development on the southeast quadrant and development directly to the east—cross access could be provided, eliminating the need for traffic using the arterial to access between adjacent, similar developments; and
- Close proximity of the south frontage road along the east leg to the U.S. highway could cause backups at the signal both along the arterial as well as the frontage road—a backage road could eliminate traffic backups.

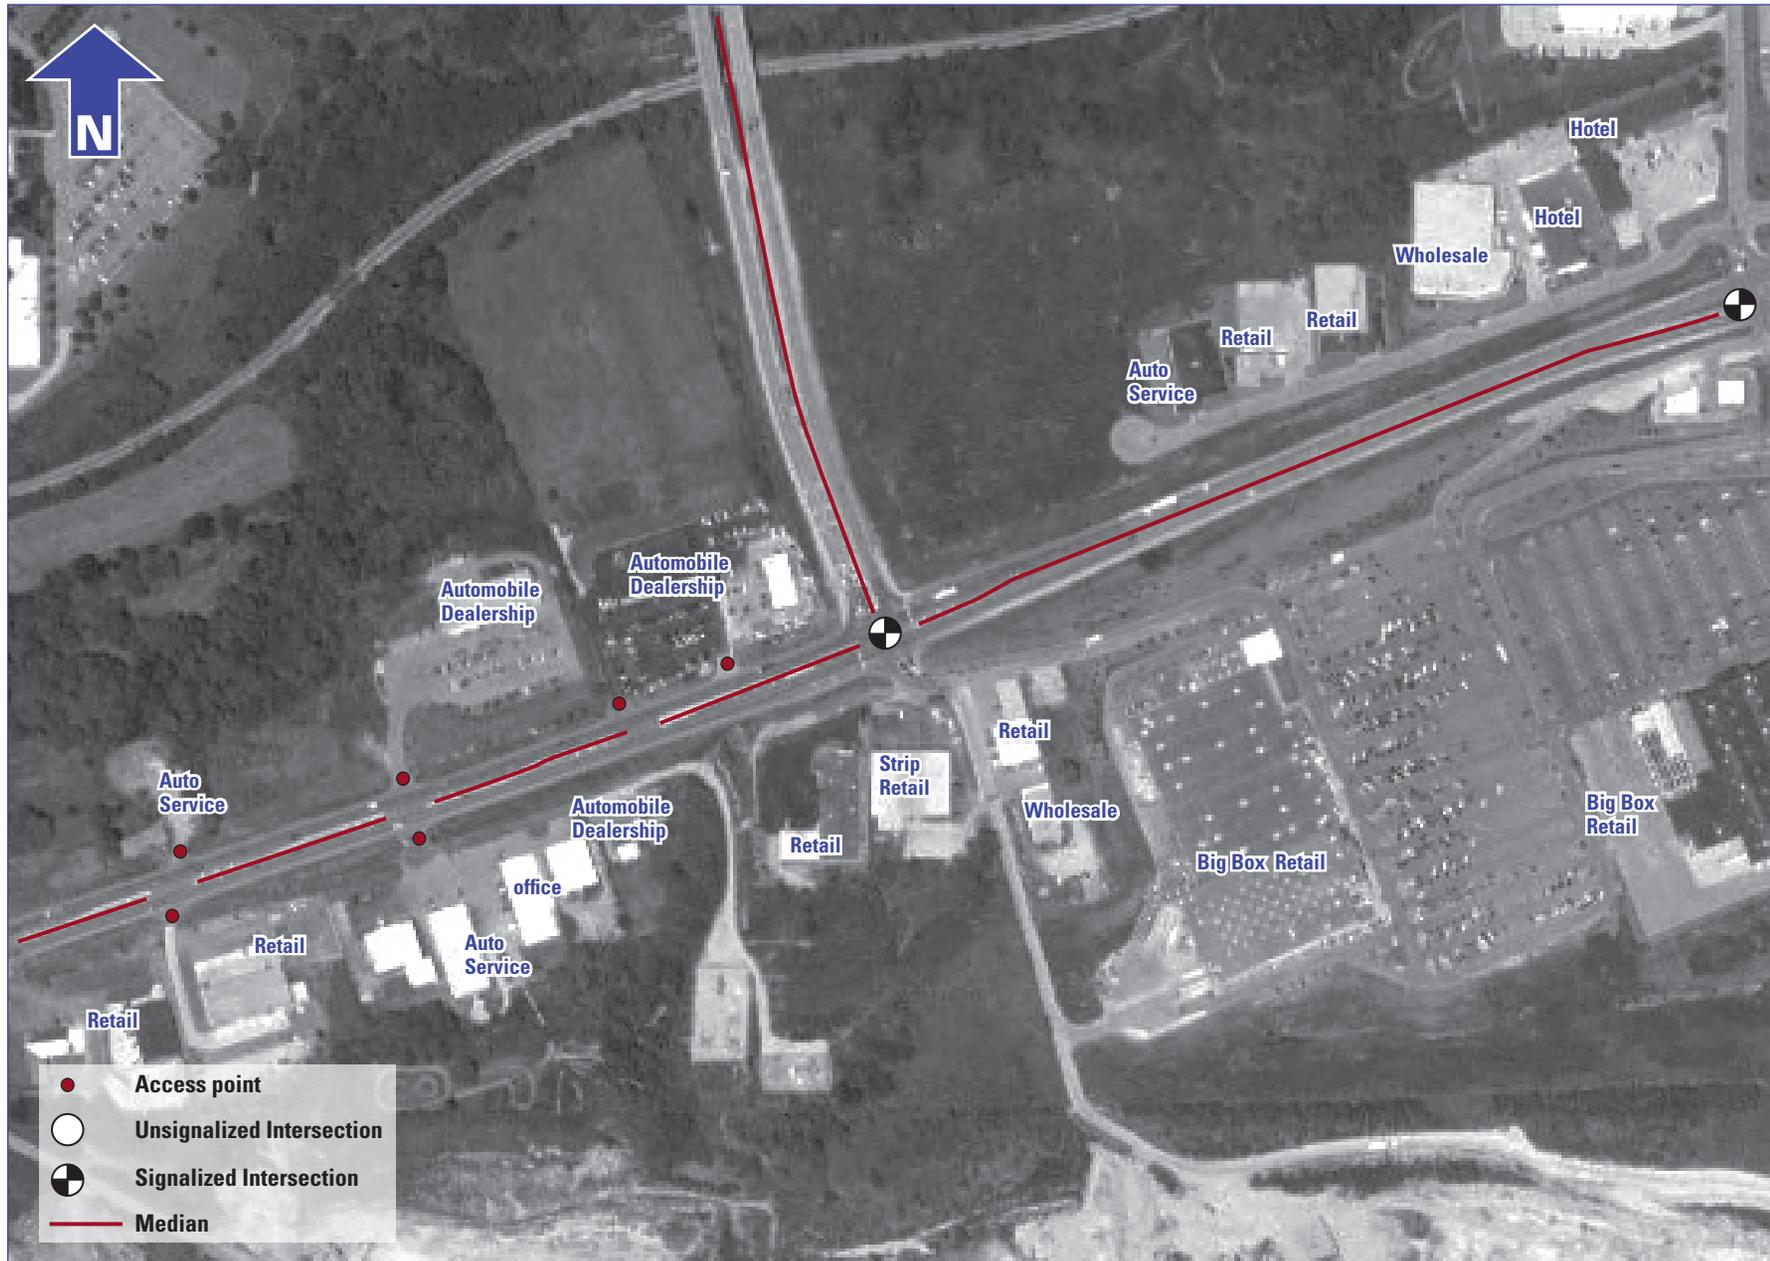
Figure 9. Case Study 9

- + Alignment of some driveways across from each other at full-access (median break) locations.

- Close proximity of the frontage road along the south side of the U.S. highway could cause backups at the signal and along the frontage road—an improved supporting roadway system could help this problem; and

Both good and poor access management practice can be noted at this location. The north leg of this case study, the local arterial, is completely access-controlled throughout the study area. The east leg is also completely access-controlled through the next signalized intersection approximately 1,900 feet farther east. To the west, access is not as highly managed. Along the north side of the west leg, accesses can be found at distances of approximately 300,

550, 1,000, and 1,500 feet from the intersection. Along the south side of this leg, there are access points approximately 1,000 and 1,500 feet from the intersection. As shown in Figure 9, median breaks are found along this leg at all but the first access point on the north side, allowing left turns into and out of development to the north and south.

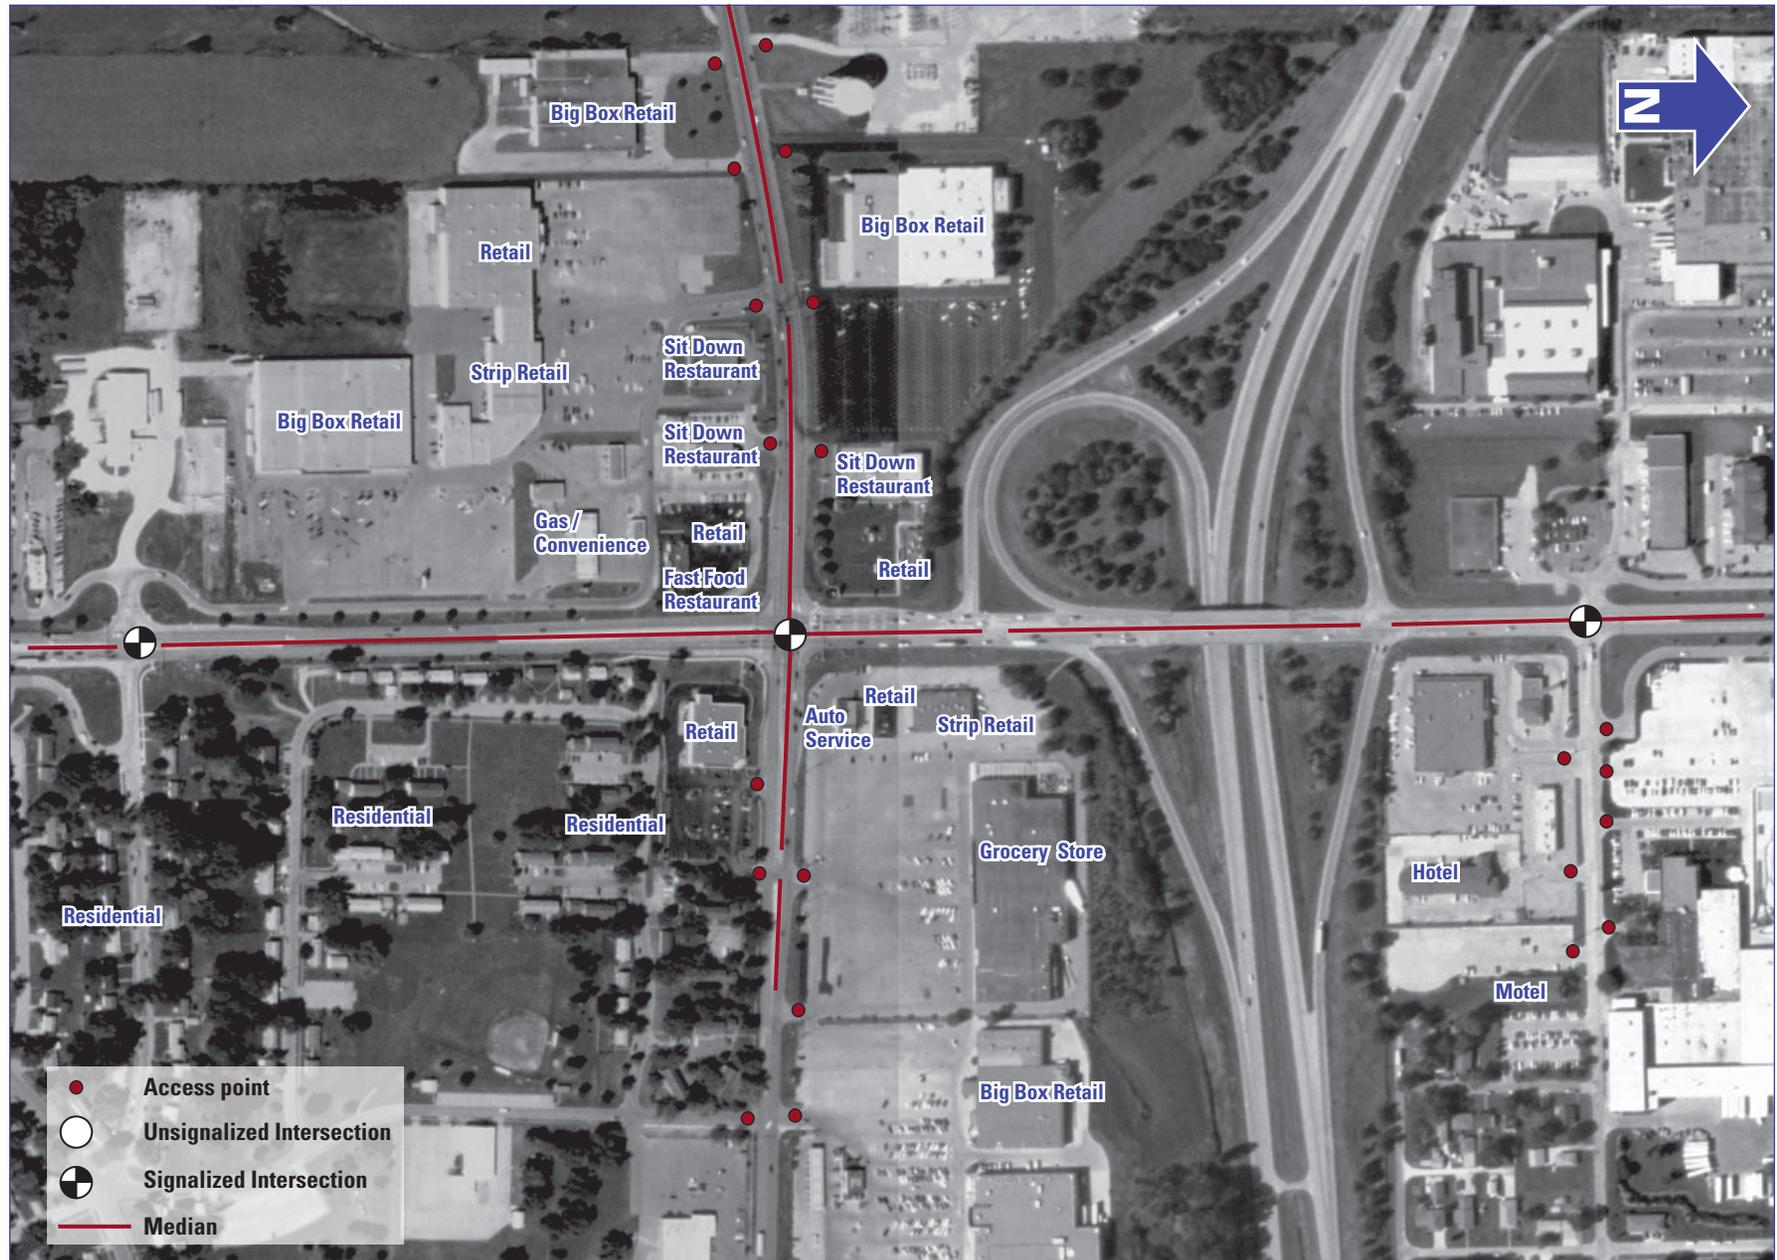
Figure 10. Case Study 10

median break and driveways on both sides of the roadway another 200 feet east. The median ends approximately

800 feet from the intersection, with more driveways accessing the minor arterial from this point east.

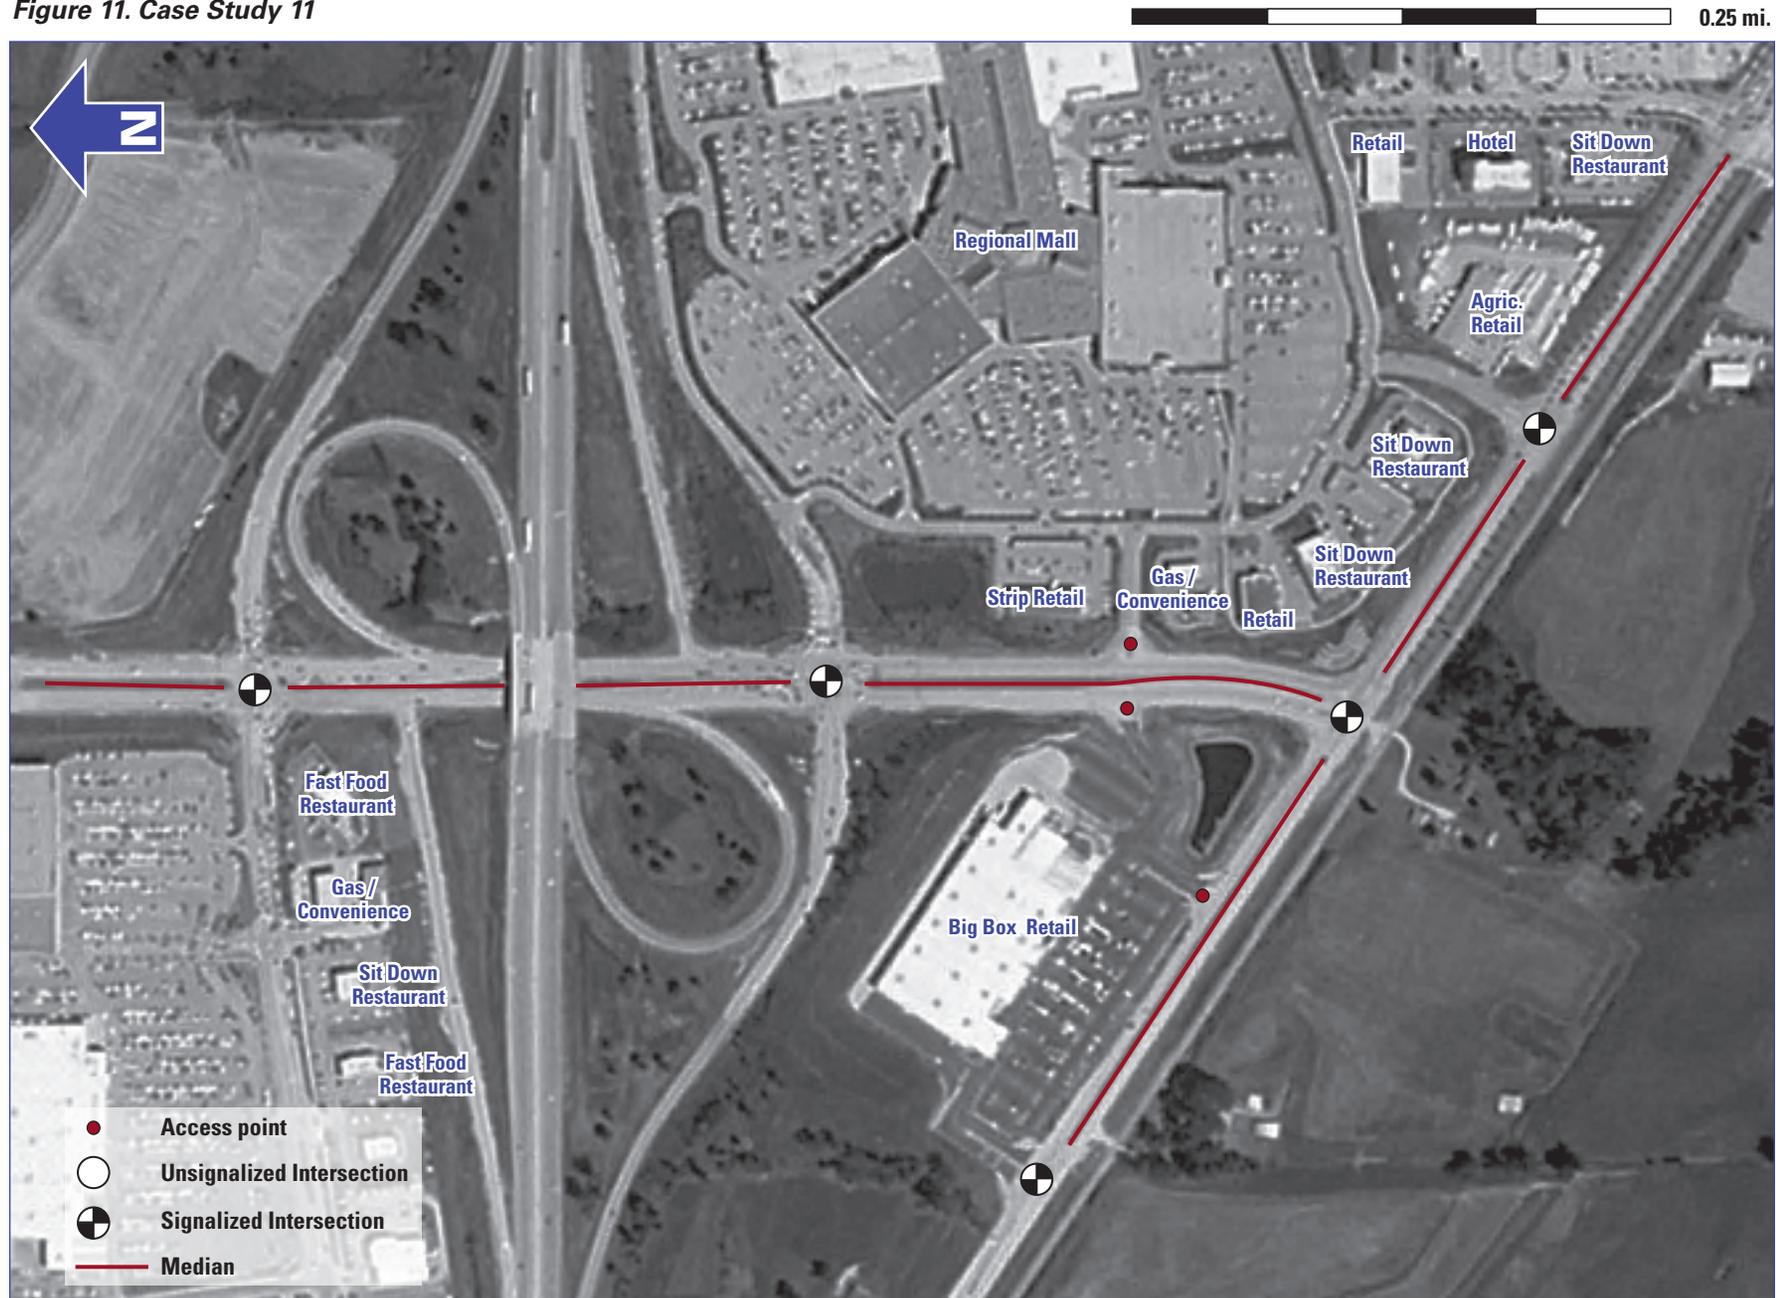
Figure 11. Case Study 11

As noted, access is very well-managed at this location. Positive applications of access management here include

out accesses serve the big box retailer to the west and the mall to the east. The state highway terminates at a signalized intersection with the major arterial another 500 feet farther south. A raised median runs the length of the major arterial with breaks at signals only. Approximately 550 feet west of this intersection along the major arterial is one right-in, right-out access to the big box retailer. Another 800 feet west, a signalized intersection provides access to the big box retailer and future development in this area. East along the major arterial, access is limited to a signalized intersection 850 feet from the state highway intersection.

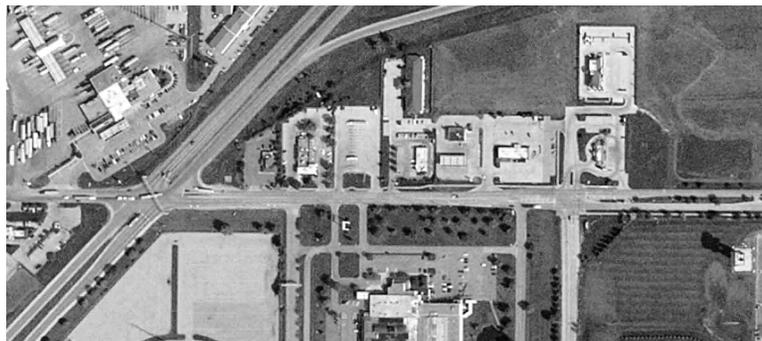
**Figure 15. Strip Development (Not Preferred)**

oping as a strip generally requires that the arterial be used for each trip between different locations within the area, as shown in Figure 15. Nodal developments, however, provide internal circulatory roads with fewer access points to the arterial. This causes limited disruption to the through traffic, while continuing to allow for relatively good and easy access to the development, as is evident in Figure 16. Strip developments can be reconfigured as a node by providing cross and joint access or backage road systems between parcels.

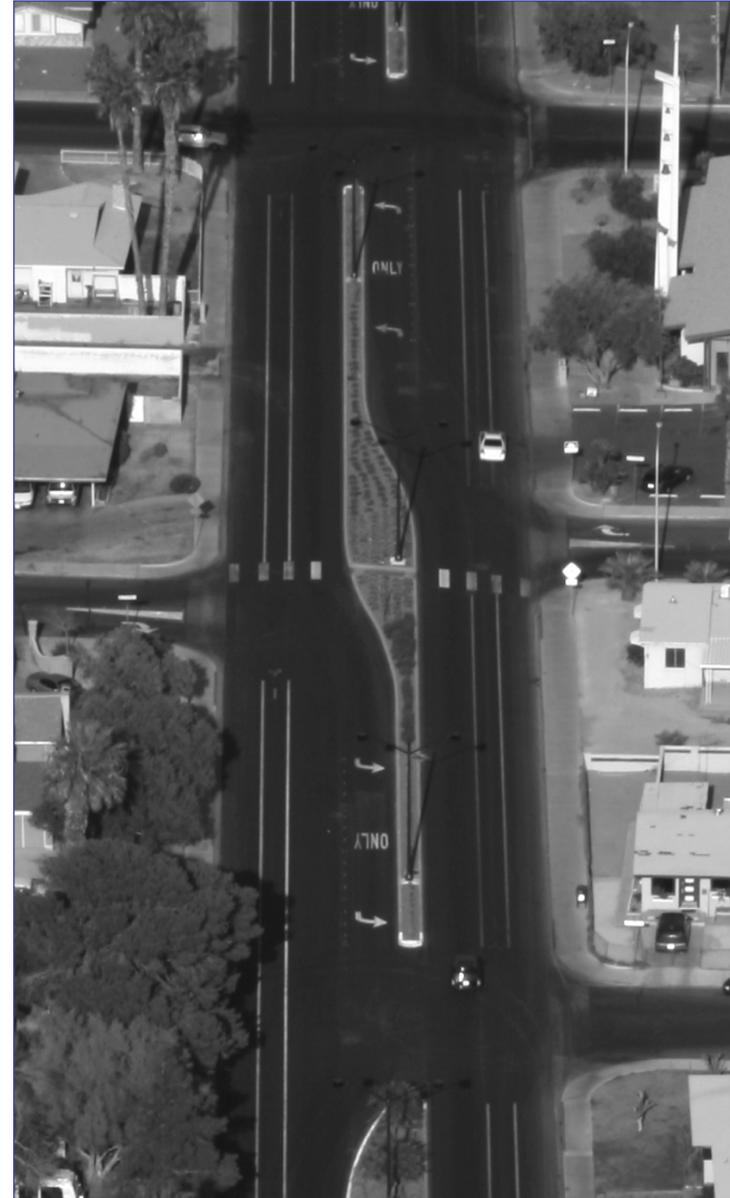
**Figure 20. Non-Traversable Median**

As urban arterial traffic is expected to rise above 24,000 VPD in a design year, a TWLTL will begin to function poorly no matter how well driveways are managed. A raised median will function much better in place of a TWLTL. Dedicated left-turn bays and right-turn slip lanes separate turning traffic from through traffic, greatly increasing the flow and capacity of the route, as shown in Figure 20.
