Assessment of Channelizing Device Effectiveness on High Speed/High Volume Roadways

Final Report July 2007

Sponsored by
the Smart Work Zone Deployment Initiative
and
the Iowa Department of Transportation
(CTRE Project 06-278)

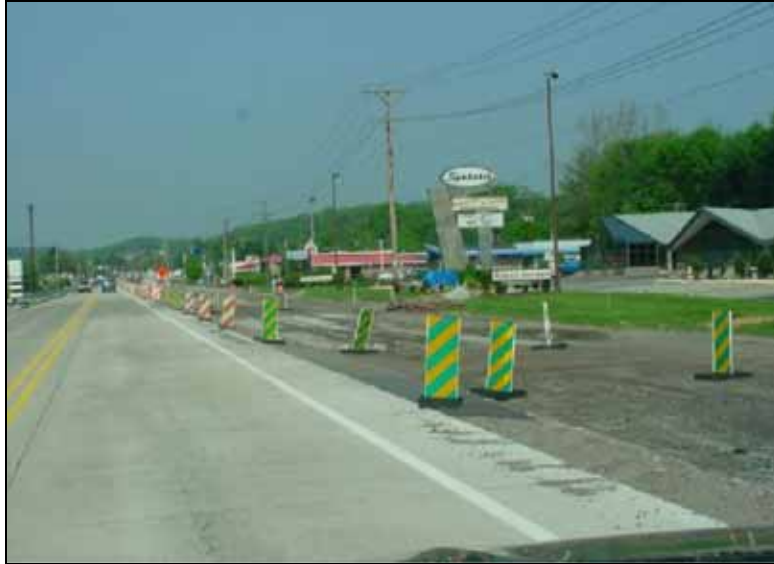
Figure 3. Alternate-colored vertical panels at entrance taper (PennDOT)

In addition to the guidance in Part 6 of the MUTCD described previously, some states have taken advantage of Section 1A.10 of the MUTCD for an opportunity to experiment with design modifications of channelizing devices to enhance driver attention and compliance with work zone TTC. Some examples of taper experiments used in Pennsylvania are shown in Figures 3 and 4. Figure 3 shows alternative green and yellow panels, instead of the standard orange panels. Another alternative configuration is shown in Figure 4, using green and white striped drums at the exit taper.

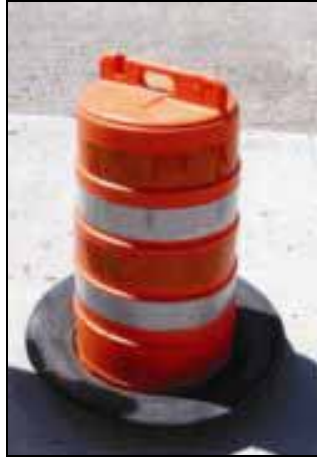
Figure 7. Drum-like channelizer

Figure 7 illustrates the standard drum-like channelizers that are generally used in work zone areas to provide longitudinal channelization within the activity area if their larger size and additional retro-reflective area are deemed appropriate. Drum-like channelizers are not generally used in areas with limited lateral clearance. When specified, quantities may be calculated and shown in the project plans.

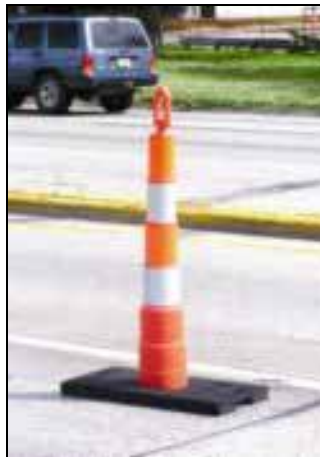
Figure 8. 42 in. channelizer

Figure 8 illustrates the 42 in. channelizers, sometimes referred to as “grabber cones”. These channelizing devices are used in work zones and can be used in ramp areas, intersections and areas with limited lateral clearances. These types of channelizers may be used in daytime or nighttime operations in many states. When specified, quantities may be calculated and shown in the project plans.

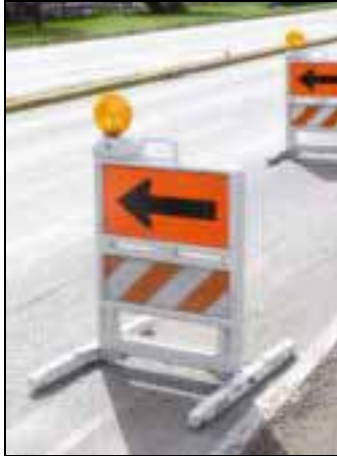
Figure 9. Direction indicator barricade

Figure 9 illustrates the direction indicator barricades (DIB) that can be used instead of other channelizers in merging tapers, as DIBs provide direction and have a larger visual target area for motorists. DIBs, however, are not recommended for shifting tapers. When specified, quantities may be calculated and shown in the project plans.

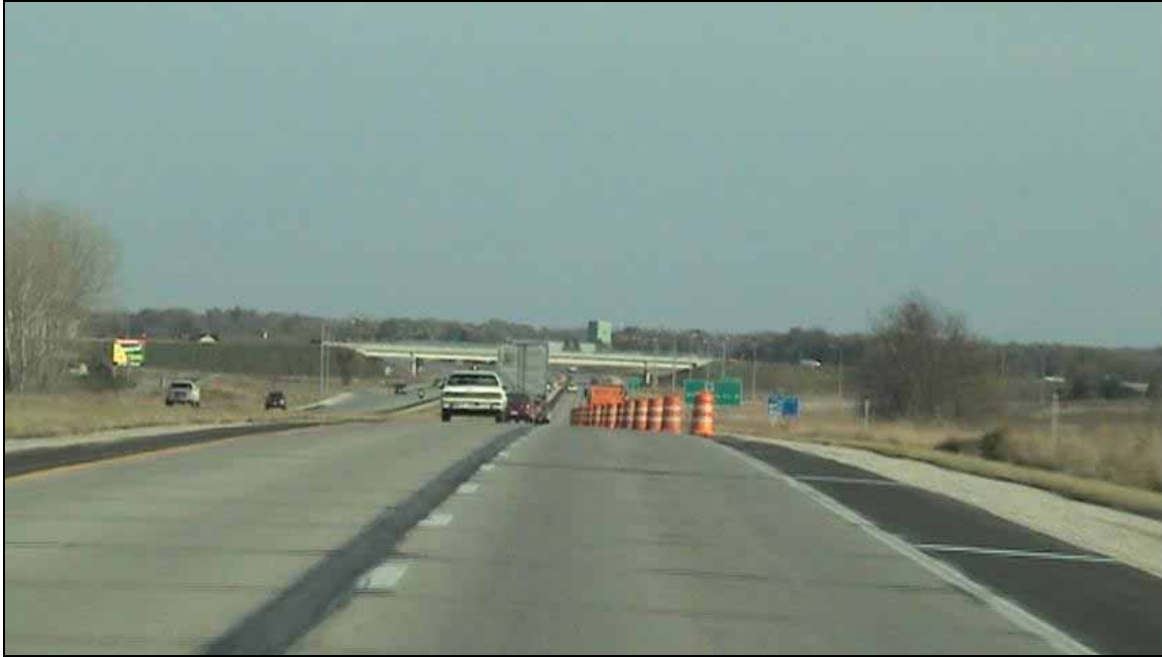
Figure 10. Drums at 60 ft.

The following three figures show different work zone configurations using different channelizing devices. Figure 10 shows the base line work zone configuration, with the standard drums set at 60 ft. intervals. Figure 11 shows the 42 in. channelizers set at 60 ft. intervals. Figure 12 shows the 42 in. channelizers, or “grabber cones,” set at 40 ft. intervals.

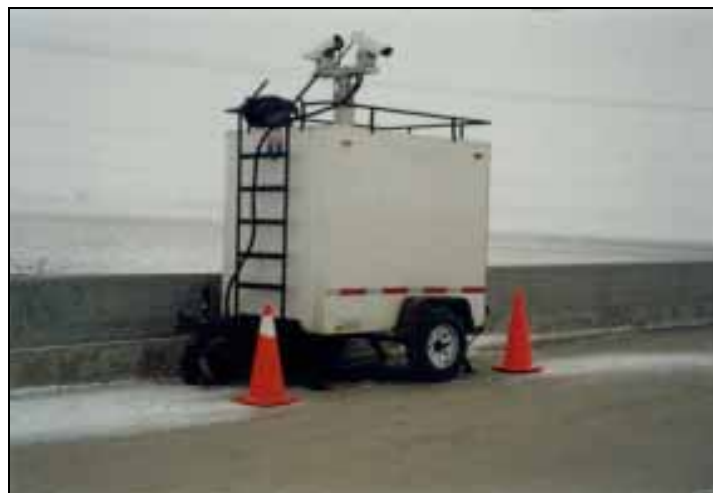
Figure 13. AutoScope video traffic detection system

US 30 traffic flow characteristics were collected during four days from October 30 to November 2, 2006 from the Y Avenue overpass over US 30 near Ames, Iowa. The data were collected with the AutoScope wide-area video detection system, which consists of a control unit, image sensors (or video cameras), and supervisor computer/software. For this research, two video cameras were mounted on a trailer and directly connected to the AutoScope control unit. Figure 13 shows the AutoScope trailer, cameras, and control unit. Traffic flow images were recorded with the cameras in the field and then stored on videotape using the electronic equipment contained in the enclosed trailer (see Figure 14).

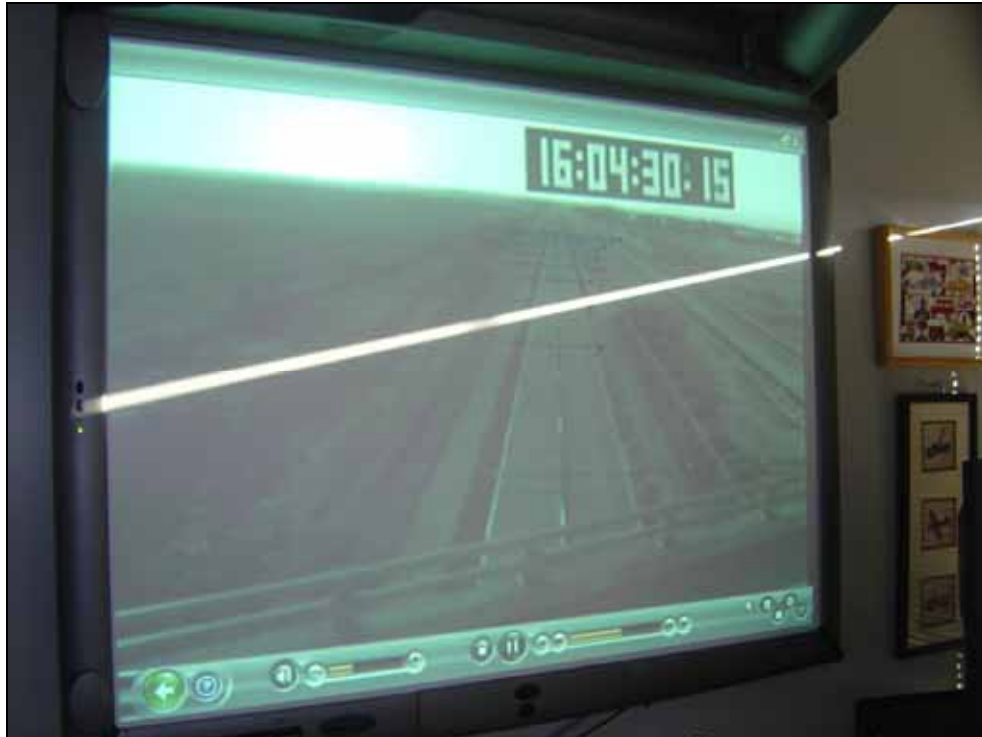
Figure 15. Video copied to DVD, projected on large screen

A large amount of data post-processing was conducted following data collection. The video images taken each day were copied and stored to DVD for added resolution and ease of analysis. The DVD images were then projected onto a large screen so that the images were more easily seen. The traffic was observed and analyzed from this point. Figure 15 shows an image as copied to DVD.

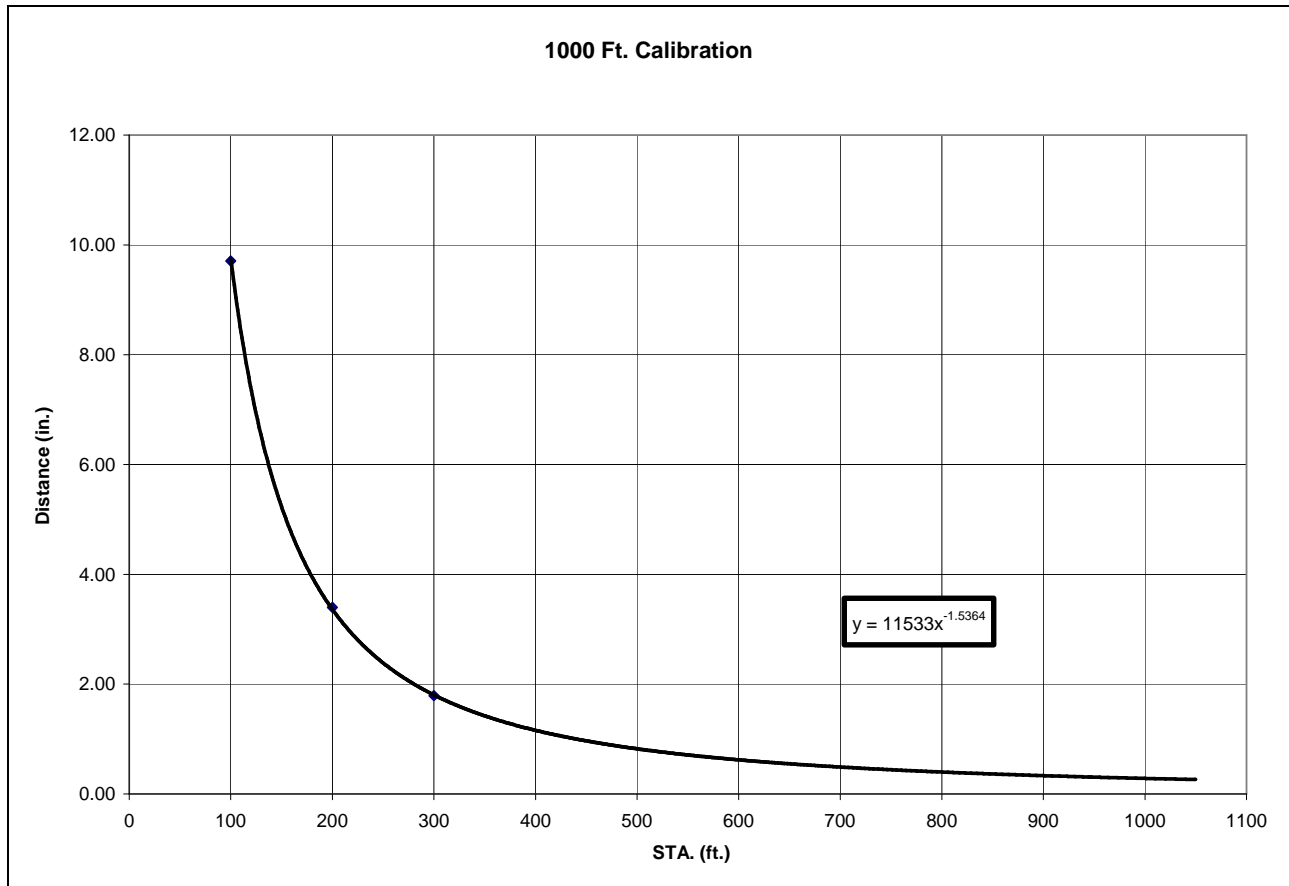
Figure 16. 1,000 ft. calibration for measuring merge distances

Previously, large lines were painted on the shoulder of the highway in 100 ft. intervals, for a total of 1,000 ft., to be used as baseline. (The lines were large enough so that they could be seen by the AutoScope camera located on the bridge). In the laboratory, an area plot was established and graphed on the screen. The video was projected onto the screen and vehicles were observed and timed traveling by each line in the plotted area. Vehicle speed was then calculated. Speed and distance calculations were then converted to dimensions that could be projected onto the screen. Following each set of calculations, a master template was made for each day and treatment condition. Using the template and projecting the video images onto the screen, vehicles were tracked and observed as they merged. The merge distance for each vehicle was estimated by calculating the time that the vehicle passed a measured point in each video frame. The calibration for this formula is shown in Figure 16.

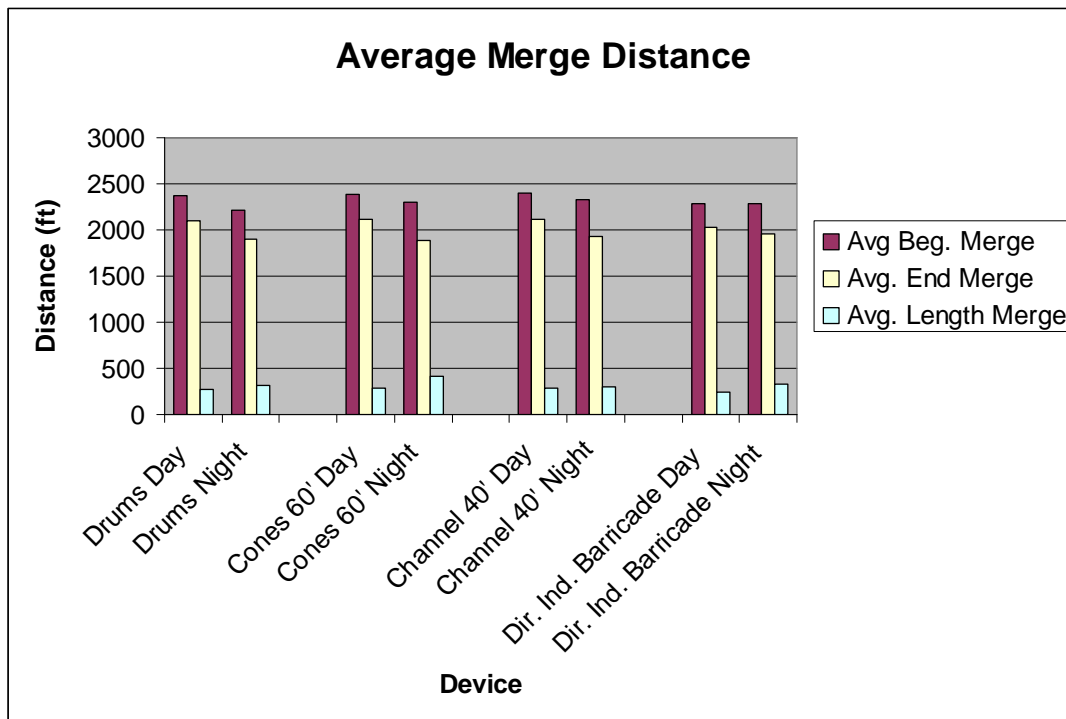
Figure 17. Average merge distance by device

Average merge distance can be expressed graphically as well, as shown in Figure 17.

Table 2 describes the merging data collected from the video observations. Traffic movements through the work zone were observed and the vehicles were counted and measured as the drivers began to change lanes and merge to the left lane. The number in the “average begin merge” column is the location where drivers began the merging movement—defined as when the left side of a vehicle meets the center “skip” line. The “average end merge” column is the location where the merge movement was deemed to be completed, defined as when the right side of a vehicle meets the center “skip” line. Average length of merge is presented in the last column. The vehicle merge points were only measured within 3,000 ft. from the top of the taper. (Some vehicles did merge earlier than 3,000 ft., but the distances beyond 3,000 ft. could not be accurately measured with the AutoScope equipment.) The data are divided into day and night categories to determine the extent to which daylight influences merging behavior.

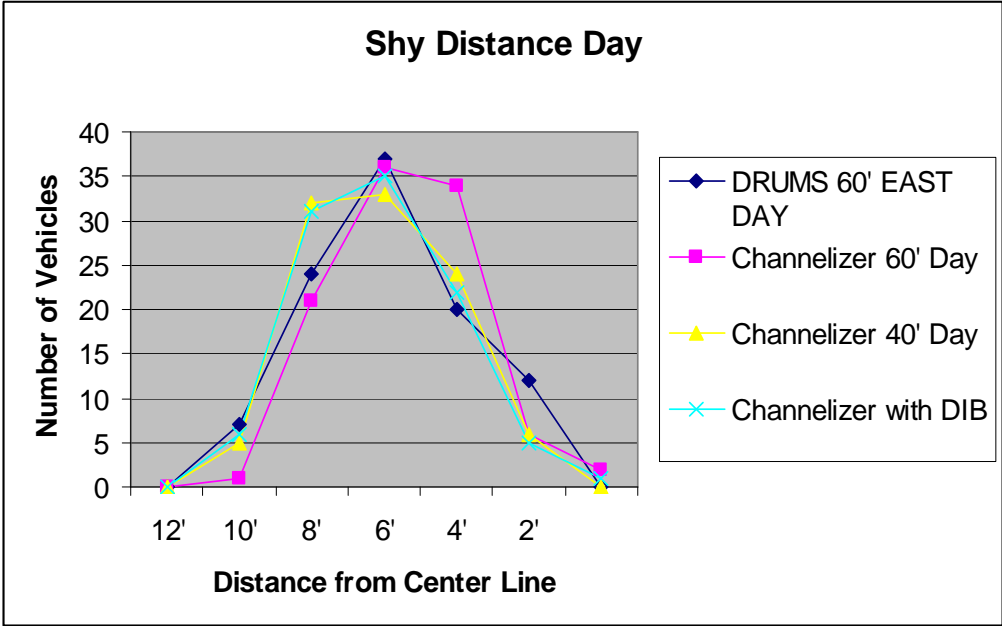
Figure 17. Shy distance by device by day

Figures 17 and 18 illustrate the shy distances of the vehicles as they passed by the channelizing devices during daytime and nighttime hours. Figure 17 shows shy distances during daylight. Figure 18 shows shy distances as measured at night. The graphs show the number of cars by the distance they moved away from the center line near the top of taper. For example, when the drums were set up at 60 ft. during the day (at the peak), approximately 37 cars moved 6 ft. away from the center line.

Shy distance is defined as the distance a vehicle is laterally displaced from the channelizing device at a designated point. Shy distance, in this instance, was estimated at the top of the taper by examining the videotape at reduced speed and calculating the distance from the designated spot, from zero to 12 ft. (12 ft. representing an entire traffic lane). Shy distances were estimated for each treatment. An examination of the data shows little significant difference between each device. Most of the shy distances were between 6 ft. to 8 ft. from the center line at the top of the taper. Distances did increase at night, however. The analysis indicates that during nighttime hours, the 42 in. channelizers at 40 ft. intervals nearly replicated the merging behavior observed with the standard drums. Shy distance for the 60 ft. intervals was lower. The treatment using the combination of 42 in. channelizers and direction indicator barricade also shows an increase in shy distances.

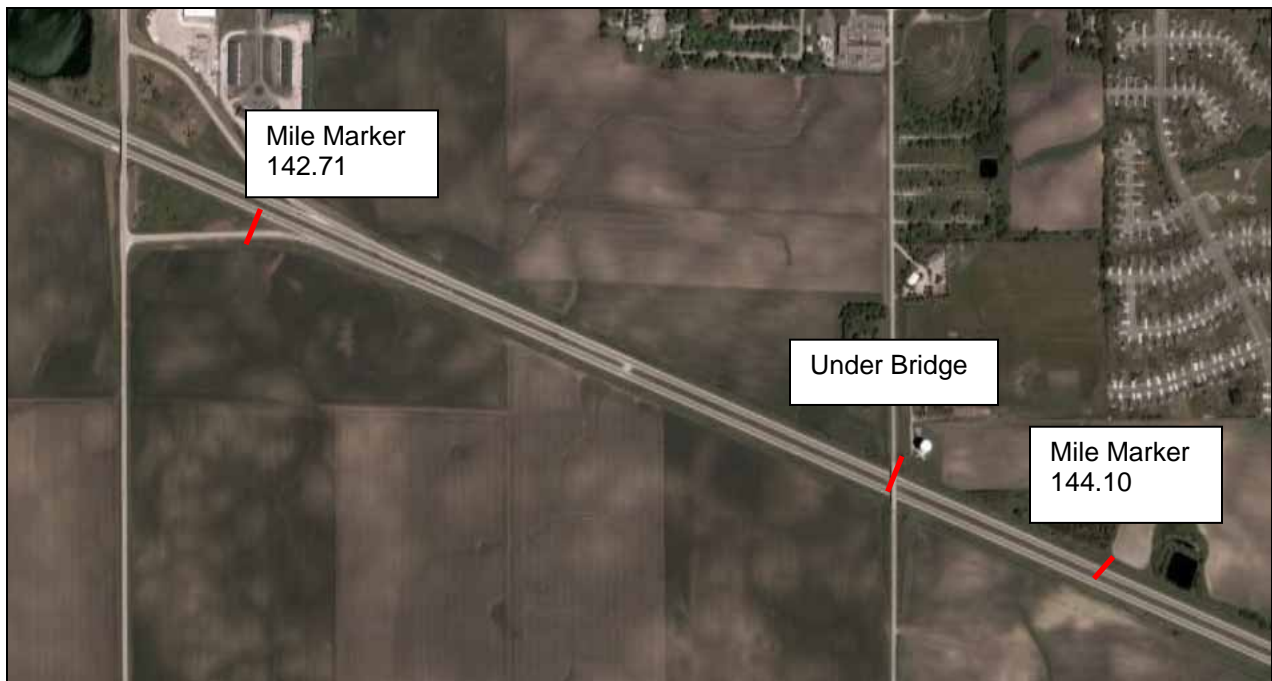
Figure 19. Placement of pneumatic road tubes

Speed was also analyzed for each channelization setup. Three sets of pneumatic road tube counters were placed on US 30 at various locations to gather traffic data. The posted speed limit for this section of US 30 is 65 mph. For this study, one set of tube counters was placed upstream, approximately one mile ahead of the work zone at mile marker 142.71. The second set was placed just under the Y Avenue Bridge, approximately 1,000 ft. from the beginning of the taper. The third set was placed approximately 1/4 mile from the end of the work zone at mile marker 144.10. The speed data show a general decrease in traffic speed through the work zone area. Figure 19 shows the approximate placement of the pneumatic road tubes on US 30 for this study. The tubes provided valuable speed and traffic data for the duration of the study.
