# Investigation of Techniques for Accelerating the Construction of Bridge Deck Overlays

**Final Report**  
**April 2016**

**Sponsored by**  
Federal Highway Administration  
Iowa Department of Transportation  
(InTrans Project 14-500)

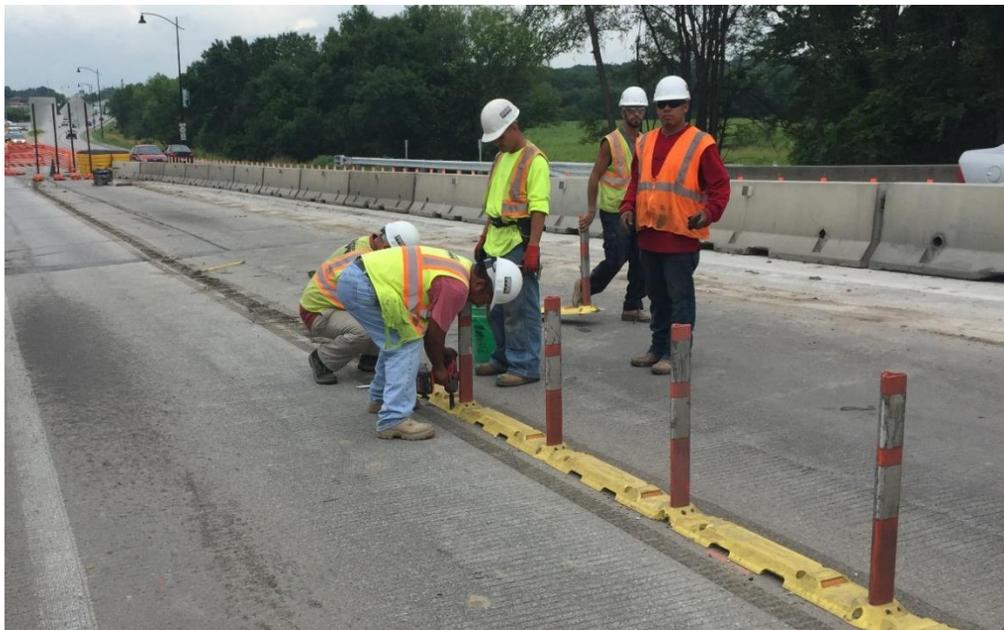
Temporary bollards were installed on the bridge deck during construction of the westbound overlay. These bollards were installed between the eastbound and westbound lanes to direct traffic safely. The bollards that were used were bolted to the deck and had to be detached using a hand drill as shown in the Figure 1.

**Figure 1. Temporary bollards being detached by workers**

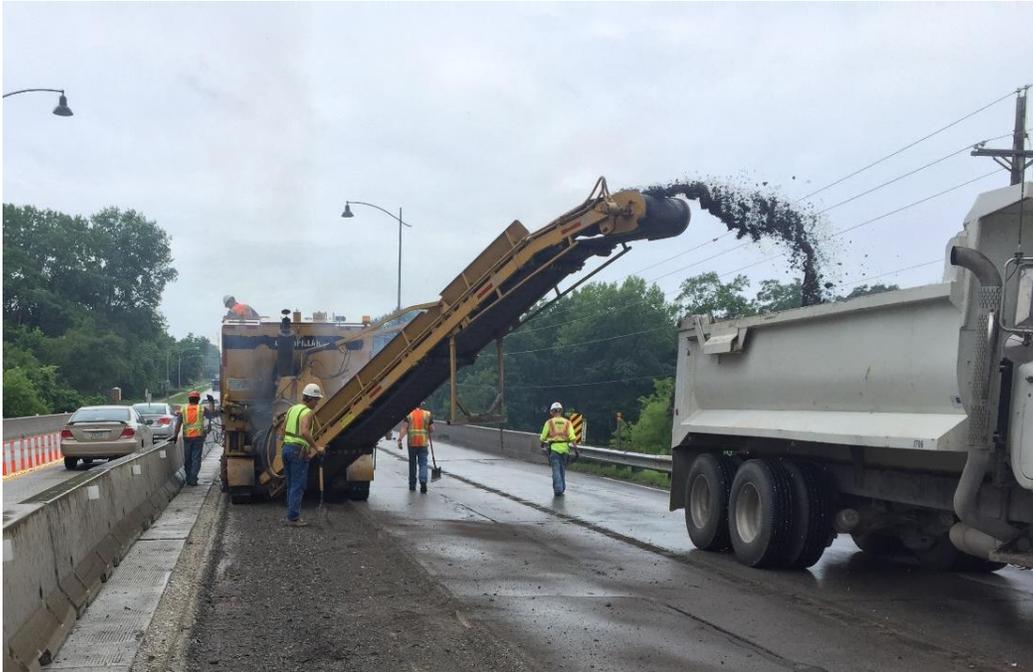
One person operated the machine and four workers watched over the machine and guided the operator. The milled concrete was transferred to a dump truck by a conveyor connected to the milling machine as shown in Figure 2.

**Figure 2. Milling machine removal of top layer of the deck**

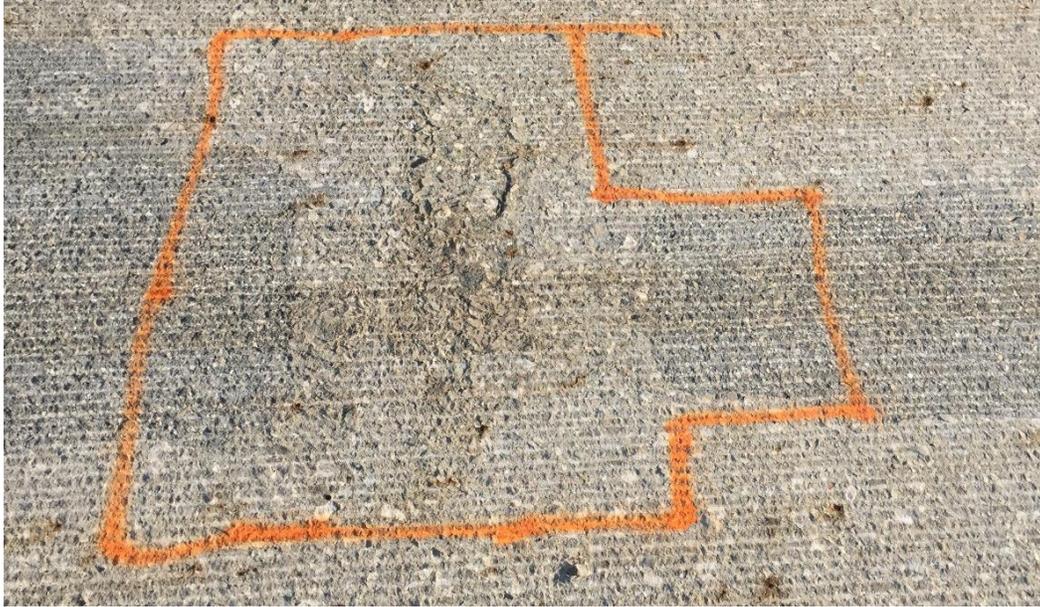
After doing five passes, all of the top layer of concrete on the deck was removed and the residual concrete was cleaned off. Alongside cleaning, the cleaned deck portion was inspected for unsound and damaged areas, which were marked for more in-depth removal as shown in Figure 3.

**Figure 3. Area marked for more in-depth removal**

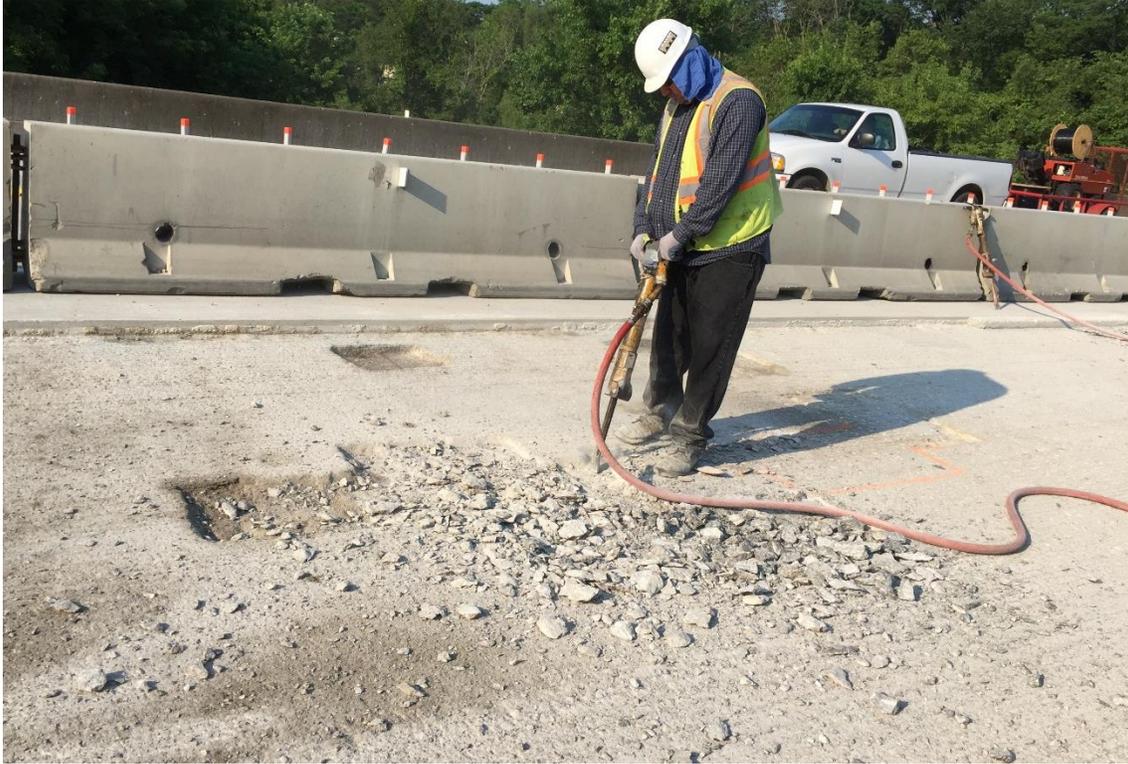
The removal of substrate concrete using the jackhammers was completed by nine workers over the course of three days. On the first day, it took an hour to prepare for the task and then removal took about six hours. By the end of second day, all marked, unsound concrete was removed. On the third day, all areas were carefully inspected and marked for additional concrete removal. After the inspection, removal of the marked concrete took place for seven additional hours. Figure 4 shows a worker removing the marked patch of concrete using a jackhammer.

**Figure 4. Removal of unsound concrete using jackhammer**

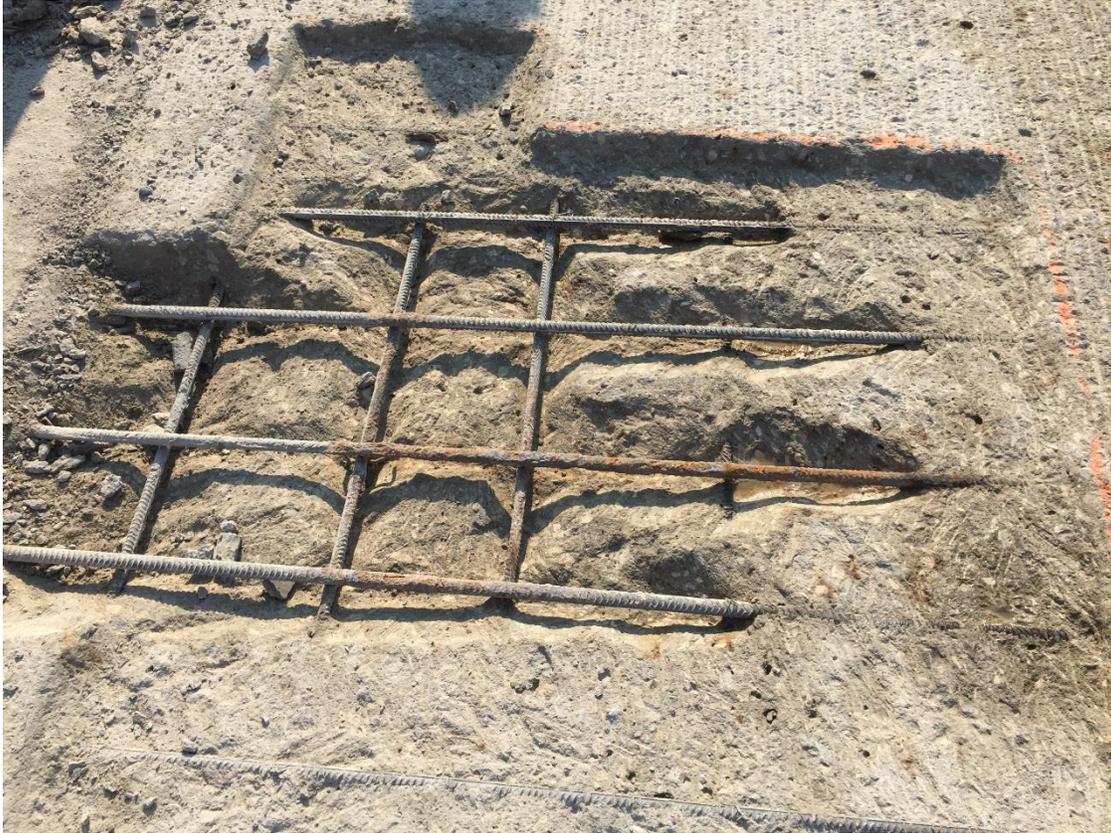
On the third day, the deck was inspected for areas where the entire reinforcing steel bar needed to be exposed. According to the contractor, about 30% of the time, the damaged concrete level is between half the diameter to the full diameter of the bar and the workers need to expose the entire reinforcing steel bar. This extra removal may take many hours to complete depending on how deep the deteriorated concrete is and over how much area it extends. In a best case scenario, it may have been possible for the entire third day of concrete removal to have been almost entirely avoided if the deteriorated concrete was just barely below the half diameter point. It seems fair to say that this additional removal may have taken 4 to 8 hours. Figure 5 shows a deteriorated area of deck concrete after removal of the substrate concrete.

**Figure 5. Deteriorated area of the deck after removal of the substrate concrete**

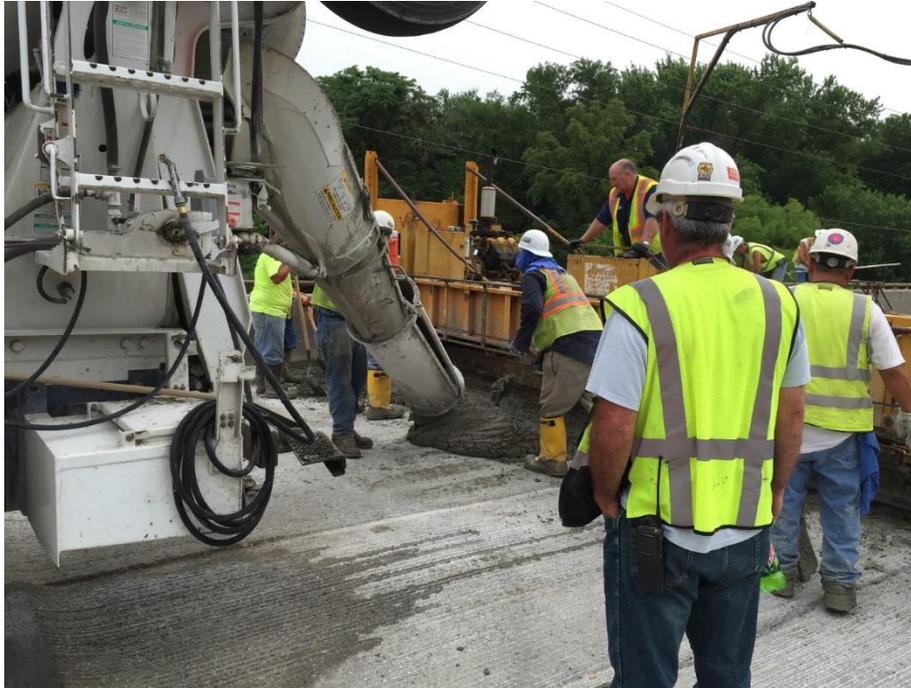
Preparatory work for overlay placement took about five hours with 10 workers. Followed by the preparation work, the ready-mixed concrete was placed on the deck as shown in Figure 6.

**Figure 6. Ready-mixed concrete being placed on the deck**

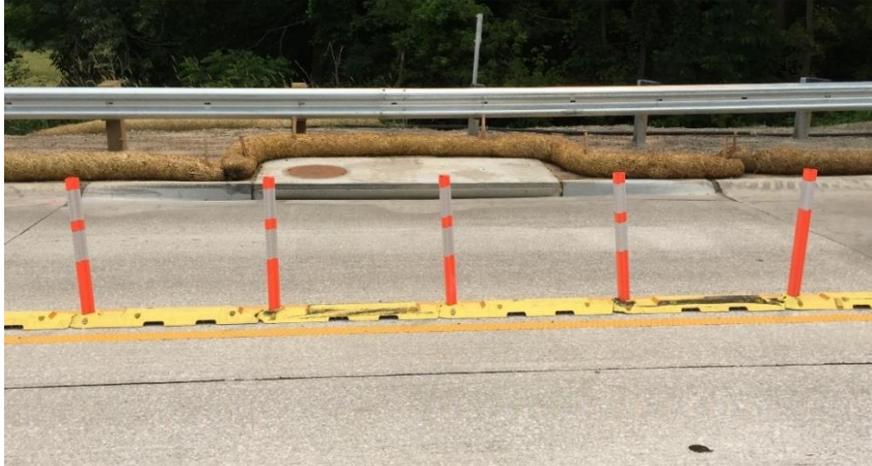
During overlay installation on the westbound lanes prior to the research team's observations on the eastbound lanes, a fiber optic cable was found near the bridge. In addition, the contractor found a manhole at the approach to the westbound lanes, which was not shown in the plans, as shown in Figure 7. Although the true impact of these observations on the project schedule are not known, the contractor, when asked, did mention this as an unexpected factor.

**Figure 7. Manhole discovered near the approach to the westbound lane**

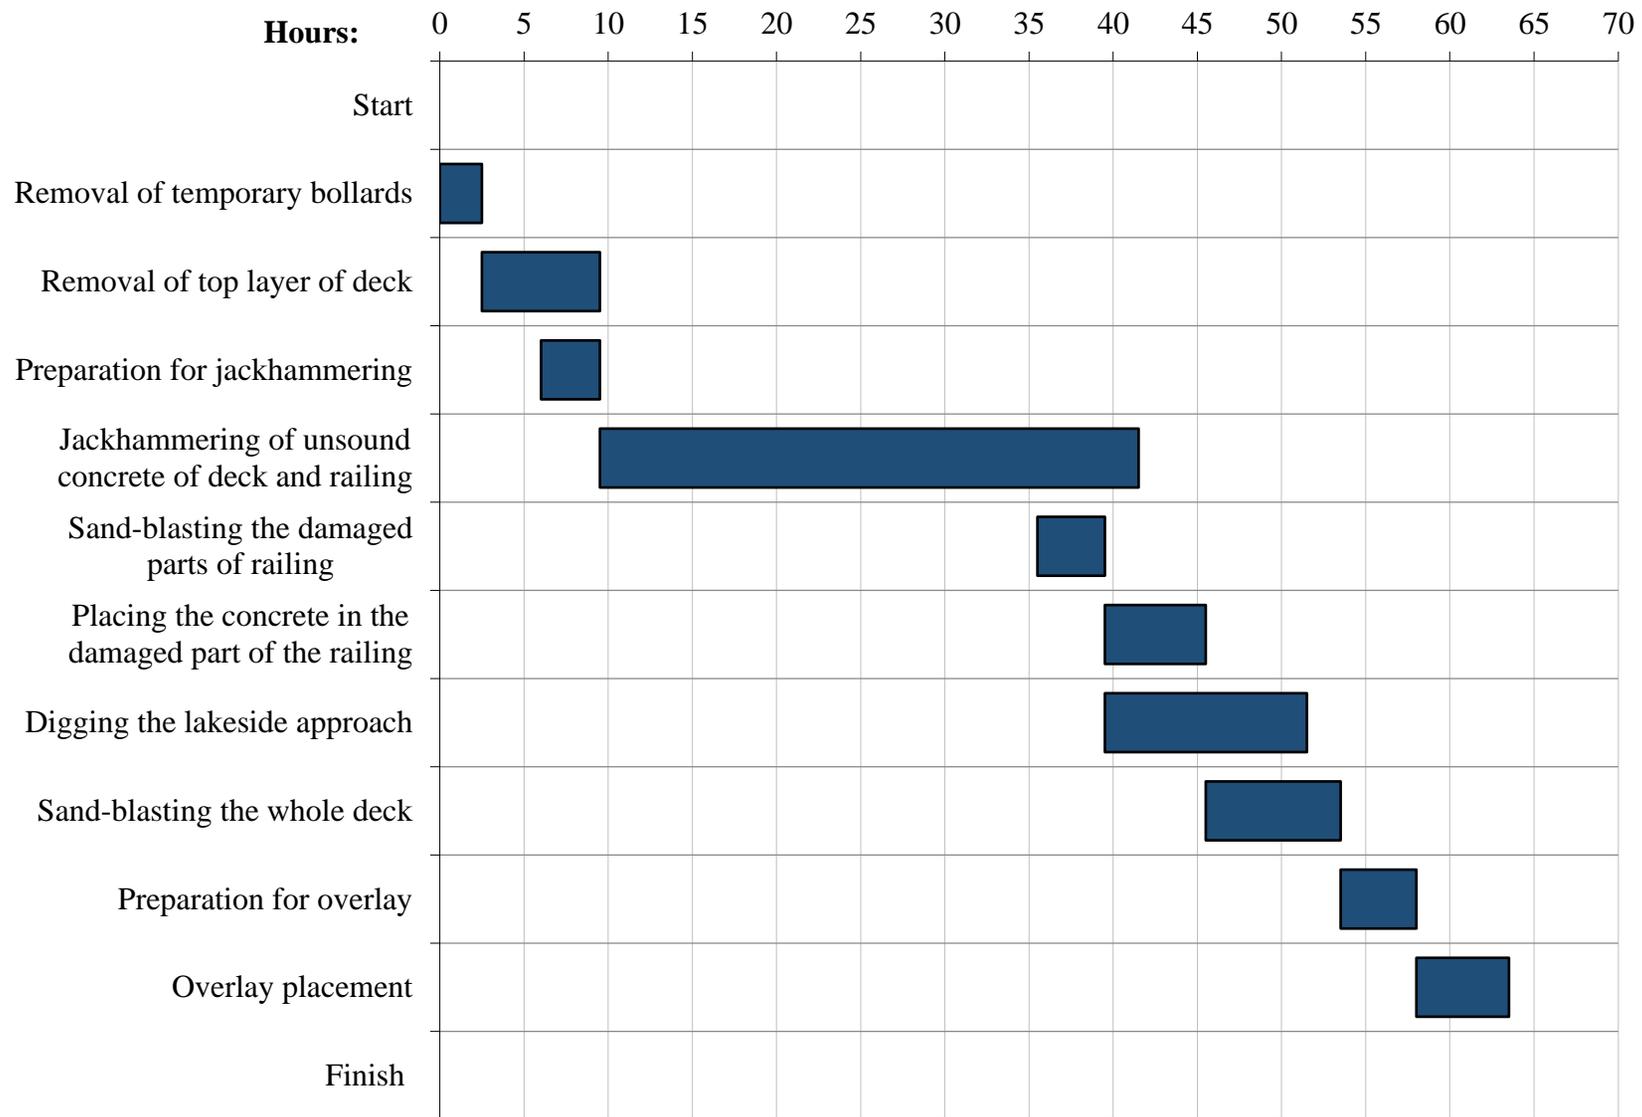
The contract proposal for the entire bridge deck overlay construction (eastbound and westbound lanes) shows a contract period of 40 working days. During this project, however, the research team only observed the overlay portion of the project, as the goal was to identify areas when traffic mobility was impacted. Collectively, the two most time-consuming operations were old concrete removal and overlay placement. If the rapid set alternatives briefly described in Chapter 2 were shown to provide the durability, permeability, abrasion resistance, freeze-thaw resistance, etc. that is needed, and if the additional concrete removal below the one-half bar diameter requirement was eliminated, it seems possible that up to 77 hours of the estimated 136 could have been saved.

**Figure 8. Eastbound overlay construction schedule as observed**

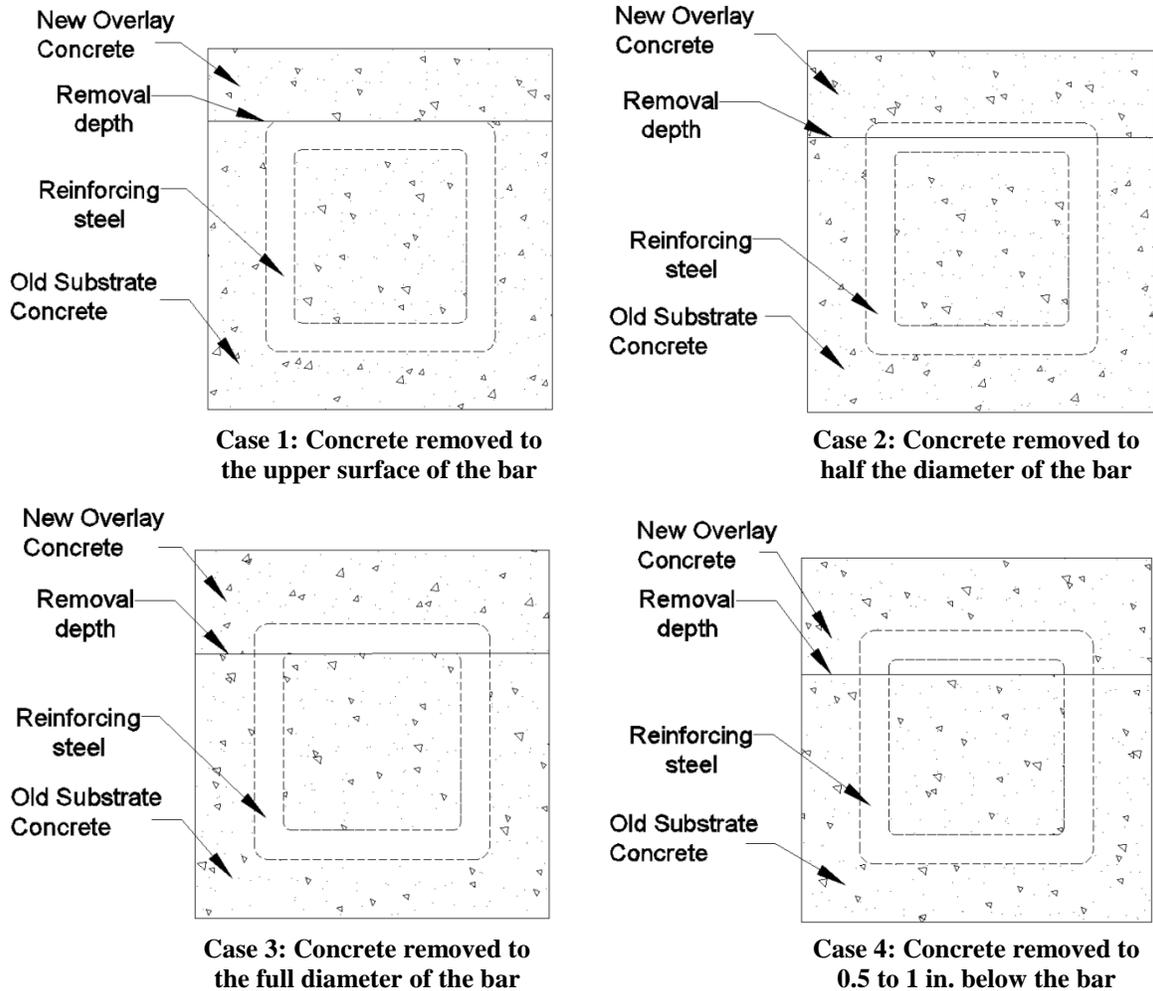
To get deeper, an additional 0.5 to 1 in. concrete was removed in addition to the full bar exposure condition.

**Figure 9. Different depths of concrete removal considered**

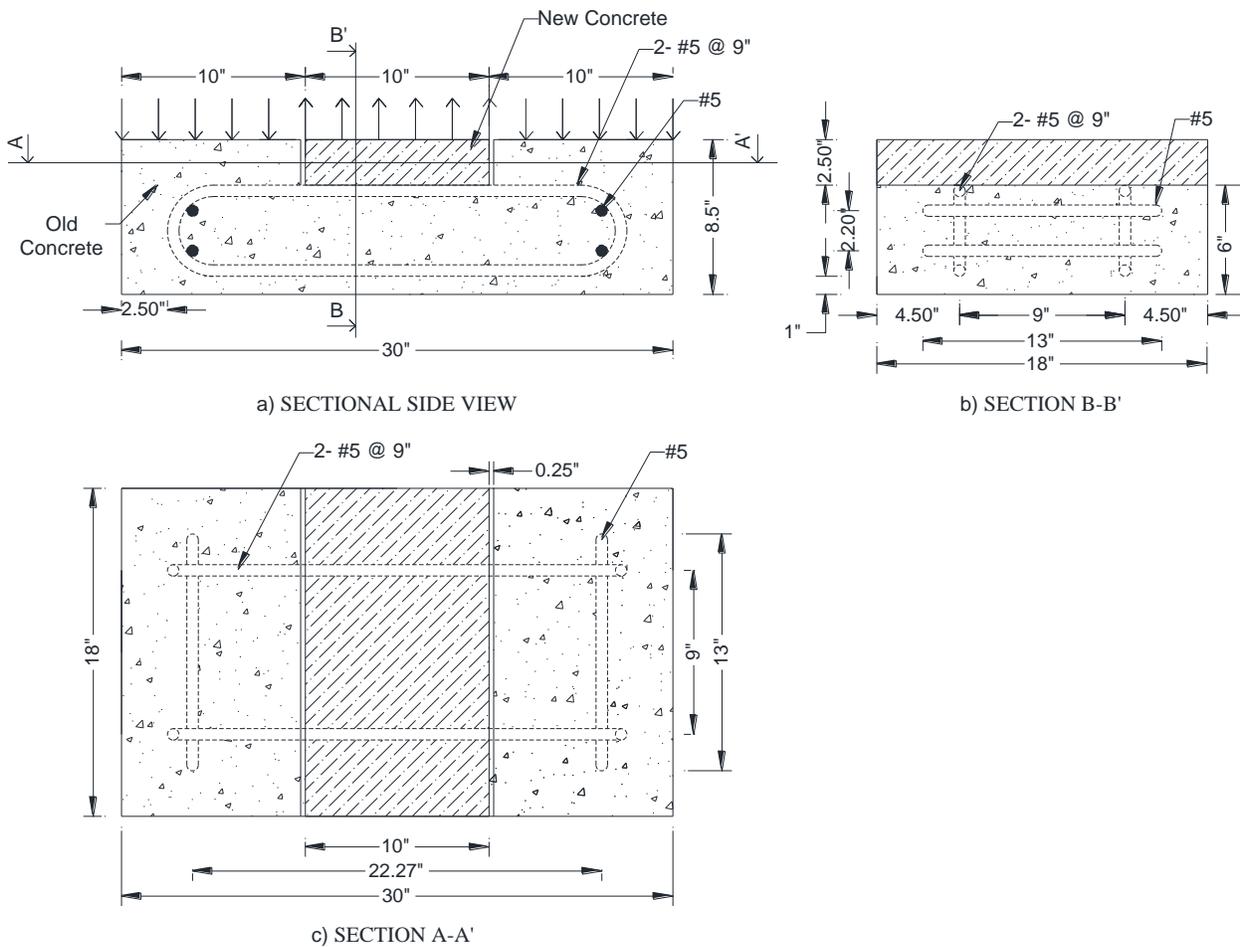
The specimens were fabricated to resemble a bridge deck slab. The dimensions of each specimen, the reinforcing steel spacing, and the detailing are all similar to an actual deck slab and are shown in Figure 10 for Case 1 (concrete removed down to the upper surface of the reinforcing bar).

**Figure 10. Pull-off test specimen schematic (Case 1)**

As shown earlier in the Figure 10 schematic (upper left), a gap is needed between the substrate concrete and the new overlay concrete for pull-off test placement of the overlay concrete. Without the gap, at the time of pull-off test loading, the vertical bond between the substrate concrete and the new overlay concrete along the edges of the overlay concrete would provide shear bond strength to resist the load in addition to the tensile bond strength provided by the horizontal bond at the bottom of the overlay concrete. To get only the tensile strength resistance, foam with a 0.25 in. thickness was glued to the C4 concrete on each side to create the voids as shown in Figure 12.

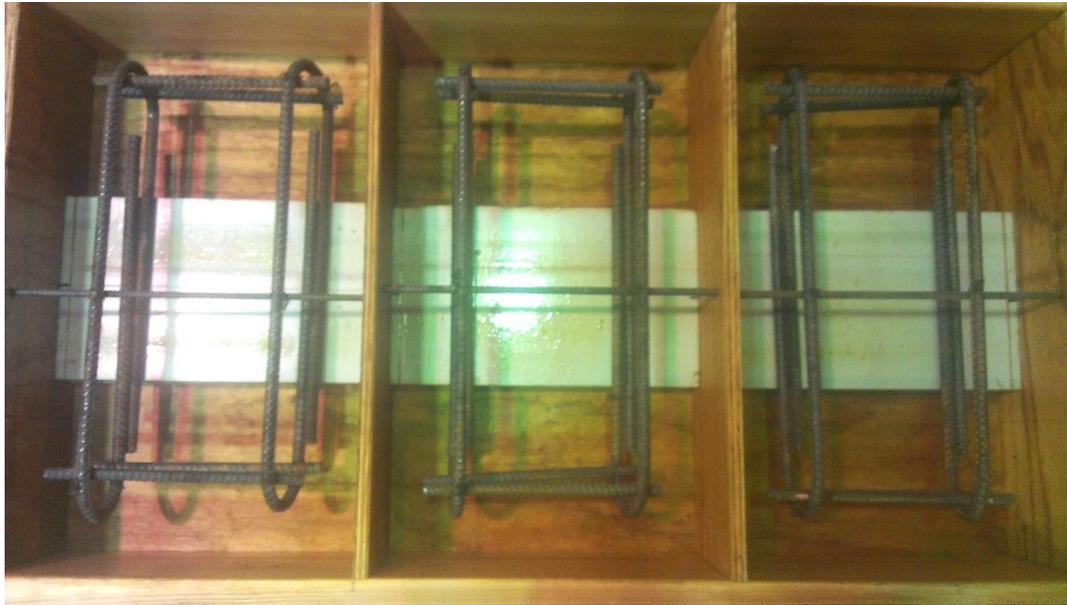
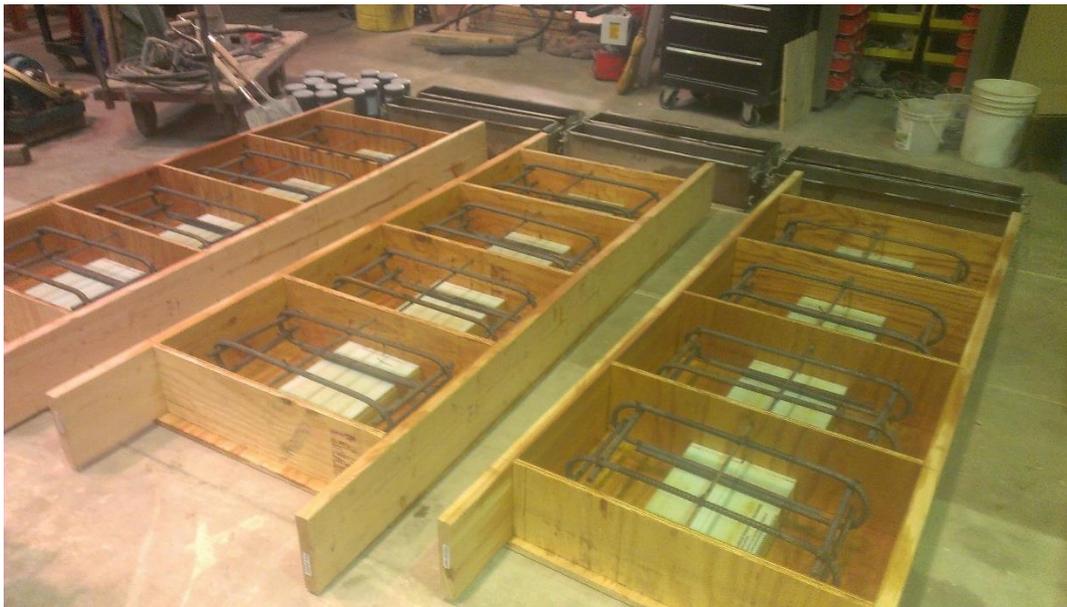
reinforcing steel was placed on the foam. An extra reinforcing steel bar was used to keep the main reinforcing steel stable horizontally. The reinforcement arrangement can be seen in Figure 11.

a) Top view

b) Angle view

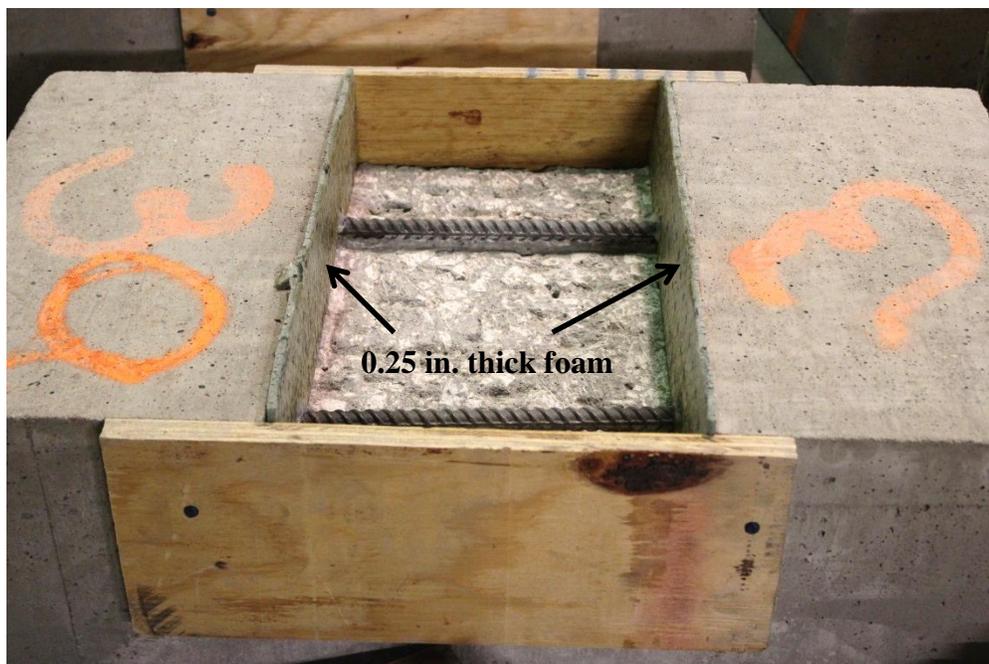
**Figure 12. Pull-off test formwork for overlay concrete placement (Case 4)**

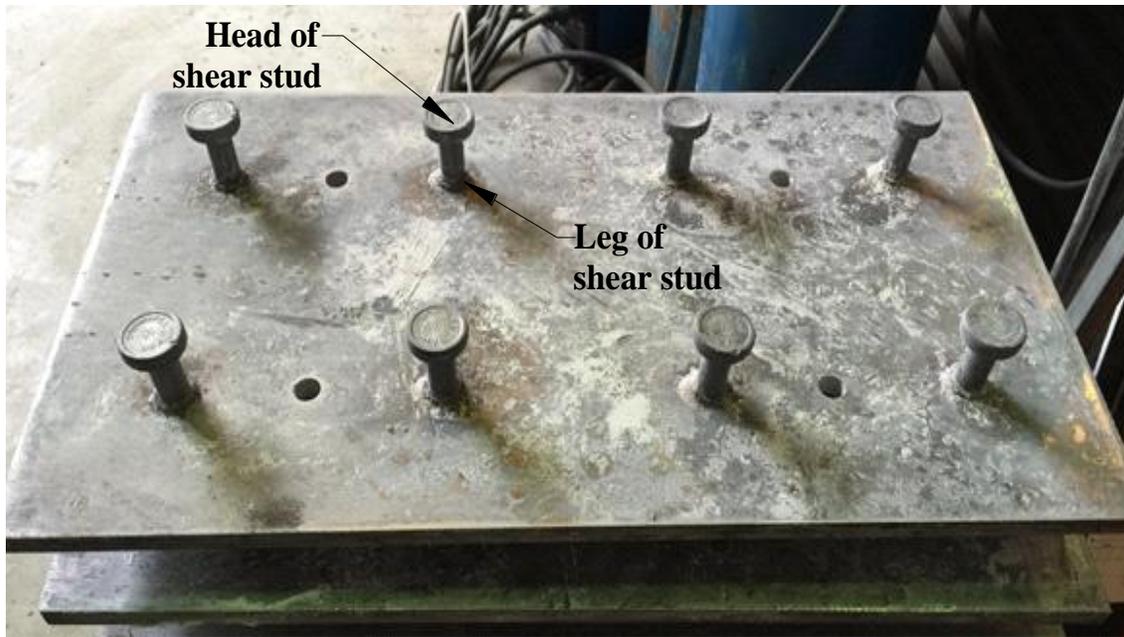
The most challenging aspect of this test was to figure out a method to apply the pull-off force to the new overlay concrete. After much discussion, shear studs welded to a steel plate, as shown in Figure 13, were used.

**Figure 13. Pull-off test steel plate with welded shear studs**

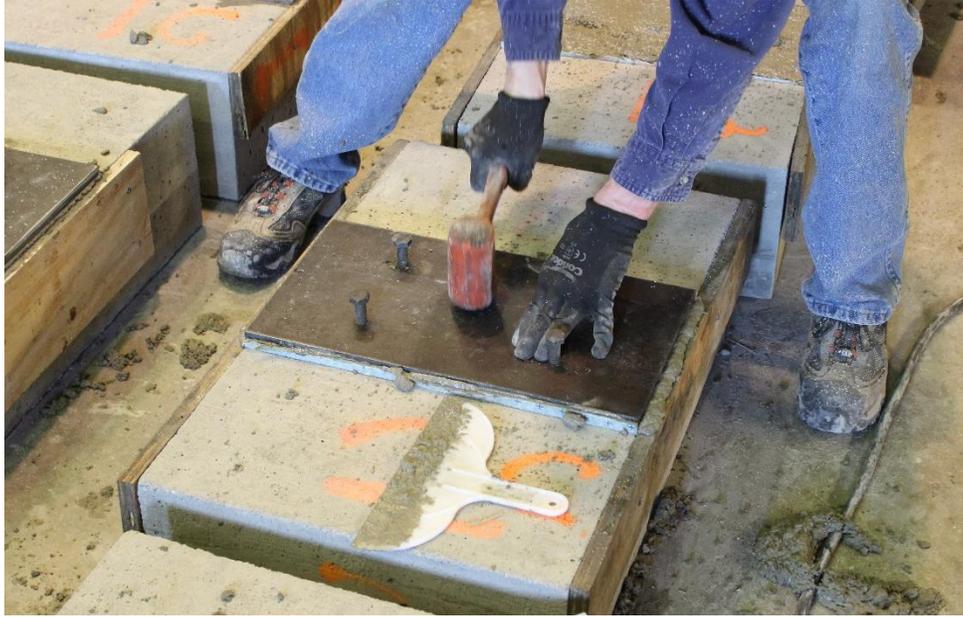
To bond the new overlay concrete to the previously placed concrete, a grout consisting of a mixture of about 5 to 6 gallons of water to each 94 lb bag of cement (12.5 to 13.8 in<sup>3</sup> of water per lb of cement) was used. The grout material was applied to the chipped portion using a stiff hand brush, just prior to placing of the overlay concrete. As soon as the grout was applied, the overlay concrete was placed so that the applied grout would still be wet when the concrete was placed. After the concrete was placed, the steel plate studs were embedded in it by firmly tapping the plate using a rubber hammer as shown in Figure 14.

**Figure 14. Tapping the steel plate to embed the shear studs on a pull-off test specimen**

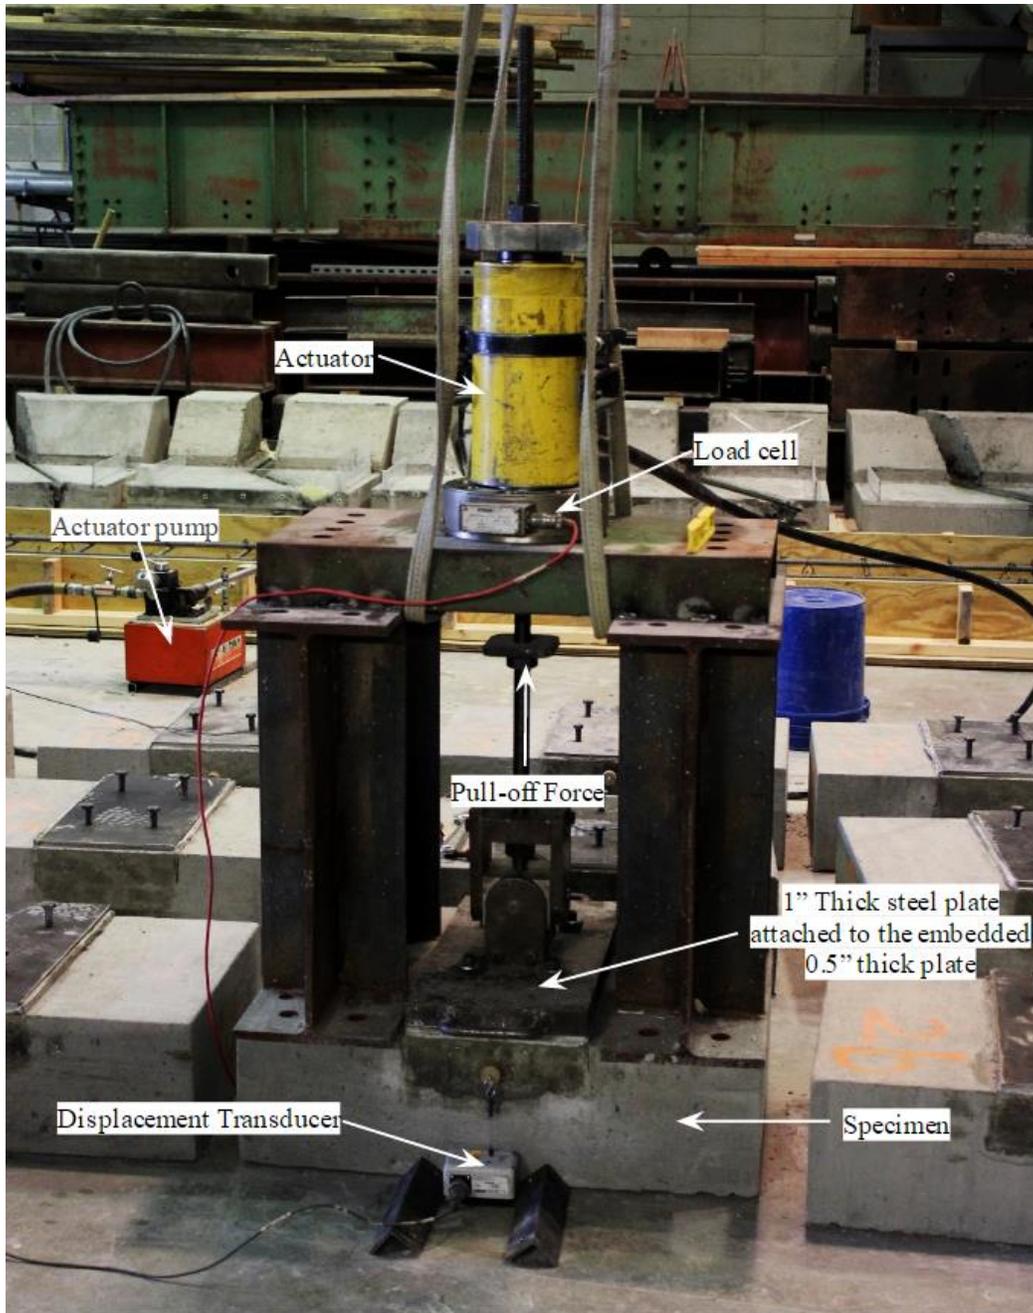
Figure 15 shows the testing arrangement for the pull-off test. Closer views of the specimens are shown in the next section.

**Figure 15. Testing arrangement for pull-off test**

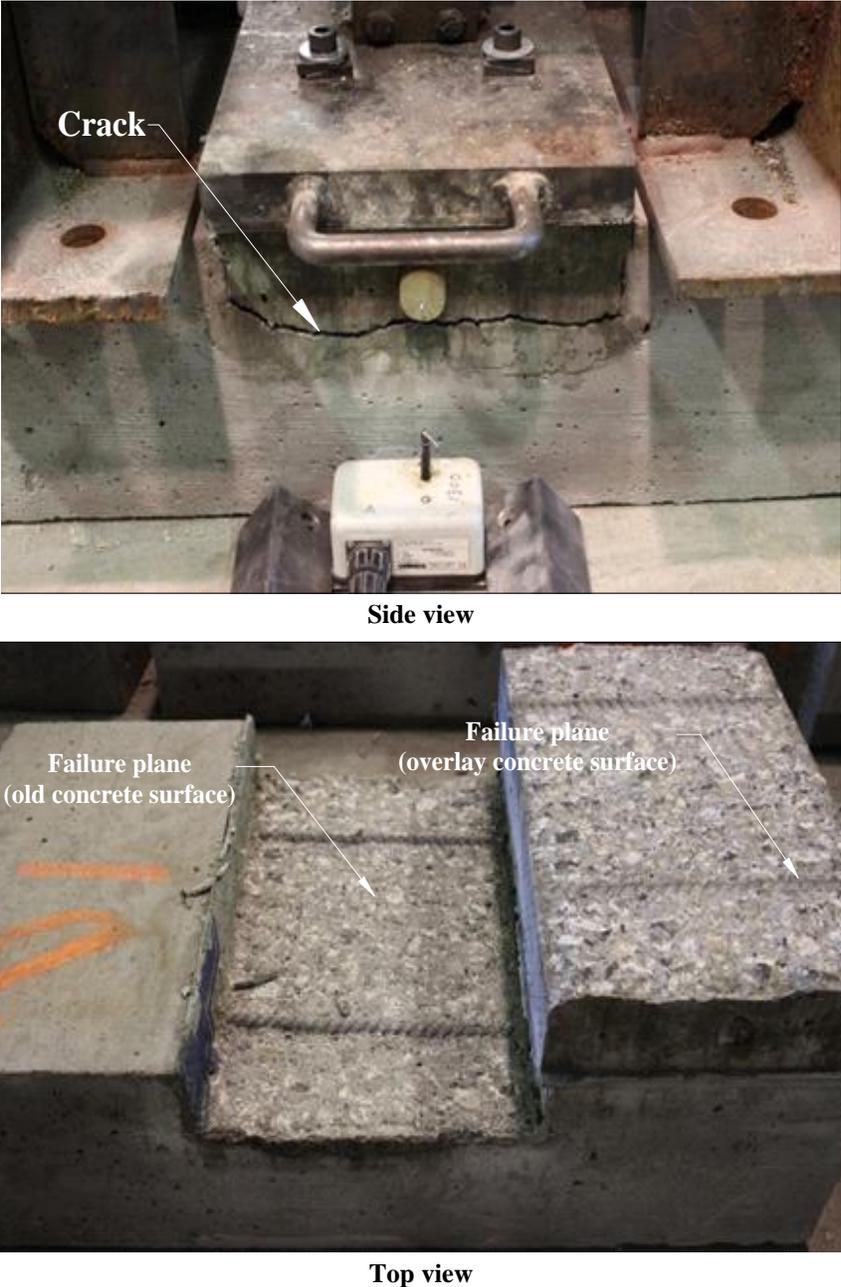
For Case 1, two of the specimens failed at the bond interface and one specimen failed in the overlay. Figure 16 shows a side view of the failure (total separation of the bond) at the interface of the substrate and new overlay concrete and a top view of the interface surface after the failure.

Figure 16. Case 1 pull-off test specimen failure at concrete bond interface

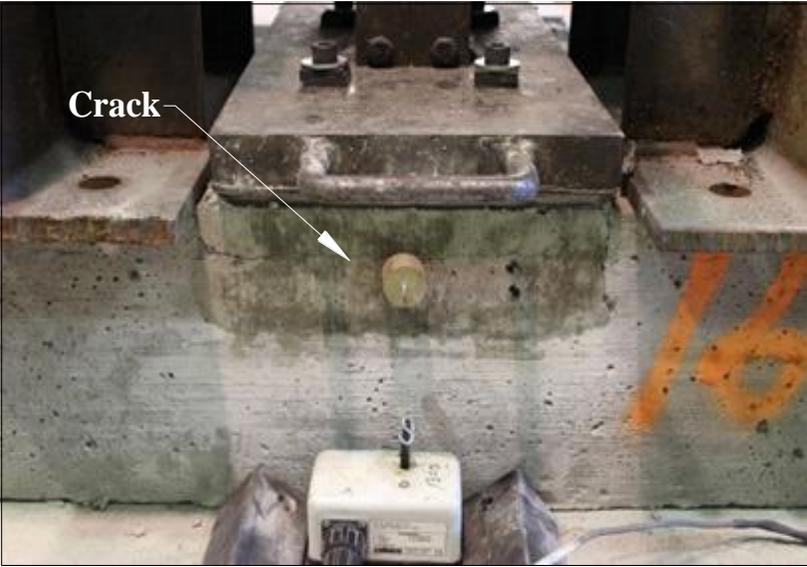
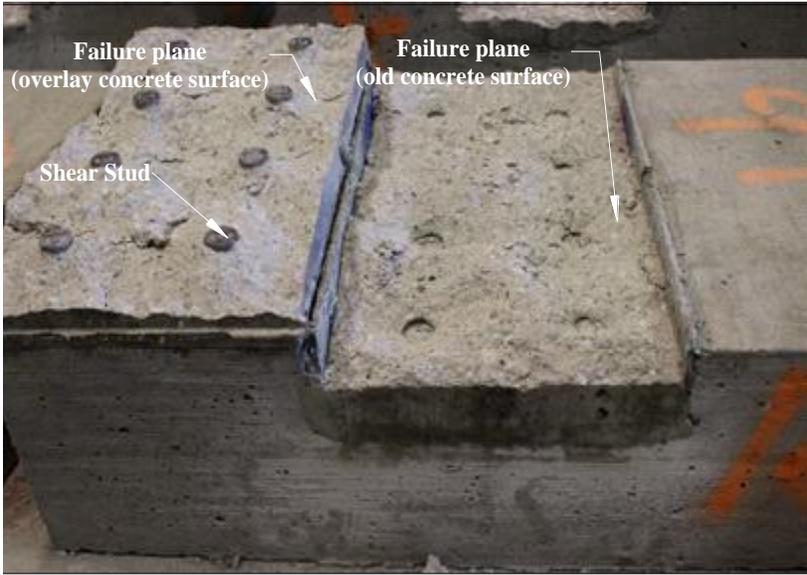
Figure 17 shows a side view of the failure of the specimen in the overlay concrete at the heads of the shear studs and a top view of the failure plane at the break in the bond.

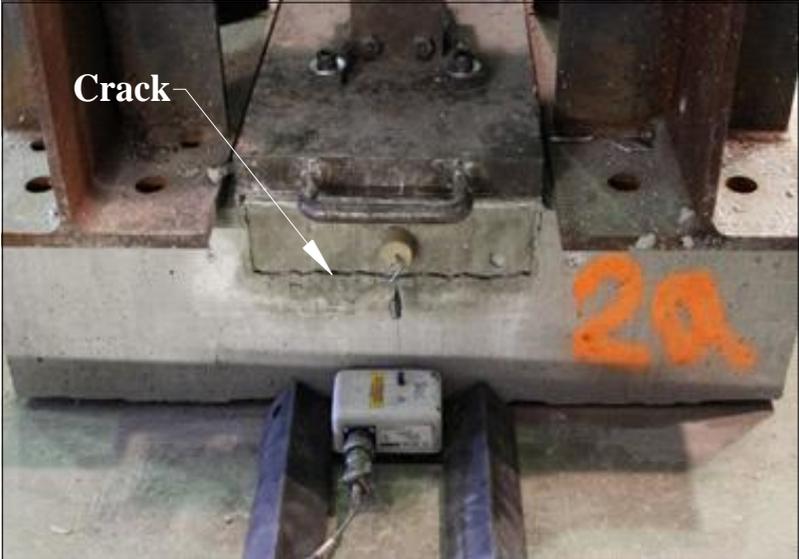
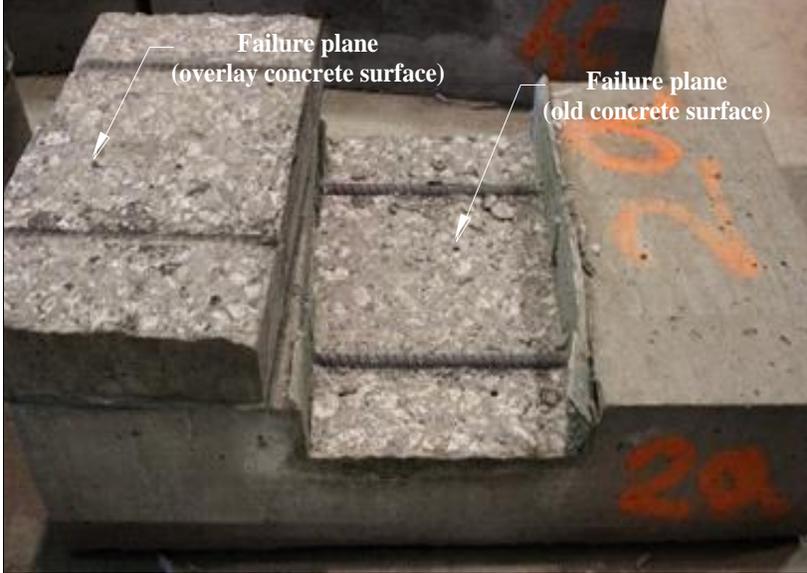
In this case, two specimen failures were observed at the bond interface and one specimen failed in the overlay concrete at the heads of the shear studs. Figure 18 shows the failure of the specimen at the interface of the substrate and new overlay concrete.

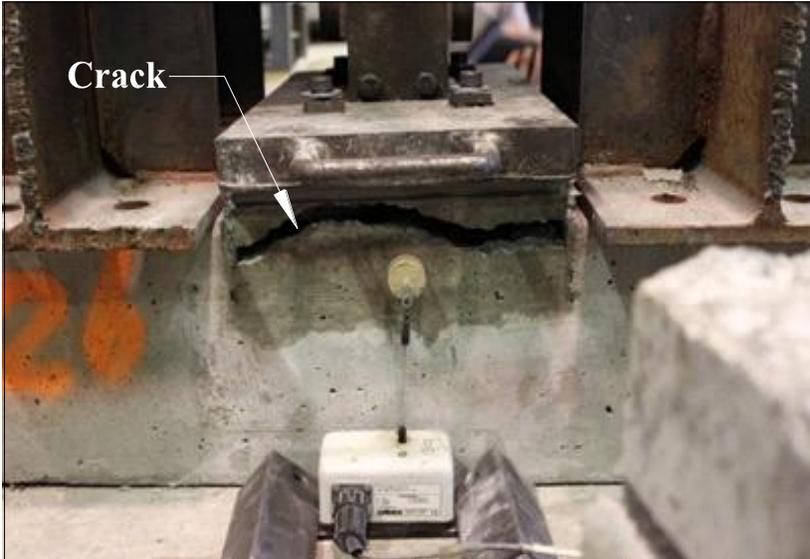
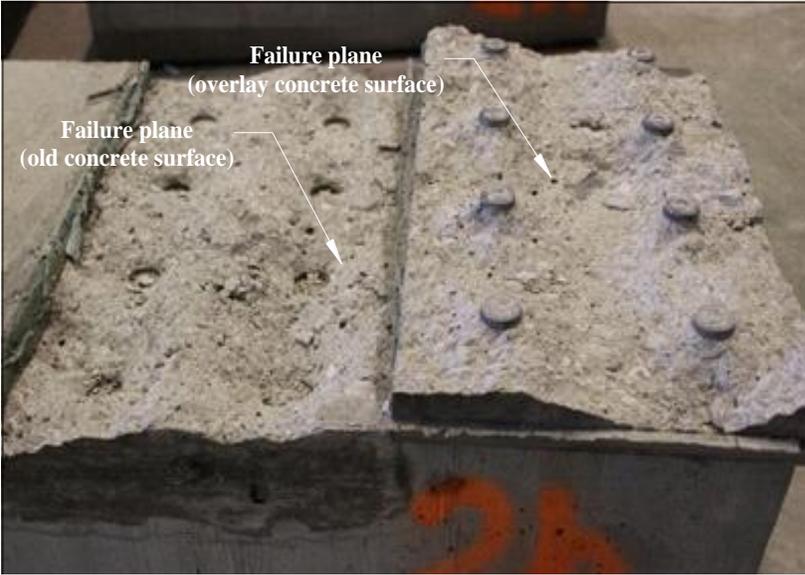
Figure 19 shows the failure of the specimen in the overlay concrete at the heads of the shear studs and the surface at which the break in the bond was observed.

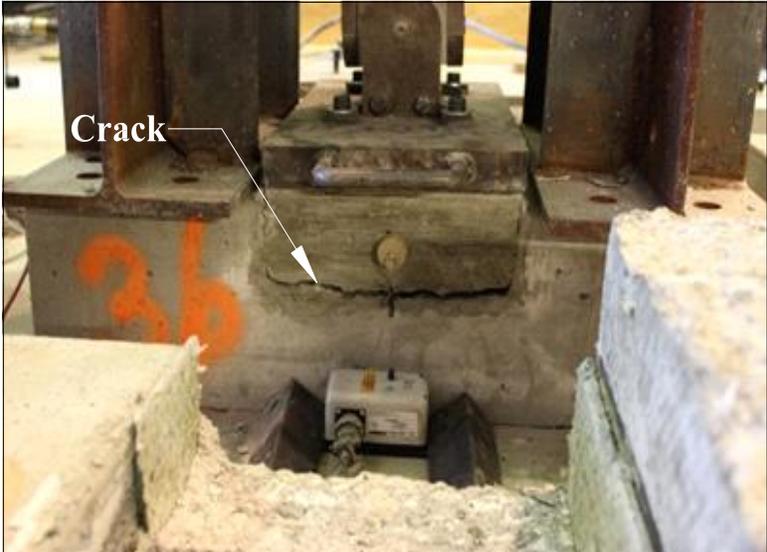
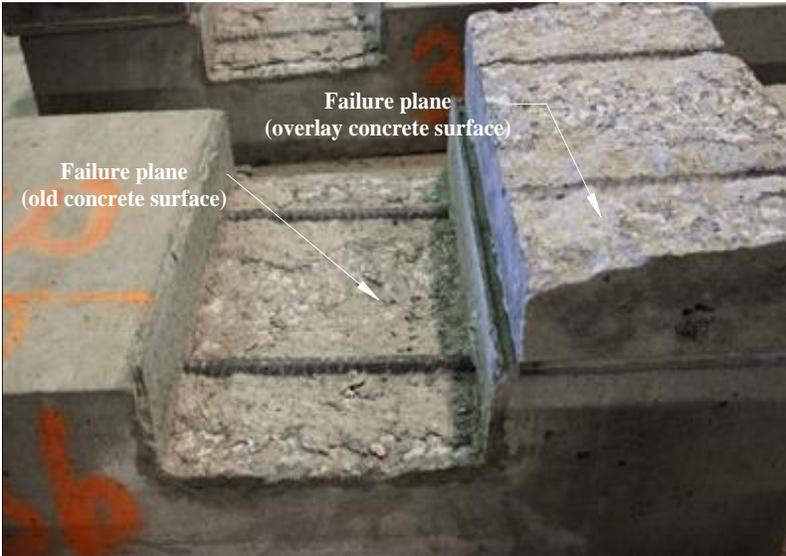
All of the specimens in this case failed at the interface level as shown in the Figure 20. The figure shows the pattern of the crack and the interface surface.

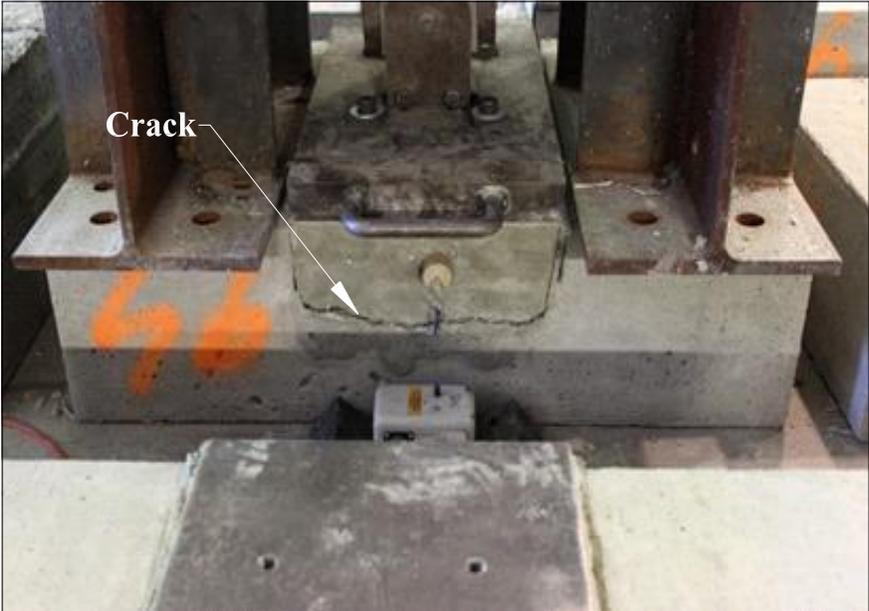
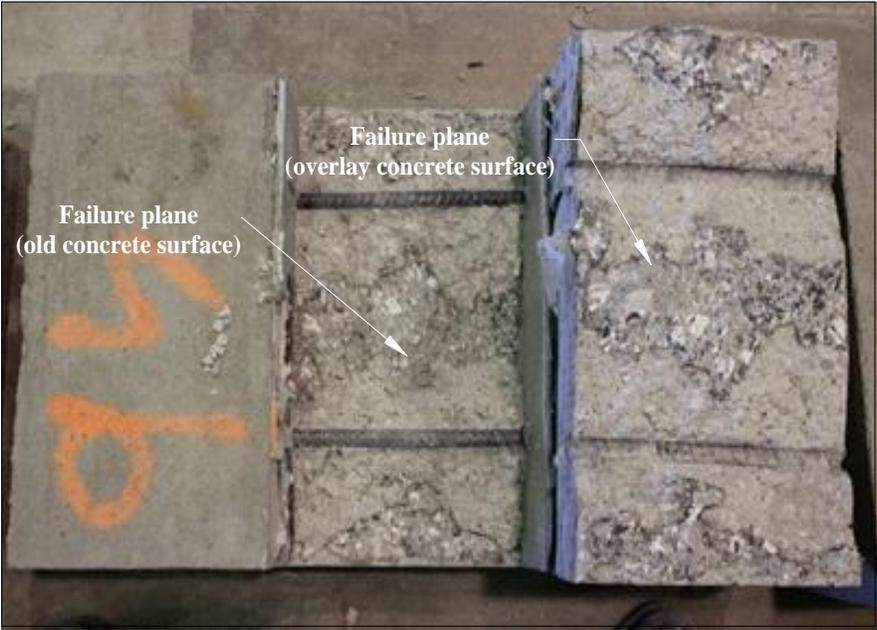
In this case, two of the specimens failed in the overlay and one specimen failed at the interface. Figure 21 shows the failure of the specimen at the interface of the substrate concrete and new overlay concrete.

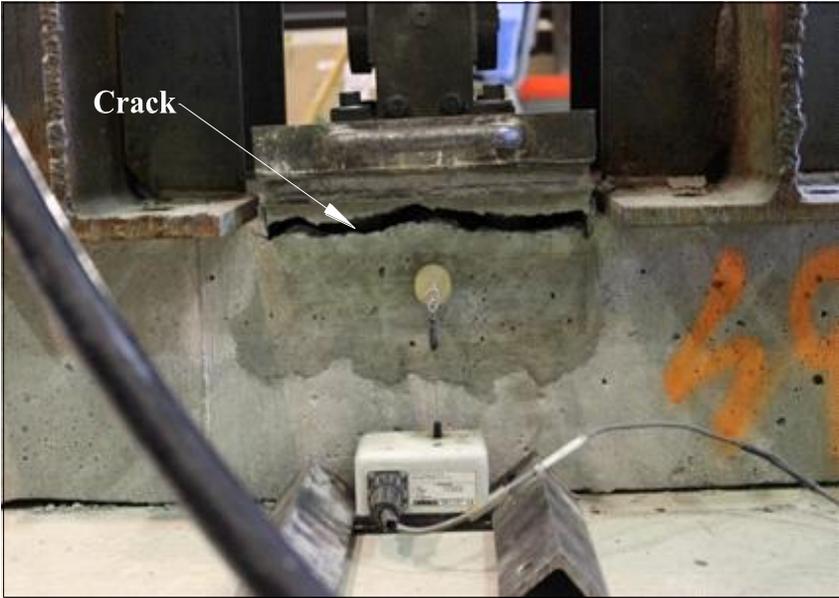
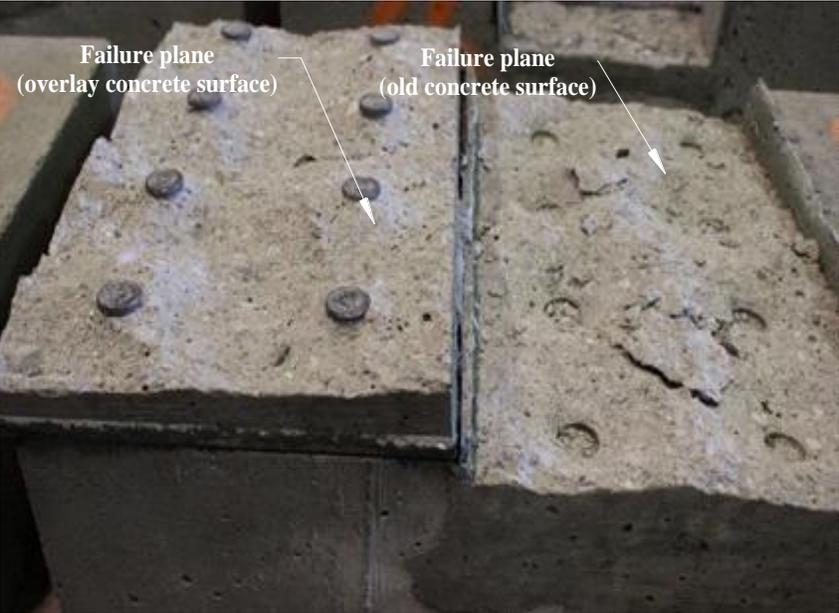
Figure 22 shows a side view of the failure of the specimen in the overlay concrete at the heads of the shear studs and a top view of the interface surface after the failure.
