# Investigation of Techniques for Accelerating the Construction of Bridge Deck Overlays

**Final Report**  
**April 2016**

**Sponsored by**  
Federal Highway Administration  
Iowa Department of Transportation  
(InTrans Project 14-500)

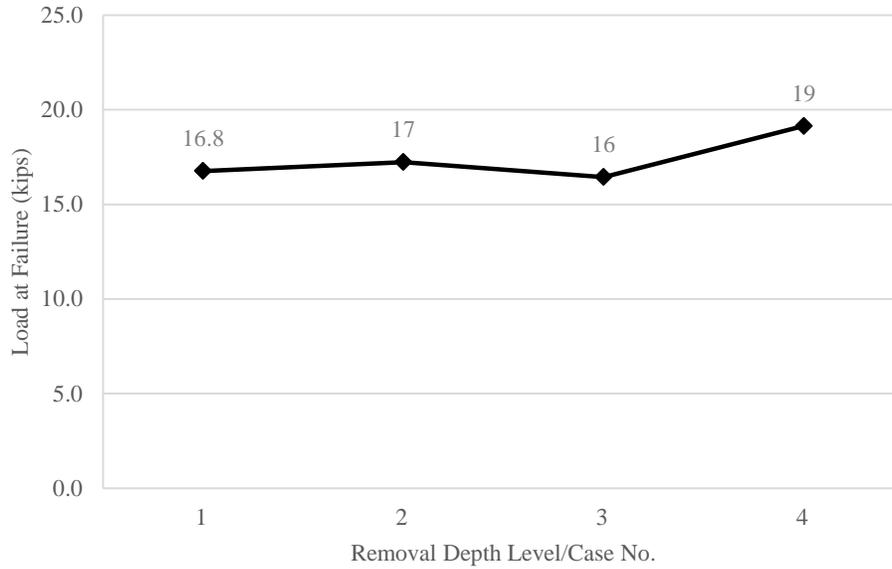
Figure 23 shows the variation of the average load at failure versus the concrete removal depth level (Case 1 through 4).

**Figure 23. Average load at failure versus concrete removal depth (pull-off test)**

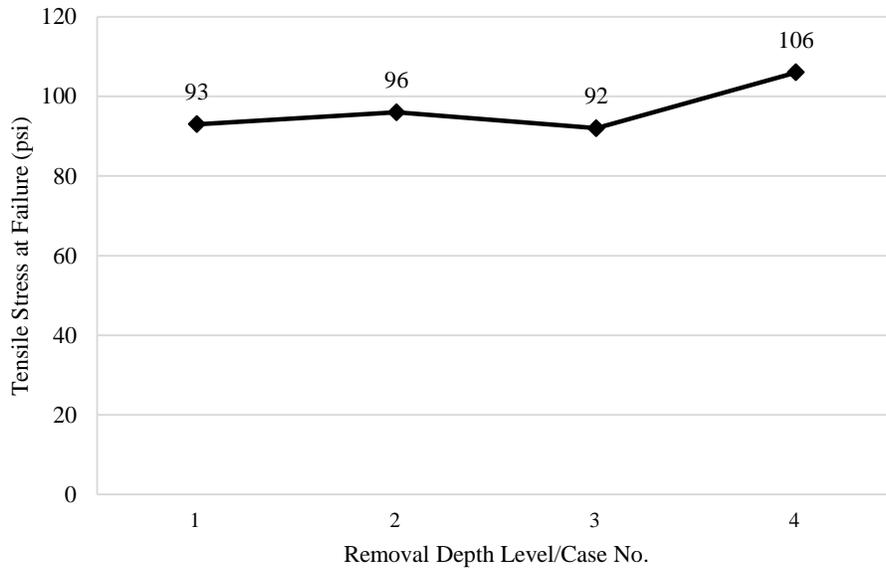
Figure 24 shows the variation of the average tensile bond stress versus the concrete removal depth level (Case 1 through 4).

**Figure 24. Average tensile stress at failure versus concrete removal depth (pull-off test)**

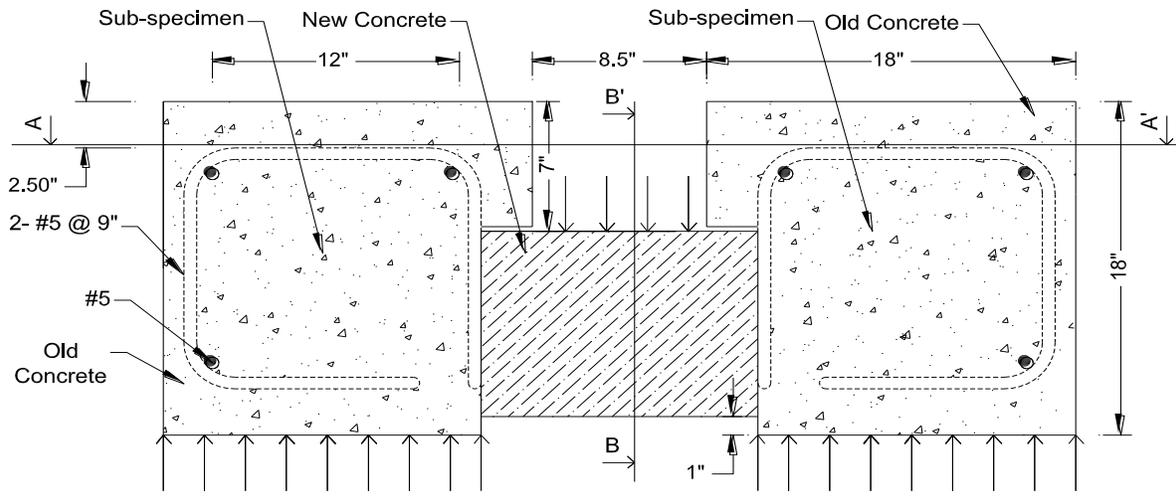
An additional steel bar was placed along the length on top of the reinforcement to prevent any horizontal movement during the concrete placement.

**Figure 25. Push-out test specimen schematic (Case 1)**

Note that a small (0.25 in.) gap was needed between the substrate concrete and the top of the overlay concrete (as shown in the schematic in Figure 25) to eliminate any tensile bond between the substrate concrete and the top of the overlay concrete. To create this gap, 0.25 in. thick foam was glued to the substrate concrete. Wooden forms were attached to the sides of each pair of specimens as shown in Figure 29 to create the space for the placement of the overlay concrete.

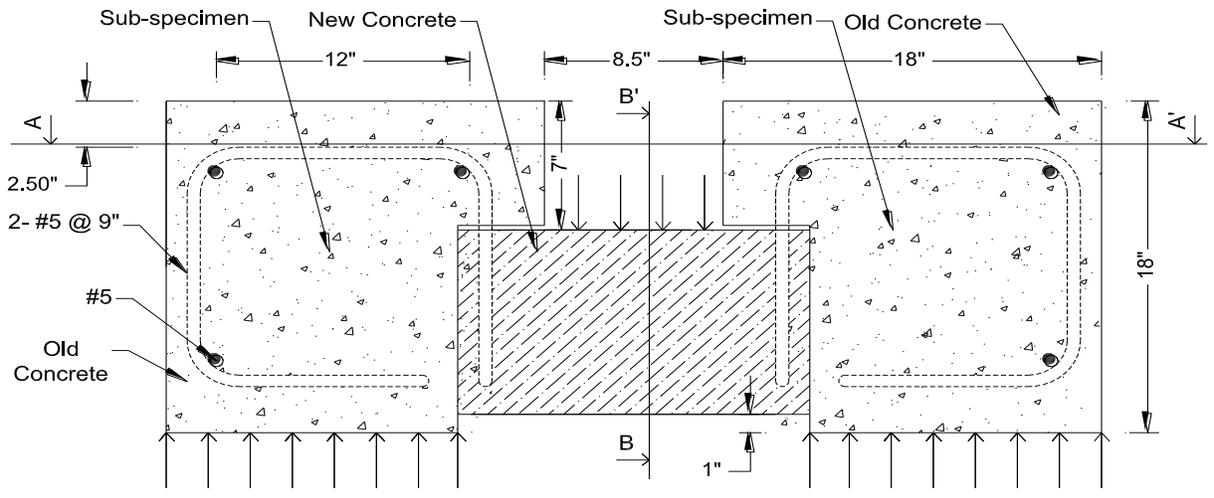
**Figure 26. Push-out test specimen schematic (Case 4)**

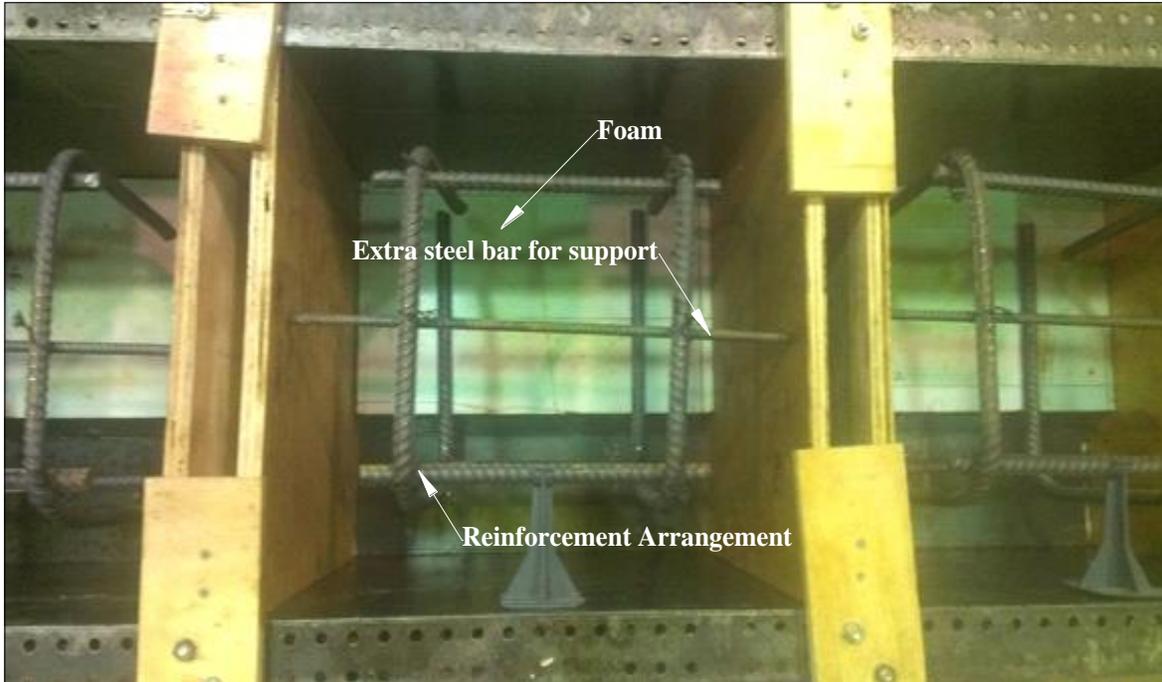
**Figure 27. Push-out test formwork for substrate concrete placement**

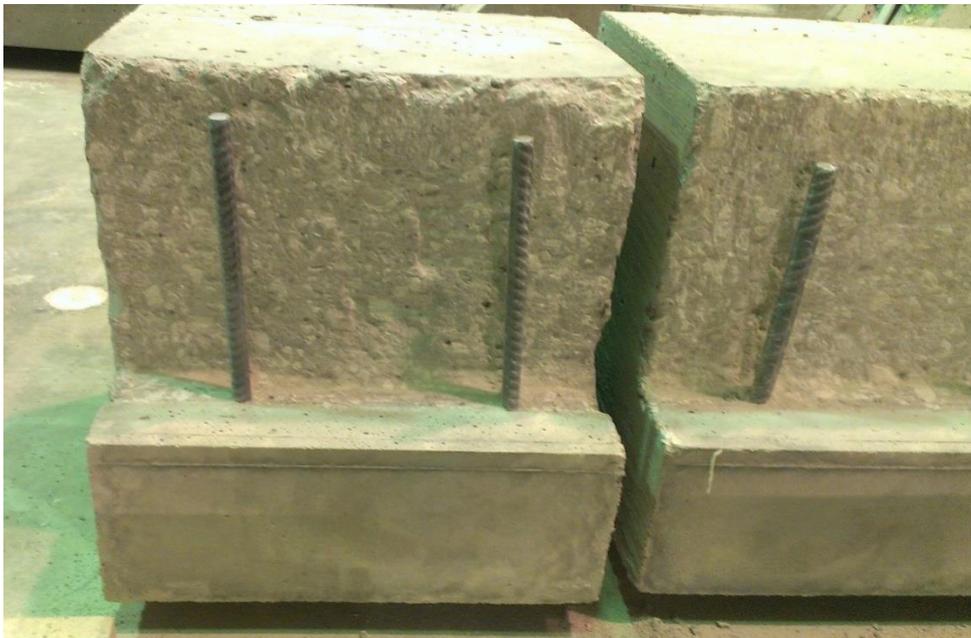
After curing the specimens for three days, the foam and the formwork were removed. The depth of the foam was only up to the face of the reinforcing steel (2.5 in.). Therefore, to achieve the different simulated concrete removal depths, additional concrete was removed and roughened using a jackhammer to the required depths, as shown in Figure 27 (Case 1 specimens only needed to have the concrete roughened).

**Figure 28. Pair of push-out test sub-specimens after concrete removal (Case 4)**

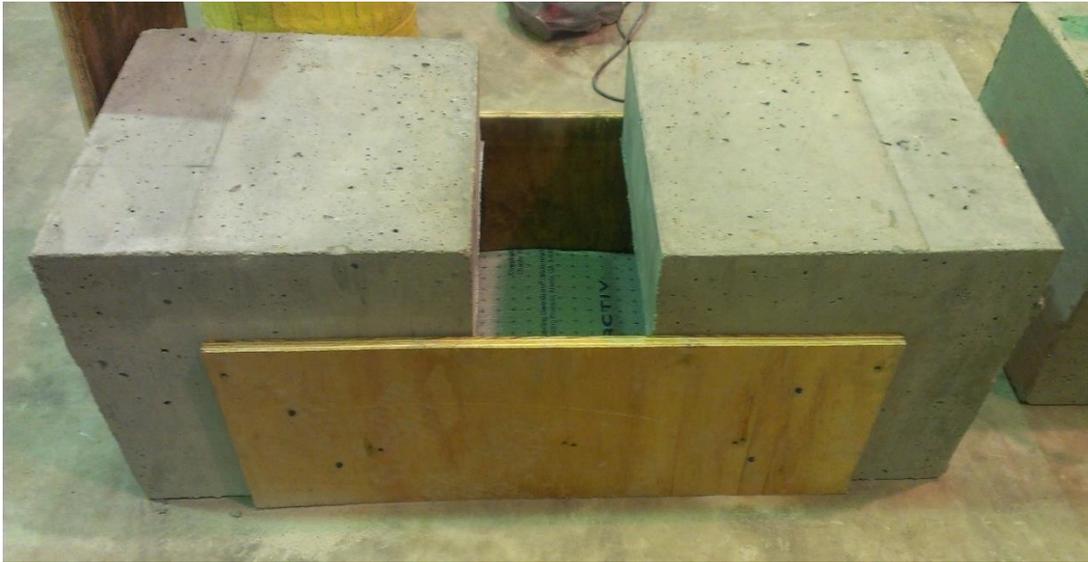
**Figure 29. Push-out test formwork for overlay concrete placement**

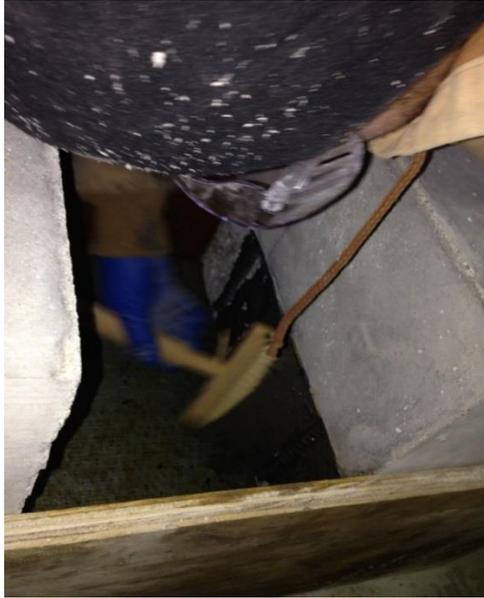
**Figure 30. Application of grout for push-out test specimen**

To fill the 1 in. gap below the overlay concrete, a 0.75 in. thick sheet of plywood coupled with 0.25 in. thick foam was used. To bond the overlay concrete to the previously placed substrate concrete, a grout consisting of a mixture of about 5 to 6 gallons of water to each 94 lb bag of cement (12.5 to 13.8 in<sup>3</sup> of water per lb of cement) was used. The grout material was applied to the roughened concrete using a stiff hand brush just prior to placement the overlay concrete as shown in Figure 30.

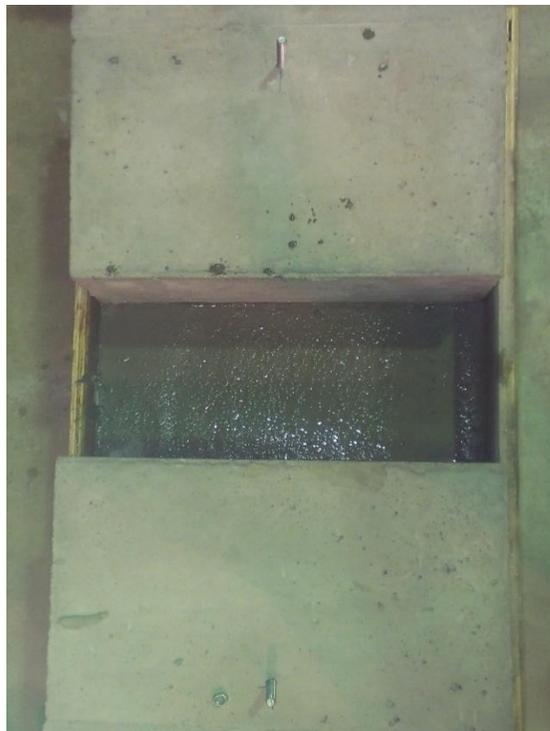
**Figure 31. Push-out test specimen after overlay concrete placement**

The overlay concrete was placed until it touched the bottom of the foam, which was used to break the bond between the substrate concrete and the top of the overlay concrete on each specimen. The overlay concrete was vibrated and wet-cured on the top exposed surface. Figure 31 shows a specimen after placement of the overlay concrete.

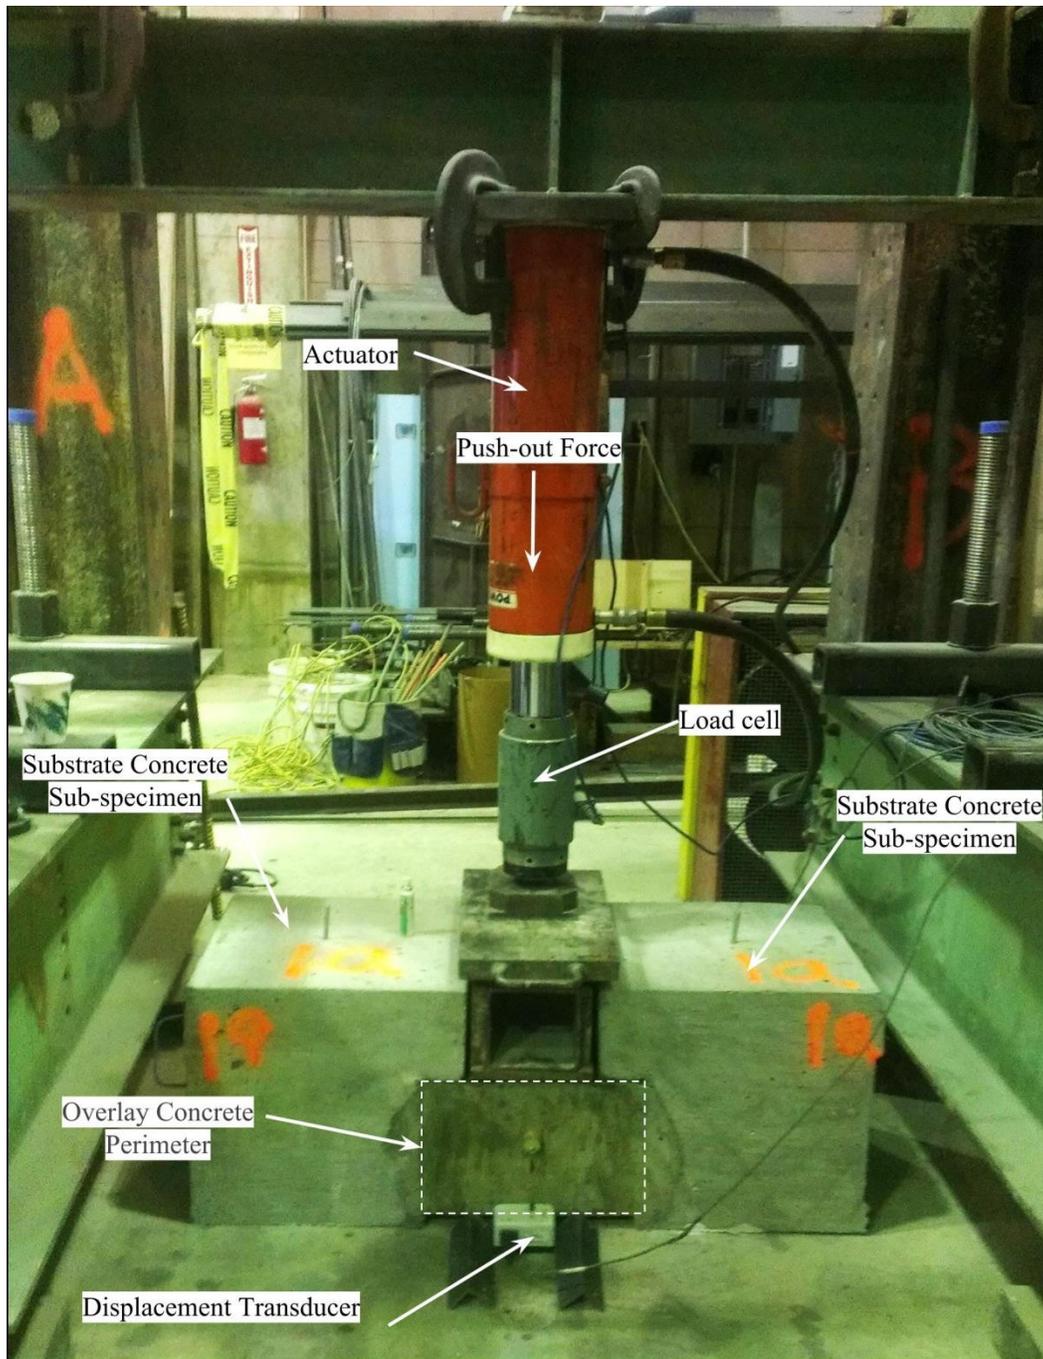
Each push-out test started 4 hours prior to 72 hours after overlay concrete placement. Figure 32 shows the testing arrangement.

**Figure 32. Testing arrangement for push-out test**

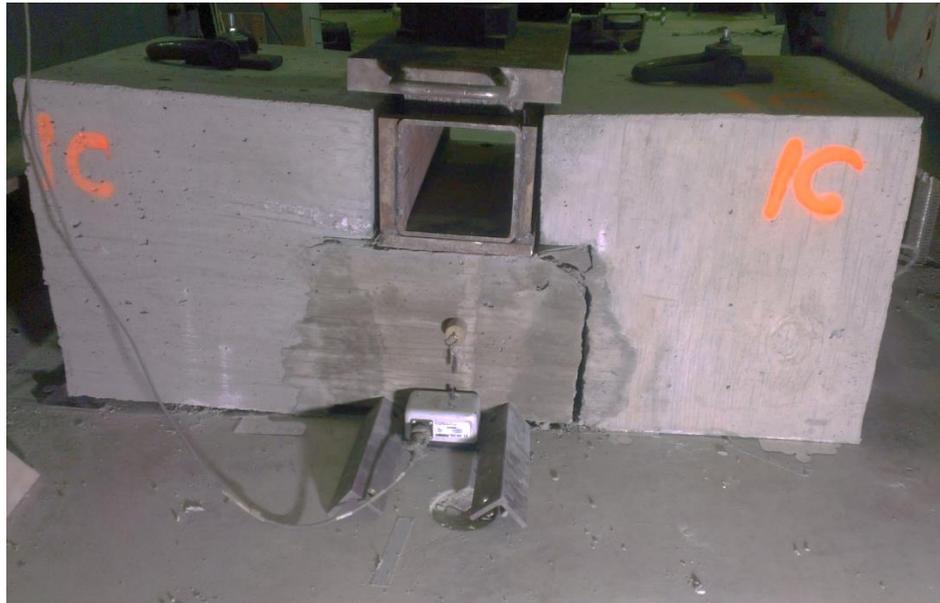
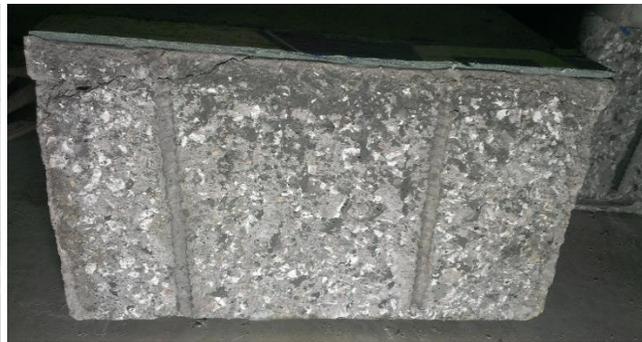
During application of the loads, sudden failures (a large drop in load and separation of one of the bonds) were observed. Figure 33(a) shows a failure surface with a crack and Figure 33(b) and (c) show an interface surface between the substrate concrete and the overlay concrete after failure.

a) Side view

c) Bond interface (overlay concrete)

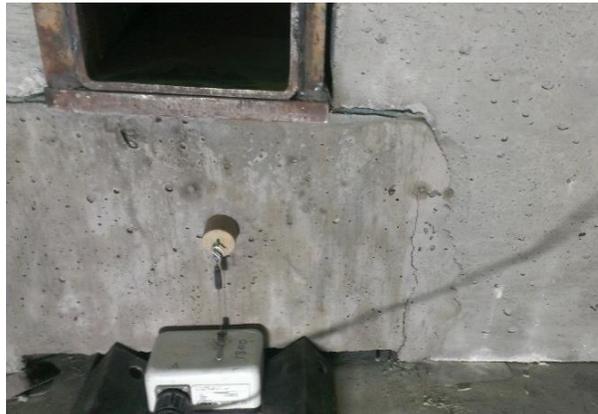
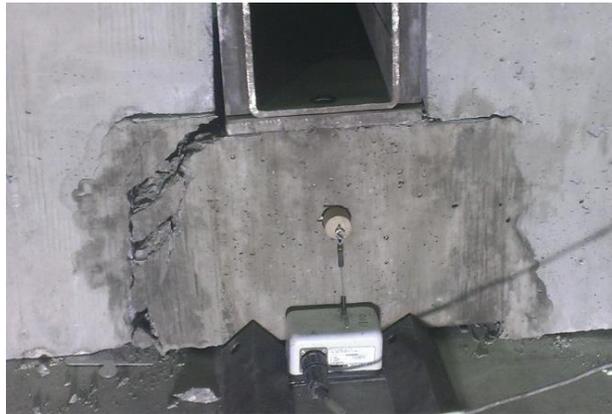
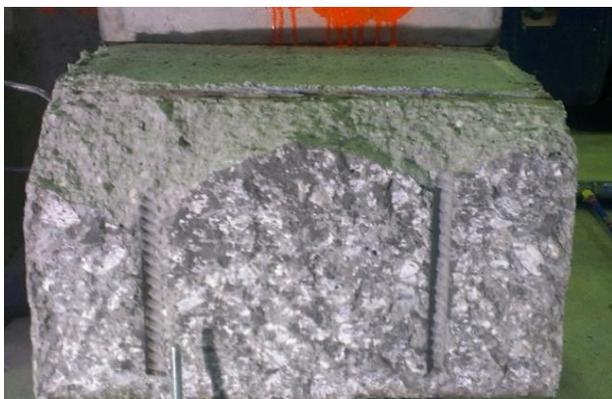
The overlay concrete for Case 2 specimens was exposed to half the diameter of the reinforcing steel. After the first cracks were observed, as shown in Figure 34(a), the specimens had not completely failed.

a) Propagation of crack

b) Separation at interface

d) Bond interface (overlay concrete)

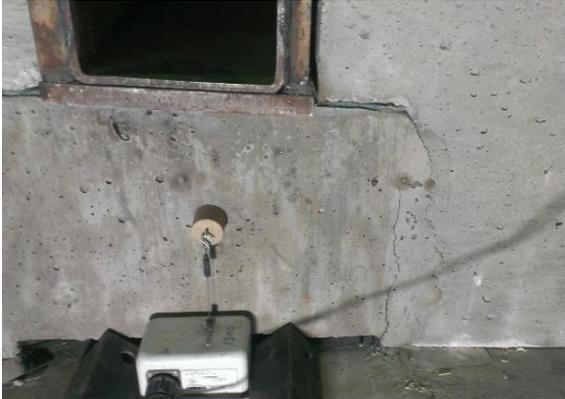
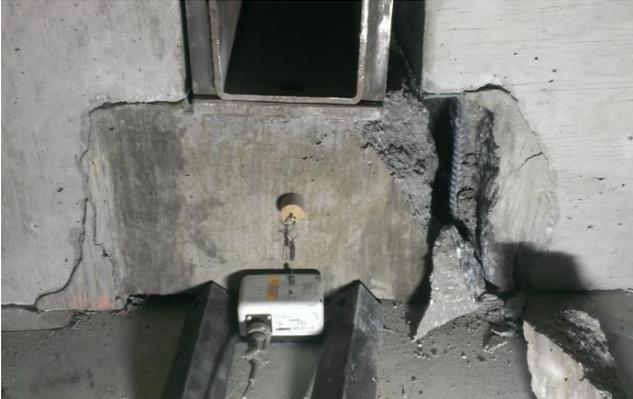
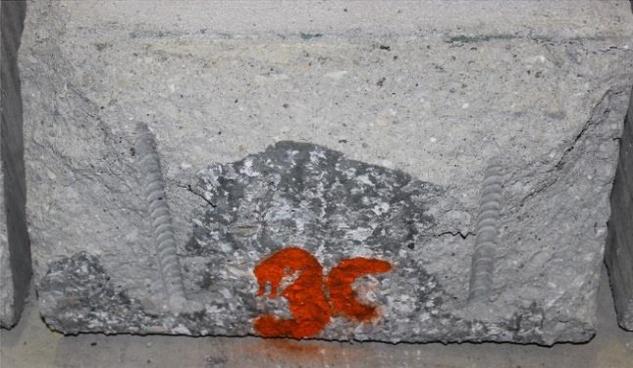
Failures similar to Case 2 were observed for Case 3 specimens; but, due to the additional exposure of the reinforcing steel to the concrete, the bonds were stronger between the concrete and the reinforcing steel, withstanding a greater load after crack initiation. Figure 35 shows the failure of a specimen.

a) Propagation of crack

b) Separation at interface

d) Bond interface (overlay concrete)

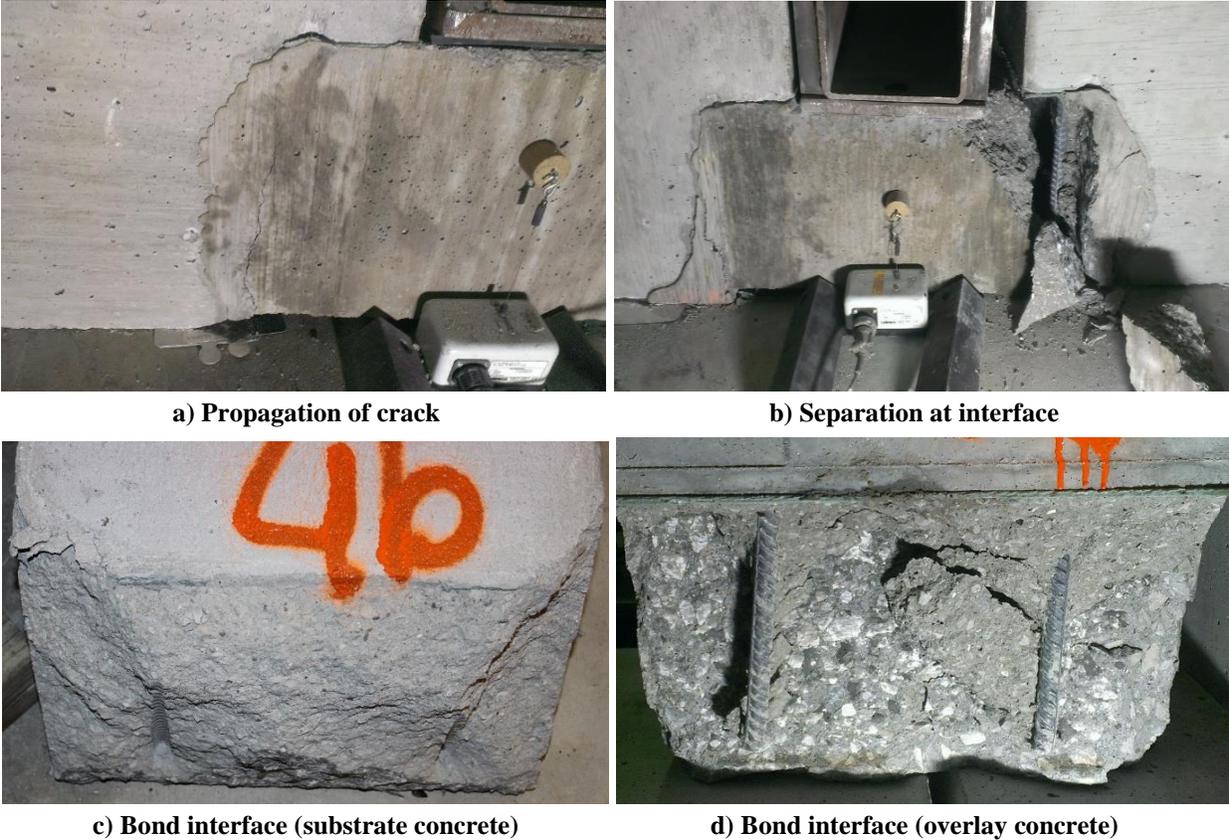
The loads for total separation of a bond were greatest for Case 4 specimens. Figure 36 shows a crack and total separation at a bond interface.

**Figure 36. Case 4 push-out test specimen failure at concrete bond interface**

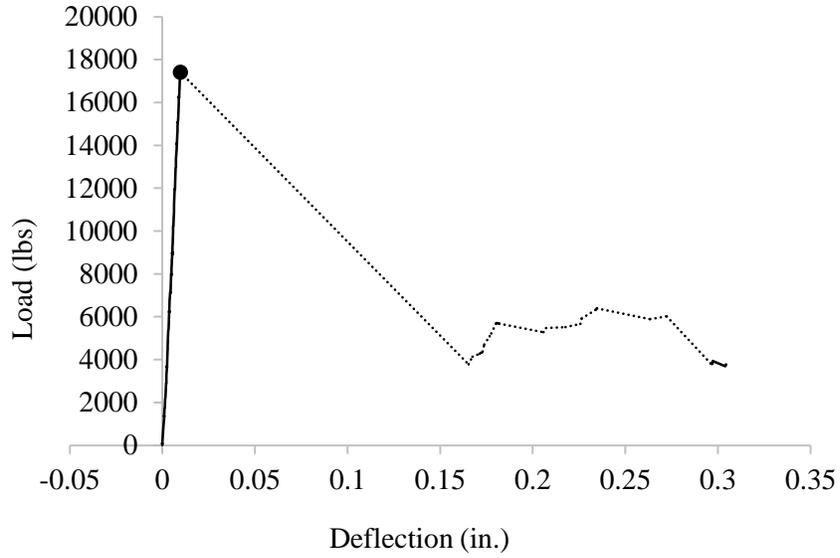
**Case 1**

Figure 37 shows the load versus deflection graph for one specimen for each of the four concrete removal depth cases. The solid circular mark on each graph represents the maximum load value for that particular specimen and the solid triangular mark represents the point where first stiffness change was observed.

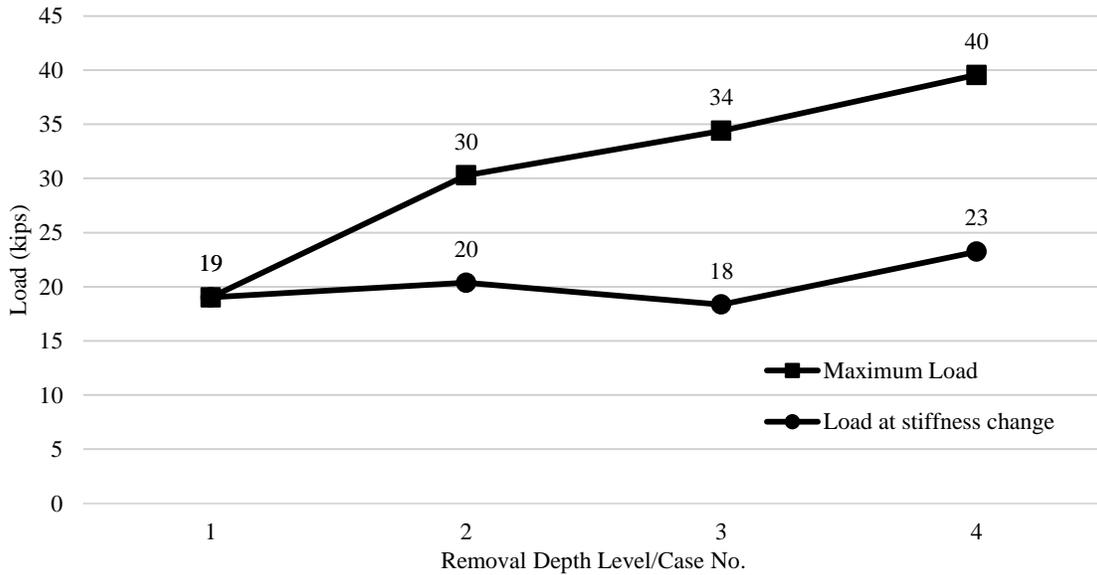
**Figure 38. Average load versus concrete removal depth (push-out test)**

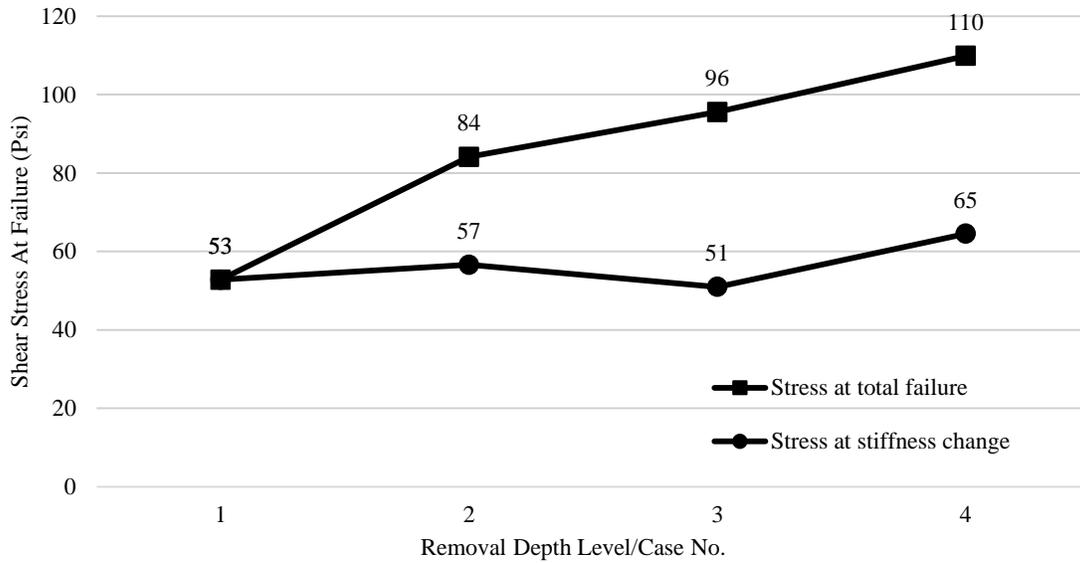
**Figure 39. Average shear stress versus concrete removal depth (push-out test)**

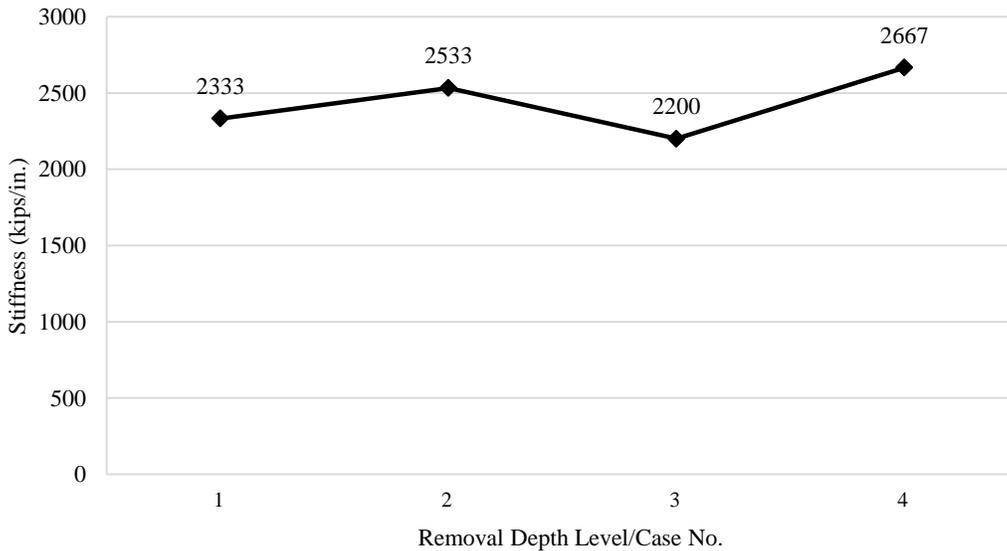
**Figure 40. Average stiffness versus concrete removal depth (push-out test)**

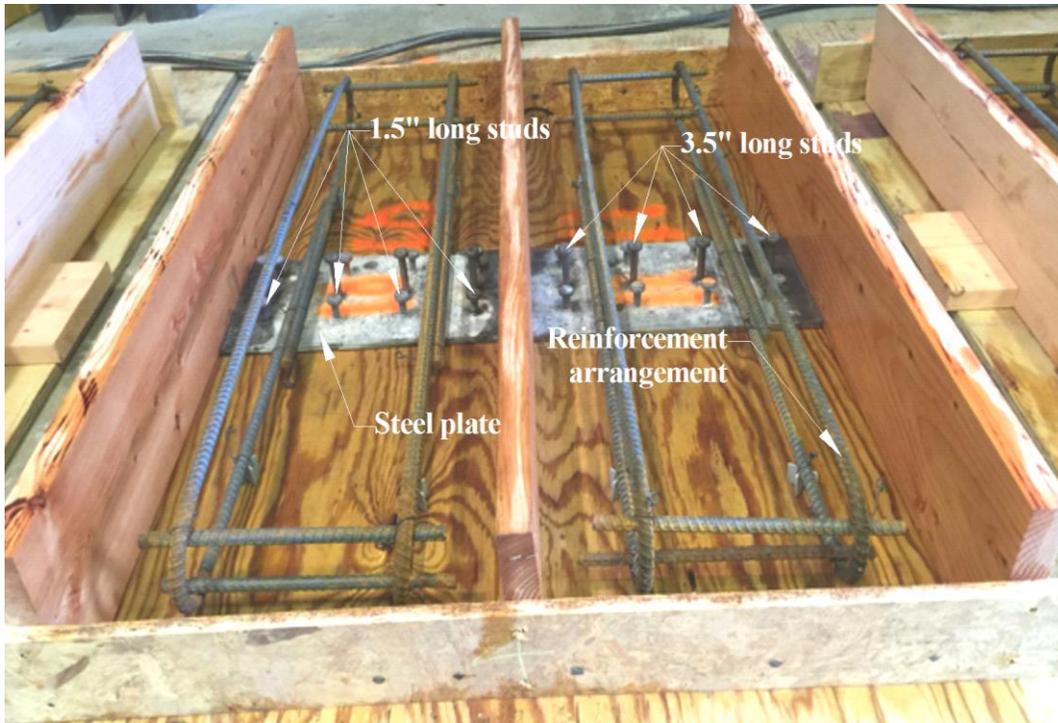
**Figure 42. Positive bending flexural test formwork for substrate concrete placement**

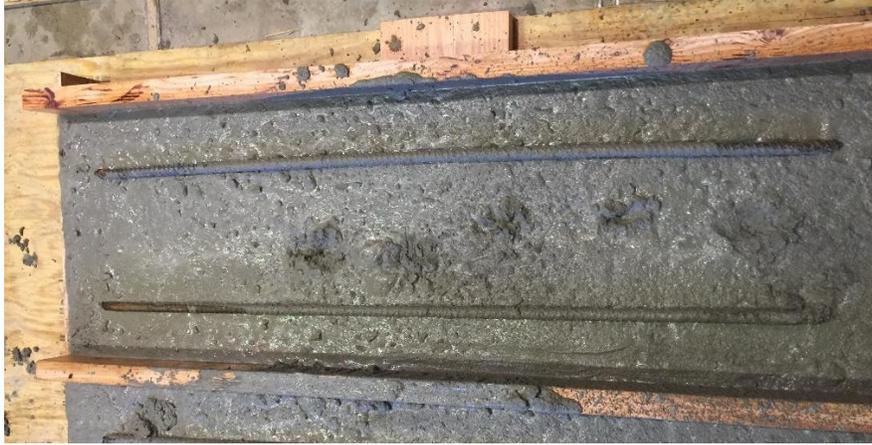
**Figure 43. Positive bending flexural test specimen after substrate concrete placement (Case 4)**

The substrate concrete was placed 0.5 in. above the required concrete removal depth level of each specimen so that a 0.5 in. of concrete could be chipped using a jackhammer to give it a proper roughened finish. Figure 43 shows a Case 4 specimen with the substrate concrete placed up to the bottom of the top reinforcing steel bars (i.e., 0.5 in. extra on top of the concrete removal depth level for Case 4).

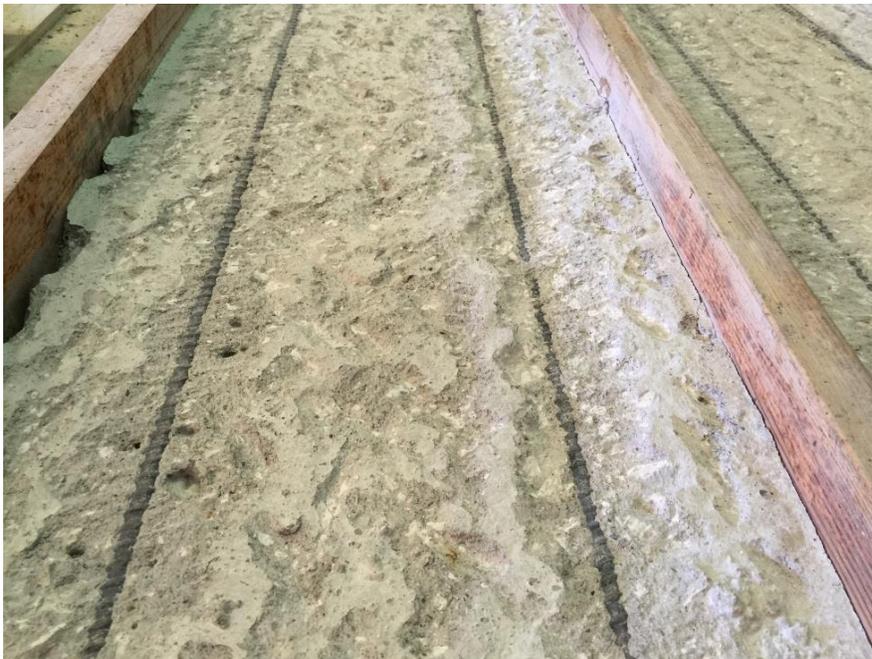
**Figure 44. Positive bending flexural test specimen after roughening of substrate concrete (Case 1)**

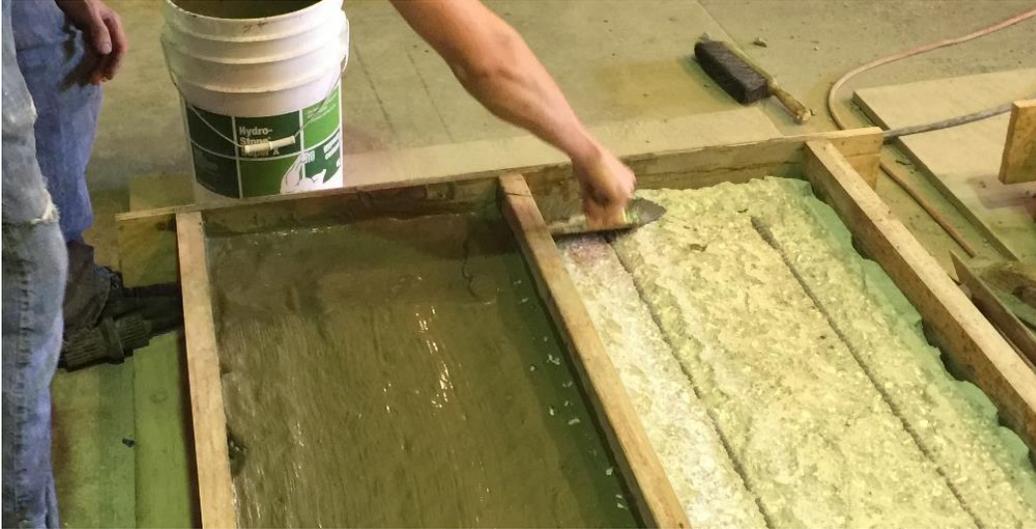
**Figure 45. Application of grout to positive bending flexural test specimen (Case 1)**

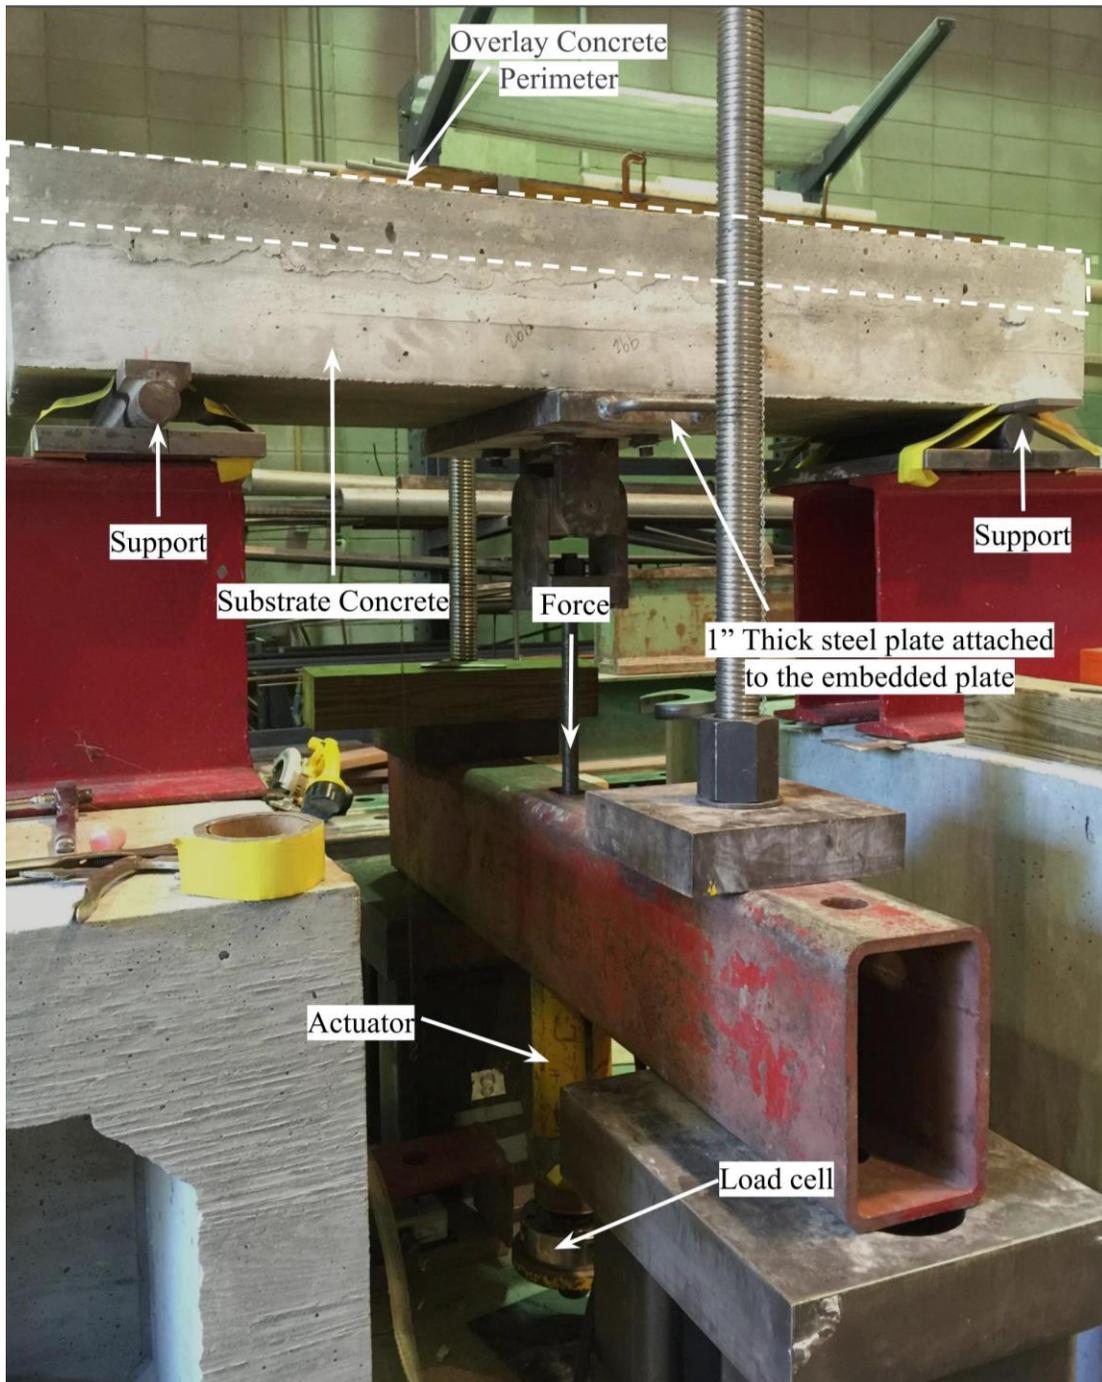
**Figure 46. Testing arrangement for positive bending flexural test**

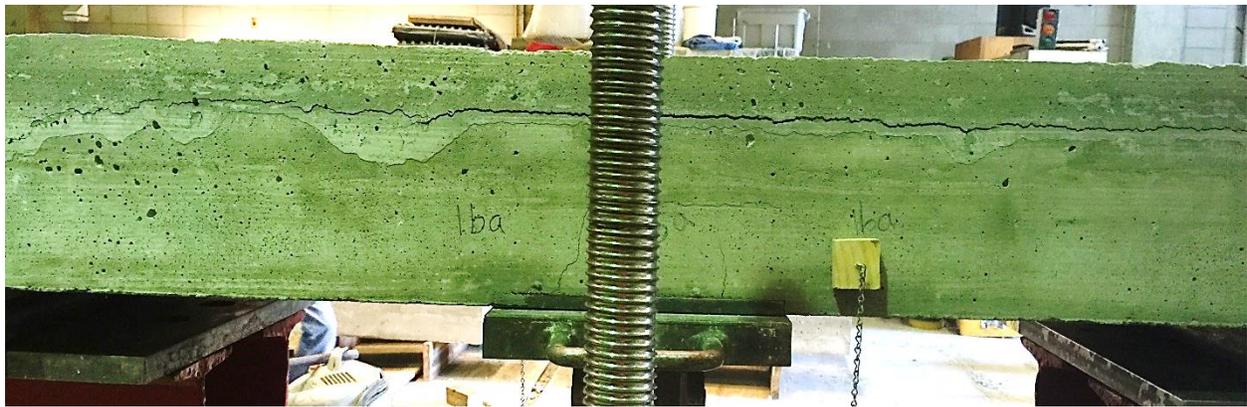
**Figure 47. Case 1 positive bending flexural test specimen failure at concrete bond interface**

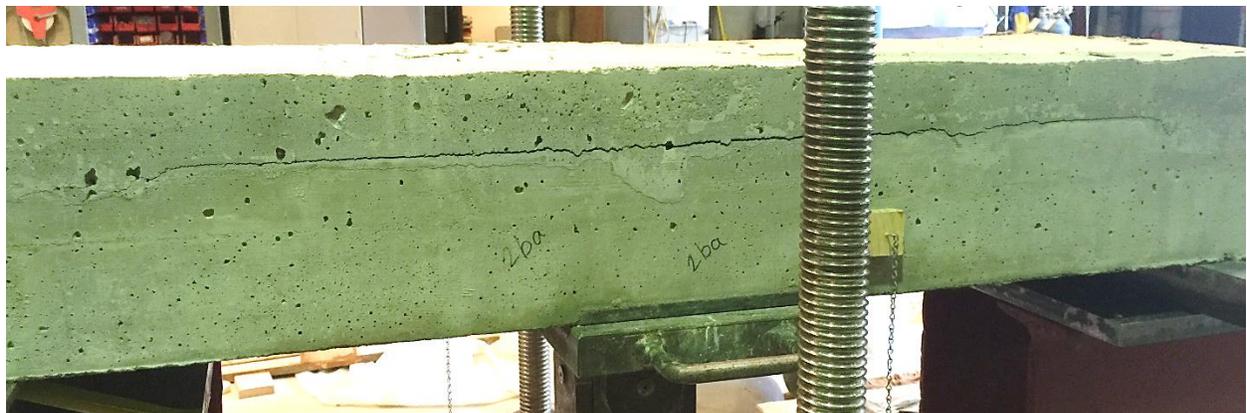
**Figure 48. Case 2 positive bending flexural test specimen failure at concrete bond interface**

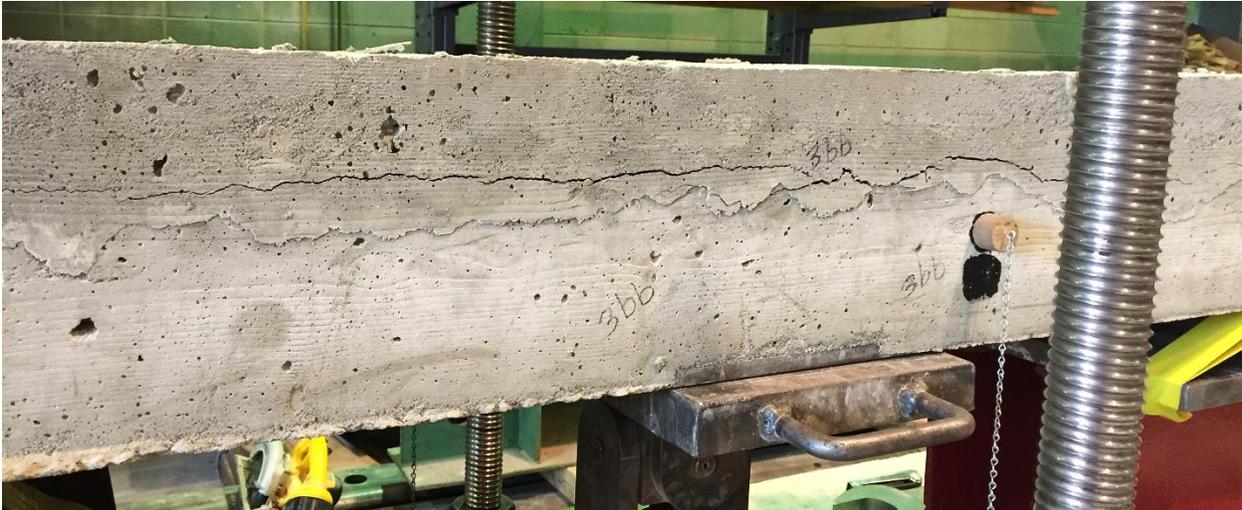
**Figure 49. Case 3 positive bending flexural test specimen failure at concrete bond interface**

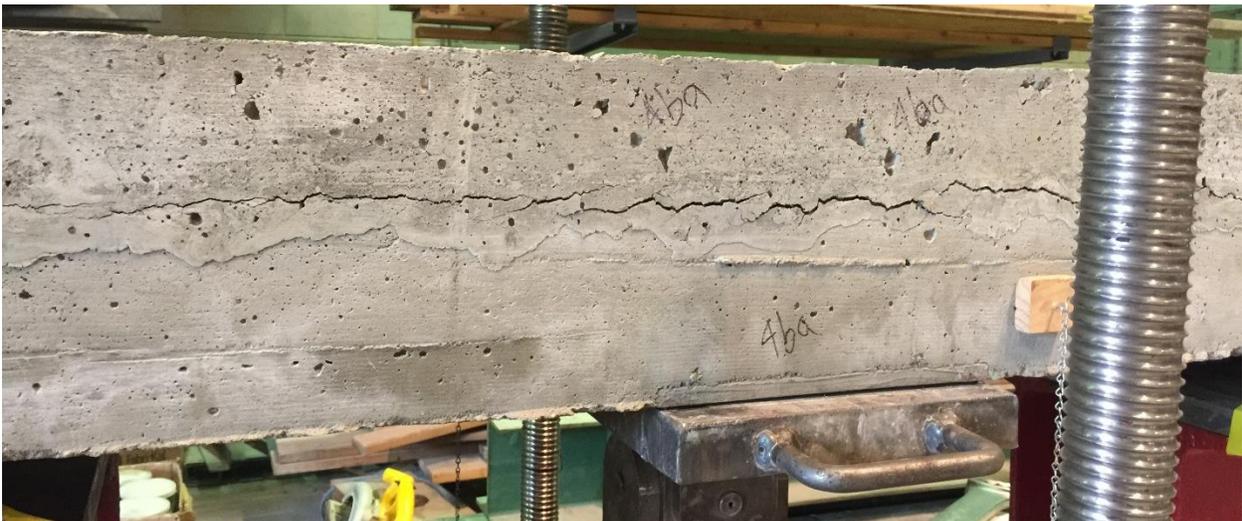
**Figure 50. Case 4 positive bending flexural test specimen failure at concrete bond interface**

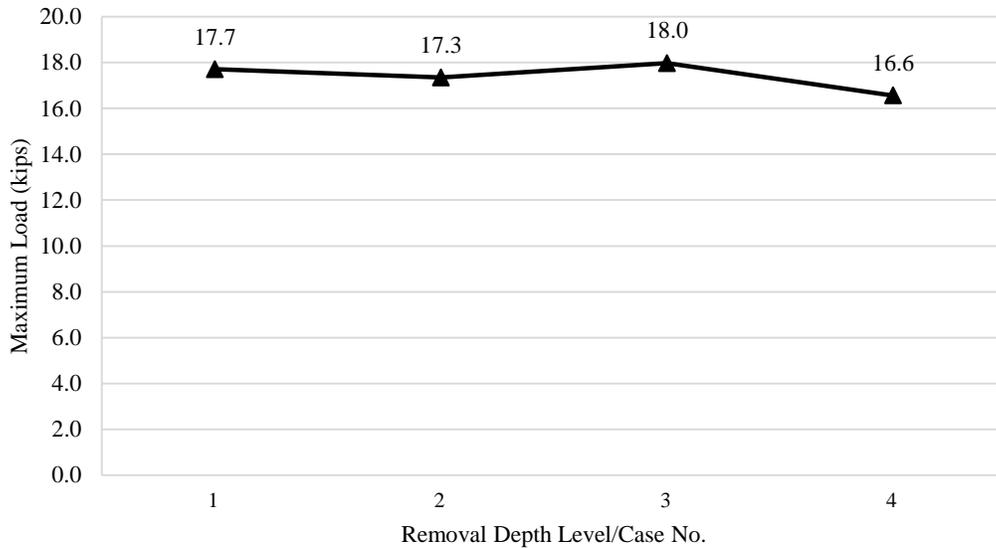
**Figure 51. Average maximum load versus concrete removal depth (positive bending flexural test)**

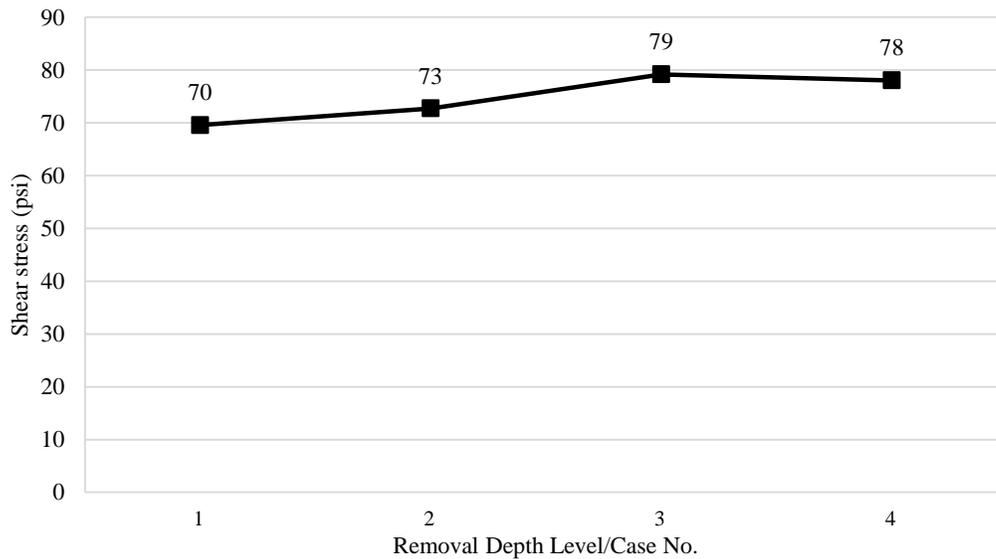
**Figure 52. Average elastic shear stress at maximum load at interface versus concrete removal depth (positive bending flexural test)**

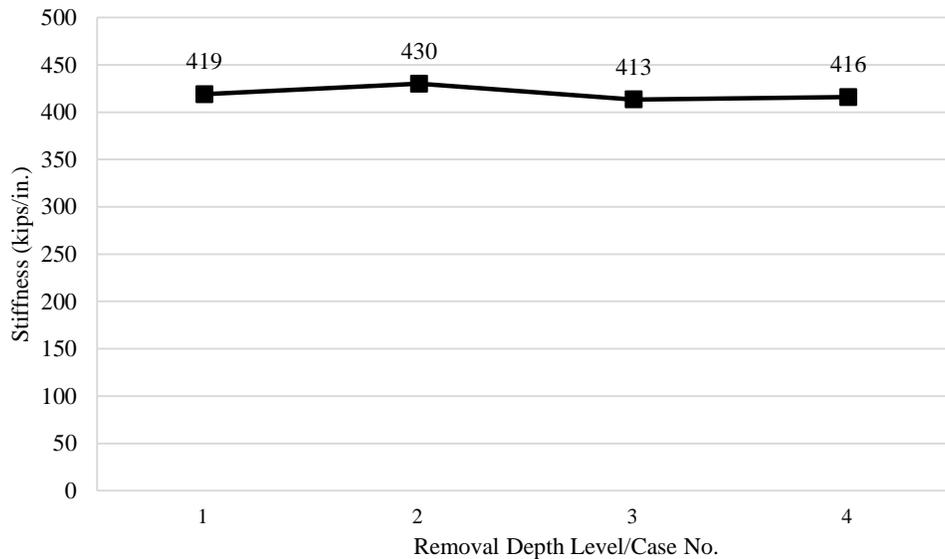
**Figure 53. Average stiffness versus concrete removal depth (positive bending flexural test)**

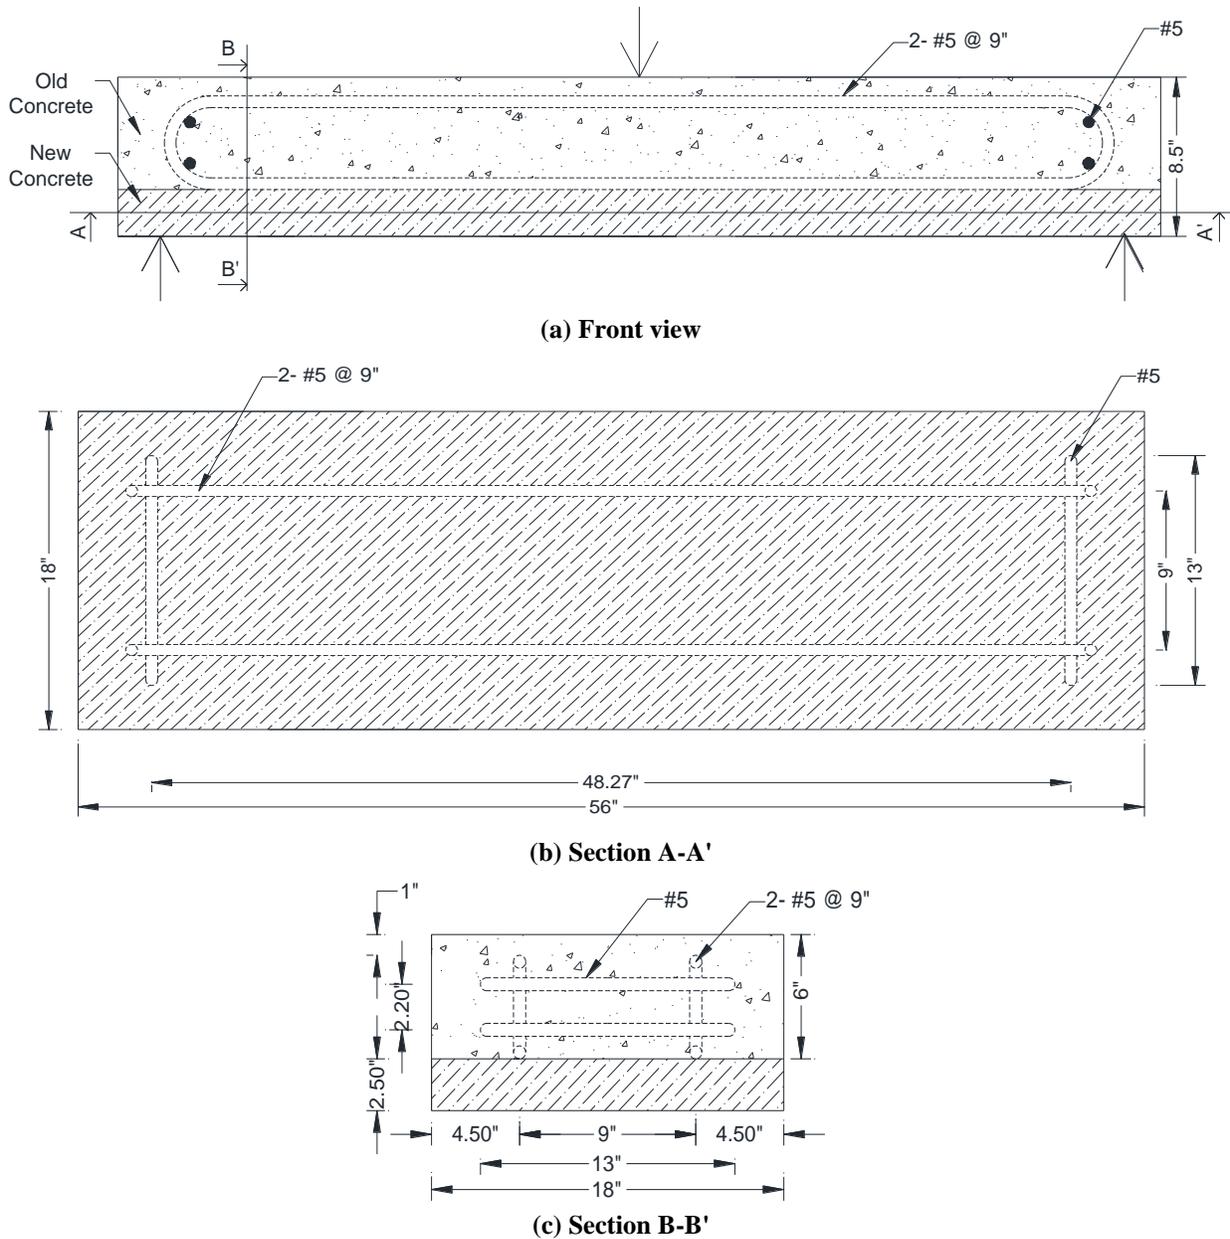
**Figure 54. Negative bending flexural test specimen schematic**
