# Investigation of Techniques for Accelerating the Construction of Bridge Deck Overlays

**Final Report**  
**April 2016**

**Sponsored by**  
Federal Highway Administration  
Iowa Department of Transportation  
(InTrans Project 14-500)

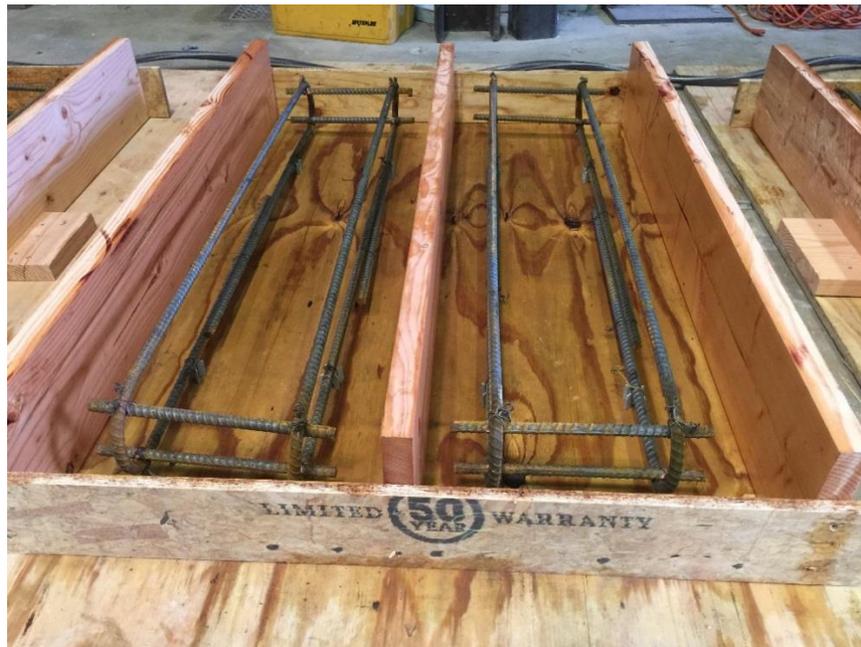
Figure 55 shows the formwork for the specimens.

**Figure 55. Negative bending flexural test formwork for substrate concrete placement**

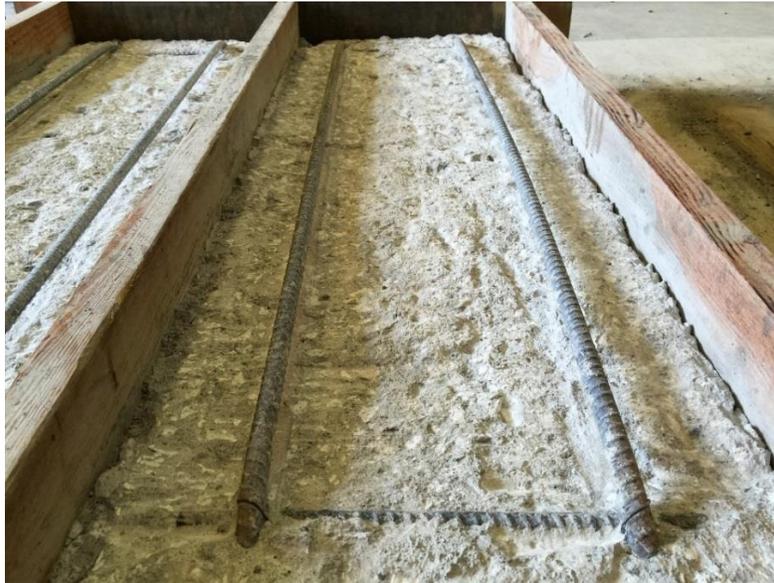
**Figure 57. Negative bending flexural test specimen after concrete removal to required depth (Case 3)**

The typical roughness of the surface after chipping and roughening is shown in Figure 57.

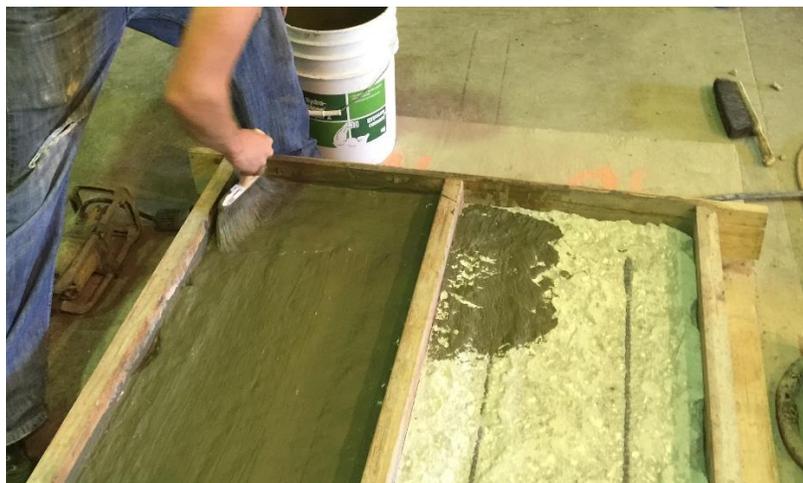
**Figure 58. Application of grout to negative bending flexural test specimen**

As described for the other tests, the same grout material was applied with a brush to the surface of the substrate concrete, as shown in Figure 58, before placement of the overlay concrete.

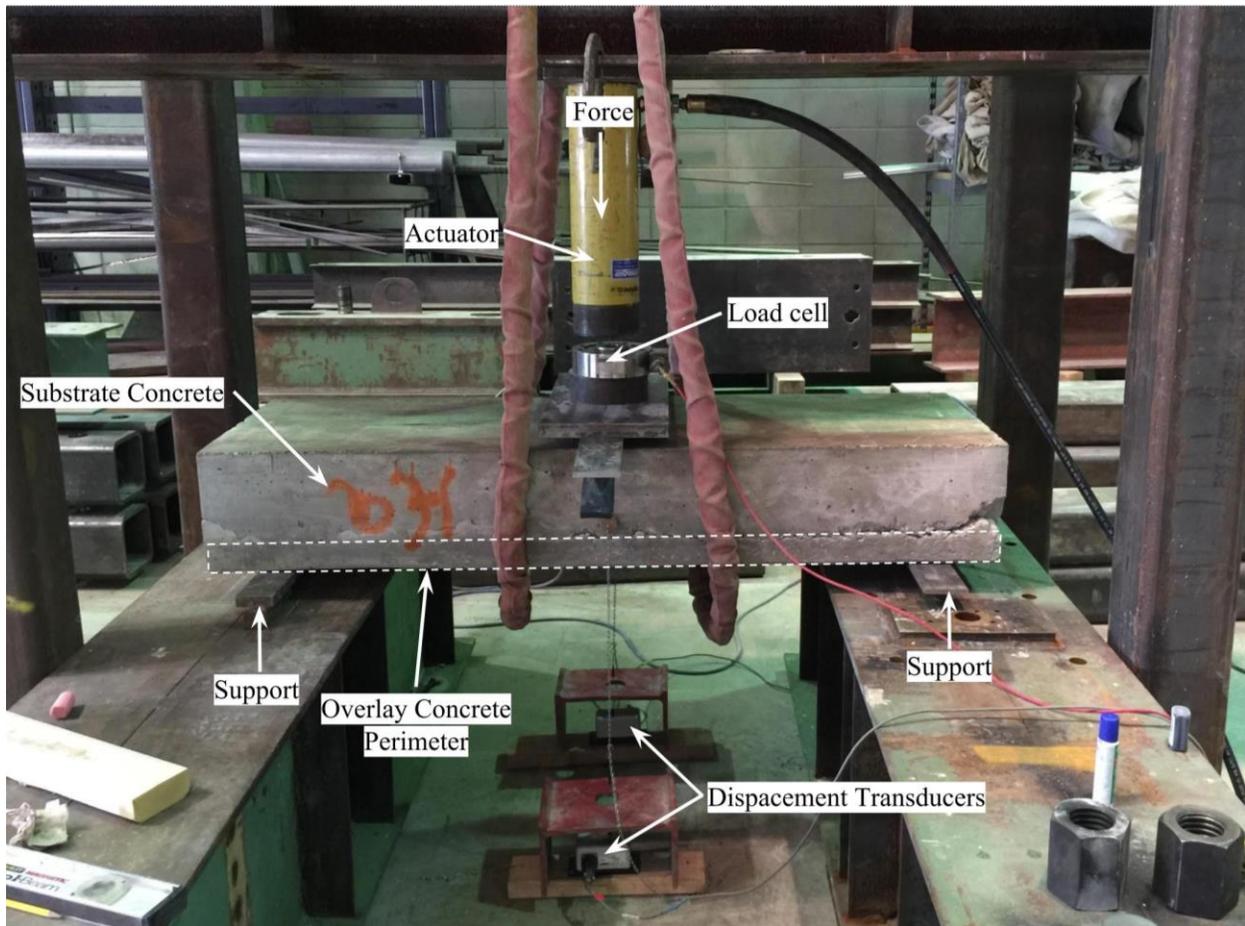
**Figure 59. Testing arrangement for negative bending flexural test**

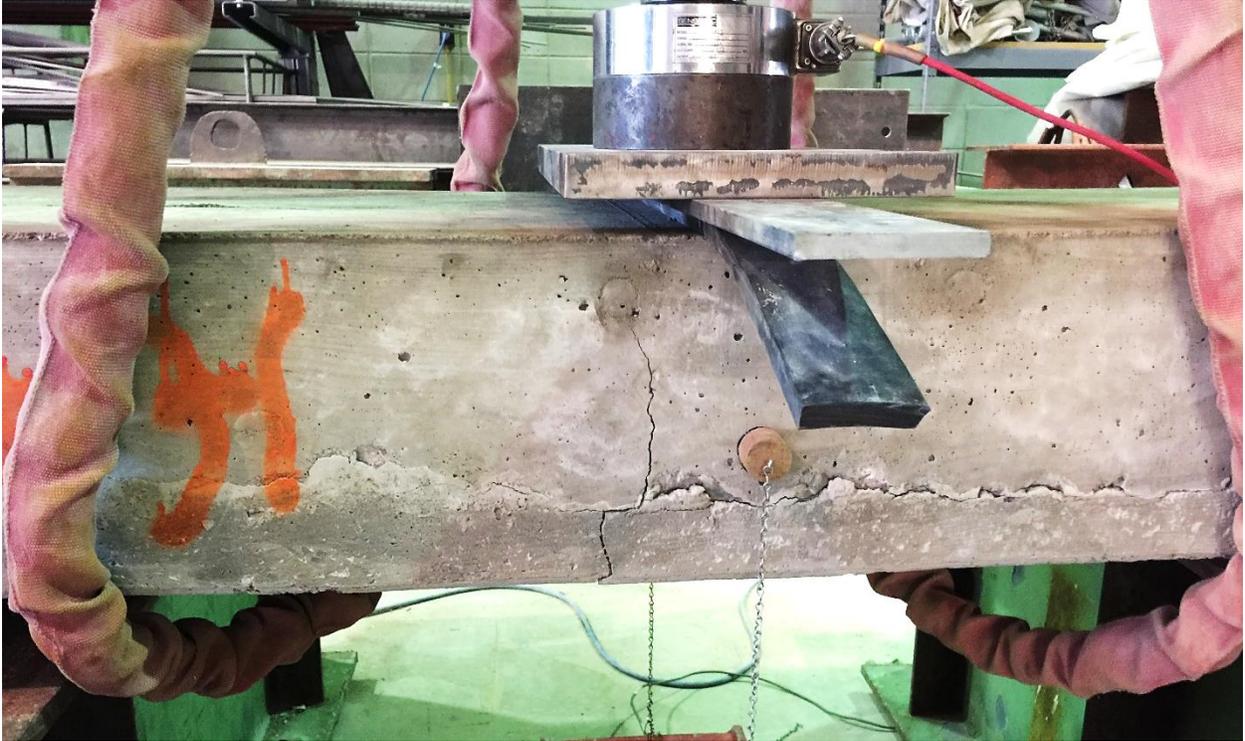
**Figure 60. Case 1 negative bending flexural test specimen failure at concrete bond interface**

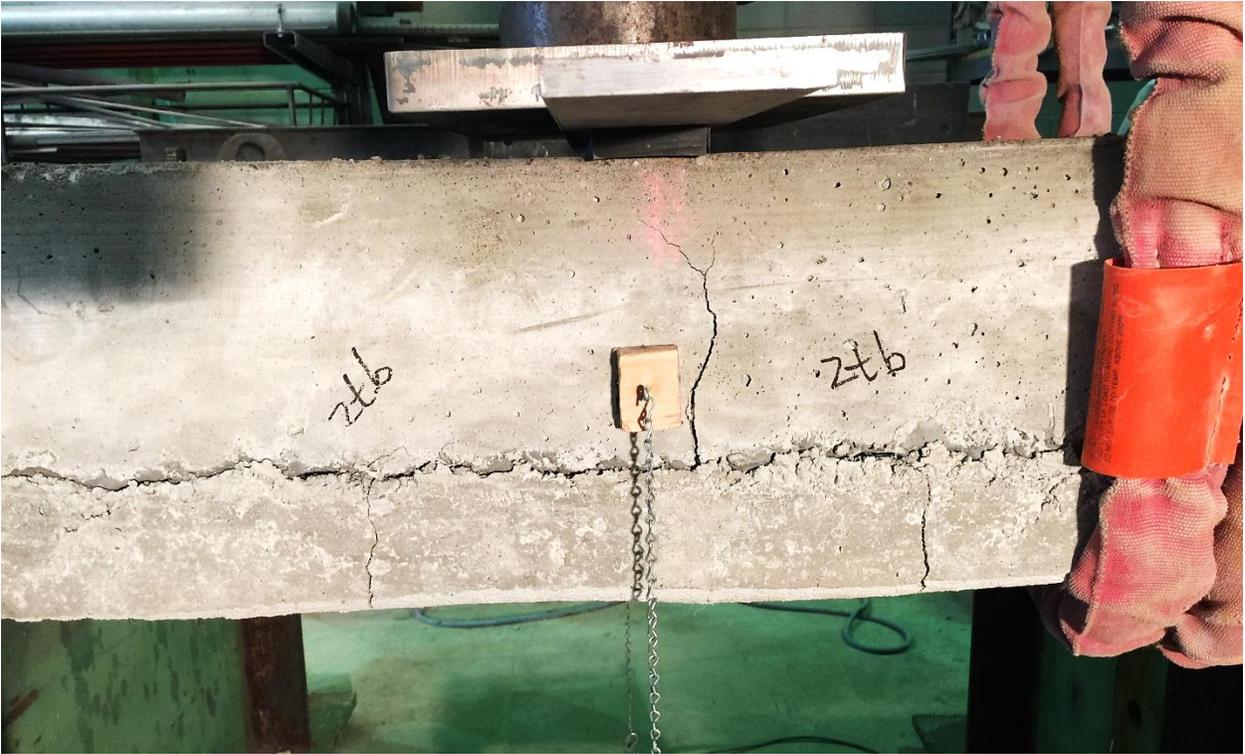
**Figure 61. Case 2 negative bending flexural test specimen failure at concrete bond interface**

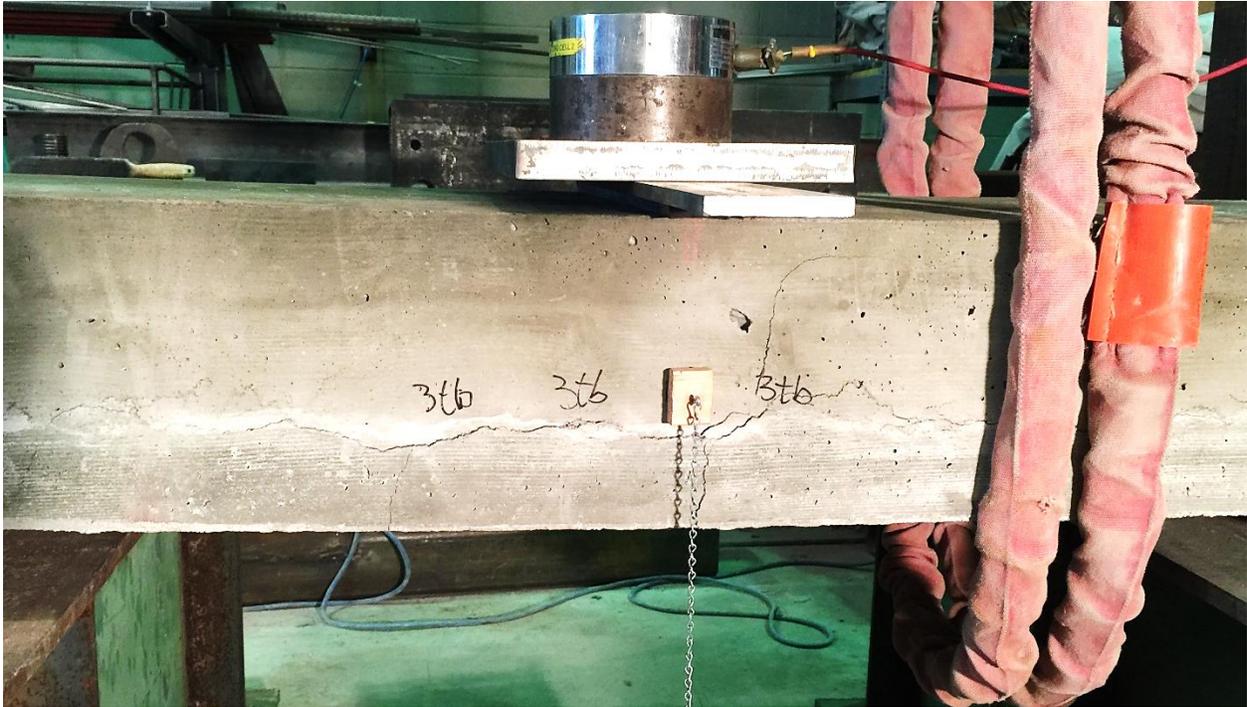
**Figure 62. Case 3 negative bending flexural test specimen failure at concrete bond interface**

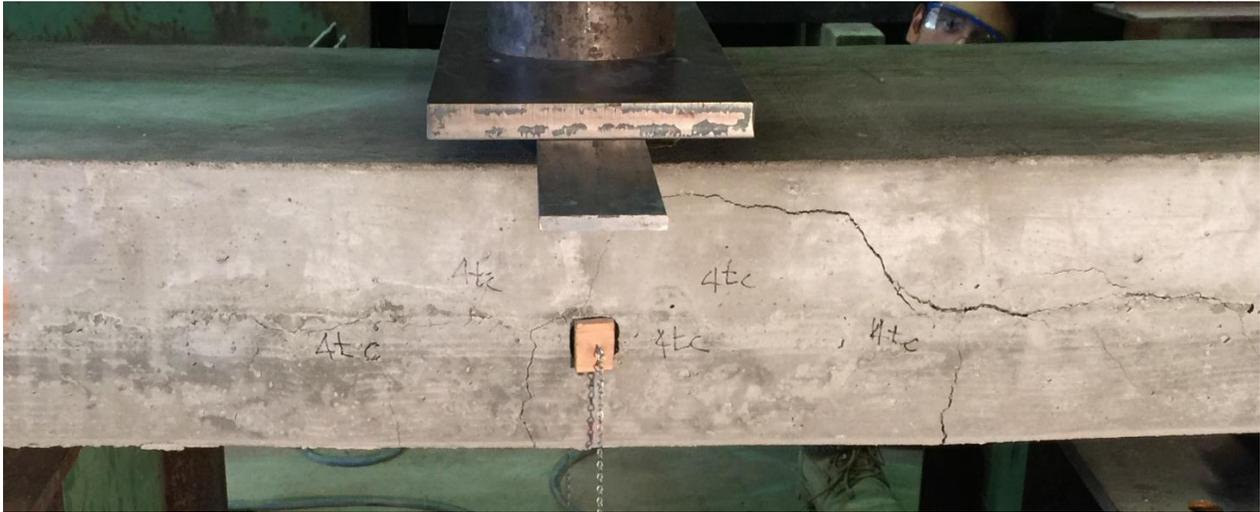
**Figure 63. Case 4 negative bending flexural test specimen failure at concrete bond interface**

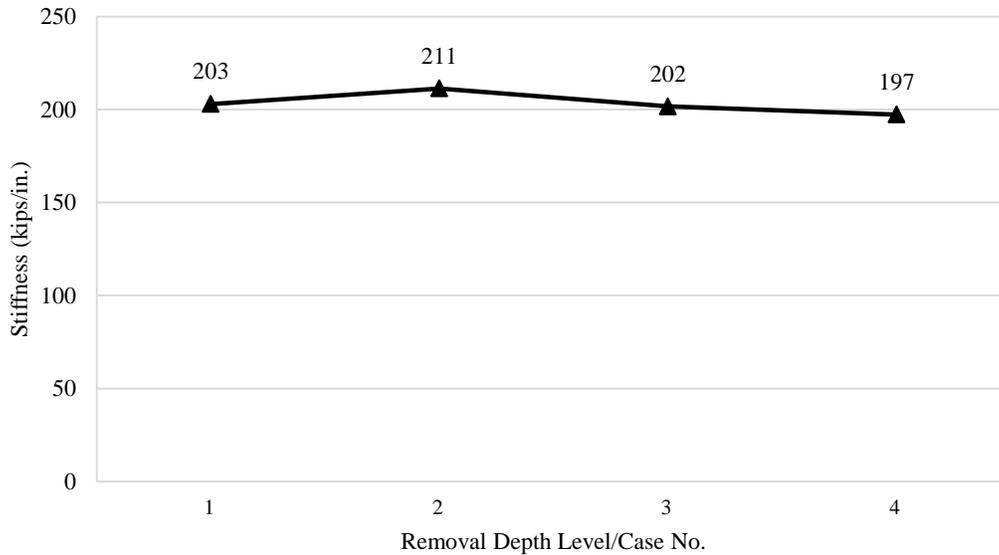
**Figure 66. Average stiffness versus concrete removal depth (negative bending flexural test)**
