Laboratory Investigation of Concrete Beam-End Treatments

Iowa Department of Transportation
(InTrans Project 12-442)

tech transfer summary

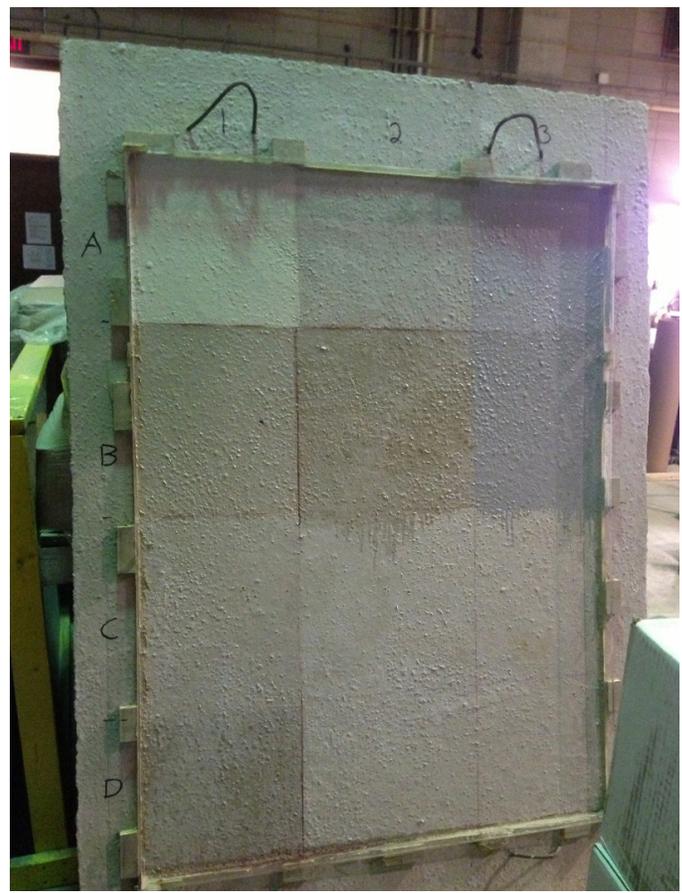
Typical ponding slab with coating alternatives applied

The selected products were tested in the laboratory according to AASHTO T259-80. Each product was applied to a designated square on each of three concrete ponding slabs, with each slab from a different precast facility in or near Iowa. In addition, two coats of Sikagard 62 were applied to one square, and two were left uncoated as controls.

The three slabs were submerged in a 3% chloride solution for 90 days, and samples were taken to be tested at the Iowa State University materials testing facilities. This procedure was repeated two more times.
