Context Sensitive Designs: Testing of Multi-Performance Level Box Beam Standards

tech transfer summary

Iowa Highway Research Board
(IHRB Project TR-681)
Iowa Department of Transportation
(InTrans Project 14-513)
Federal Highway Administration

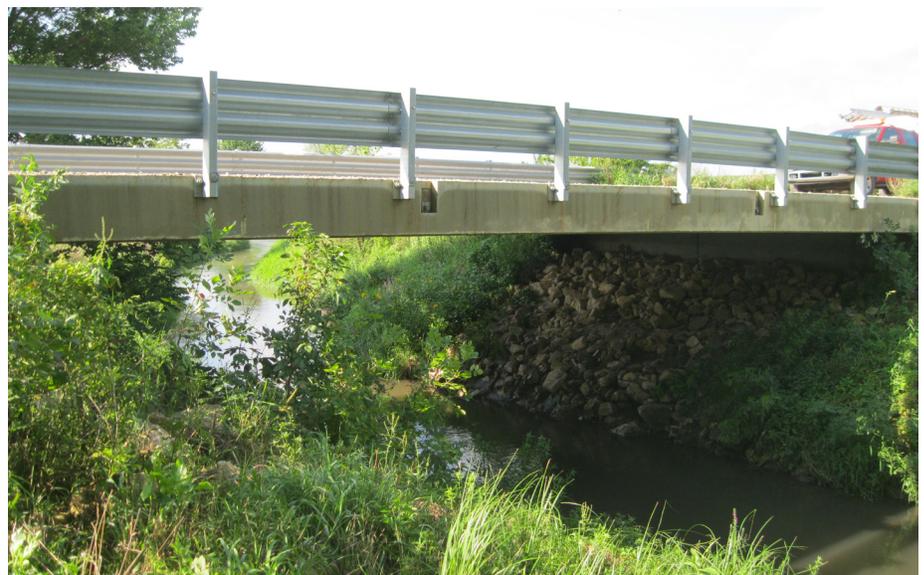
Box beam bridge in Buena Vista County, Iowa

- No cracks were found during the joint inspection of the bridge in Madison County.
- Moisture staining was found at the bottom surface of the bridge in Buena Vista County, which indicated that the bridge had cracks and experiences water leakage.

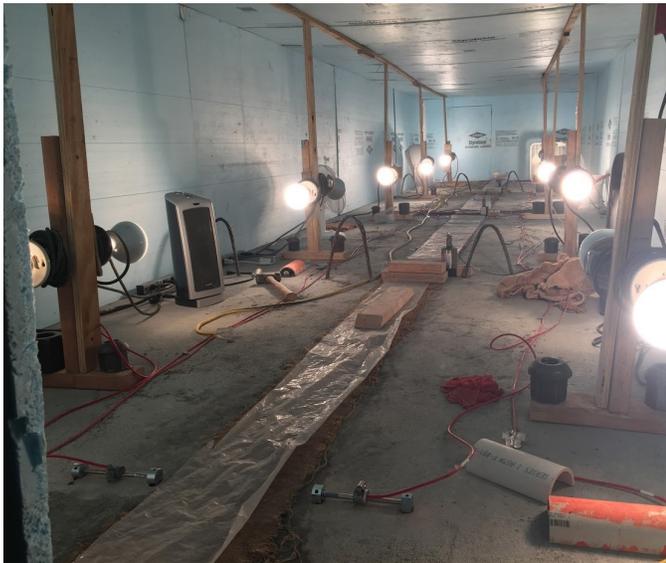
Temporary temperature isolation room on top of the specimen allowed for the application of heat that would simulate normal thermal radiation consisting of heating of the top surface (Note the joint concrete down the center was covered with burlap, with plastic over that, while the material cured)

The temperature loading was applied during the early age of the joint concrete in conjunction with concrete expansion, heat of hydration, and concrete hardening. During the early-age testing of the innovative joint that was developed in this work, the daily temperature loading simulated a 40 °F vertical temperature gradient through the depth of the specimen. The test continued for seven days.

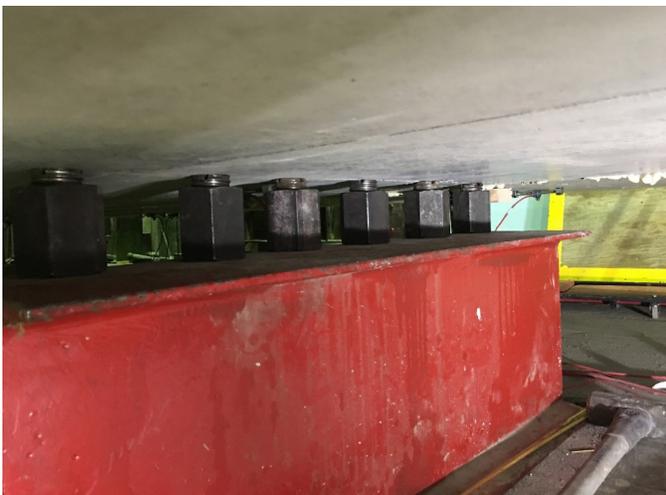
Restraints used to restrict deflection under one beam

Following full curing of the joint (when the joint concrete was two months old), a series of cyclic live loading tests were conducted on the specimen. Generally, the cyclic loading was applied at a frequency of 2 Hz and the beams were tested with two different boundary conditions: both beams simply supported and one beam restrained (to generate higher stresses in the joint).
