Effectiveness of Dynamic Messaging on Driver Behavior for Late Merge Lane Road Closures

Final Report
March 2009

Sponsored by
the Iowa Department of Transportation
(CTRE Project 08-327)

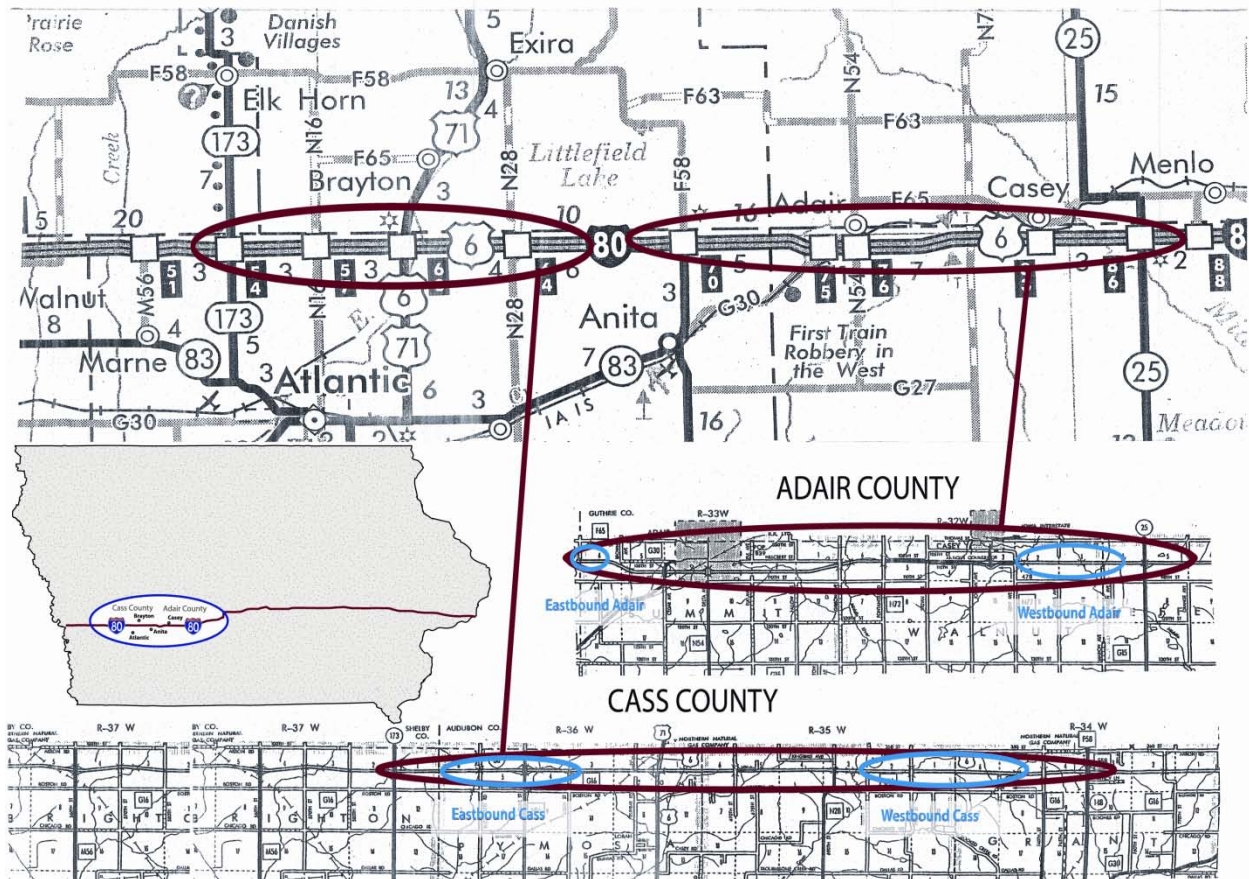
Figure 1. General plan of work area and study sites

This report documents the efforts on a project to evaluate the effectiveness of dynamic messaging systems at locations with lane closures on driver behavior. The report also presents findings of these efforts and some recommendations. The findings are based on the deployment of two DLMS on Interstate 80 in western Iowa in Adair and Cass Counties. These locations are shown in Figure 1.

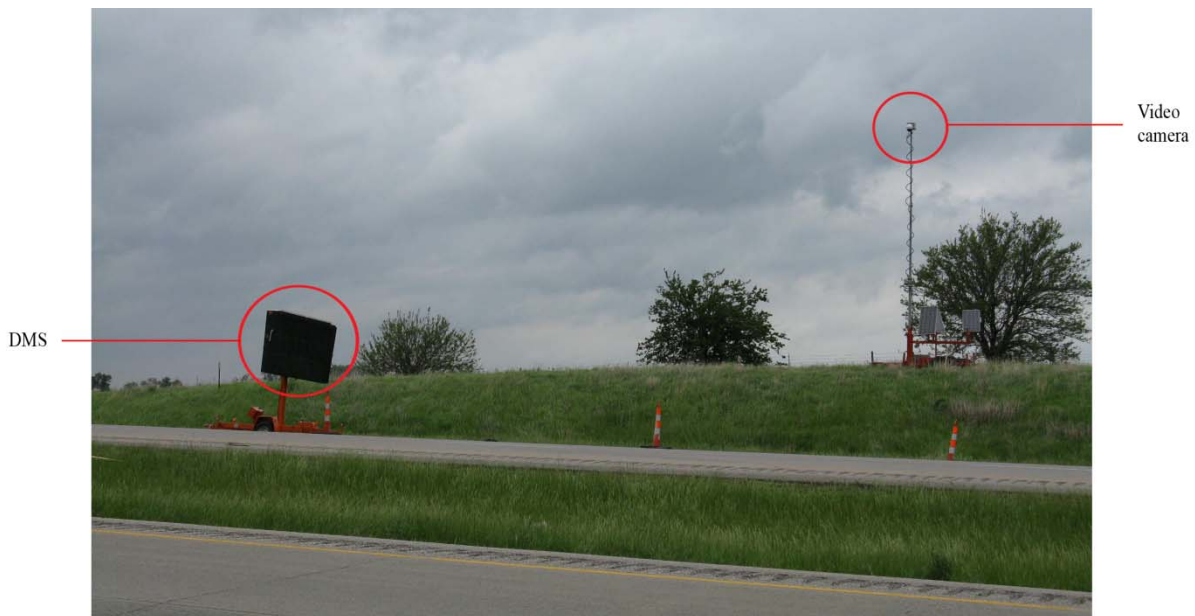
Figure 4. Typical installation (may include the DMS, left, and sometimes a solar-powered video camera, right) (photo courtesy of Iowa DOT)

The prime contractor for the entire Lane Merge “package” was Quality Traffic Control (QTC) of Des Moines, IA. ASTI of New Castle, DE provided the cameras, Wavetronics speed sensors, and cellular communications. The portable DMS signs were manufactured by Precision Solar Controls (PSC) of Garland, TX. The DMS signs were 76 in. in height and 127 in. in width. Each unit was capable of displaying up to three lines of text and up to eight characters on each line, with an individual character size of 18 in. tall and 12 in. wide. These trailer-mounted signs are located on the shoulder facing traffic, and normally the bottom of the sign is 5 to 6 ft. above the shoulder (Figure 4). Telescoping masts on other trailers were capable of extending to a height of 162.5 in. for mounting cameras or speed sensors (Figure 5).

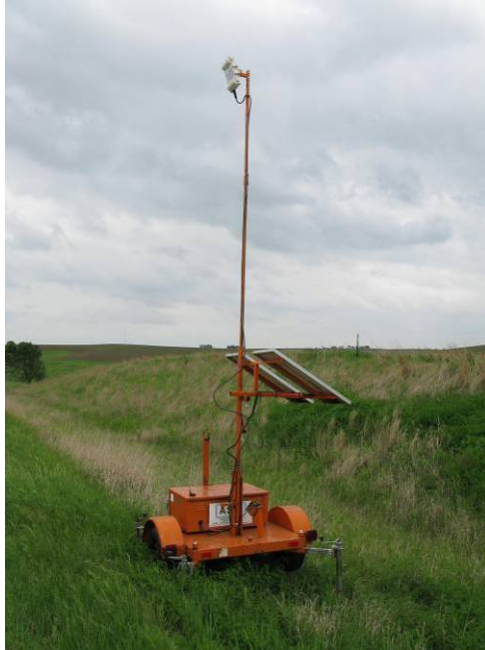
Figure 5. Speed sensor (photo courtesy of Iowa DOT)

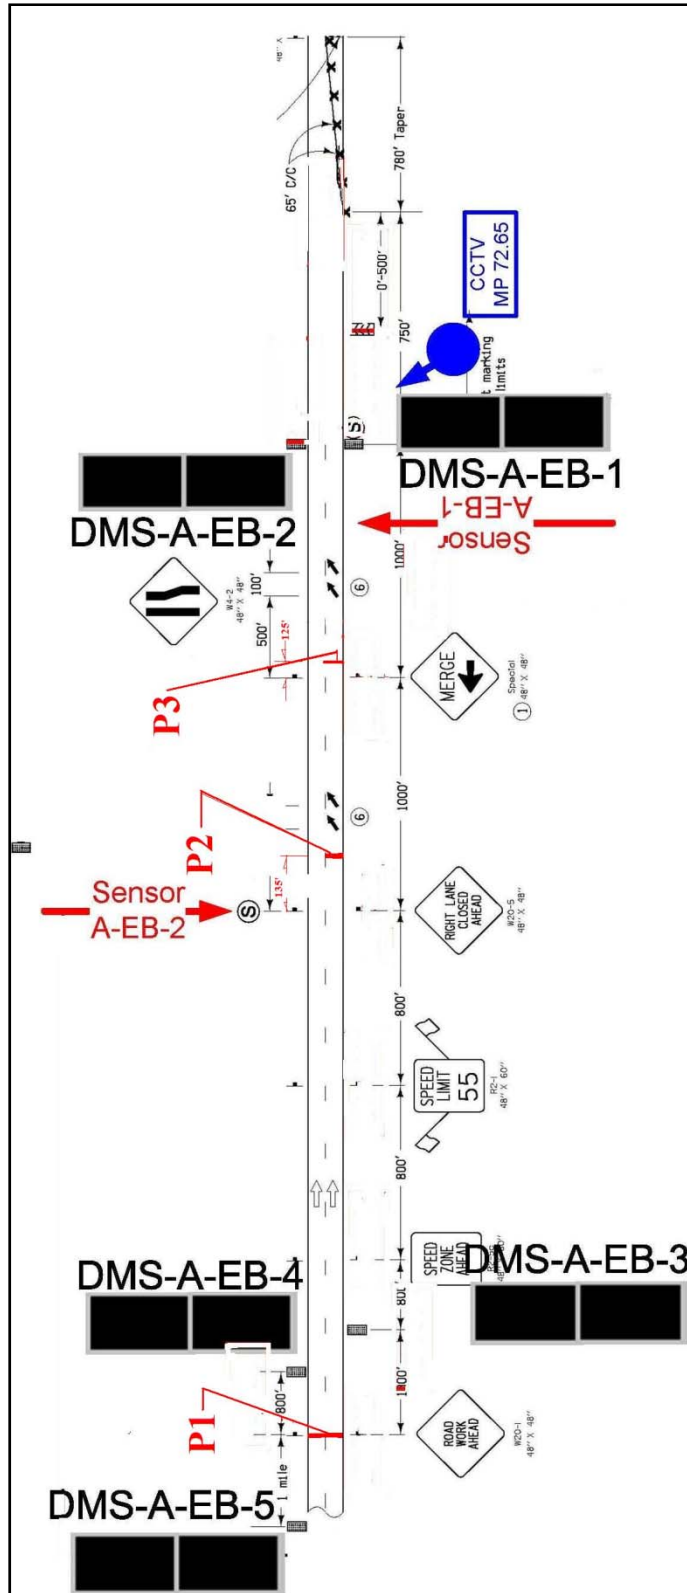
Figure 6. P1, P2, and P3 positions relative to static TTC and DMS signs

- P1 position in both lanes at the approximate location of the TTC static “Road Work Ahead” signs, which were installed about 6,450 ft in advance of the lane closure taper, which is point of lane closure. Data from this location was utilized for determining total and unrestricted traffic data or free flow conditions.
- P2 position, in the lane being closed, at a location approximately 135 ft beyond the TTC “Left [or Right] Lane Closed Ahead” signs, or about 2,615 ft in advance of the point of

Once selected, these data gathering positions were used for all the observation periods. See Figure 6 for placement of data gathering equipment relative to DMS signs.

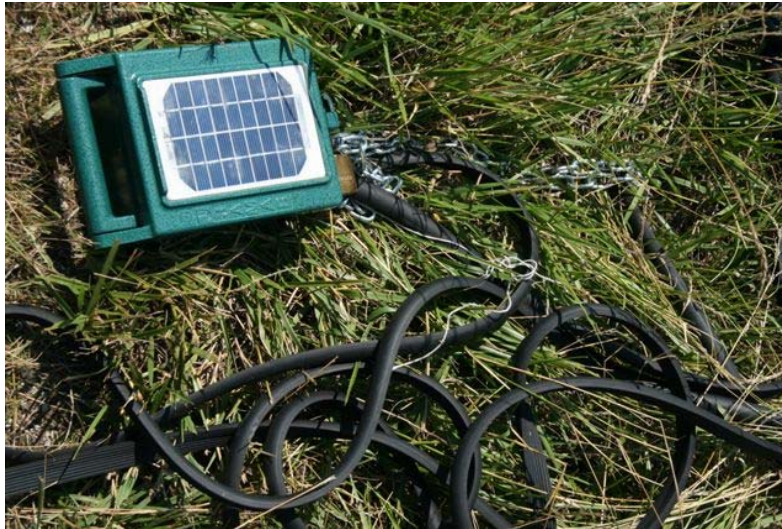
Figure 7. Typical Jamar counter and HD road tubes (photo courtesy of Brad Grefe, CTRE)

Following location selection for data gathering, the equipment to be used was obtained and examined for proper operation. Data gathering was initiated using heavy-duty road tubes and Jamar model TRAX Flex HS counters, shown in Figure 7 (see product specifications in Appendix B). Heavy duty tubes were selected in consideration of anticipated wear from high volume truck traffic.

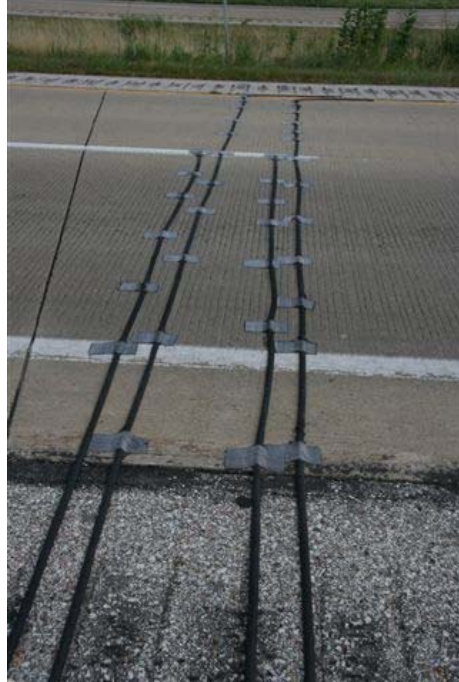
Figure 8. Position 1 setup (photo by Brad Grefe, CTRE)

General note: Even with the Adair County Iowa DOT maintenance personnel providing excellent traffic control, the high volume of traffic on I-80 made the operation of laying the road tubes, especially in the open lane, potentially hazardous when placing the hold-down tape. Particularly concerning was installation of tape near the centerline of the two lanes (Figures 8 and 9).

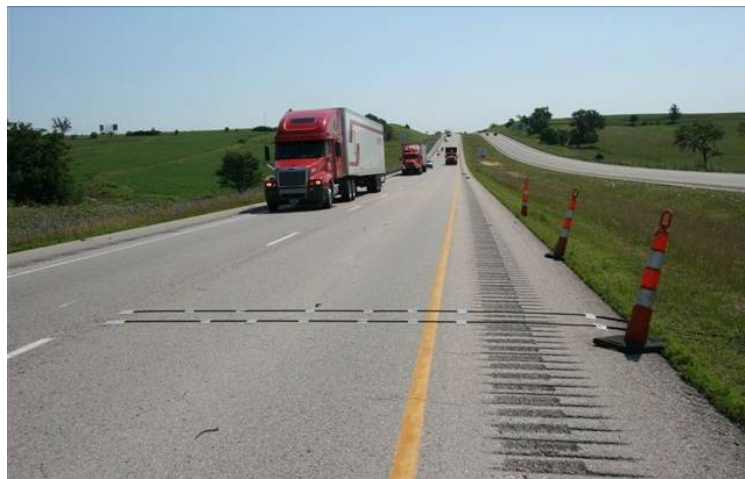
Figure 9. Position 2 road tube setup with Iowa DOT truck in background (photo by Brad Grefe, CTRE)

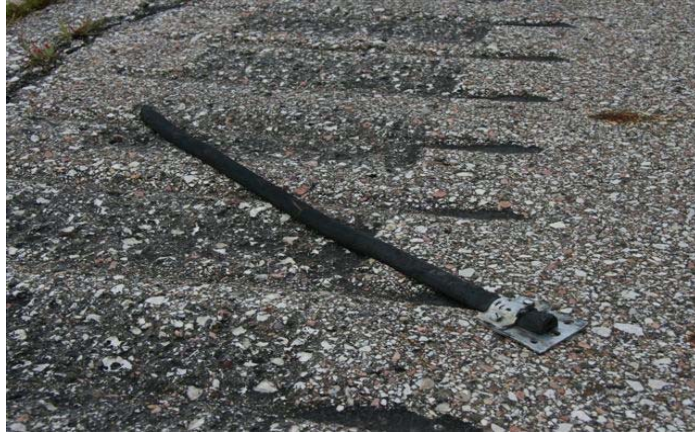
Figure 11. Severed end of road tube (photo by Brad Grefe, CTRE)

Incorrect connection of the road tubes at location P1 required data manipulation before processing to provide a corrected data set for this counter. A severed road tube found at the P2 position may have been caused when the metal end plate embedded in a vehicles' tires. (see Figure 11).

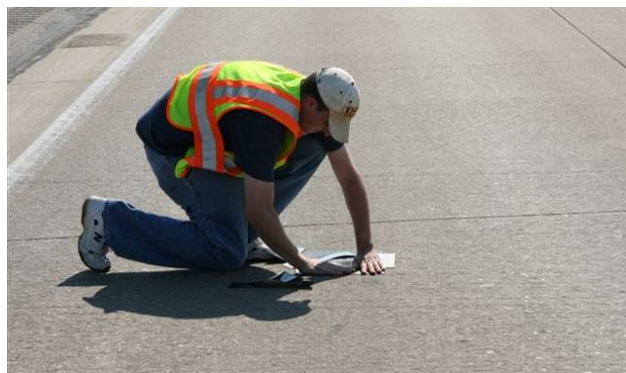
Figure 12. Placing NuMetrics plate counter (photo by Brad Grefe, CTRE)

DMS signs were in place at this location. However, due to extensive traffic speed reductions the previous weekend the trigger speeds were reset for a 40 mph upper limit and a 20 mph lower limit for activation of the messaging. The heavy-duty road tubes with Jamar counters were used at the P2 and P3 locations, supplemented with older NuMetrics plates borrowed from the Iowa DOT District 5 office. Data at the P1 position in both lanes were obtained only from the NuMetrics plates to minimize the installation time in the open lane. (Figures 12 and 13)

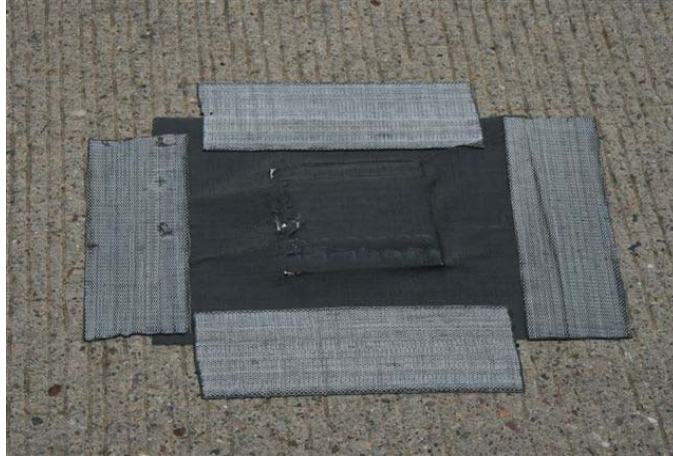
Figure 13. Typical NuMetrics plate counter installation (photo by Brad Grefe, CTRE)

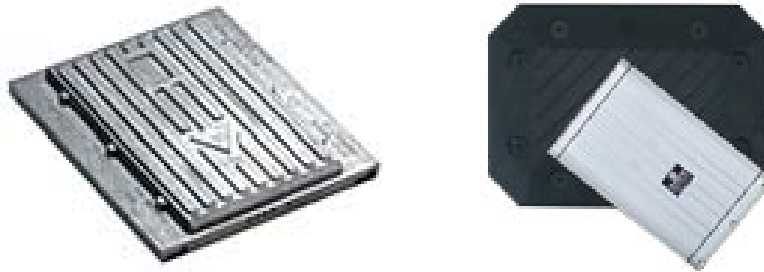
Figure 14. NuMetrics plates, older model Hi Star NC- 97, left, and new model NC- 100/200, right (photos from www.qttinc.com)

DMS signs were present at this location. Trigger speeds were set with a 40 mph upper limit and a 20 mph lower limit for activation of the messaging. The four recently repaired older model NuMetrics plates (Figure 14) were used at all EB locations, with no road tubes placed. The plates were programmed to begin data collection on Friday at noon until Monday at 1 a.m. in 60 minute bins.

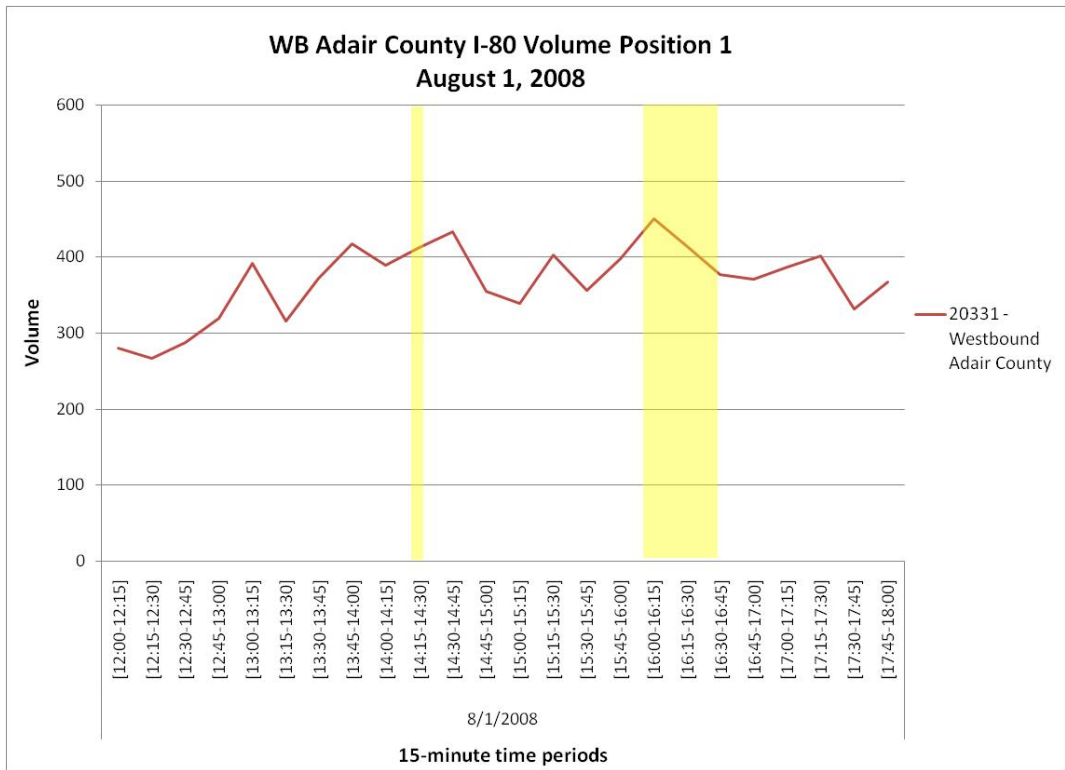
Figure 16. Traffic volume WB Adair County on August 1 during two transition periods

The possible relationship of traffic volume to the initiation of a transition speed or congestion period might be analyzed by reviewing the graphs located in Appendix A that show each weekend’s data. Enlargements of the graphs for the periods leading up to the two transition speed periods on Friday, August 1, and the congestion periods on Friday, August 8, and Sunday, August 10, are shown in yellow in Figures 16 and 17.

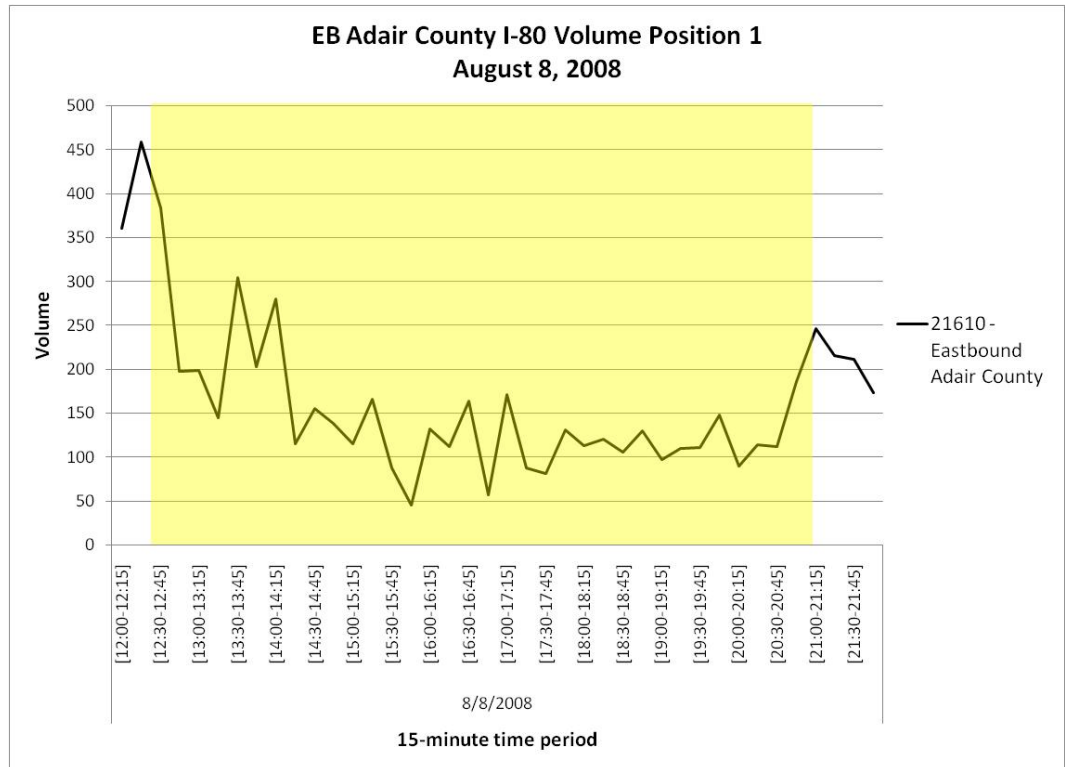
Figure 17. Traffic volume EB Adair County on August 8 during congestion period

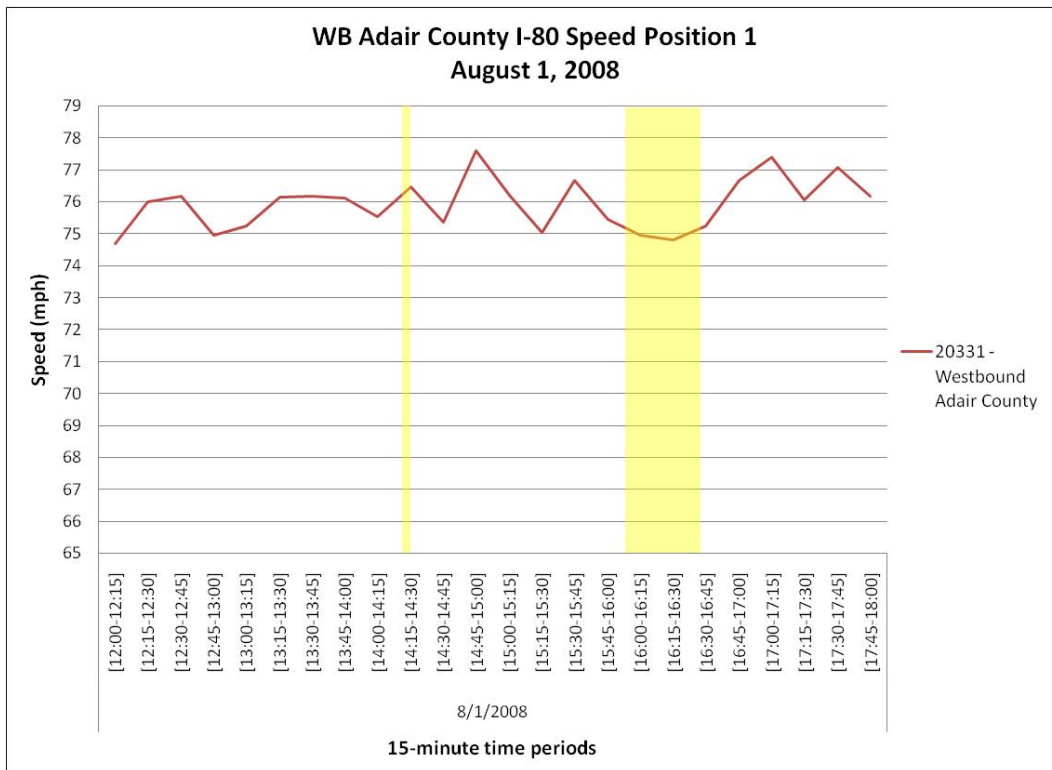
Figure 18. Traffic speed WB Adair County on August 1 during two transition periods

The relationship of traffic speed to the commencement of a congestion period may be analyzed by reviewing the graphs located in Appendix A that show each weekend’s data. Enlargements of the graphs for the period leading up to the backup periods shown in yellow on Friday, August 8, and Sunday, August 10, are shown in Figures 18 and 19.

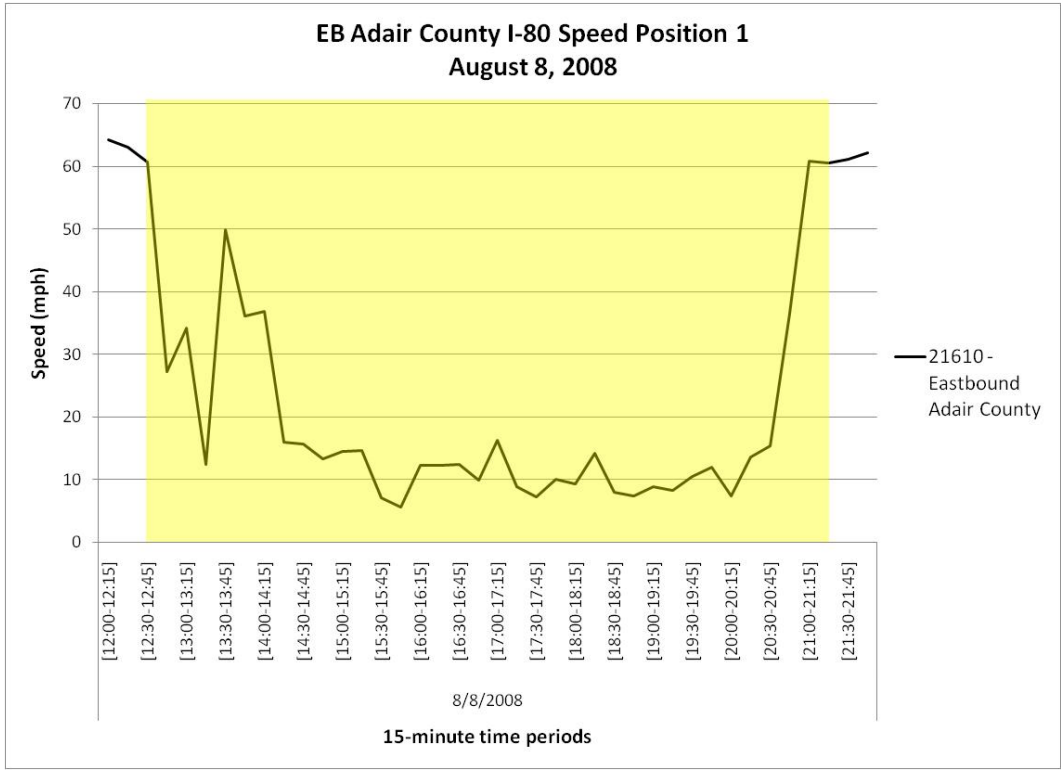
Figure 19. Traffic speed EB Adair County on August 8 during congestion period

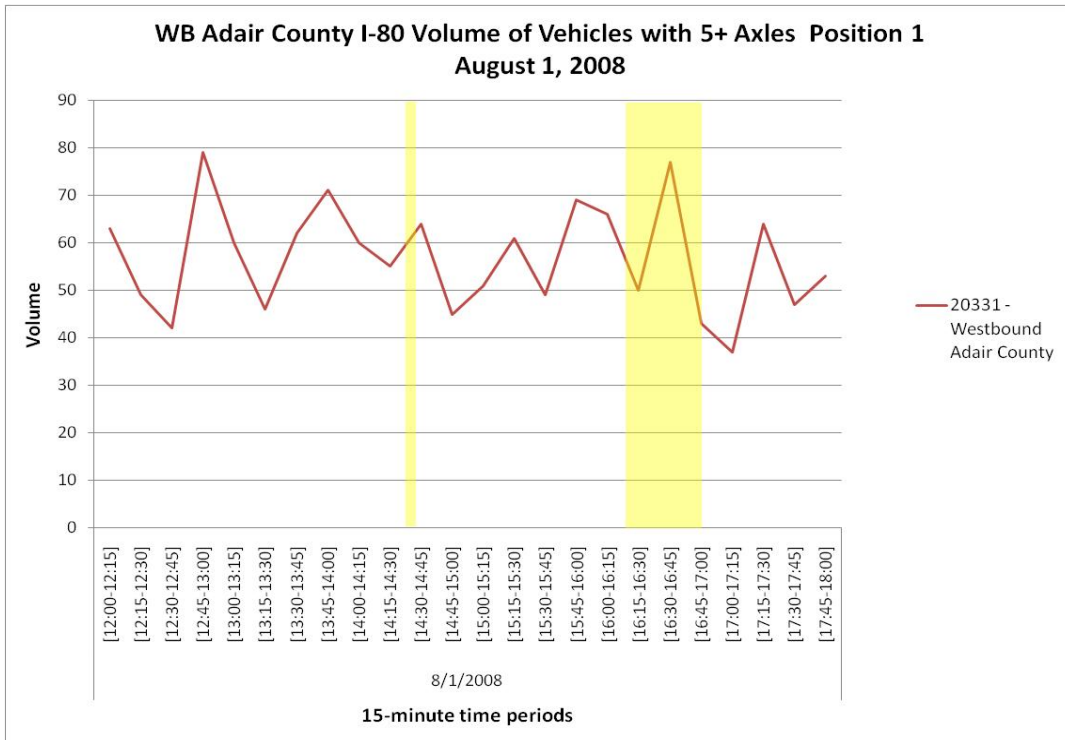
Figure 20. Heavy truck volume WB Adair County on August 1 during two transition periods

The relationship between traffic classification (i.e., number of heavy (5+ axle) trucks) and the commencement of a congestion period may be analyzed by reviewing the graphs found in Appendix A that show each weekend’s data. Enlargements of the graphs for the period leading up to the backup periods shown in yellow on Friday, August 8, and Sunday, August 10th, are shown in Figures 20 and 21.

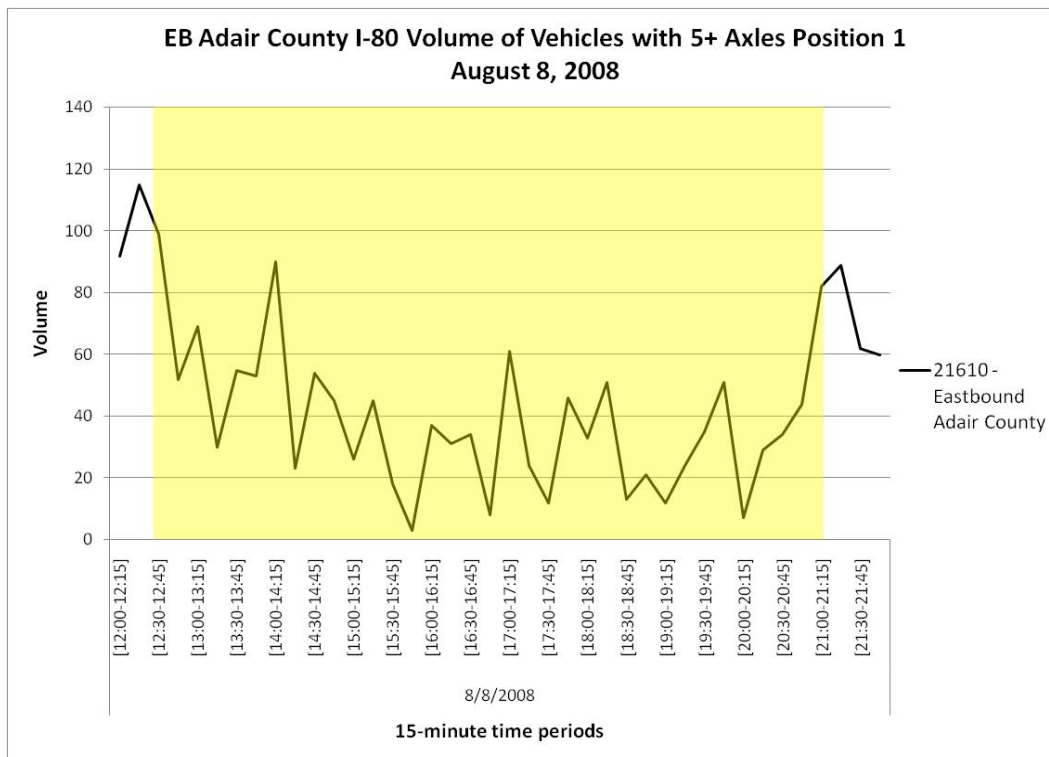
Figure 21. Heavy truck (5+ axles) volume EB Adair County on August 8 during congestion period

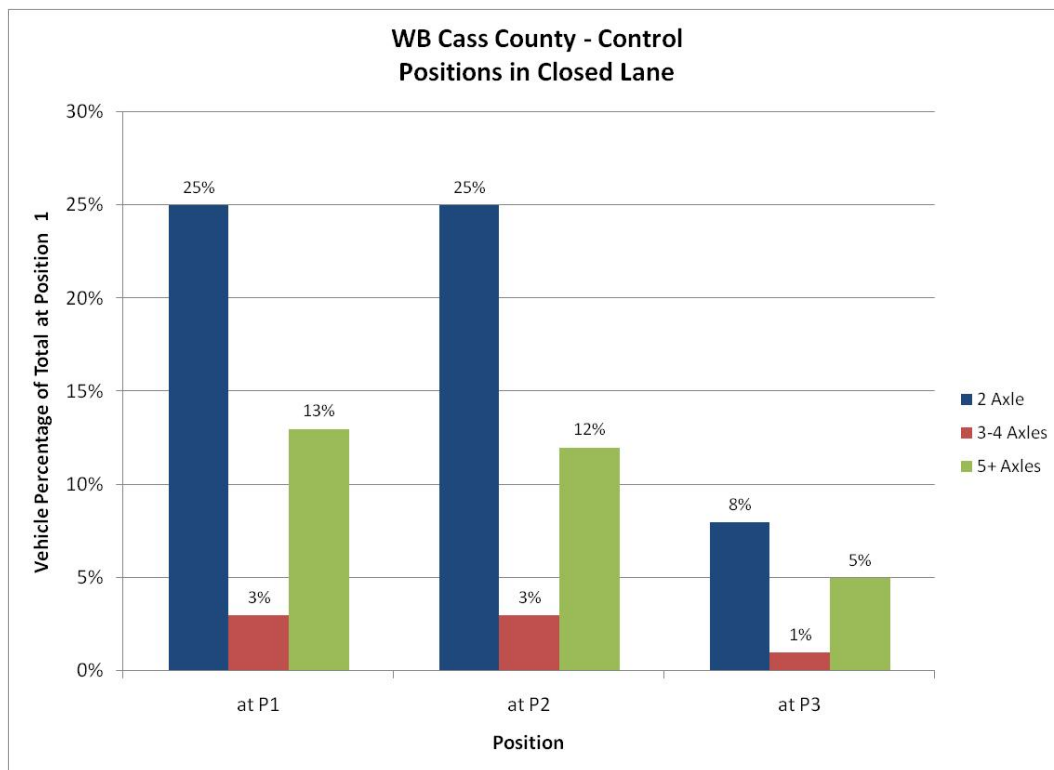
Figure 22. Free flow with no DMS signs present

Note that the amount of early merging taking place by cars and heavy trucks is less with no DMS signs present than with them on the job, but not activated. This would indicate that the mere presence of DMS signs on the site promotes early merging.

A final review of the late merge data previously presented in Tables 3 & 4 is illustrated below in graphical form in the figures below. These graphs again show the percentages of vehicles in the closing lane at locations P1, P2, and P3, by classification under all the available DMS options. The information is first shown for the control situation (Figure 22), where no DMS signs are in place at all. Then the information was combined from all weekends where the DMS signs were in place (Figure 23), but not activated (i.e. the speeds remained above the upper trigger speed). Figure 24 shows the merge data for the transition flows of traffic (DMS signs 1-5 activated) on the first weekend. The final Figure, 25 shows the data for the congestion flow of traffic during the second weekend with all DMS messages activated.

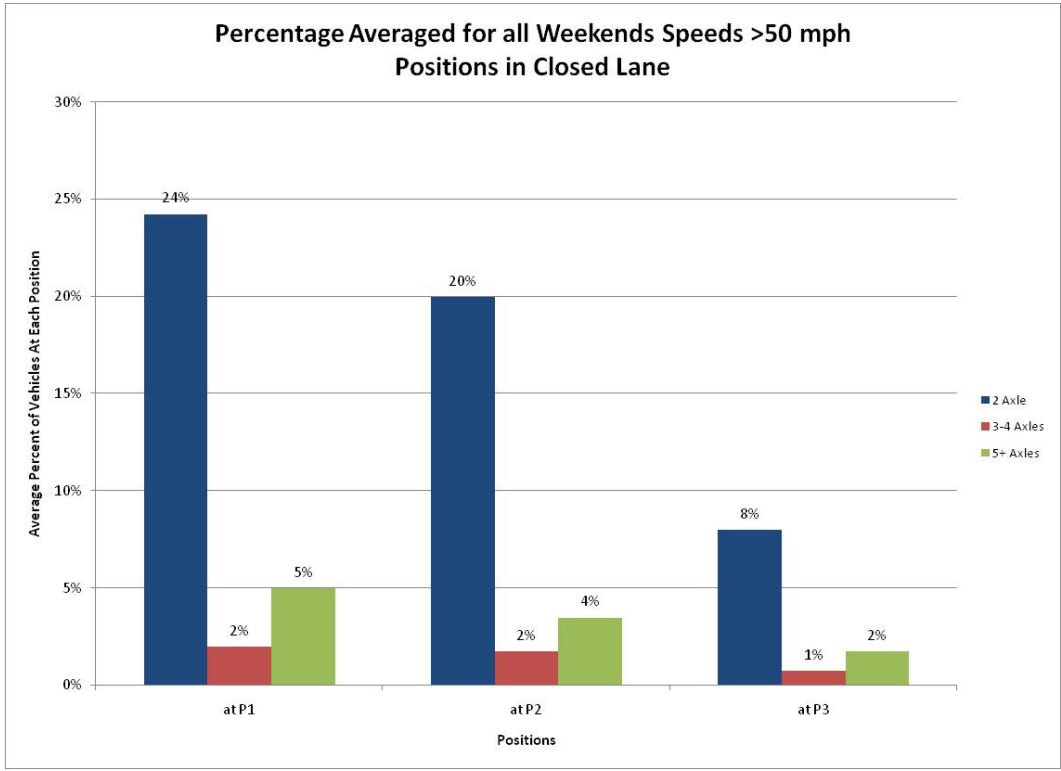
Figure 23. Free flow with DMS signs present but not activated

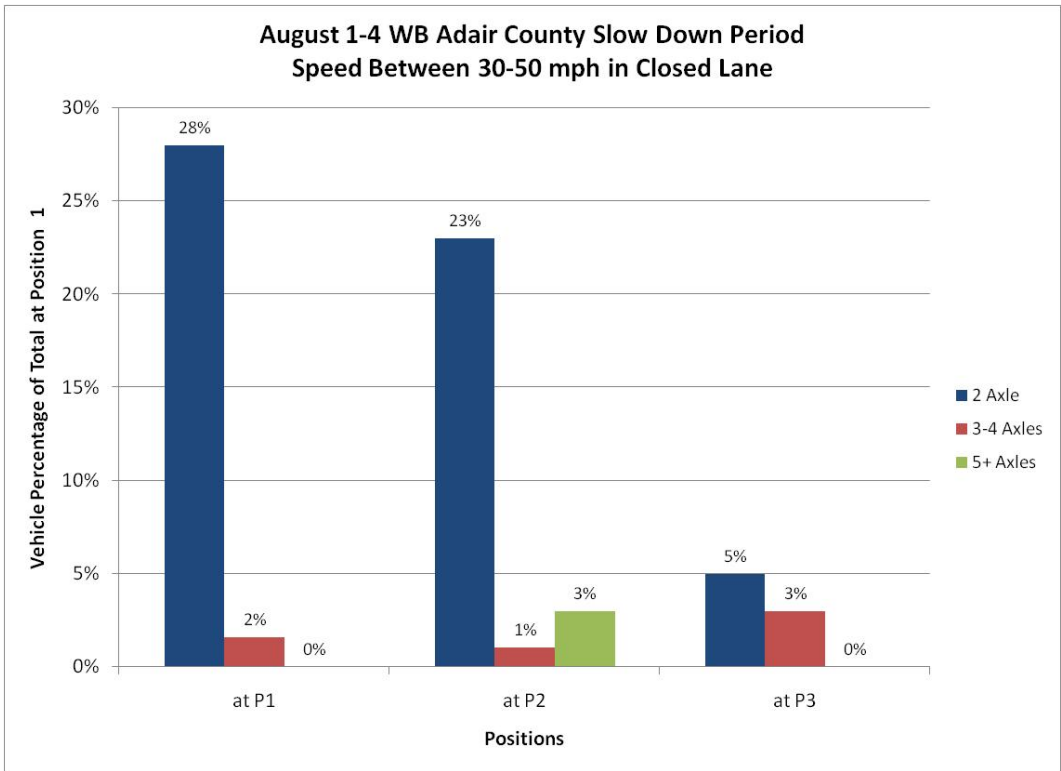
Figure 24. Transition flow with DMS signs activated

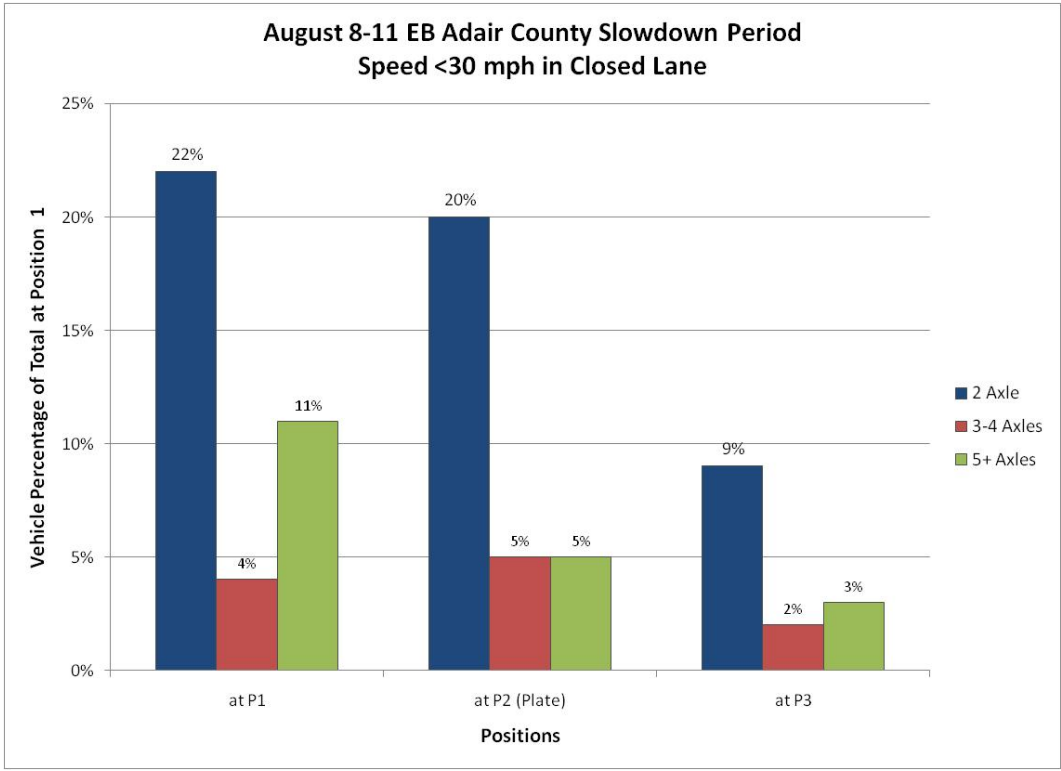
Figure 25. Congestion with all DMS signs activated

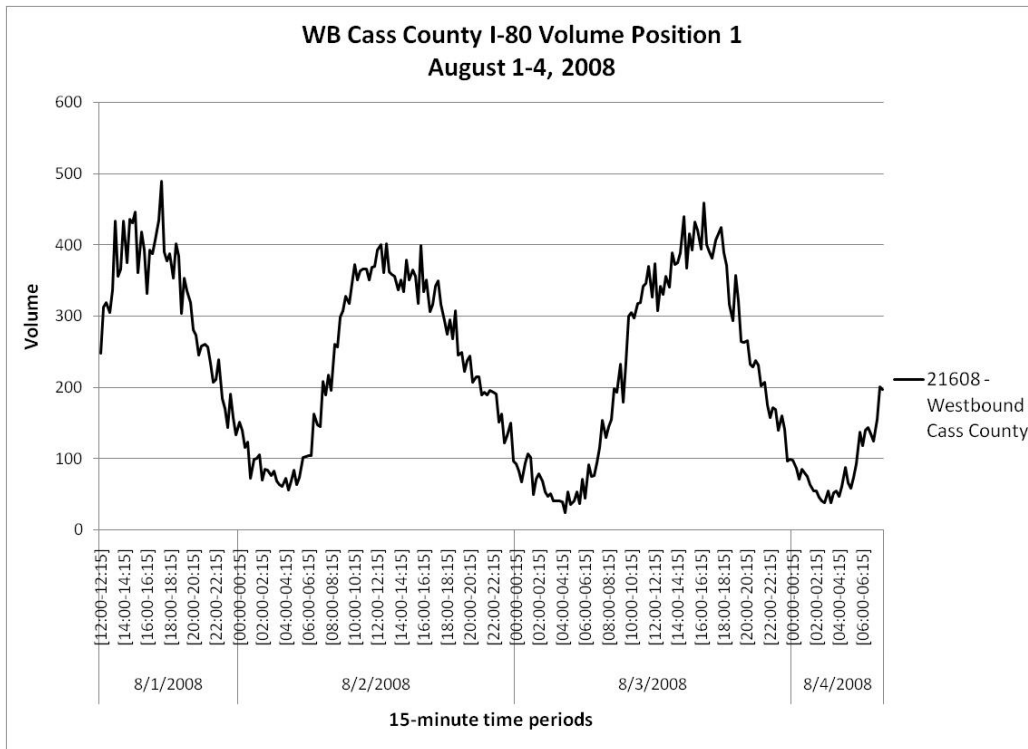
Figure A.2. Average vehicle volume (both lanes) at P1–August 1–4, 2008

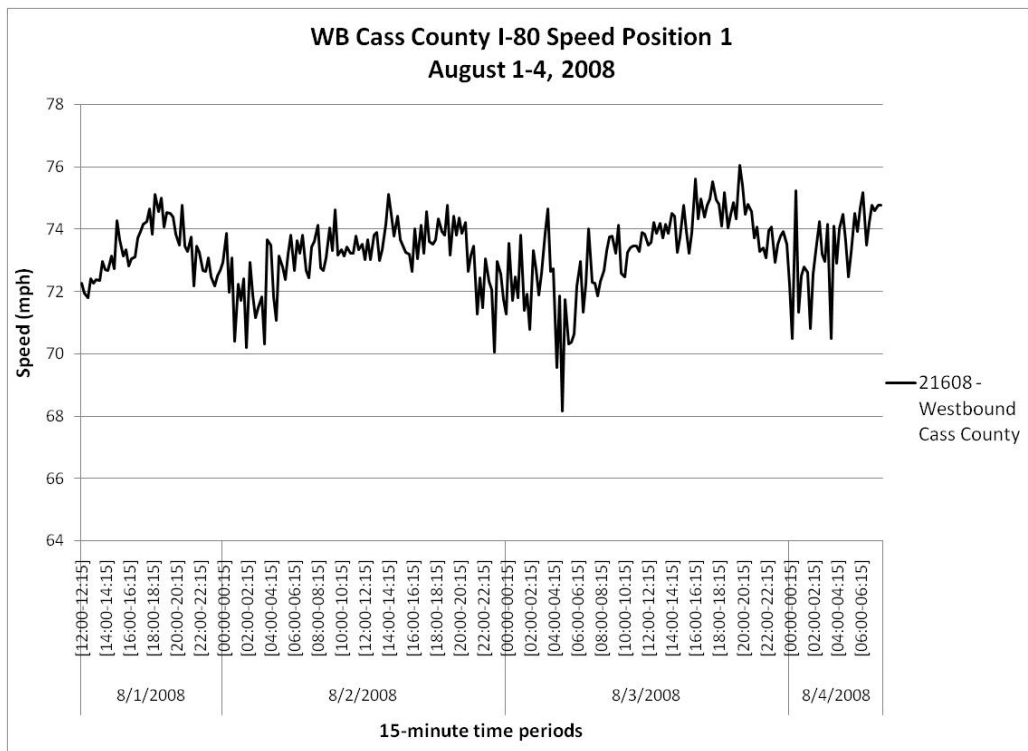
Figure A.3. Average vehicle speed (both lanes) at P1–August 1–4, 2008

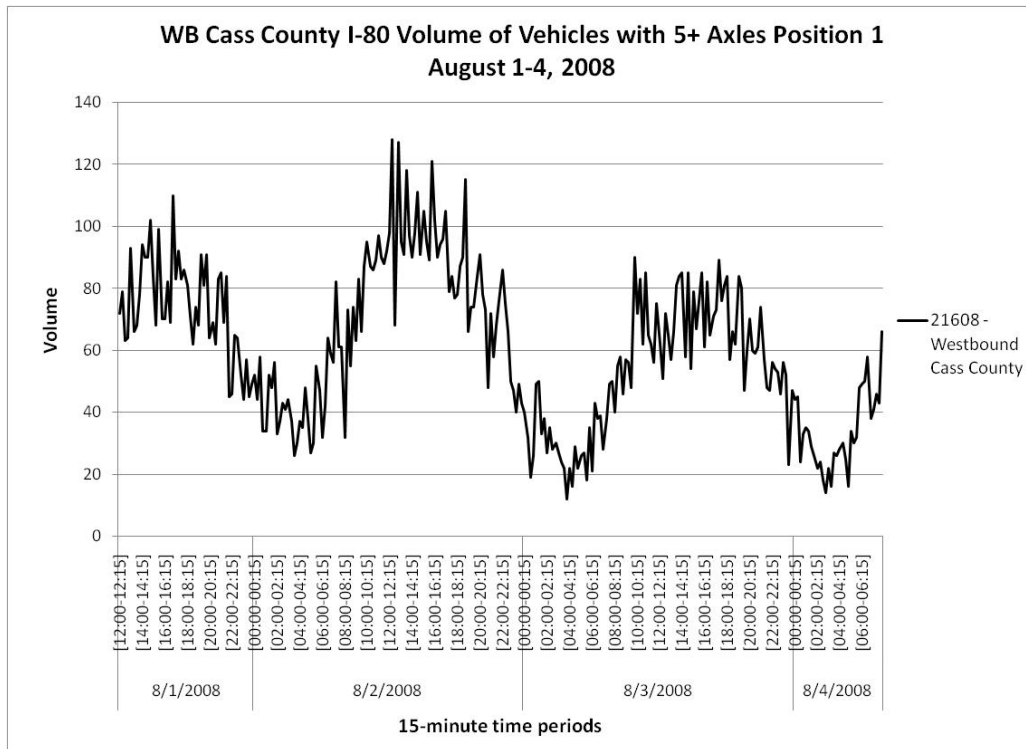
Figure A.4. Average heavy truck (5+ axles) volumes (both lanes) at P1 position–August 1–4, 2008

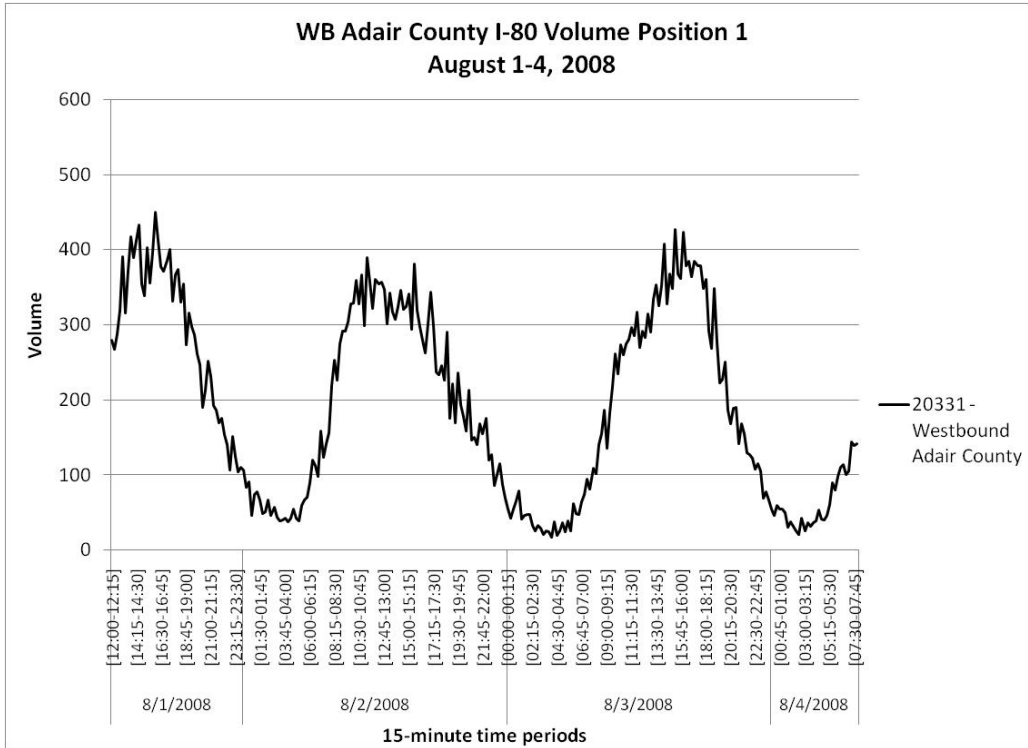
Figure A.6. Average vehicle volume (both lanes) at P1–August 1–4, 2008

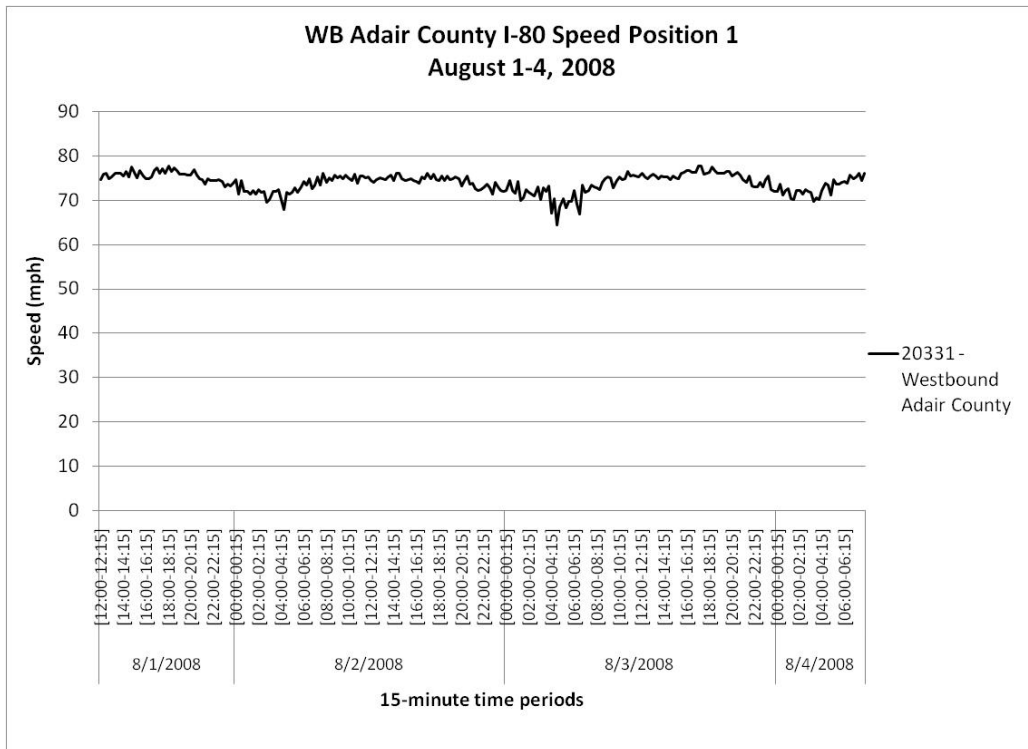
Figure A.7. Average vehicle speed (both lanes) at P1–August 1–4, 2008

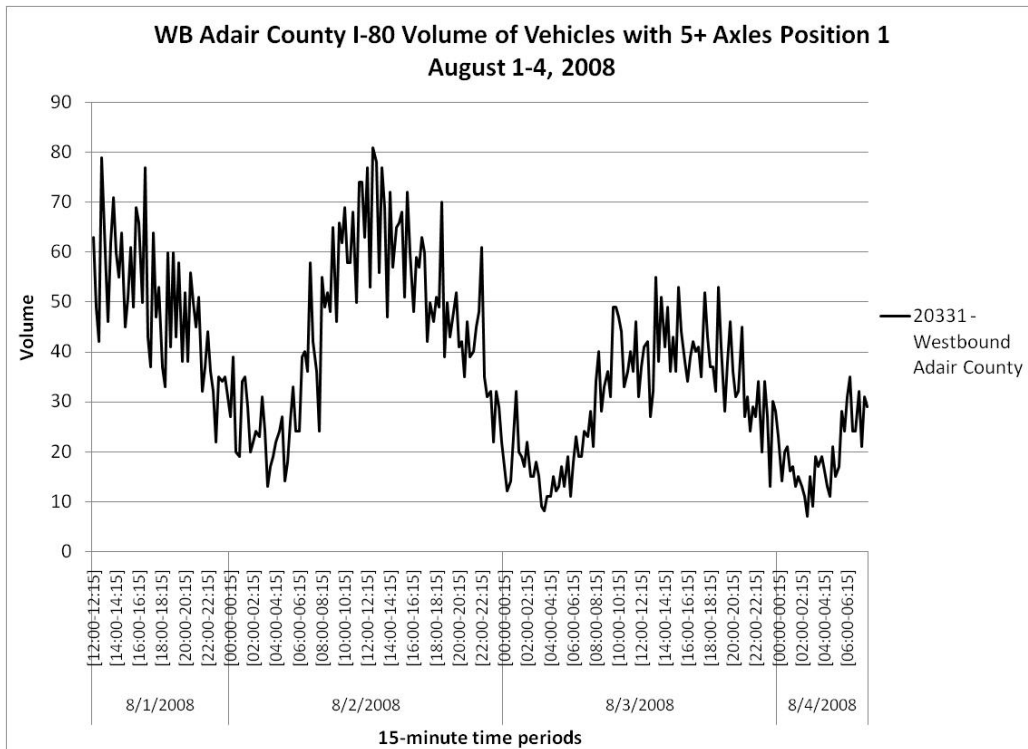
Figure A.8. Volume of heavy truck traffic at position 1 (both lanes) –August 1–4, 2008

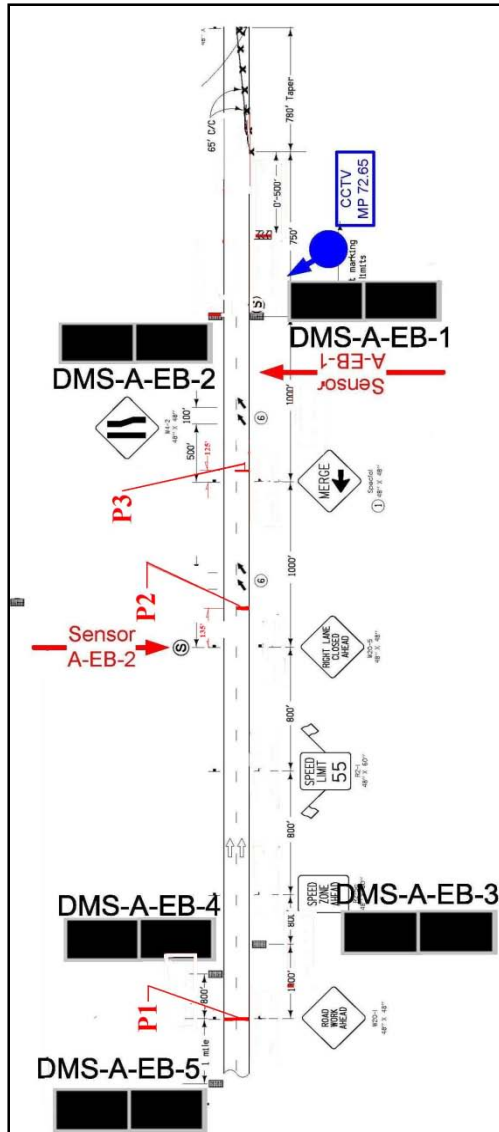
Data collection was conducted west of the construction site in the eastbound lanes. The driving lane was the closed lane at this location. Jamar road tubes were placed across both lanes at Position 1 (P1) prior to DMS’s 3 and 4. Road tubes were laid across the closing lane at P2 after the “Right Lane Closed” static sign and at P3 after the static “Merge” sign. NuMetric plates were deployed at each position in the same lanes as the road tubes.

Figure A.9. Counter placement–EB Adair County–August 8–11, 2008

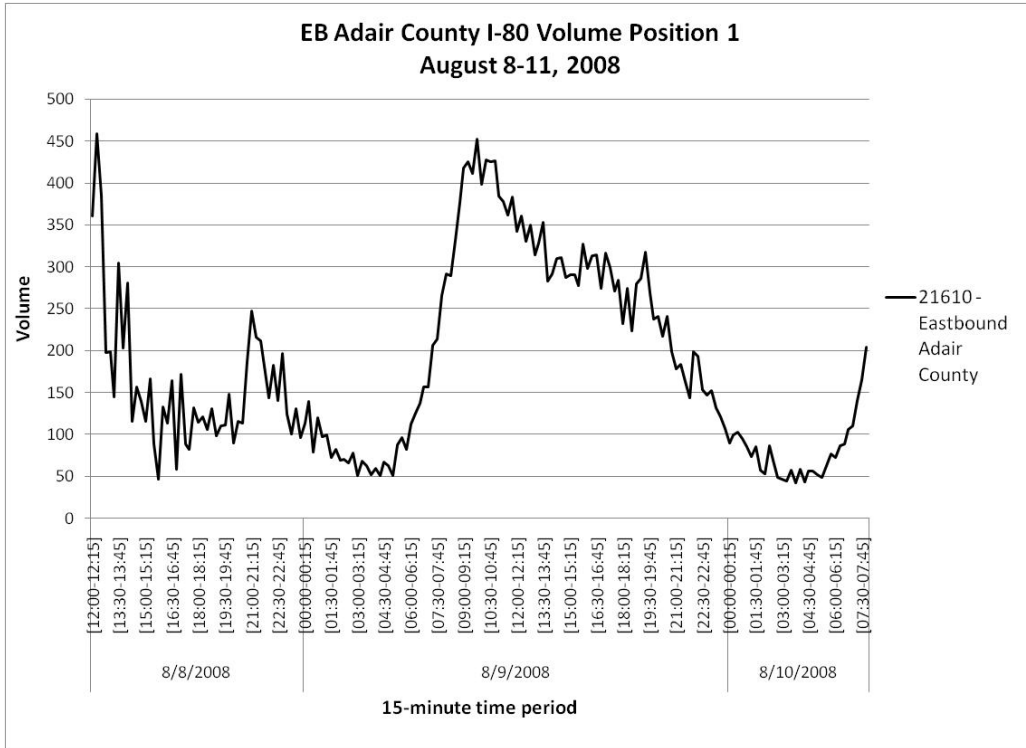
Figure A.10. Average vehicle volume (both lanes) at P1–August 8–11, 2008

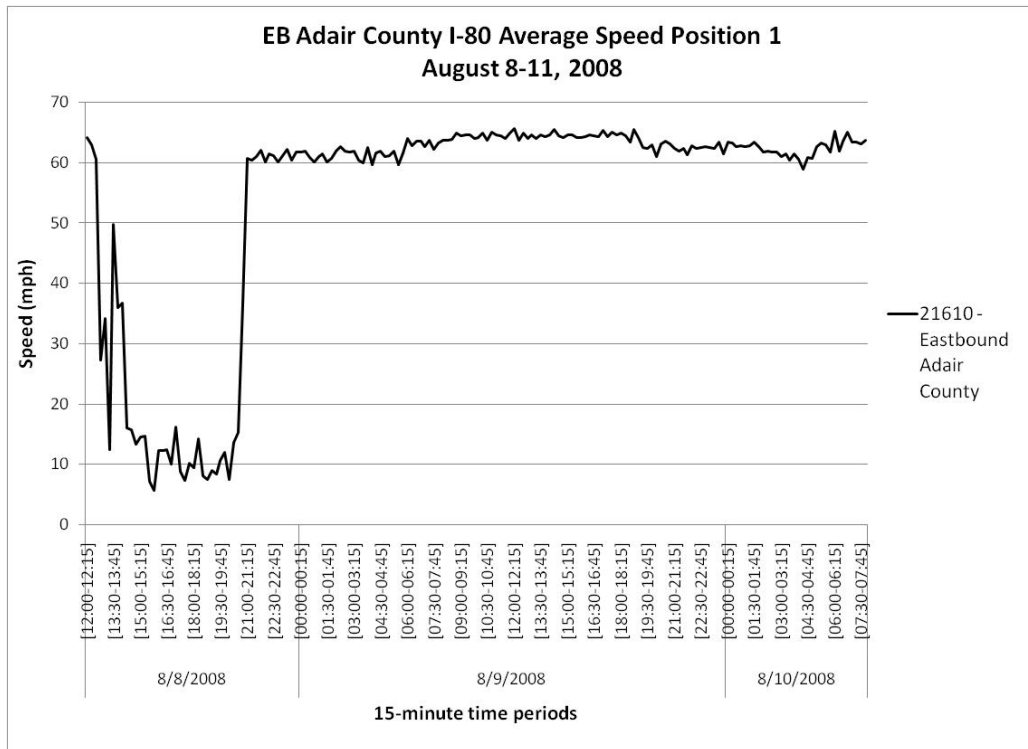
Figure A.11. Average vehicle speed (both lanes) at P1–August 8–11, 2008
