Effectiveness of Dynamic Messaging on Driver Behavior for Late Merge Lane Road Closures

Final Report
March 2009

Sponsored by
the Iowa Department of Transportation
(CTRE Project 08-327)

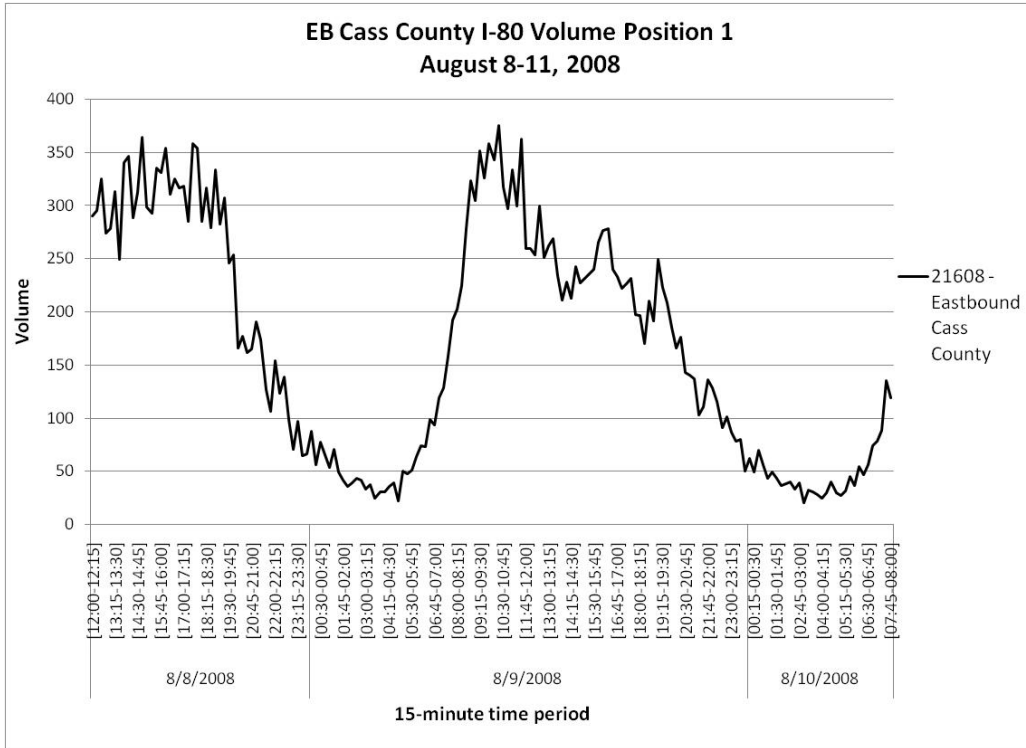
Figure A.14. Average vehicle volume (both lanes) at P1–August 8–11, 2008

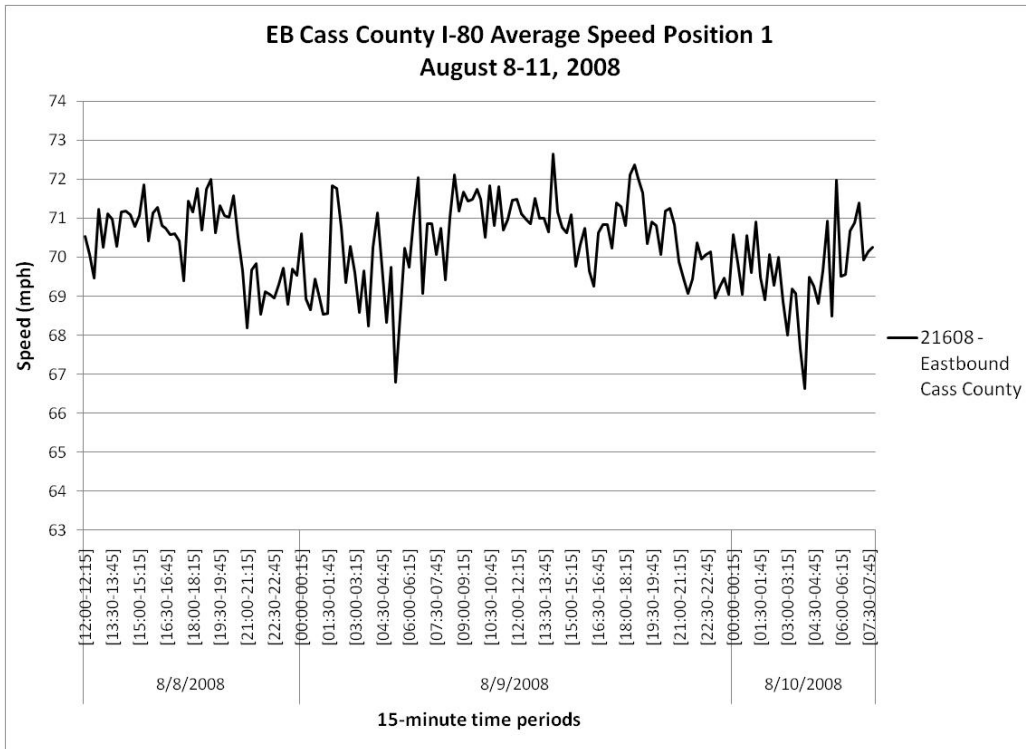
Figure A.15. Average vehicle speed (both lanes) at P1–August 8–11, 2008

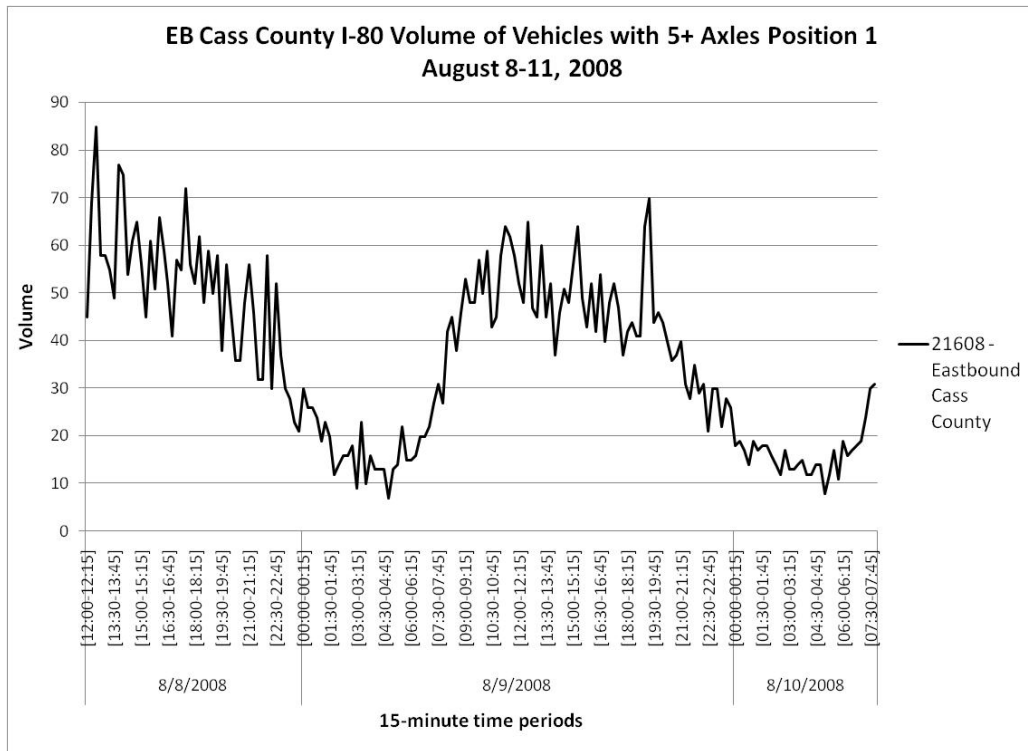
Figure A.16. Volume of heavy truck traffic at position 1 (both lanes)–August 8–11, 2008

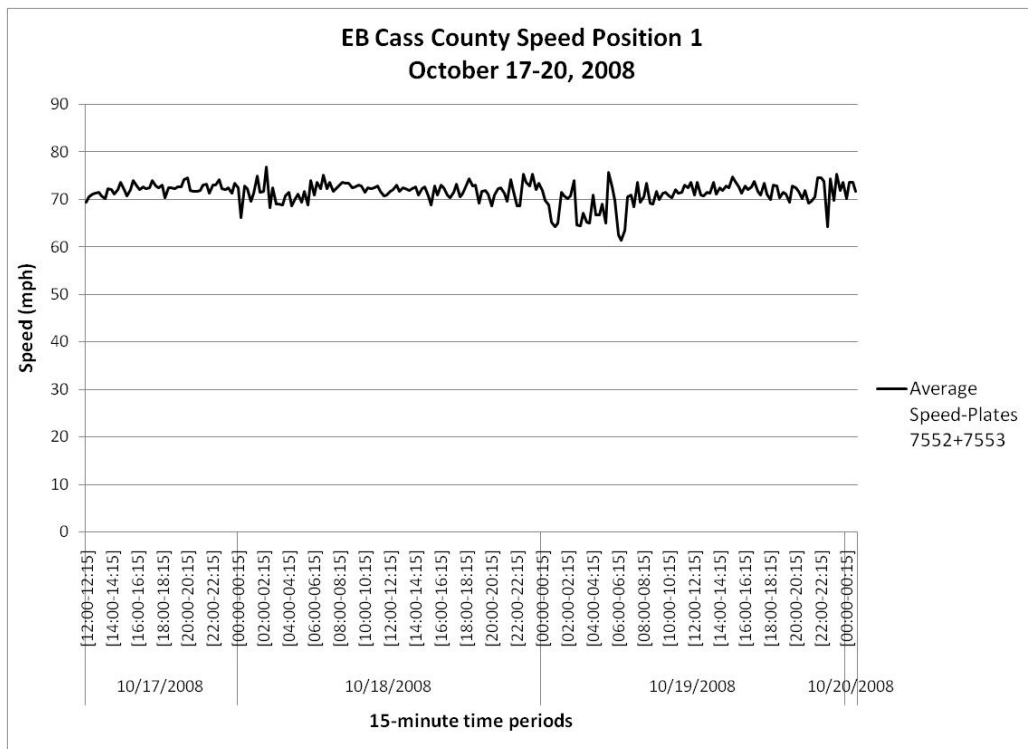
Figure A.22. Average vehicle speed (both lanes) at Position 1–October 16–20, 2008

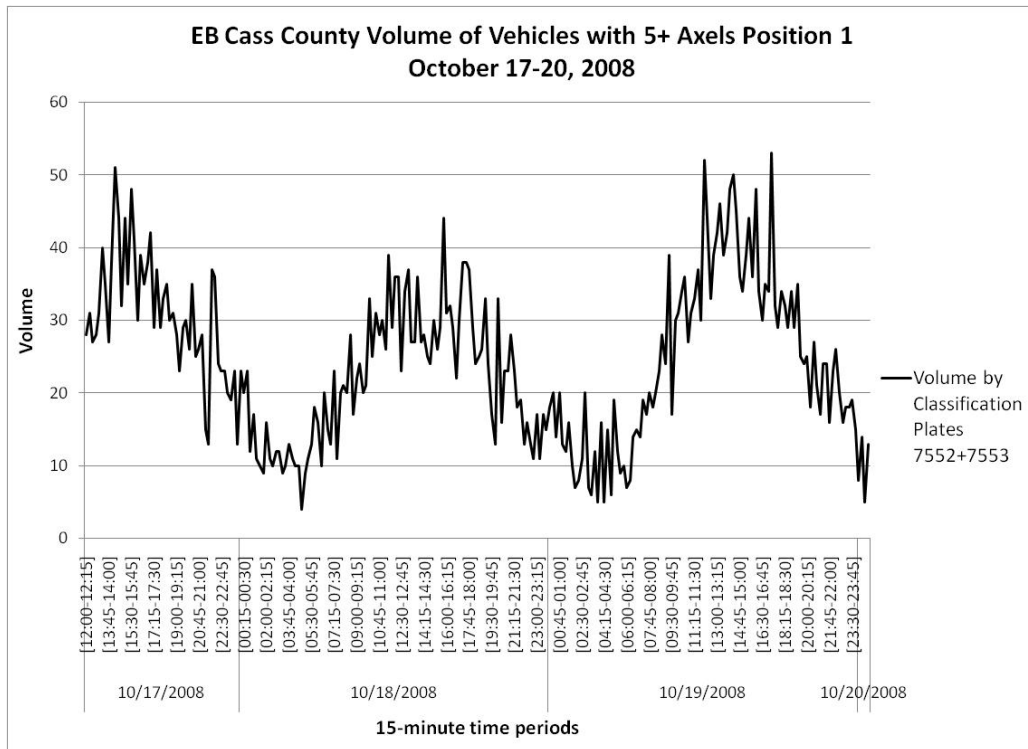
Figure A.23. Volume of heavy truck traffic at position 1 (both lanes)–October 16–20, 2008

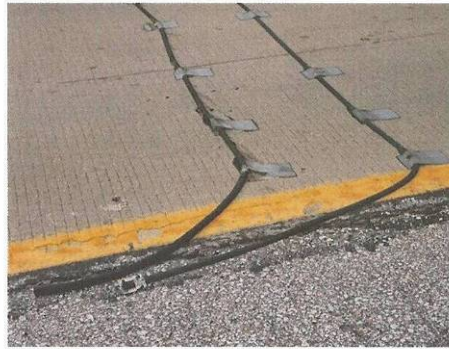
Figure C.2. Photos of damaged tubes, tape, and hold-down devices (continued) (photos by Brad Grefe)
